RAA Regional Road Assessment

# Eyre Peninsula

February 2015

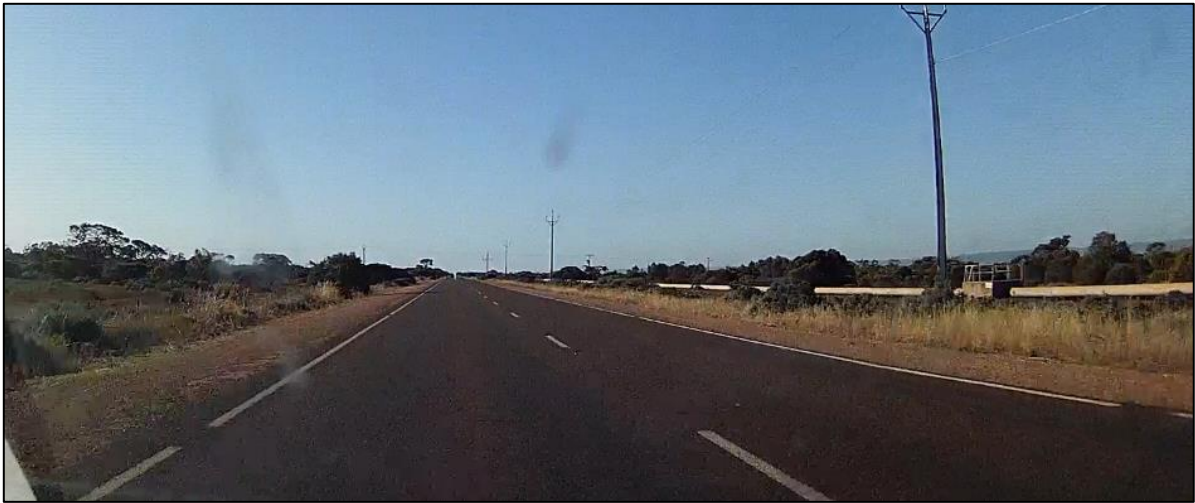
**Figure 4 – Typical road and environment between Whyalla and the Eyre Highway**

Roadside hazards along this road include small shrubs and trees on the roadside set back 3-5m. These can be quite dense in some locations, but in the middle section of the journey they became sparse as the terrain opens up for some long sections. There are also power lines that run alongside the road for approximately 2km on the southern end near Whyalla. These are set back approximately 5m and are another hazard that would benefit from construction of audio tactile line marking to prevent run-off road crashes occurring at that location. Each end of the road, closer to both Whyalla and the intersection of the Eyre Highway was where the most dense shrubbery and foliage was located. In these areas there is an animal hazard which is demonstrated by the crash history with a number of recorded

animal crashes in the area. It is also common for these types of minor crashes to not be reported to authorities. Therefore RAA also recommends the installation of kangaroo warning signs on the locations with dense foliage.

- Install audio tactile line marking for 5km on southern section
- Increase shoulder seal by 300mm for first 5km on southern section (prior to Point Bonython Road)
- Increase the frequency of hazard marker posts on bends where required
- Review key intersections and provide upgrades to address safety issues
- Investigate the presence of wildlife and the possibility for kangaroo warning signage on densely foliated areas

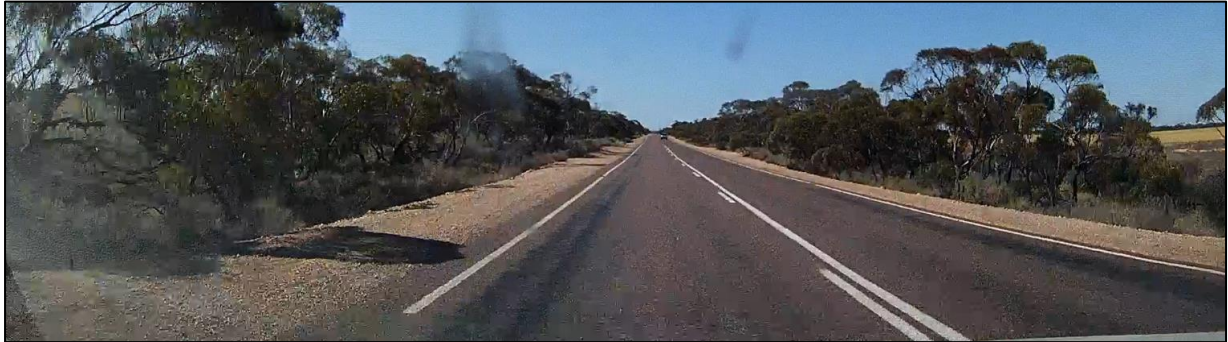
**Figure 5 – Typical road environment with bitumen bleeding, roadside drops and large trees**

The pavement condition varies from relatively poor condition on the southern section of the road then generally improves on the northern section. Exiting Cowell there are many sections of bleeding and rutting on road. There was also evidence of edge break which had previously been repaired. Ride quality was quite smooth and pleasant to drive on despite the rutting. At approximately 29km from the start of the trip meter, the pavement condition improves with no signs of bleeding or rutting. At this location the texture is quite good with a coarse surface. The surface remains unchanged for another 35km. Just north of the Kimba-Whyalla road intersection the road surface changes in colour and becomes more rutted with bleeding on the passenger wheel path. After 83.3km there were some small sections of edge break and edge drops of 50-80mm from the sealed surface to the unsealed shoulder. The shoulders should be regraded with extra material at this location.

Small to medium shrubs and the occasional large tree are present on the roadside for the majority of the journey, and there are only a couple of sections of road where the foliage opens up for short sections of up to 2km. Roadside drops were occasionally seen, and some of the worst were already protected with W-beam or wire rope barriers. There were some unprotected roadside drops recorded at 5.34km, 44.4km, 48km, and 56.3km from the trip meter which should be protected with barriers. There were also Stobie poles on right and left hand side on the exit from Cowell, although these veered away from the road after 1km. There were numerous rises to the side of the road where the road surface has been cut into a hill. At these locations the rises are within 1m of the seal and are hazardous for run-off road crashes. These are protected with hazard boards at the beginning of each rise. It was noted that in some locations near the 40km mark, the unsealed shoulder consisted of quite loose dirt and was soft and unkempt with grasses and tufts of plants growing on it. At approximately 82km, sheep were encountered on the roadside which is also hazardous for vehicles driving this route especially if this occurs in a location where trees and shrubs block

the view of the animals. If sheep regularly escape from the paddocks in this area, animal warning signage may be required.

- Install audio tactile line marking for entire length to reduce run-off road crashes
- Repair to sections of rutting and bleeding on the southern end of the road near Cowell
- Relocate 110km sign on exit of Cowell to after the sharp bends
- Regrade shoulders with extra material approximately 40km from Cowell

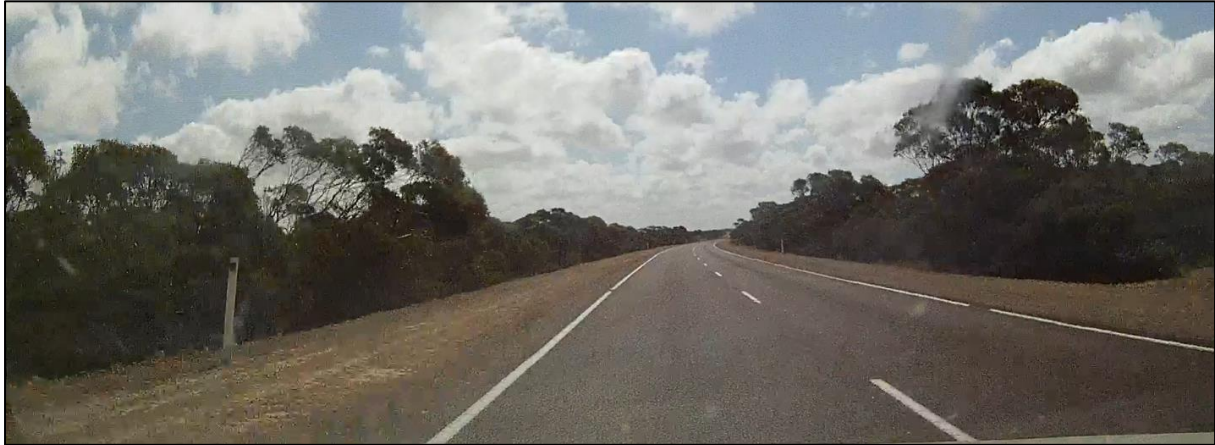
**Figure 8 – Typical road environment with roadside drops and trees beyond**

The major roadside hazards for this section of road were trees, shrubs, and roadside drops of up to 3m. Roadside drops are very common along this road. Some drops were larger and steeper than others. Drops of more than 3m should be protected with W-beam barriers especially when situated on the outside of sharp bends. Currently unprotected drops of this magnitude were recorded at 18.1km, 25.8km, 30.8km, 37.3km and 95.9km from Elliston (trip meter was started at the intersection of Memorial Drive and the Flinders Highway). On the exit from Elliston, Stobie poles run alongside the eastern side of the road for a short distance which are a safety hazard and should be protected with hazard boards. There were some significant trees noted within 2.5m of the road seal at 27.8km which would also benefit from hazard board protection.

The trees and shrubs progressively became more significant and dense when travelling further north. An animal hazard is also present with the high number of kangaroos in the area and consequently, a high number of recorded hit animal crashes. A number of kangaroo warning signs were seen. On the day of the assessment a sheep was encountered on the road approximately 20km from Elliston. Further up at 24km a large number of sheep were seen outside of their paddock on the roadside which is also a threat to motorists.

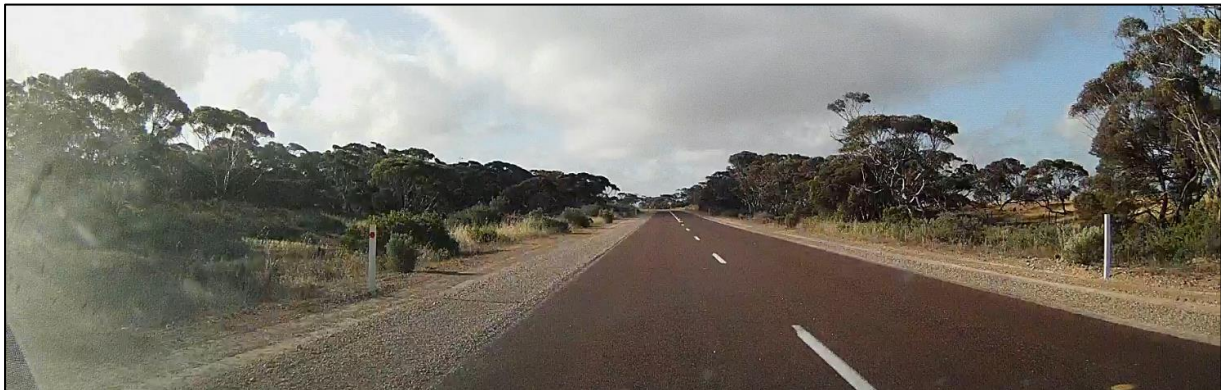
**Figure 9 – Typical road environment with roadside drops, trees beyond and lack of edge lines**

also noted which should be protected with W-beam barriers. These drops were noted at: 50km and 64.9km from Streaky Bay (using the trip meter). There are some sections of road where the trees and shrubs become less dense and pose little threat to run-off road incidents. The shoulders at the time of assessment were noted to contain lots of loose material. There was also times where it was difficult to determine where the shoulder starts and if the shoulder was sealed or unsealed due to the position of the sun. This can be misleading and dangerous should a vehicle accidentally hit the loose material. It is highly recommended that the shoulder seal be widened along this section of road and edge lines be painted.

The combination of narrow lanes and shoulders with loose material was also noted to cause large pieces of the loose material on the shoulders to flick up, which would reduce with sealed shoulders and edge lines.

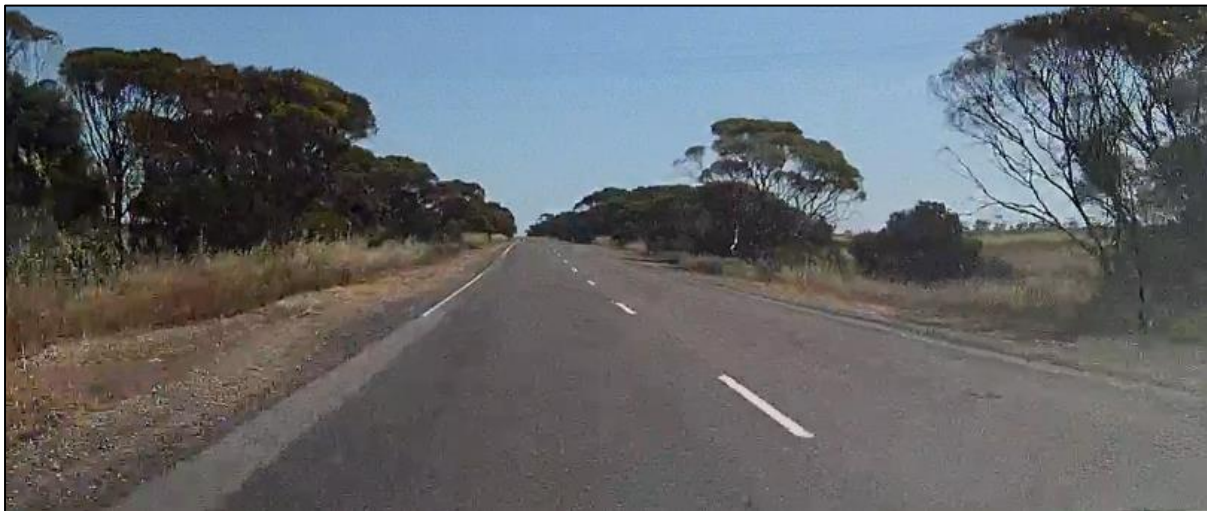
**Figure 12 – Inconsistent edge line marking**

The lane widths and line marking was quite inconsistent along this road. Along the first section of road the line marking is slightly faded but still providing a good delineation. There were no edge lines and a 3.6m lane in westerly direction and 3.3m easterly direction with a 2m unsealed shoulder on both sides. After 11.3km, edge of carriageway lines were added on the very outer edge of the road causing very little if at all, sealed shoulder. Some sections of the edge line were sealed over and not visible because of the edge break patching. After 12.8km, edge of carriageway lines were moved in from the edge of the road, which caused the lanes to become 3.3m with a 0.3m sealed shoulder, which is good because it helps to keep vehicles away from the edge of the seal, while still providing extra room if required. At 29.8km, the edge line appears to move closer to edge of seal again, only providing 200mm to 300mm sealed shoulder and approximately 3.2m lane width. The condition of the line marking improves to the west and provides a good contrast to the road surface. The lanes and line markings don't change again until Bramfield. At 58.3km the edge lines disappear for a short section of 400m and then return. After passing Bramfield, the edge lines disappear and the lane widths appeared to be between 3.4m and 3.5m in both directions.

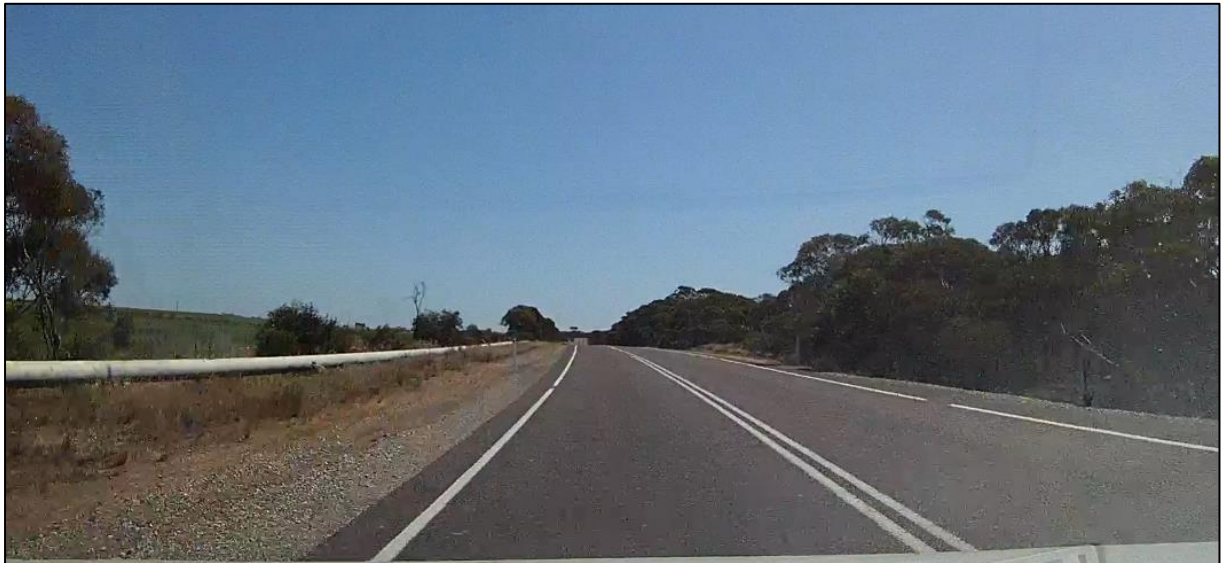
**Figure 13 – Roadside hazards – High pressure pipeline (left) and edge drops with vegetation (right)**

The photo below displays some of the roadside hazards encountered on the assessment. A large high pressure pipeline is on the left. A roadside drop of 1m is on the right, with large trees beyond.

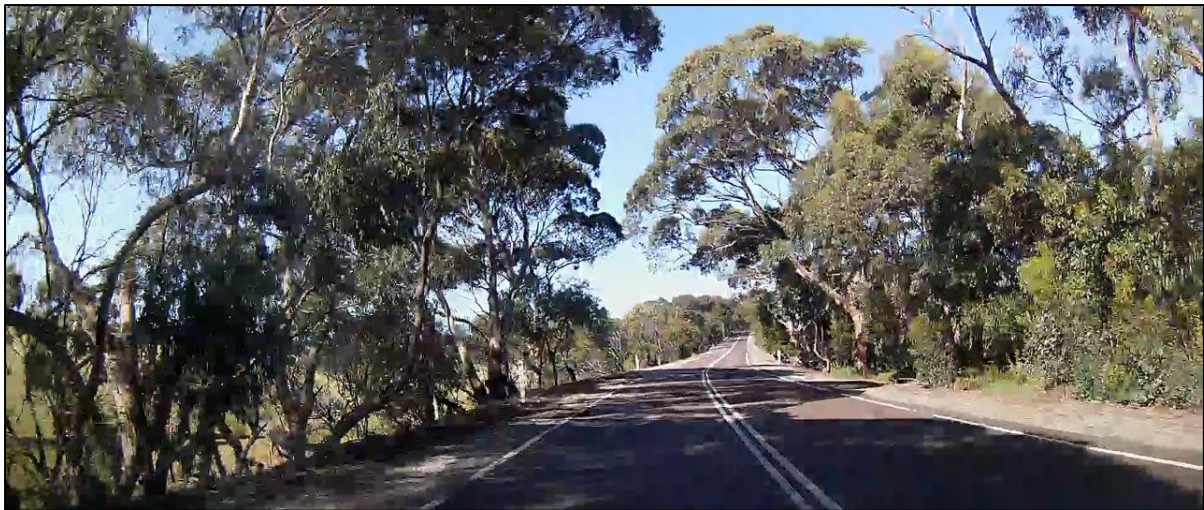
**Figure 18 – Significant vegetation with large drop (left)**

On the outskirts of Cummins there are steep roadside drops of up to 1.5m with medium to large trees set back another meter beyond. At 11.7km there is a bend to the left in the road which has a steep unprotected drop and significant trees beyond. A seal extension to provide sealed shoulders and ATLM would be advisable for this bend and others of similar nature. After 17km there are many significant trees lining the roadside, which are set back only 2m from the sealed surface and this section would again benefit from an extra sealed surface and ATLM. At 29km there are very large drops of up to 10m that are protected with W-beam barriers. In this area there are also smaller drops of 5m that are currently not protected. These should also be protected with barriers. In areas where these roadside hazards are not protected with W-beam barriers, the sealed shoulder should be extended and ATLM should be used to prevent run-off road crashes from occurring. The figure below shows a section of road with significant trees and large drops that are a hazard for run-off road crashes.

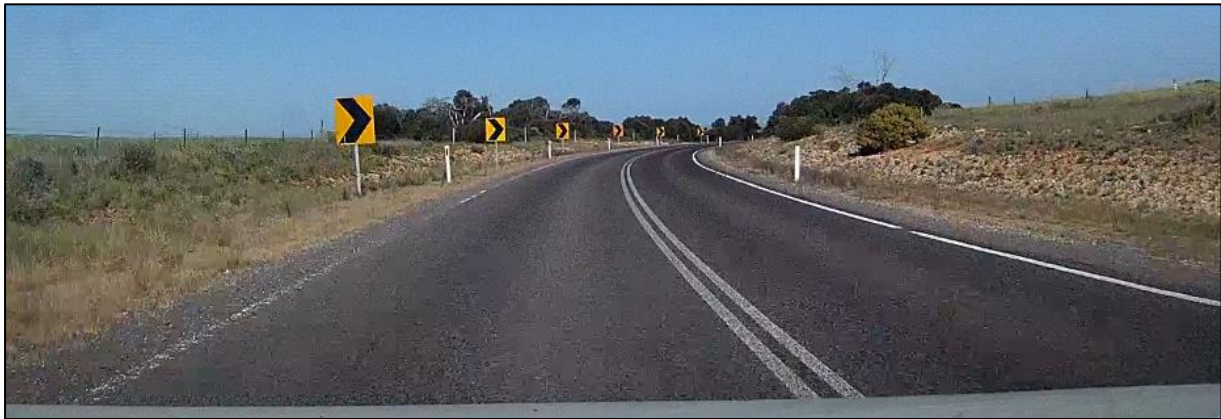
**Figure 19 – Chevron Alignment Markers provide clear delineation on bends**

Along this route, it was noted that hazard markers are in good condition and used in 150m spacing and increased in frequency on the bends. Speed limits are well signed, with a number of repeaters after major intersections. Chevron alignment markers were used well to delineate the major bends in the road and can be seen in the figure below. It was noted that there wasn't any distance advisory markers for Cummins. On entry of Cummins, on the intersection with the Tod Highway just prior to the rail crossing, the give way line is set back too far from the road and doesn't allow a good position for determining if safe to cross. This line should be moved further forward. The disused rail crossings still have faded give way signage and pavement markings which should also be removed.

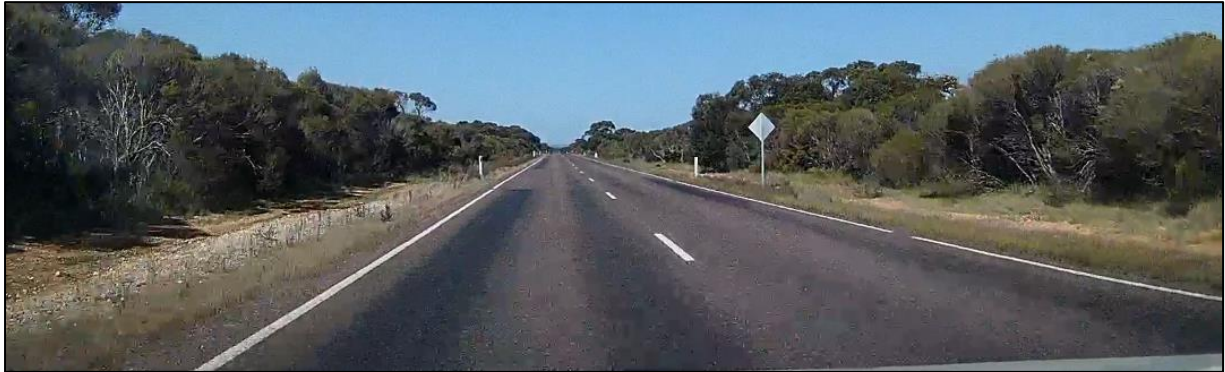
**Figure 20 – Bitumen bleeding under wheel paths**

were recorded at 20.5km and 30.5km before they become large and damage vehicles. There was evidence of more repairs to the road at 31km which has attempted to patch over bleeding surfaces but still requires more work. The ride quality however is smooth with only a few bumps. After 31.9km, the road condition improves slightly until Cummins with much less rutting and bleeding with occasional patches to edge break.
