Mid North

RAA Regional Road Assessment

October 2015

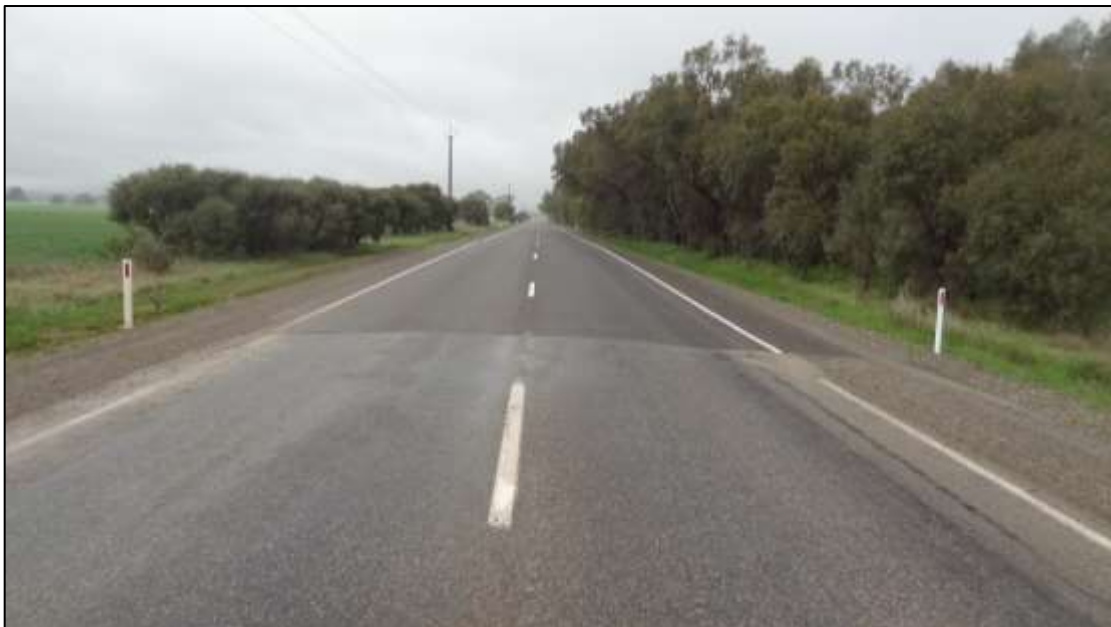
There was no sealed shoulder between Georgetown and Gladstone but from a point approximately 1km north of Gladstone, there were sealed shoulders of between 1 and 1.1m provided through to Laura. RAA welcomes the seal extension that has been undertaken on bends between Laura and Stone Hut. Along this section of the B82, RAA wish to see an increase in the lane widths to 3.5m with a minimum sealed shoulder of 300mm.

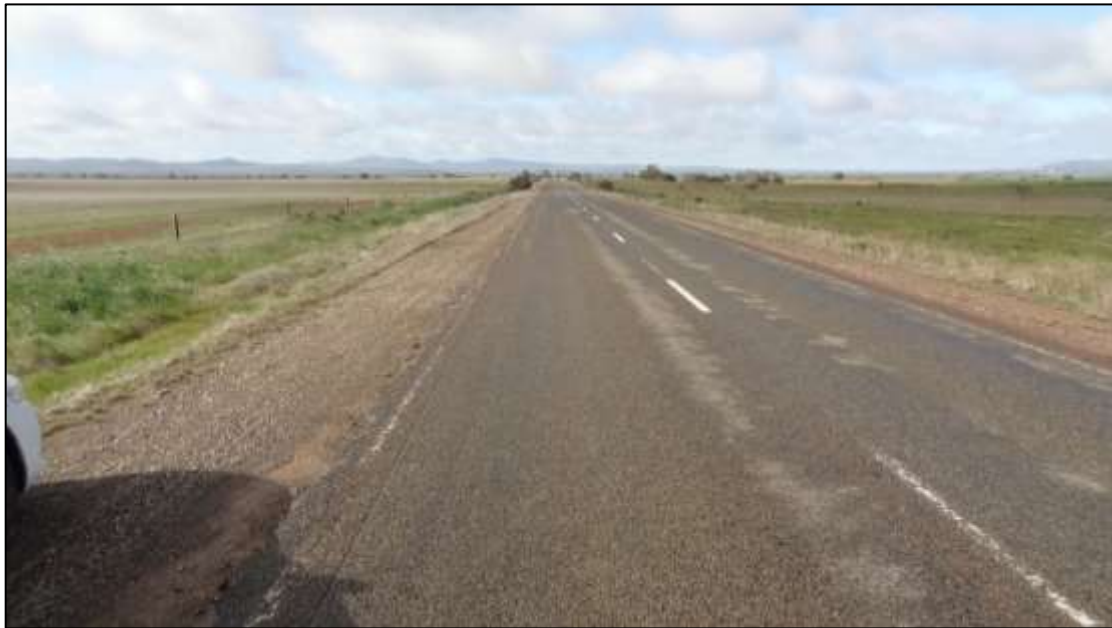
The quality of the line marking was good between Cradock and Carrieton, having appeared to have recently been refreshed, and was highly visible in the conditions encountered.

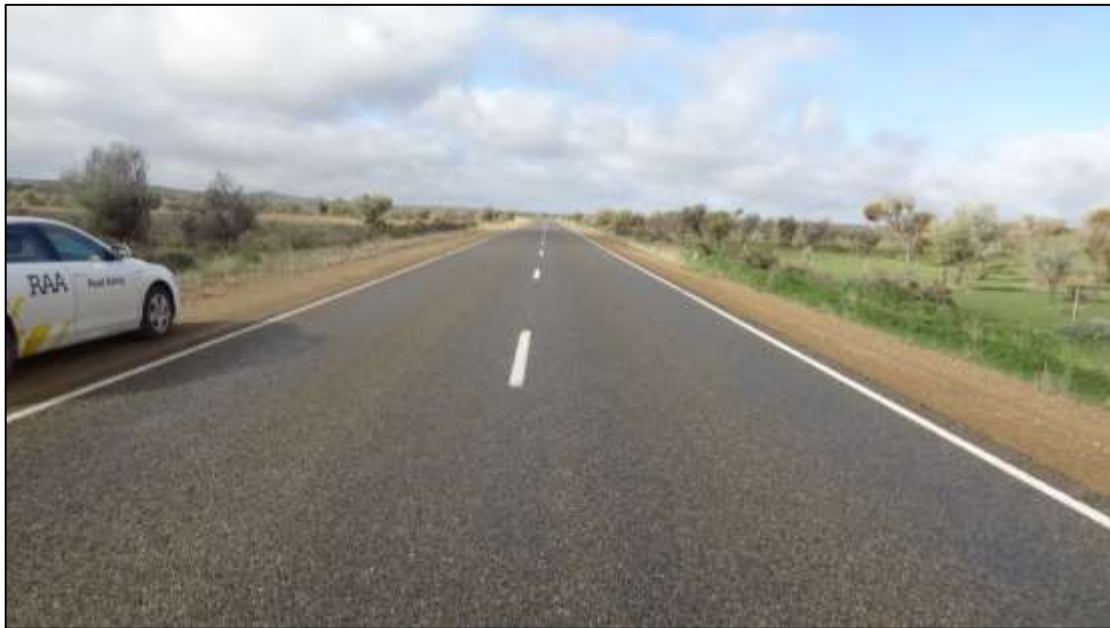
By contrast, the line marking between Carrieton and Orroroo was badly faded and about 84km south of Carrieton, had almost completely faded away. Prior to Orroroo, the centreline marking appeared to have been recently refreshed but the edge lines had not been marked at the same time. It is therefore recommended that the line marking be refreshed along this section as a priority.

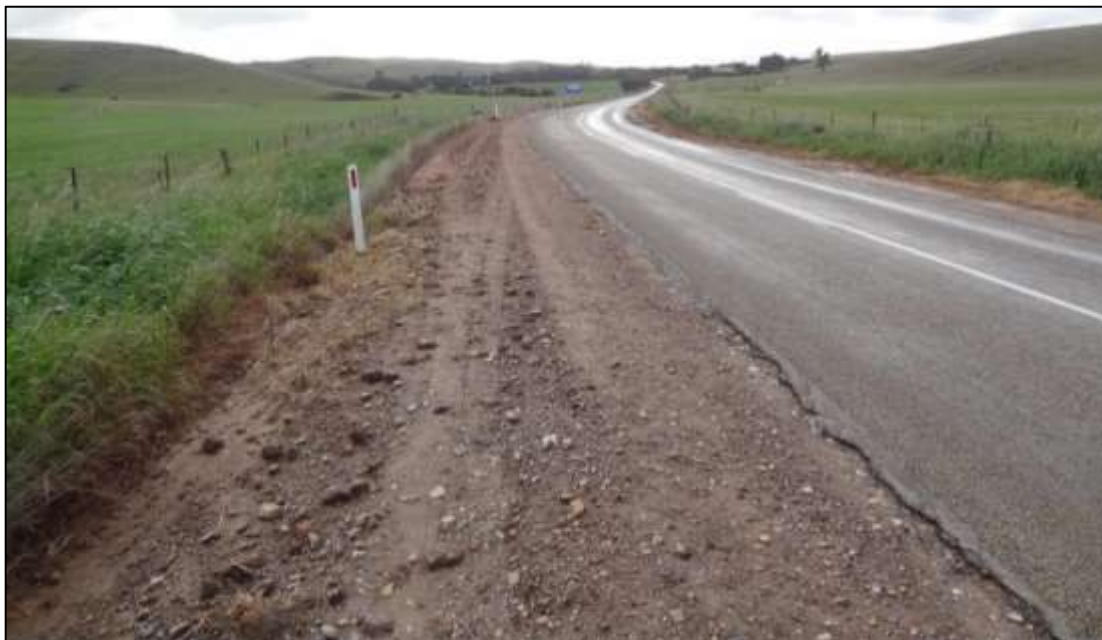
At 8.4km the road surface improved somewhat with what appeared to be a reseal that happened sometime in the past. With this the ride quality improved with less pot holes and patches, however at the same time the road showed signs of rutting and bleeding on the surface. Both of these issues persist for a further 15km and quite often water was observed pooling in the ruts which were often located on the passenger wheel path.

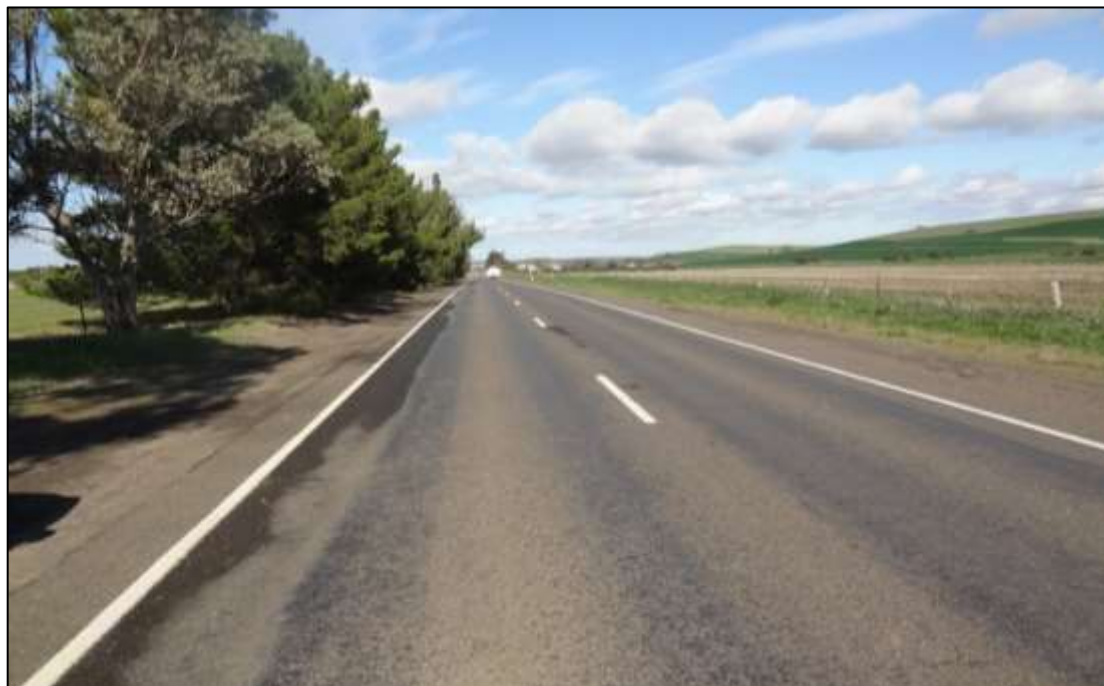
On the southern half of the highway between Hansborough and Kapunda, the rough ride quality, rutting, bleeding and general texture of the road improves somewhat with the exception of severe rutting and bleeding at 15.33km. The final 12km of road before Kapunda displays very severe edge break which appears to be crumbling away and causing the shoulders to be highly variable in width.

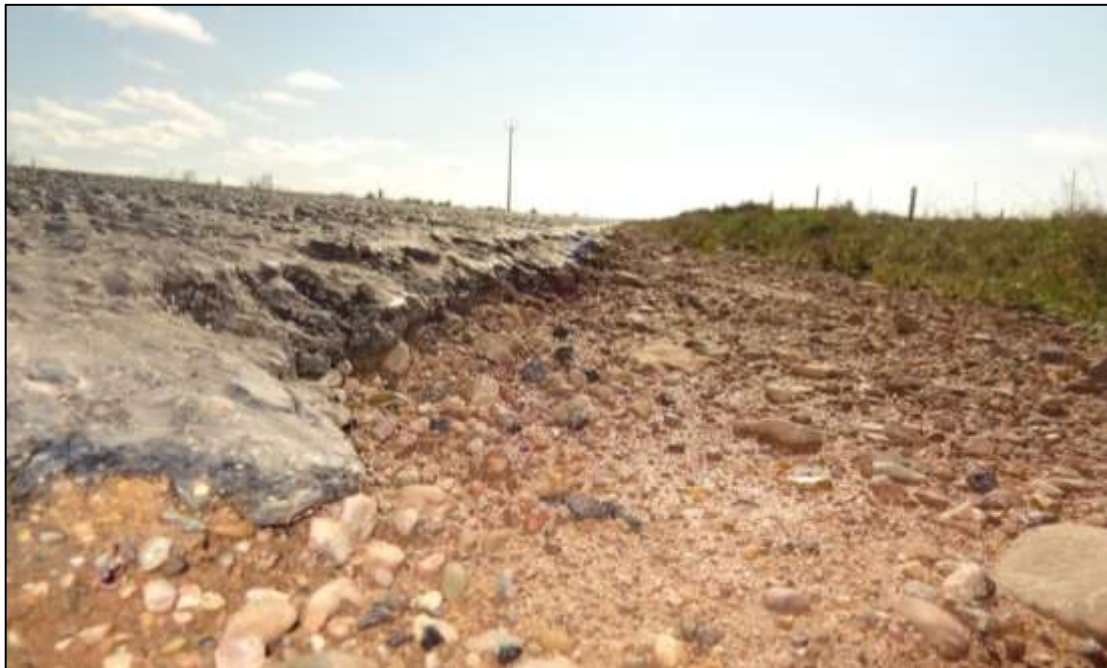
The texture was also quite poor and it appeared that the surface was becoming worn down to a smoother macro and micro texture. Despite this the road surface was not smooth. The ride quality was poor because of many bumps and undulations. These bumps were often but not always caused by small sections of patching and repairs. Rutting and bleeding was again very common along this section of road, particularly when closer to Eudunda. The surface at 15.95km was particularly bad and should be remediated.
