OUTBACK

Regional Road Assessment

August 2015

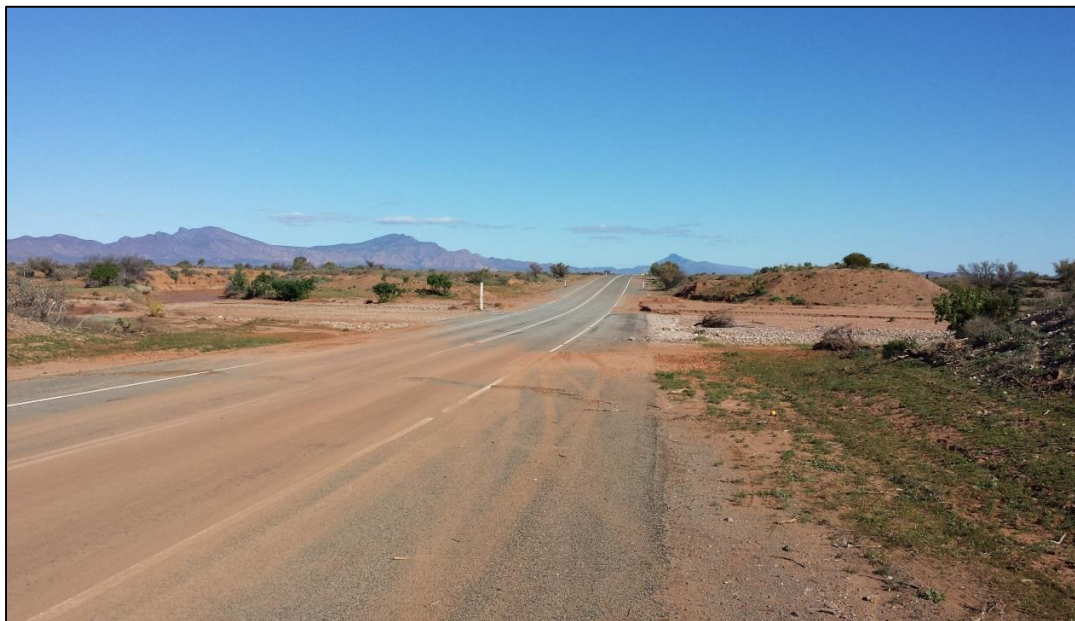
A number of floodways had sediment deposits across the road and could present a skid hazard in wet weather. Warning signs to advise of slippery road conditions may be appropriate where consistent sediment deposits are found.

Figure 4 – Sediment has washed across the road and could create a skid hazard under wet conditions.

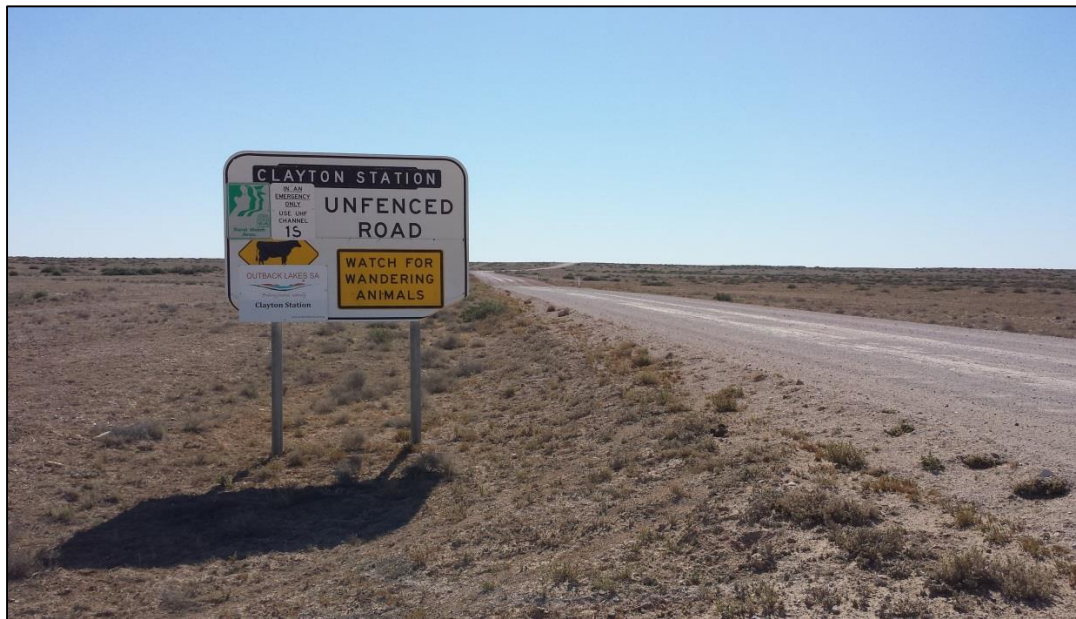
The survey noted that some warning signs had unauthorised promotional signage applied directly over the sign or on the same pole. This should be discouraged since the additional signs detract from the key message. DPTI may consider providing a facility in appropriate locations to allow promotional or community information signs to be displayed.

Figure 8 – Additional unauthorised signs have made this warning sign cluttered and difficult for the motorist to read.

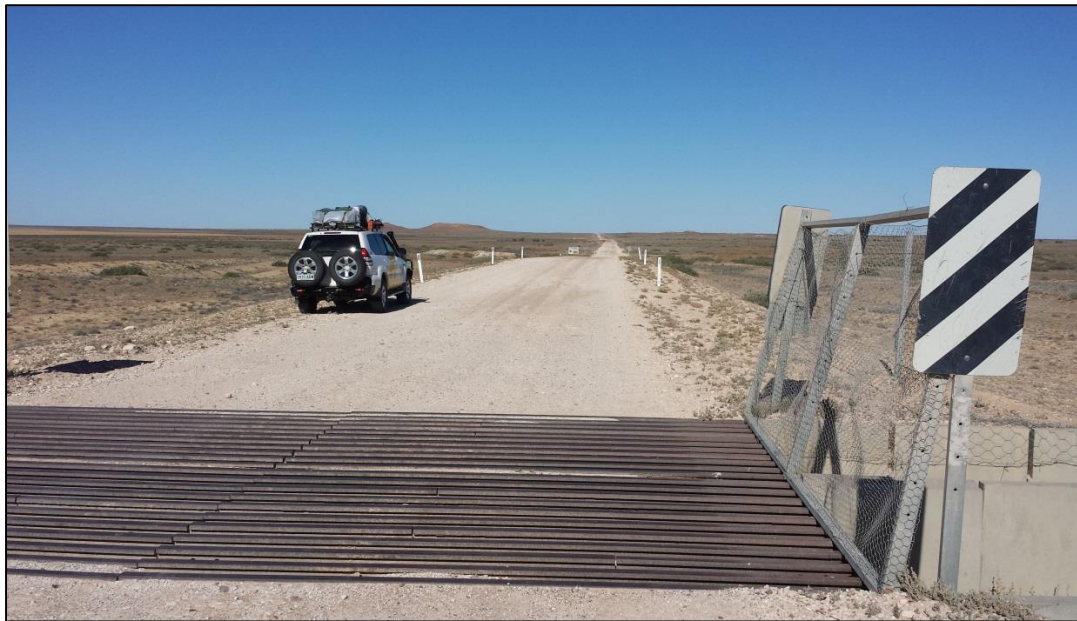
On approach to cattle grids, warning signs for a grid ahead have been provided and the edges of the grid have been marked with hazard boards however due to the extent of the reduction in road width passing over the grid, “Road Narrows” signage should perhaps also be included.

Figure 9 – Hazard boards have been provided at grids where the road narrows but little protection is offered from the drops on either side.

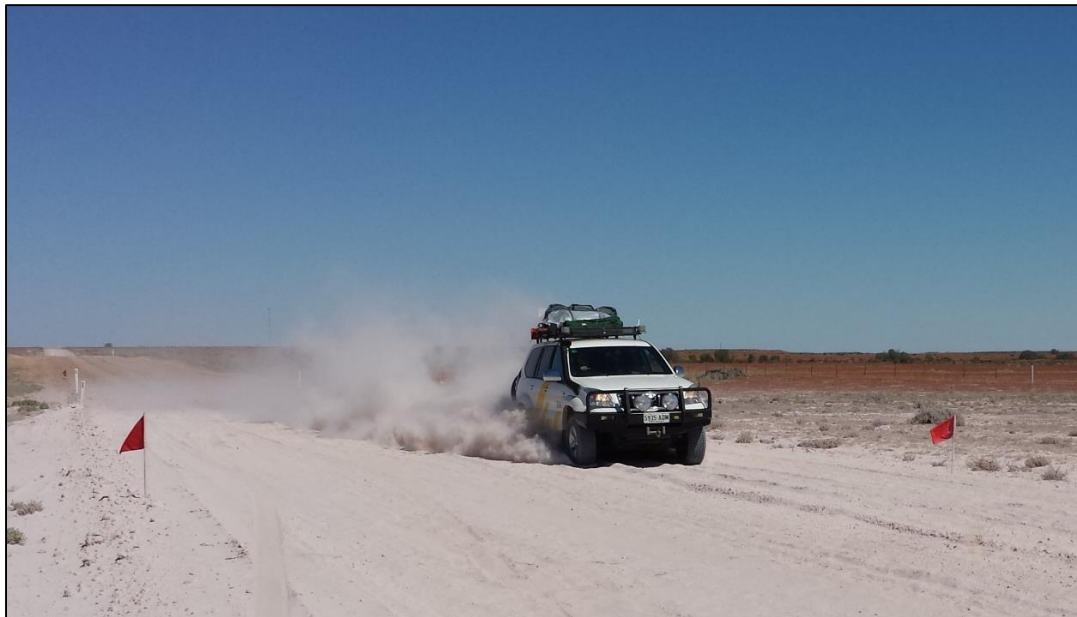
Bull dust holes are ruts or depressions in the road that gradually fill over time with a talcum-powder like dust and usually occur in areas that are subject to flooding or ponding and then dry. They are particularly dangerous because they are hard to see and often the road looks smooth and driveable. The dust has no bearing capacity and if hit at high speed, they have been known to cause blowouts, break suspension and cause vehicle rollovers. Passing over the bulldust holes at lower speed could still cause dust to suddenly rise around the vehicle and seriously restrict visibility. During the assessment, RAA encountered a number of bulldust holes, many of which had been marked with red flags to warn drivers of their presence. Because the surface of the road frequently changes between in the wet season between grading runs, the red flags seem to be most effective way of warning motorists about these hazards.

Figure 10 – Bull dust holes have been marked with red flags. They create a rollover risk and severely restrict sight distance for any vehicles following or passing the vehicle travelling through them.

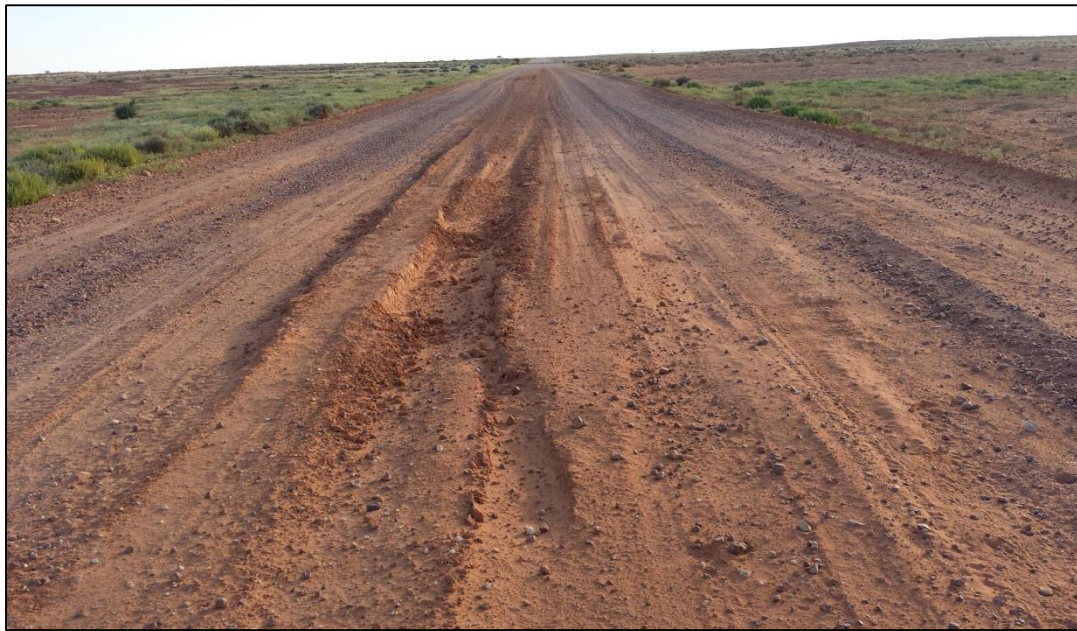
There was one exception to the ride quality which occurred about 245km east of Lyndhurst. Along this section, severe rutting was noted with ruts estimated to be

between 200 and 300mm deep. This could cause potential roll over hazards for high centre of gravity vehicles and effect the tracking of trailers, so rehabilitation work should be undertaken soon as possible. It is likely that the rolling grader works will address this section, nevertheless it is recommended that the pavement continues to be monitored to determine if further pavement strengthening or drainage work is required.

Figure 16 – Bad rutting recorded along the track.

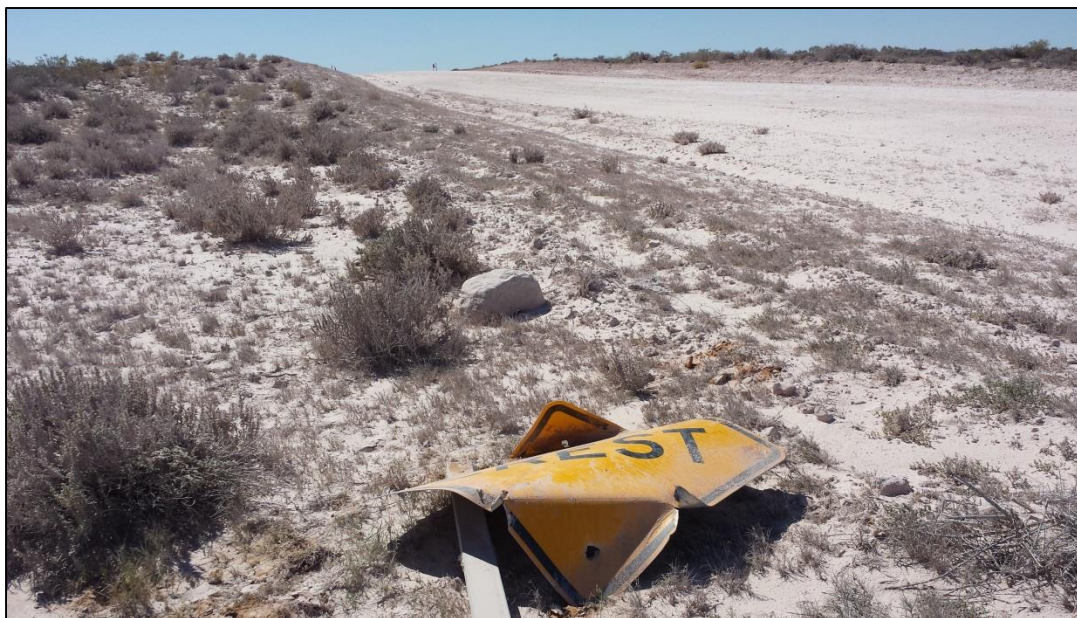
In a majority of the cases, the road signs have been knocked flat, a likely result of wind loading. RAA noted from the examination of a number signs that the poles appear to be installed directly into the ground with no form of footing provided. It is therefore recommended that damaged signs are reinstated as part of a regional program, with footings that will adequately resist the wind loading.

Figure 17 – A number of signs were found to be damaged along the track.

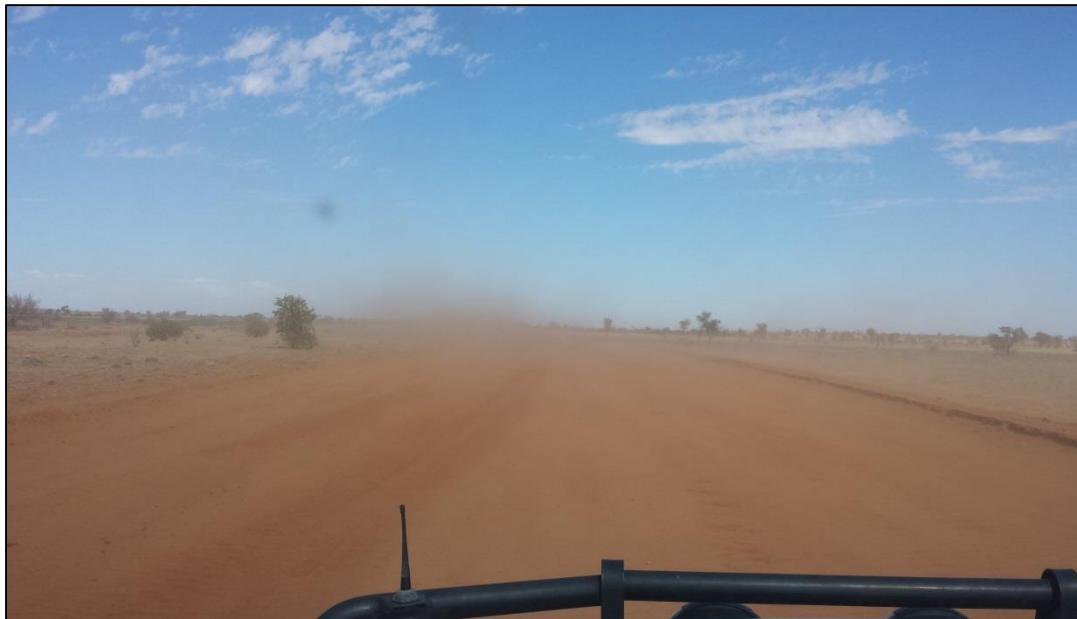
In addition to upgrading infrastructure, it is clear that there is still a lot of work to be done to educate tourists in preparing to drive in the outback. There were several occasions during RAA's assessment that the team encountered tourists driving a two wheel drive vehicle on sections of track that were inappropriate for a vehicle of this type. Road hazards such as bulldust holes will not be obvious to those inexperienced in driving in the outback. Simple defensive driving techniques such as slowing down to pass vehicles and avoid loose material damaging windscreens form part of a larger educational campaign. RAA therefore recommends that a simple publication is developed that discusses journey preparation, types of hazards and defensive driving techniques for safe travel Outback. The publication should be made available through the South Australian Tourism Commission to capture not only the Australian market but also international tourism.

Figure 18 – Tourists and those inexperienced driving in the outback should be made aware of some of the hazards, such as dust clouds, and the appropriate driving techniques required.
