# Barossa and Light

## Regional Road Assessment

October 2017

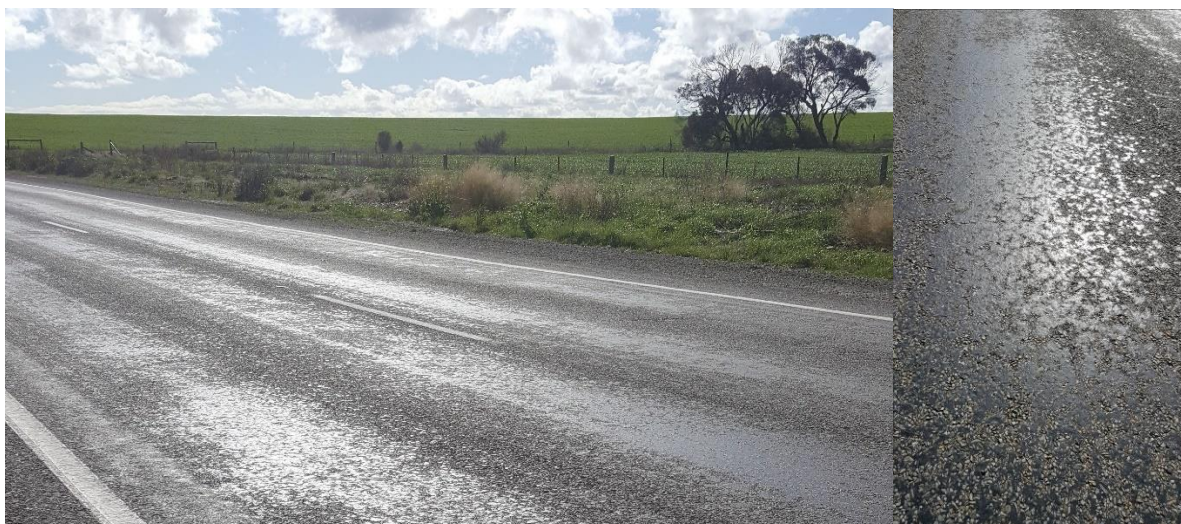
*Figure 32: Example of the polished surface and bleeding along the majority of Horrocks Highway.*

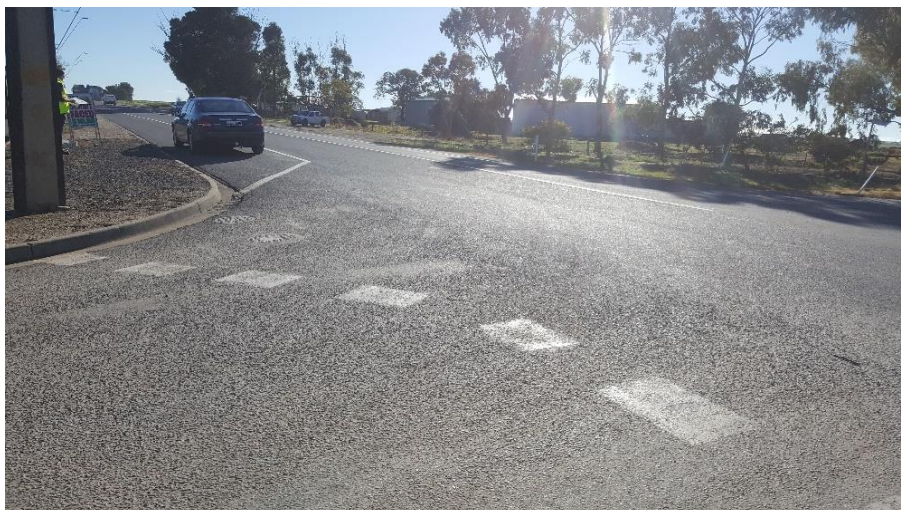
Figure 33: Sight distance looking north from Gartrell Street with a vehicle parked along Horrocks Highway

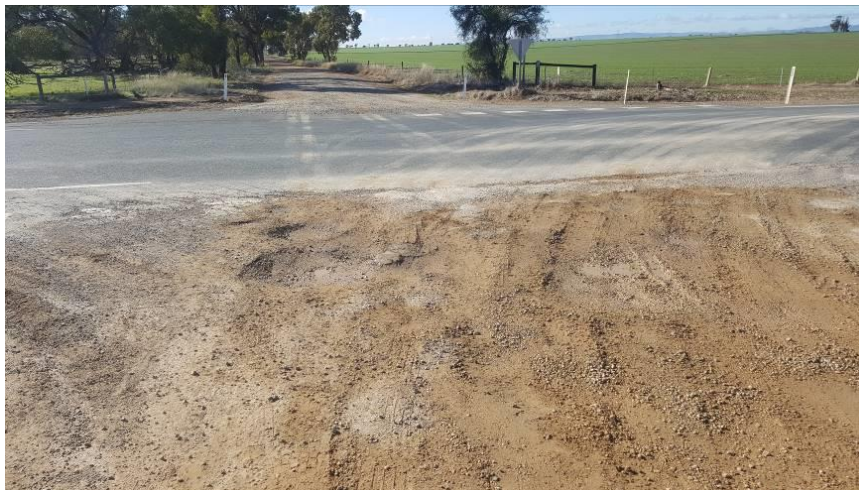
Figure 34: Ashwell Road intersection, typical of unsealed junctions with Horrocks Highway.

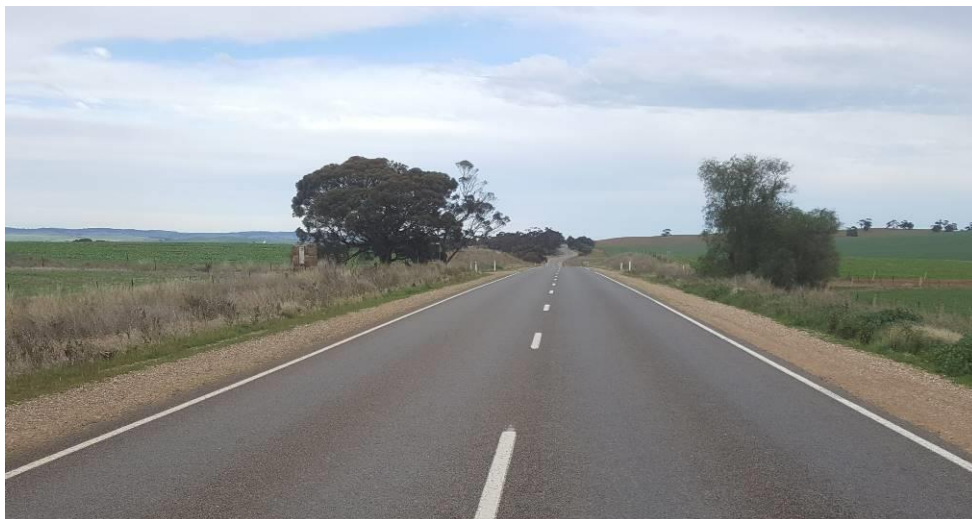
*Figure 35: Sealed shoulders were generally very narrow between Kapunda and Eudunda*

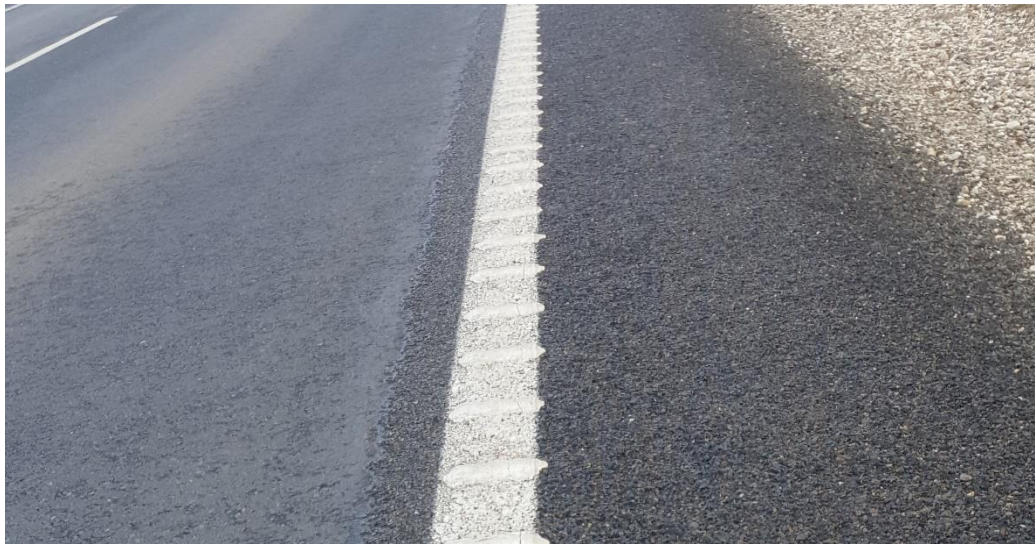
*Figure 37: A highly polished carriageway next to recent installation of ATLM and shoulder widening*

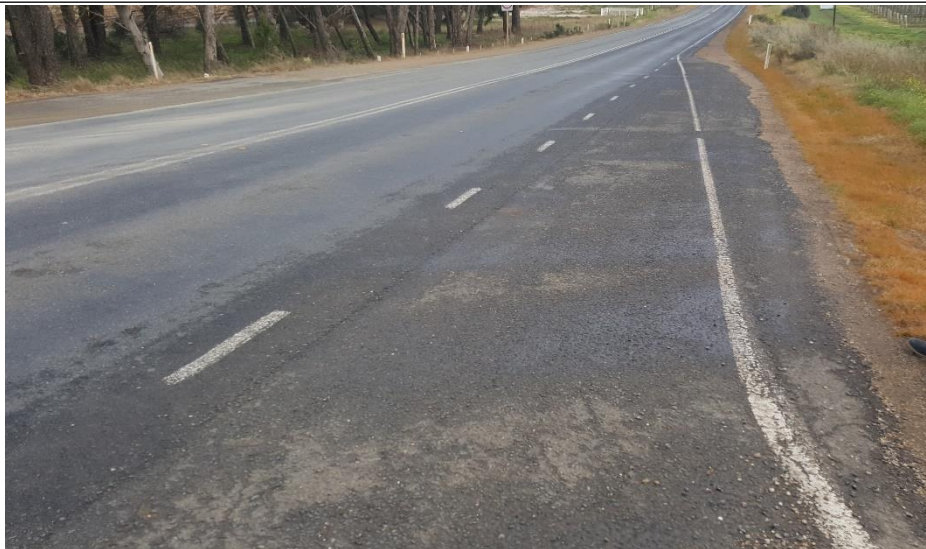
*Figure 38: Short and narrow left turn lanes are not very effective*

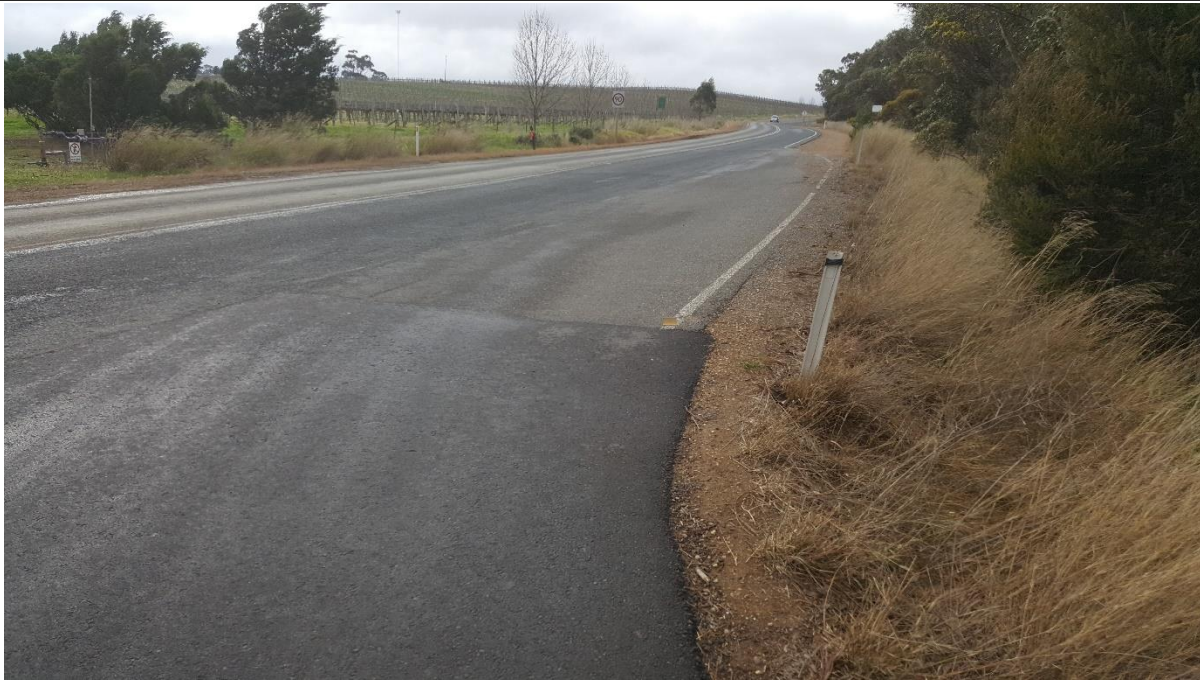
Figure 39: missing and faded line marking at the intersection of Rosedale Road

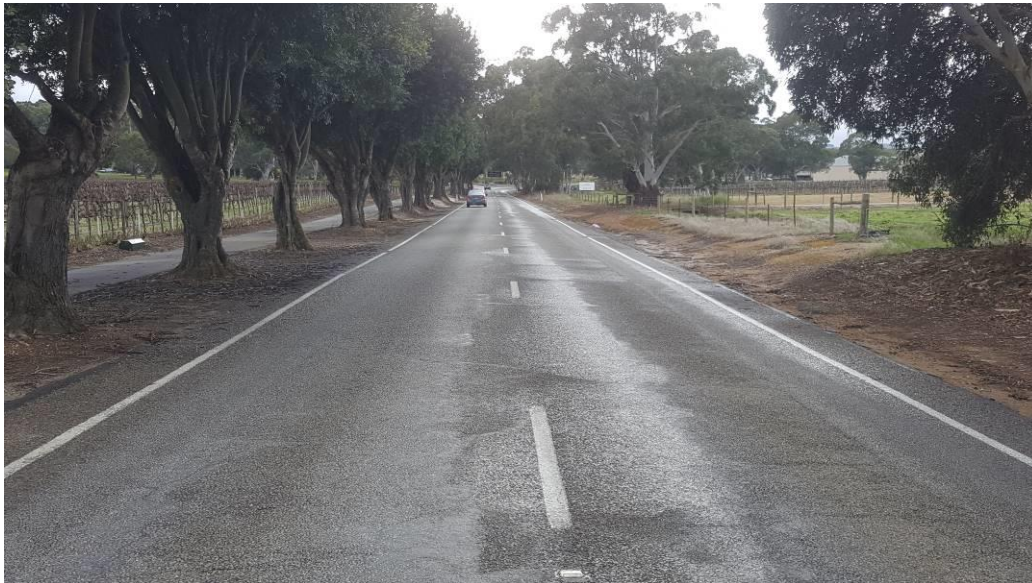
*Figure 41: Significant trees as close as 2m to the edge line after leaving Lyndoch*

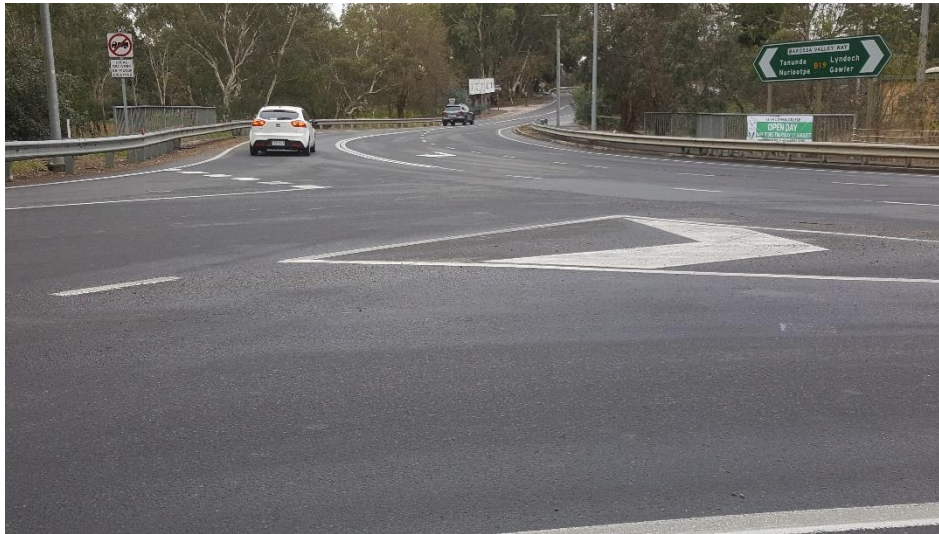
Figure 43: The left turn slip lane onto Gomersal Road (foreground) causes some confusion with priorities

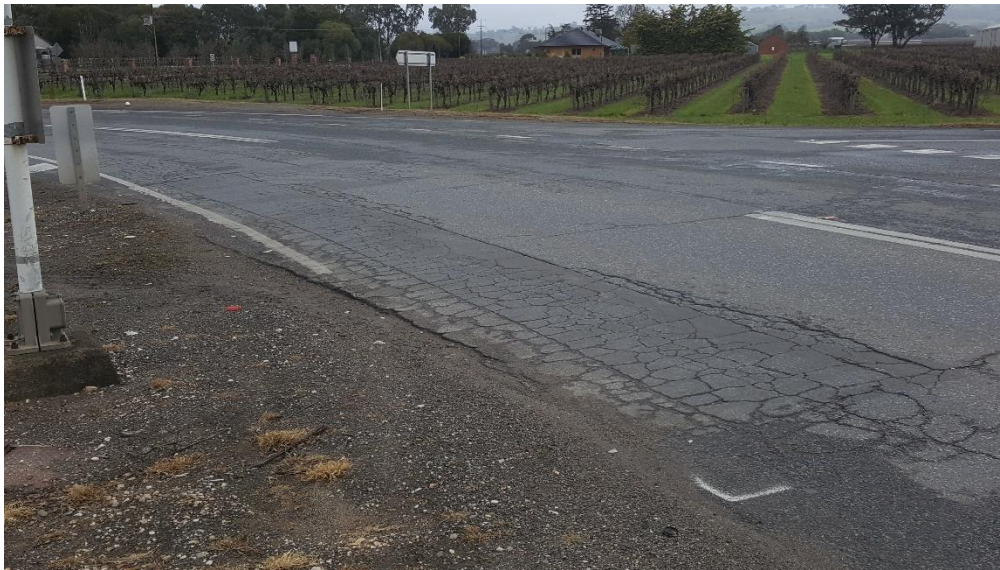
Figure 45: The surface at this intersection is in very poor condition

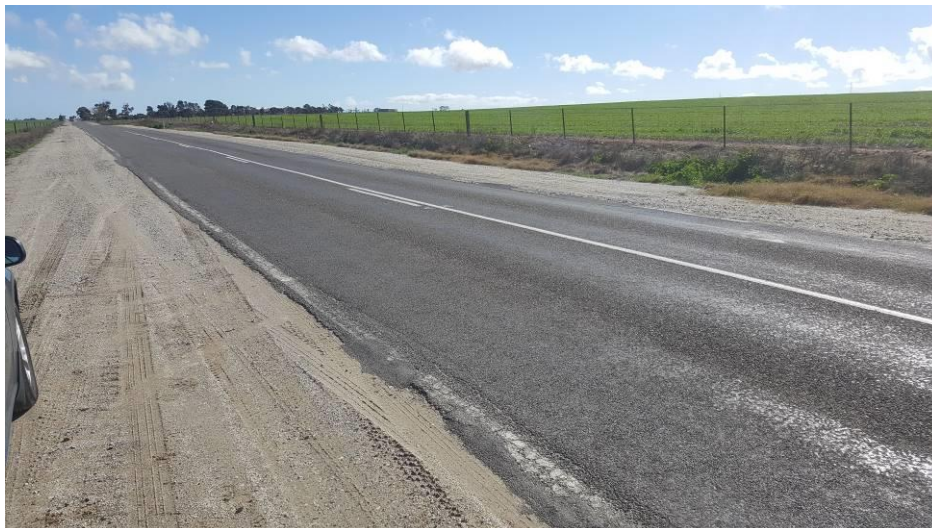
It was also noted that edge line marking was deteriorated in some locations due to the crumbling road edges.

*Figure 46: Poor edges and a lack of unsealed shoulders were some of the primary concerns on Owen Road*

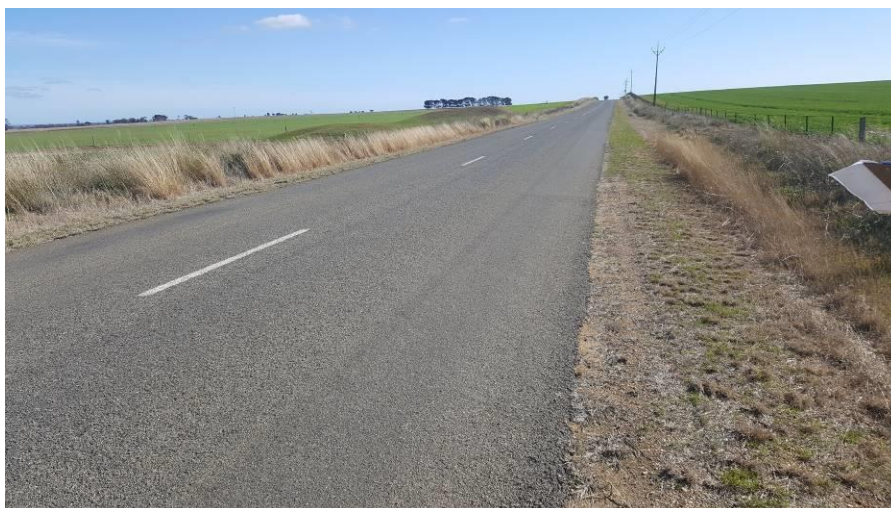
*Figure 47: Templers Road (Wasleys-Templers) lacks edge lines and sealed shoulders*

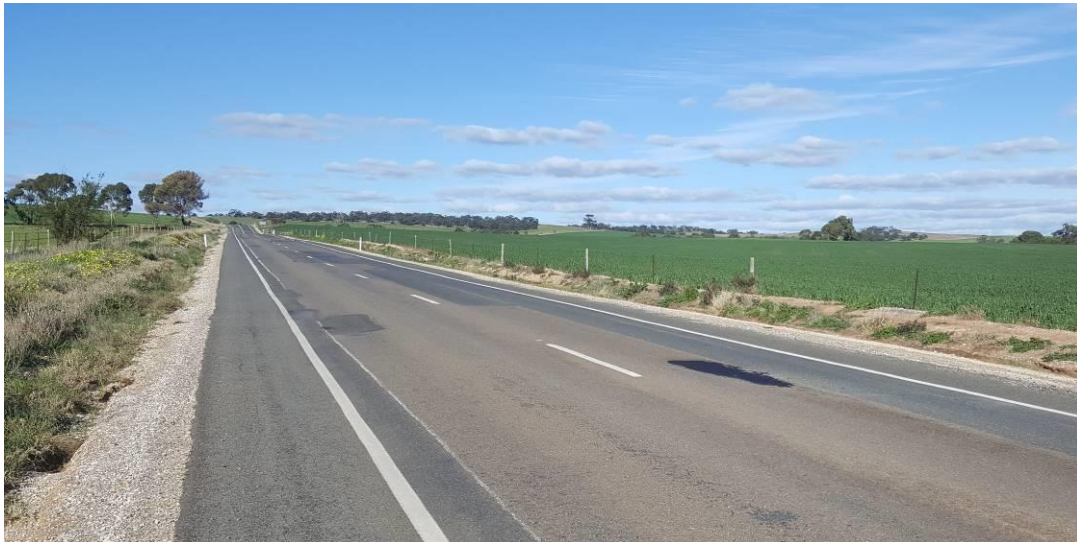
Figure 48: Uneven and patched surface at the eastern end of Daveyston Road.

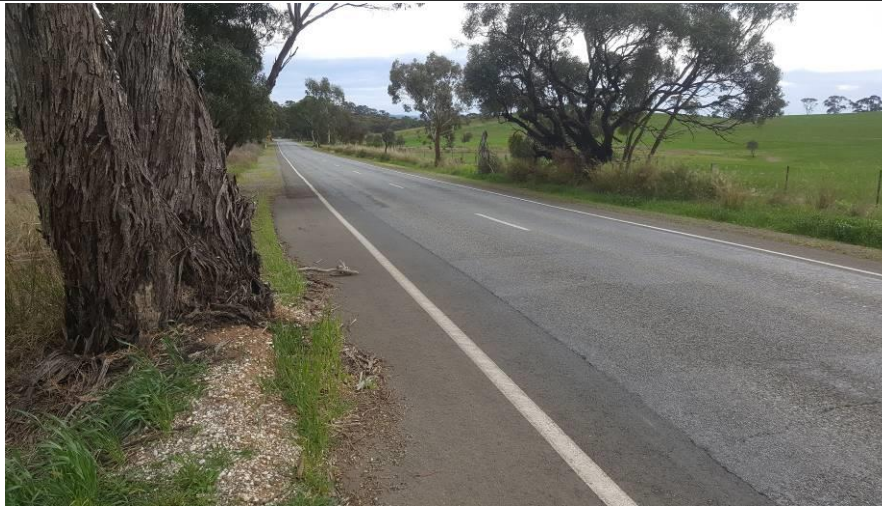
Figure 49: Significant gum tree located very close to Greenock Road posing a significant hazard

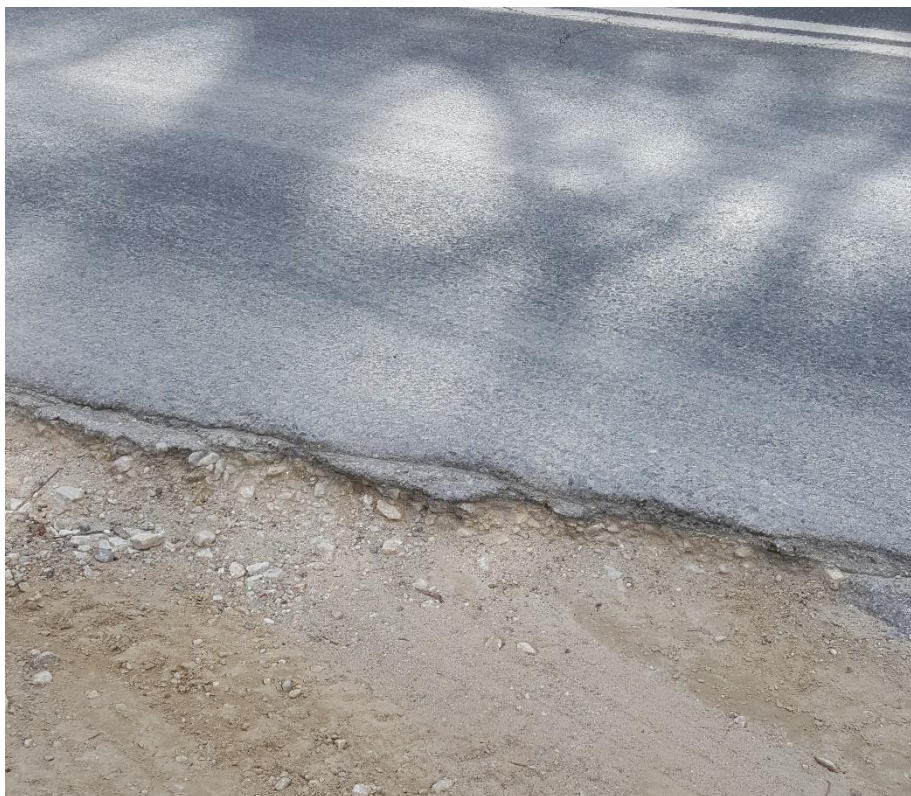
*Figure 50: 100mm drop off at the intersection of Parbs Road and Sir Condor Laucke Way*

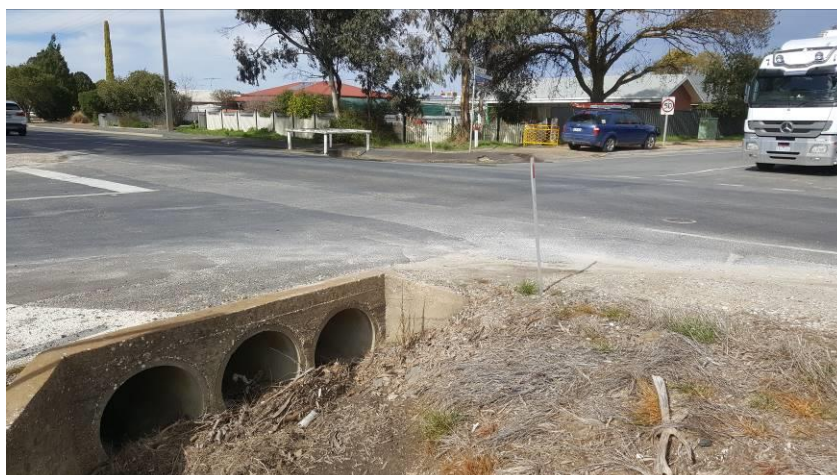
Figure 51: The Samuel Road and Sir Condor Laucke Road intersection struggles with heavy vehicle turn paths

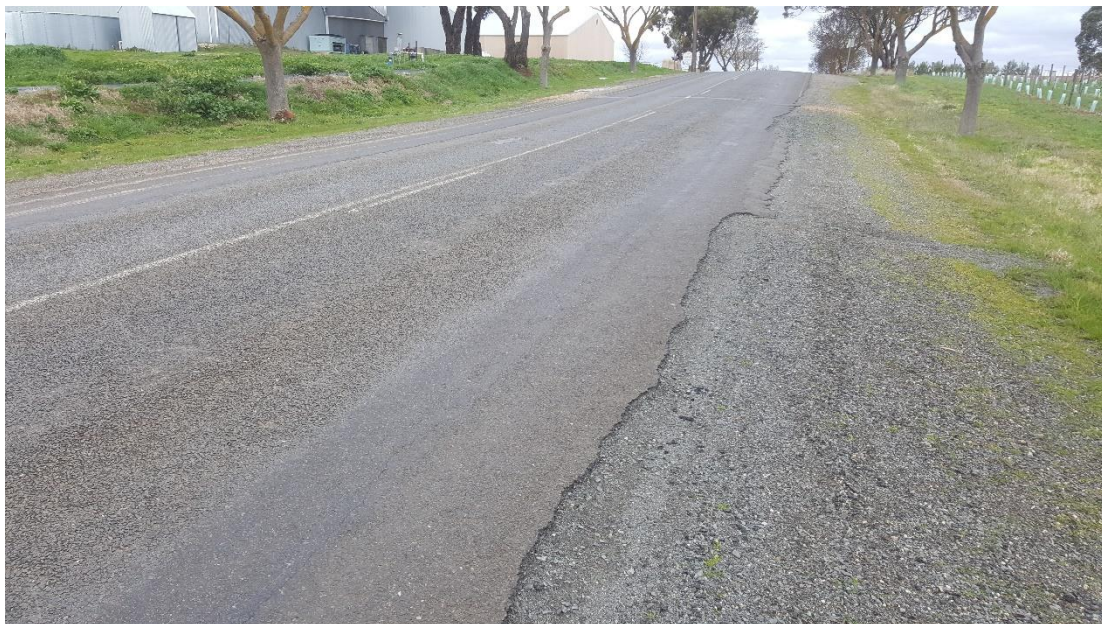
*Figure 52: Crumbling edges are a significant issue in some sections of Seppeltsfield Road*

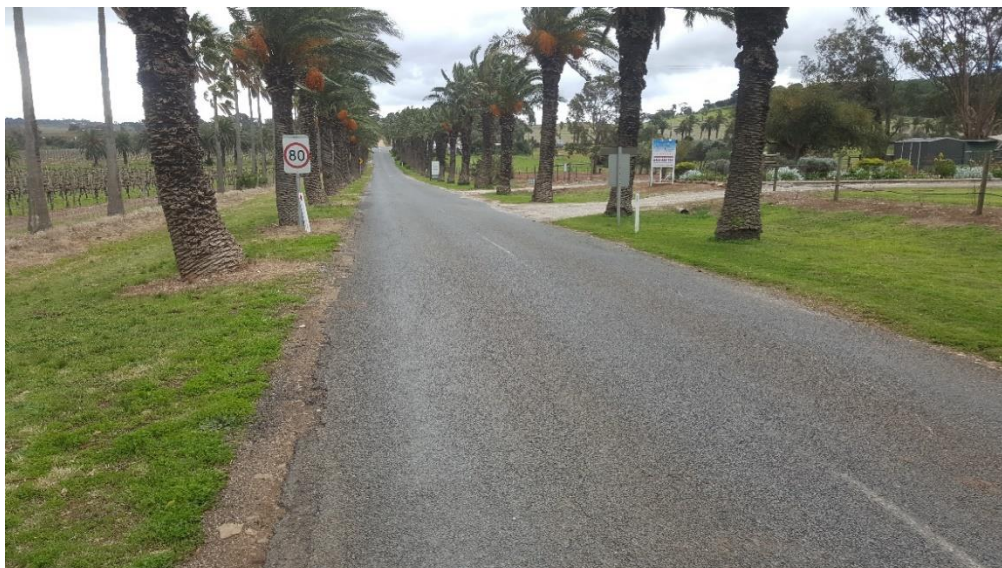
Figure 53: The 80km/h speed limit increases the risk of serious crashes involving the palm trees on Seppeltsfield Road

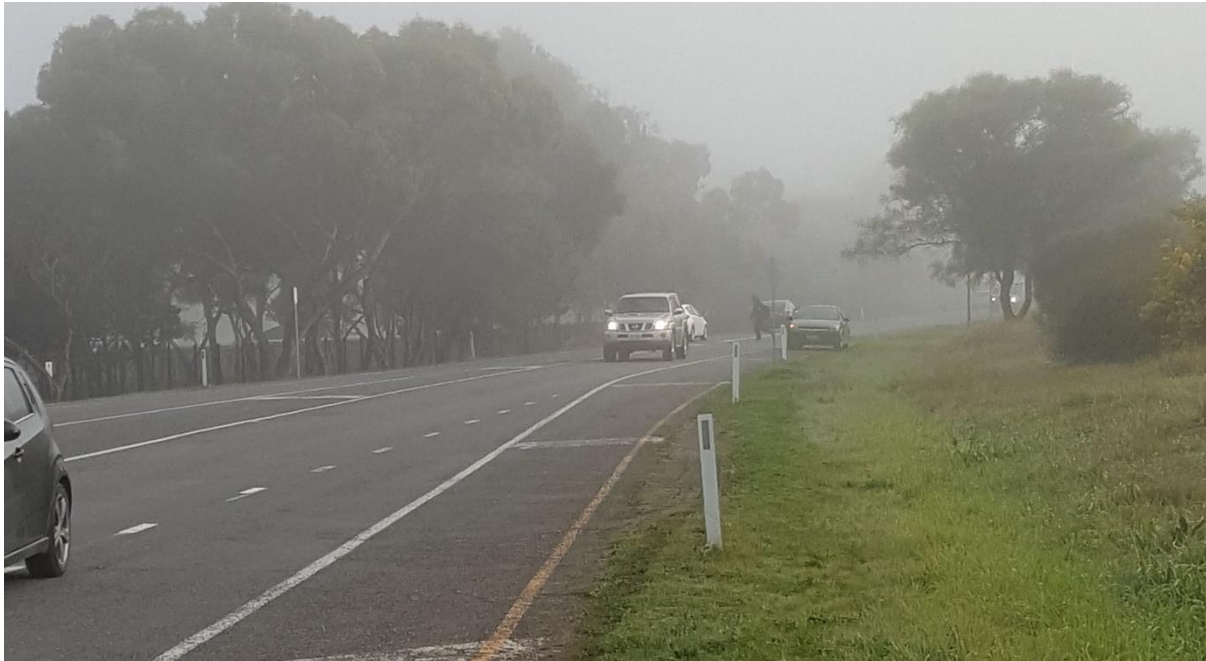
*Figure 54: Students crossing Redbanks Road east to west after being dropped off on the western side*

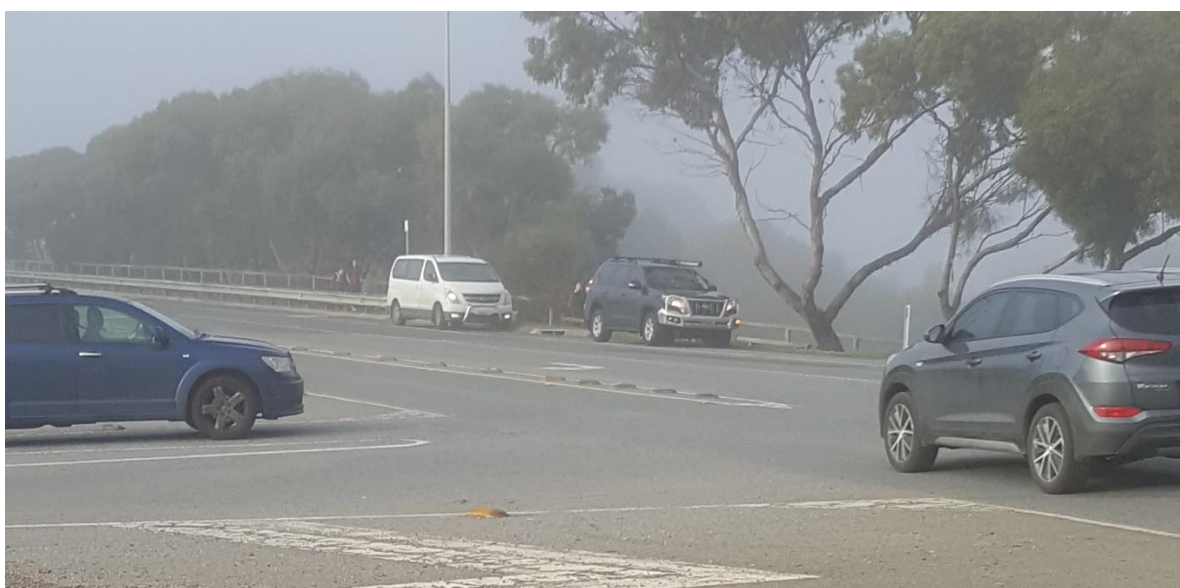
*Figure 55: Vehicles setting down students on the western side of Redbanks Road*

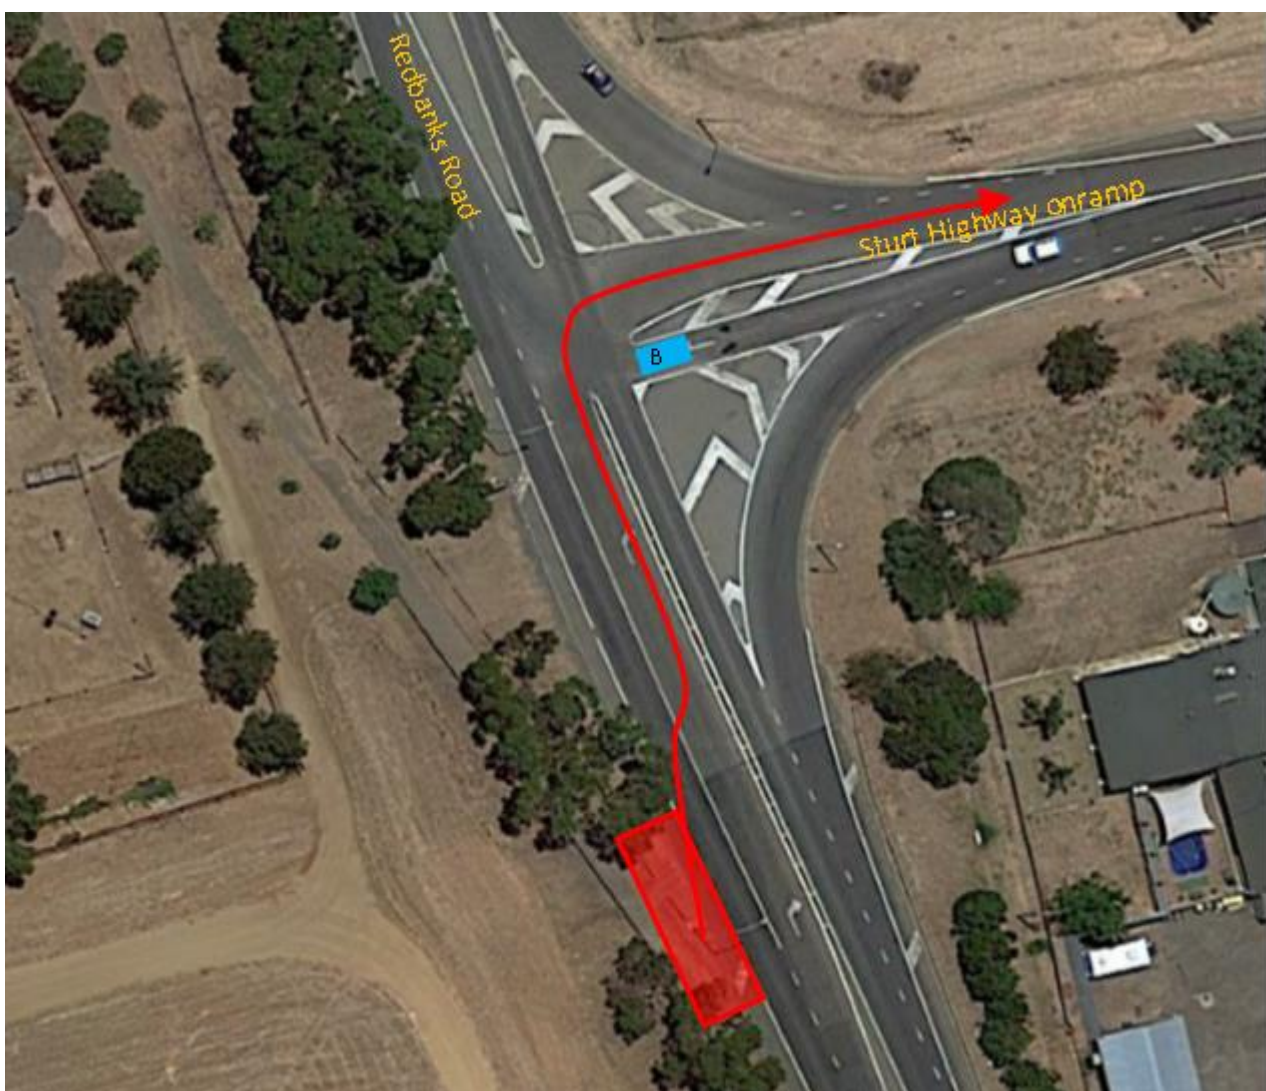
Figure 56: Dangerous manoeuvre from Redbanks Road no stopping zone onto Sturt Highway onramp

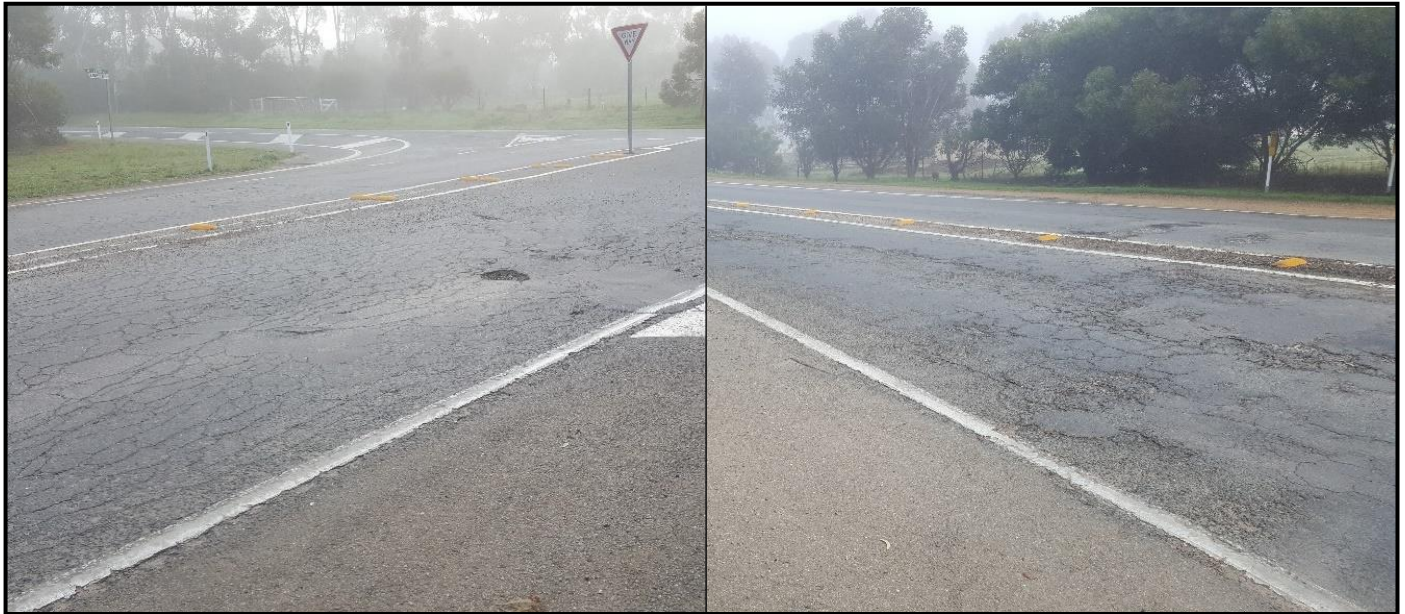
*Figure 57 Cracking and Potholes on Kentish Road*

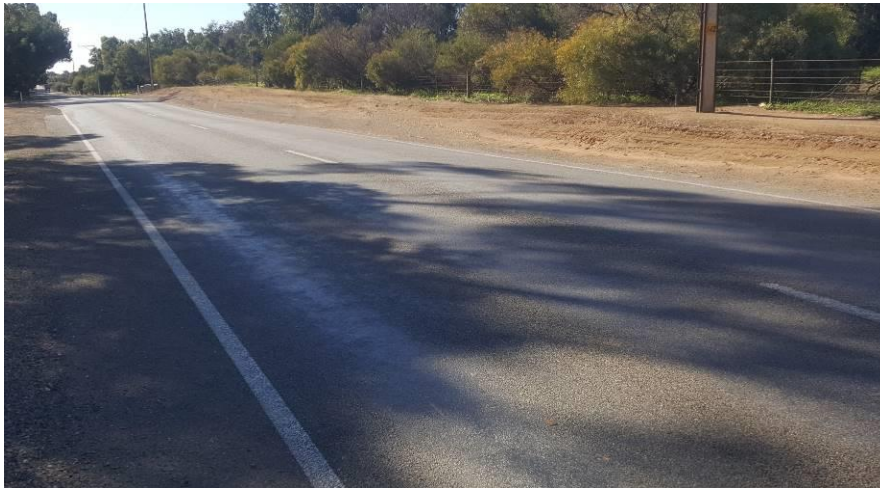
*Figure 58: Undulations and surface polishing on Mudla Wirra Road south of Roseworthy Campus*

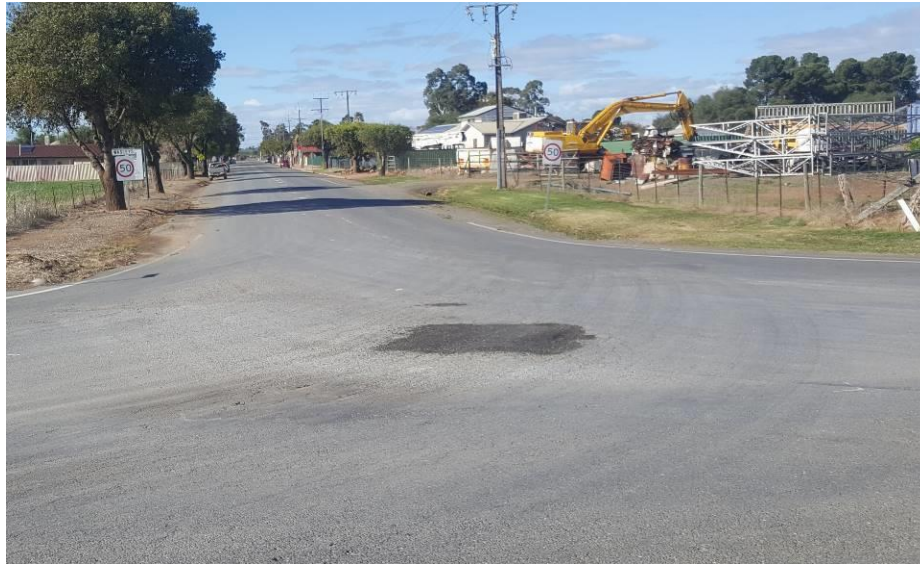
Figure 59: Line marking is barely visible at the intersection with Annie Terrace

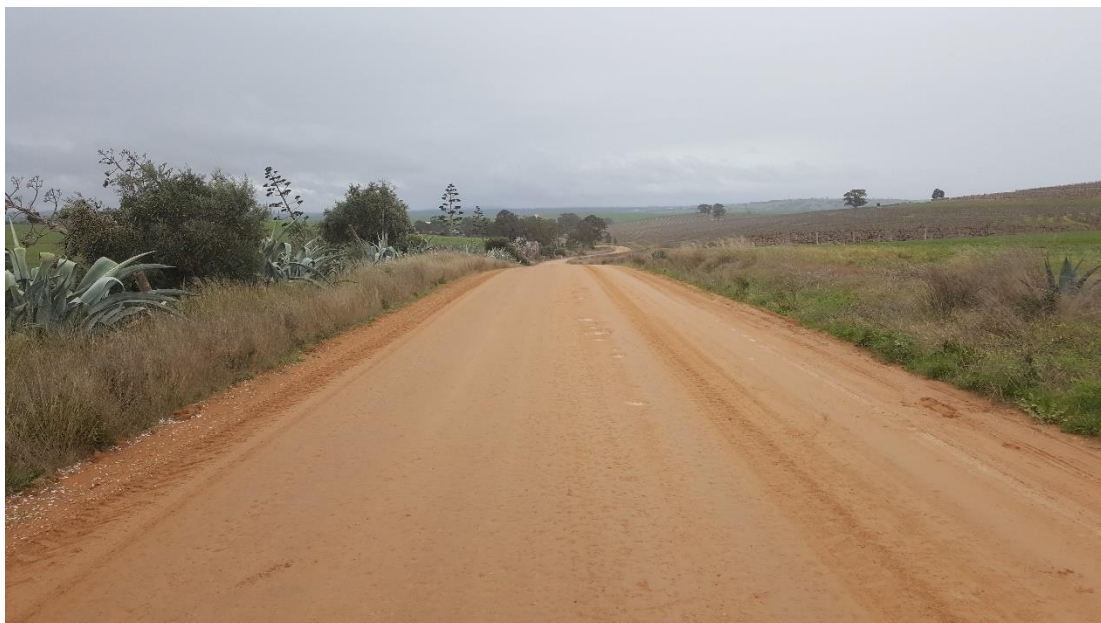
*Figure 61: Lyndoch Road poses some challenges for tourists not acclimatised to unsealed conditions.*

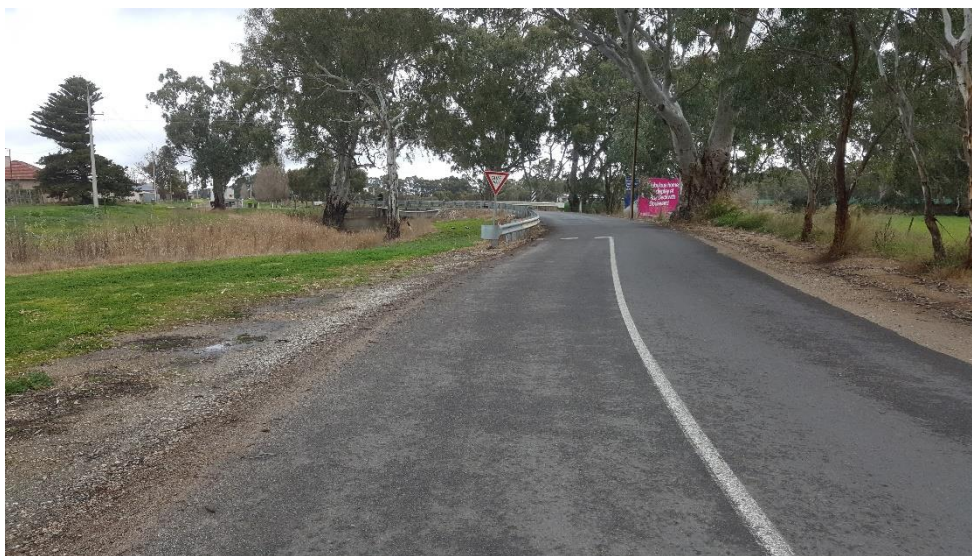
Figure 63: Visibility is very poor for southbound vehicles crossing the bridge.

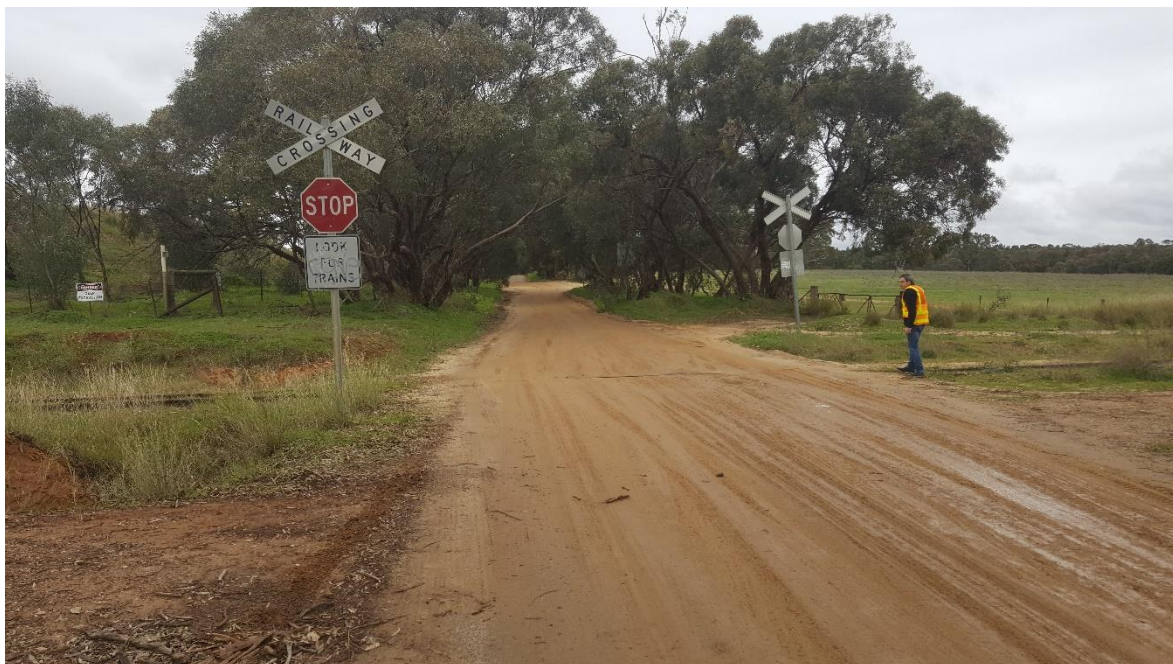
*Figure 64: Disused rail crossings require vehicles to stop although trains do not use the line*
