Riverland

Regional Road Assessment June 2018

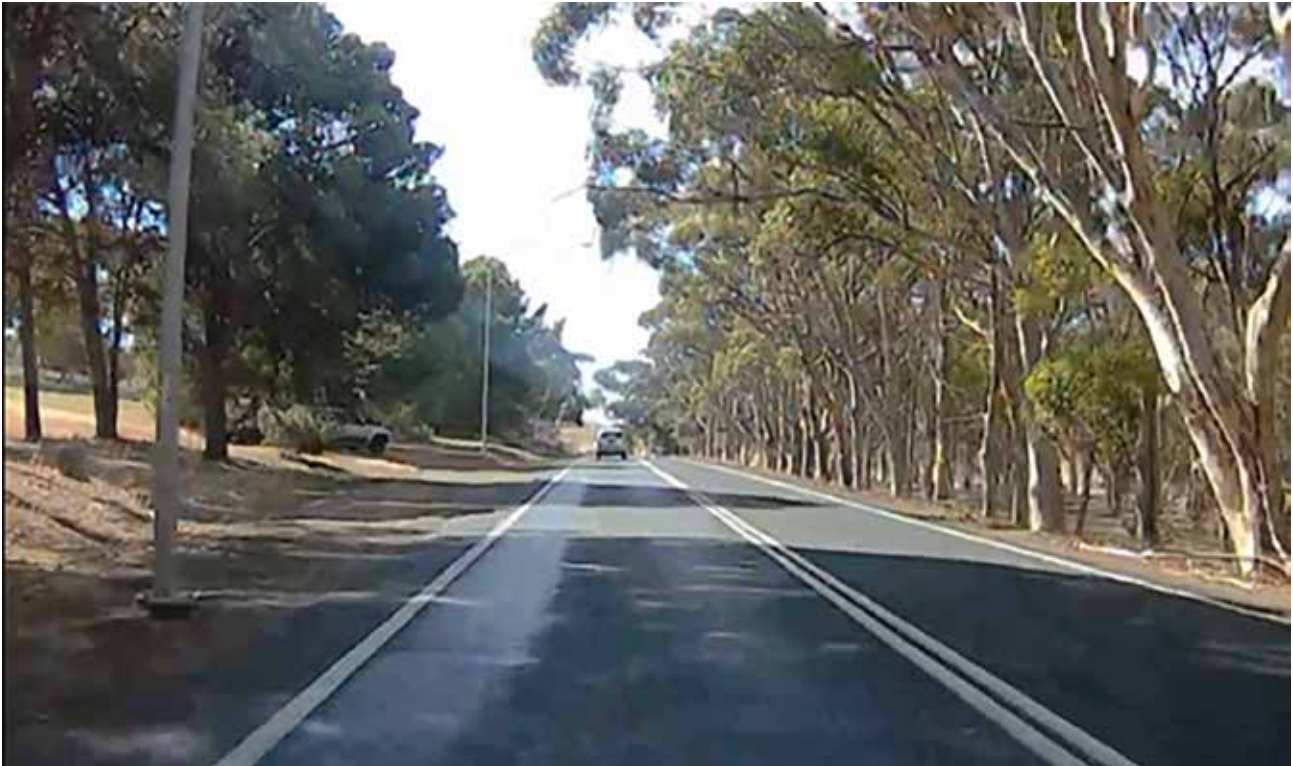
Trees line the highway approximately three metres from the edge line just east of Truro, and it is recommended that barrier protection is considered to reduce the crash severity should a vehicle run off the road in this location.

Surface polishing and trees along the edge of the Highway heading east out of Truro

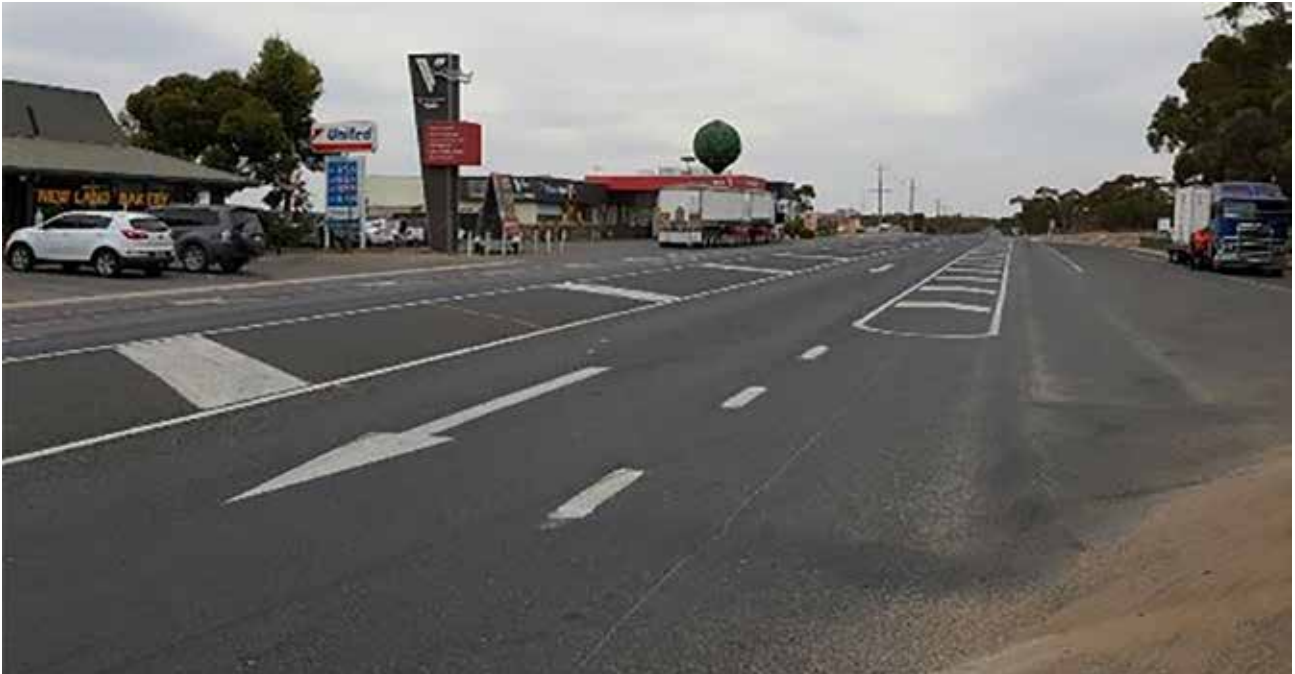
There are numerous safety hazards present on Sturt Highway through Waikerie

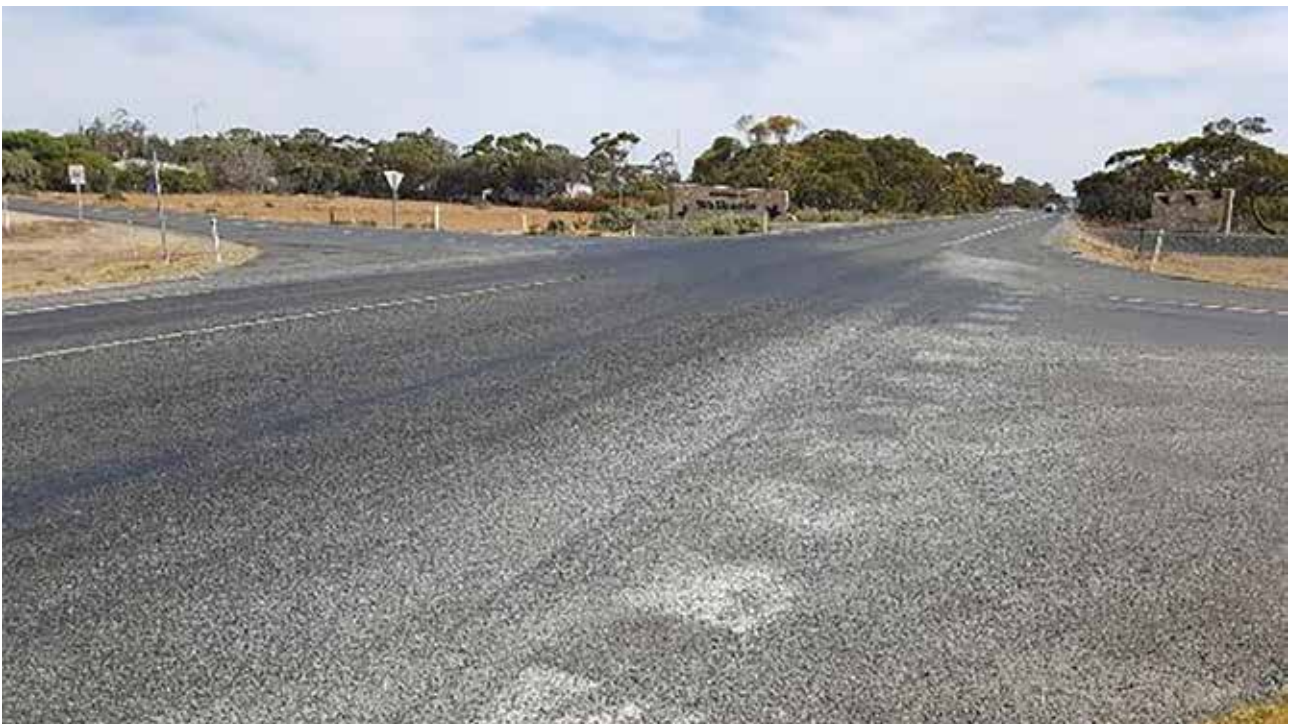
Numerous deficiencies were identified at the intersection with Sturt Highway and Holder Top Road

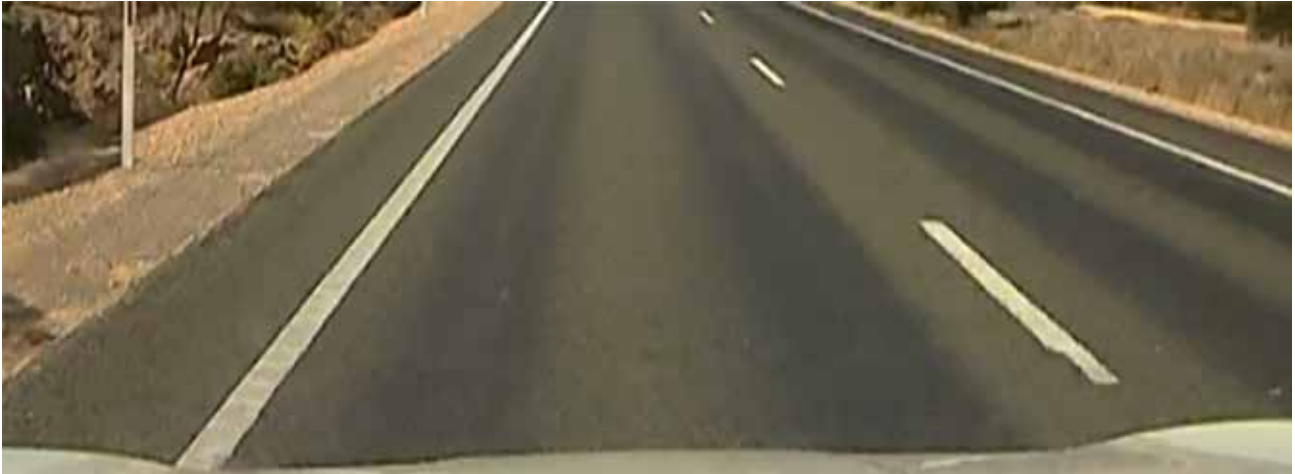
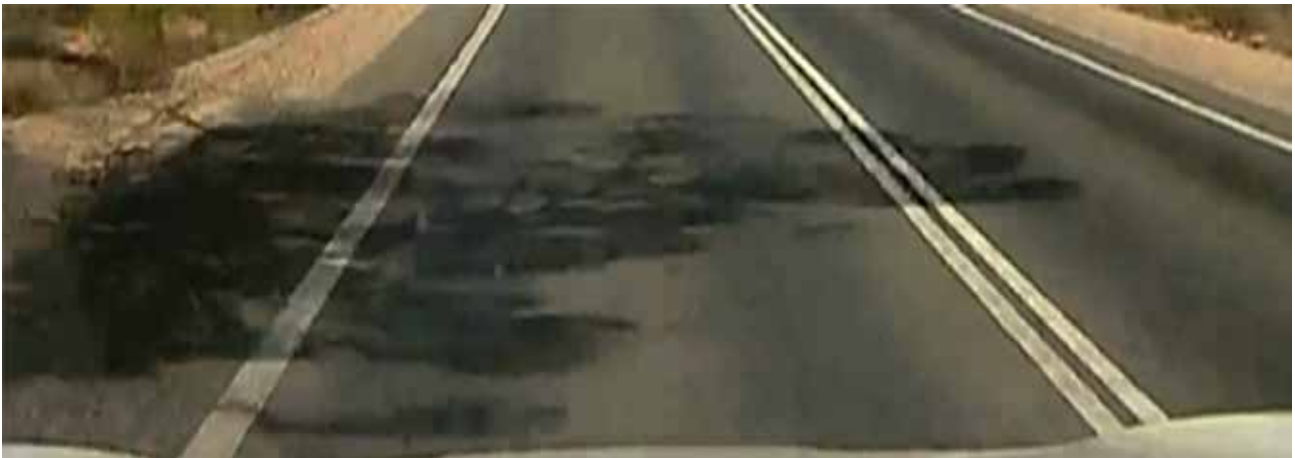
Wire rope barrier is used to protect vegetation on the north side of the Highway between Holder Top Road and Dunstone Drive, however, little protection is provided to roadside vegetation in the remainder of this section of Sturt Highway. A number of steep drop offs are unprotected through Lowbank and it is recommended that all steep drop offs are protected with w-beam or wire rope barrier along this section of Sturt Highway. Some drop offs were not even delineated with additional guide posts and these should be installed as an absolute minimum interim measure to provide additional awareness of the hazard.

Steep drop offs are prevalent between Waikerie and Barmera

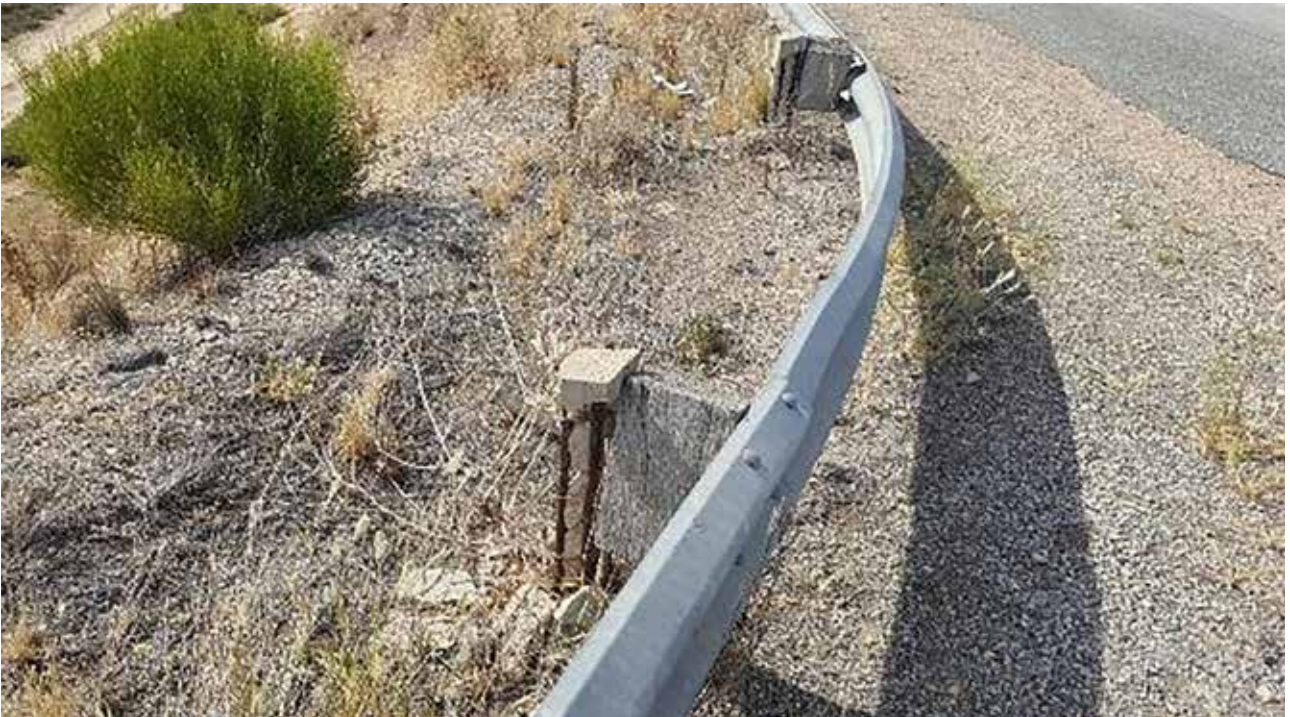
It was also noted that w-beam guard rail supports at the intersection were in poor condition and their crashworthiness may be compromised. It is recommended that crash barriers are inspected and repairs made where required due to the high severity of a crash involving an errant vehicle driving over the edge.

W-beam barrier supports at this intersection are in poor condition

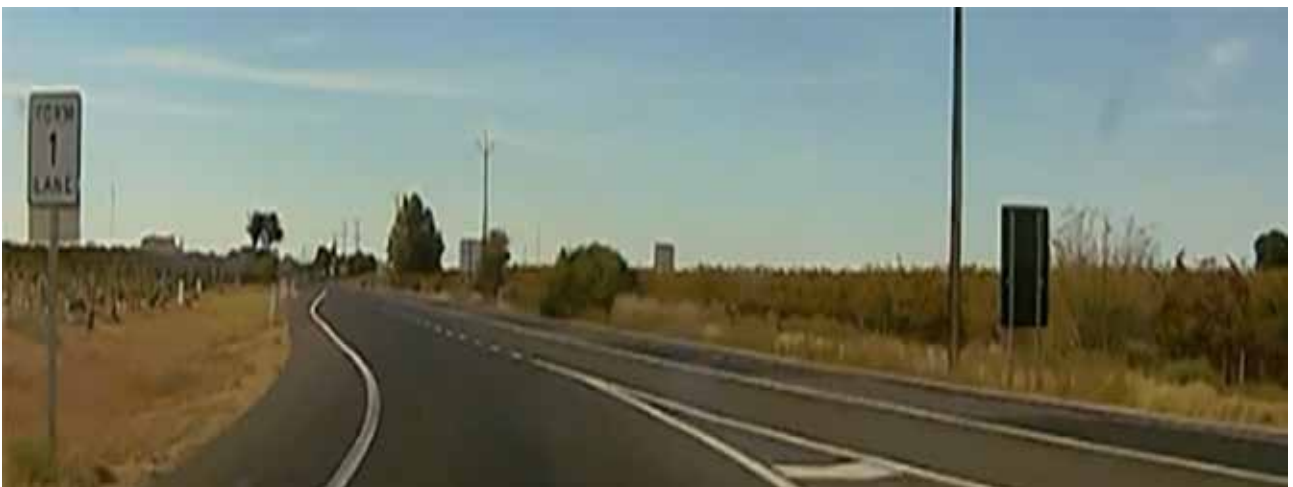
Incorrect 'form1 lane' sign at the Barmera intersection with old sturt highway

- Extend acceleration lane for vehicles turning left onto Sturt Highway towards Monash.
 - At the lane reduction, in the northeast direction, replace incorrect G9-15 'form 1 lane' sign with W4-9 'left lane ends' sign and W8-15 'merge right' plate with additional G9-73 'merge right' sign as per standard signage procedures for a lane reduction.

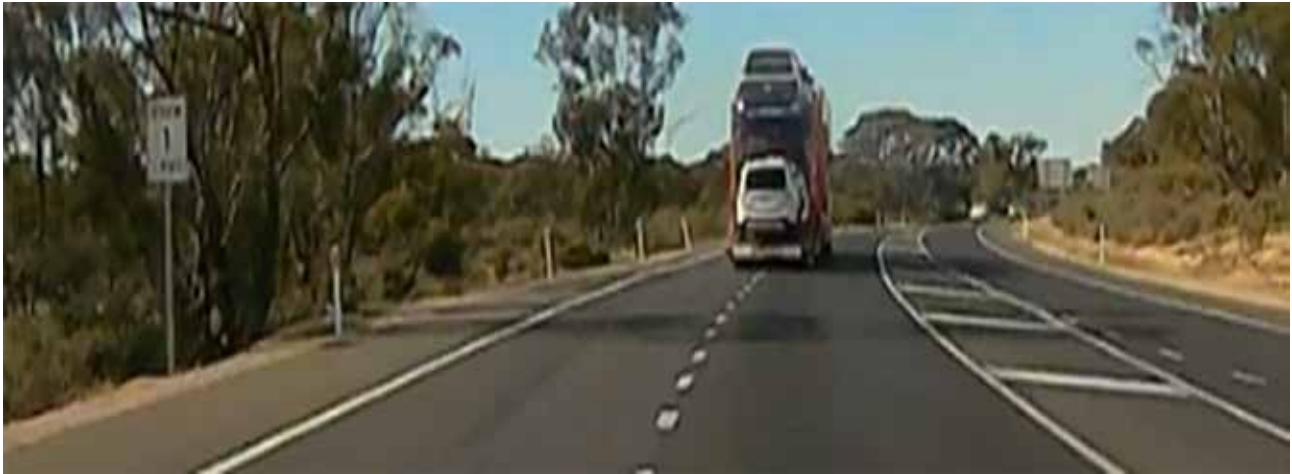
Incorrect 'form1 lane' sign at the Monash intersection with old sturt highway

- Install R1-2 'give way' sign, and set back holding line in the right turn lane on Sturt Highway for vehicles turning right onto Old Sturt Highway.
 - At the lane reduction, in the northeast direction, replace incorrect G9-15 'form 1 lane' sign with W4-9 'left lane ends' sign & W8-15 'merge right' plate with additional G9-73 'merge right' sign as per standard signage procedures for a lane reduction.

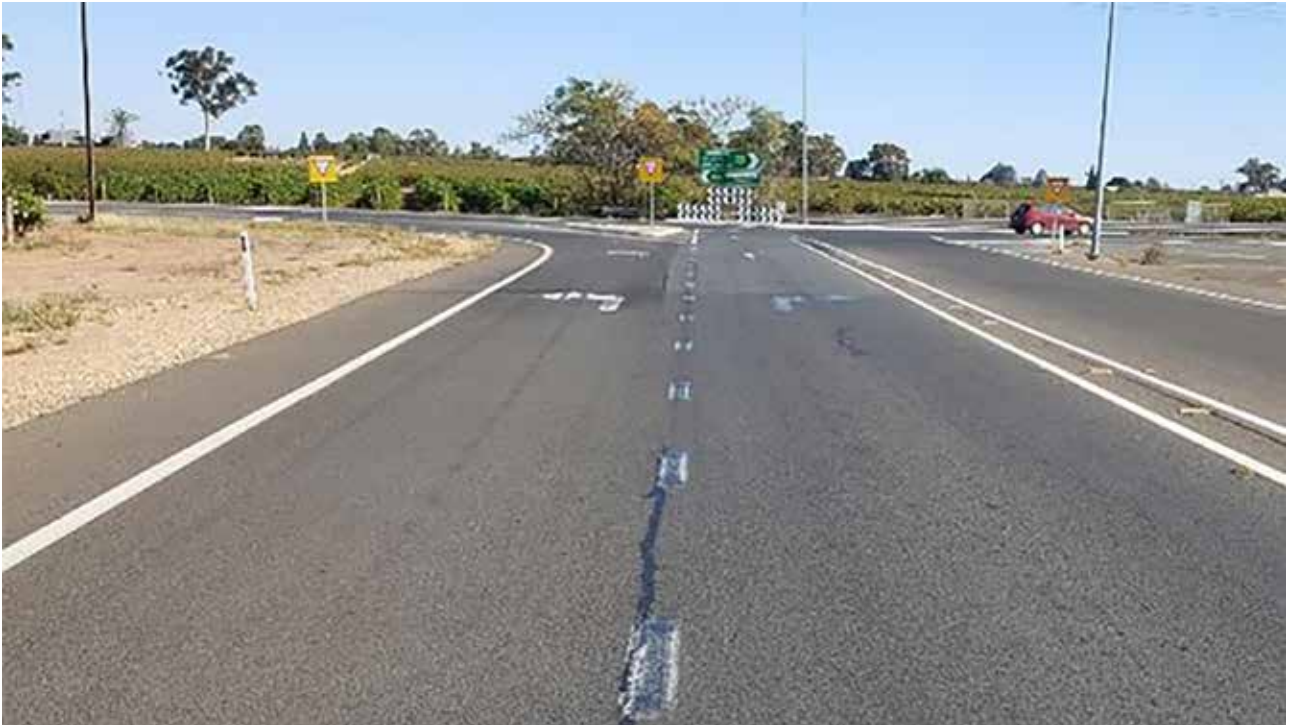
There are many safety treatments installed at this intersection, however there is still a crash problem.

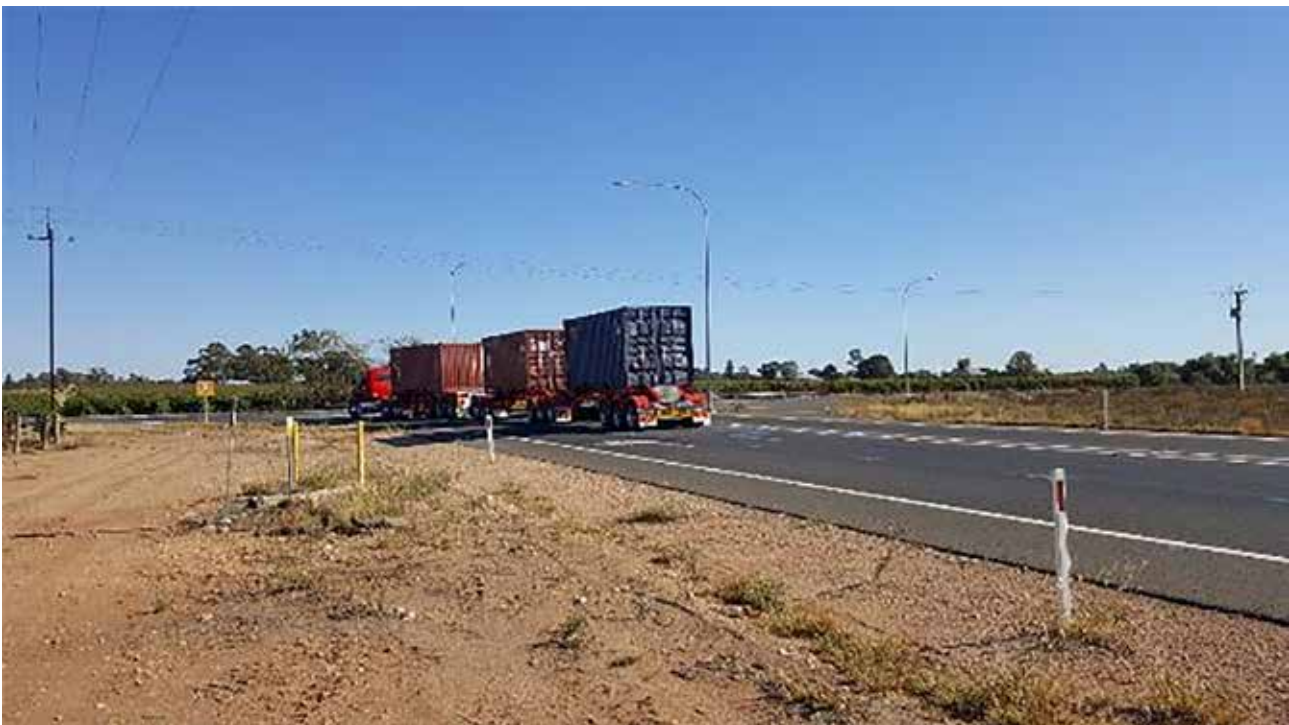
As seen in the above image, line marking is also substantially deteriorated as heavy vehicle combinations turn left from the right hand lane (as pictured below). This is due to the tight geometry of the left hand turn lane.

Long vehicles turn left from the right hand lane

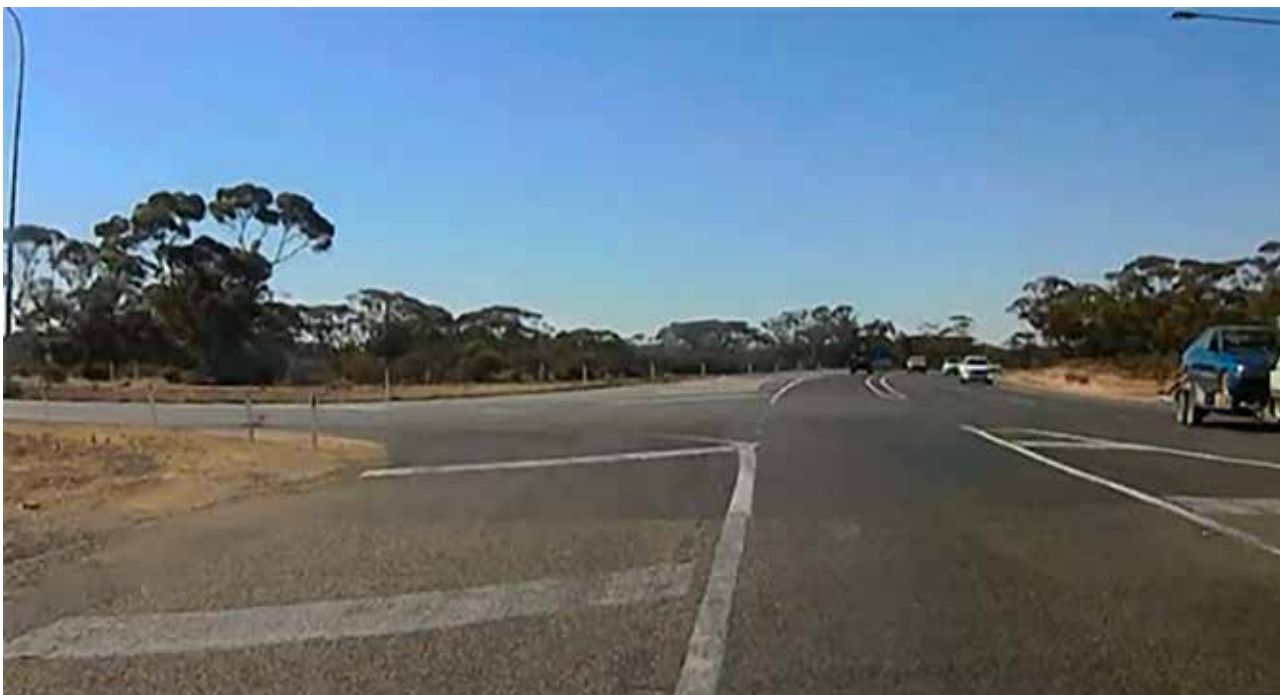
There were two primary issues identified at this intersection following our site inspection. Firstly, some northeast bound vehicles turning left towards Monash would turn left from the through lane whilst others would utilise the painted island to make a safer left turn.

Turning left from the through lane is dangerous at this location

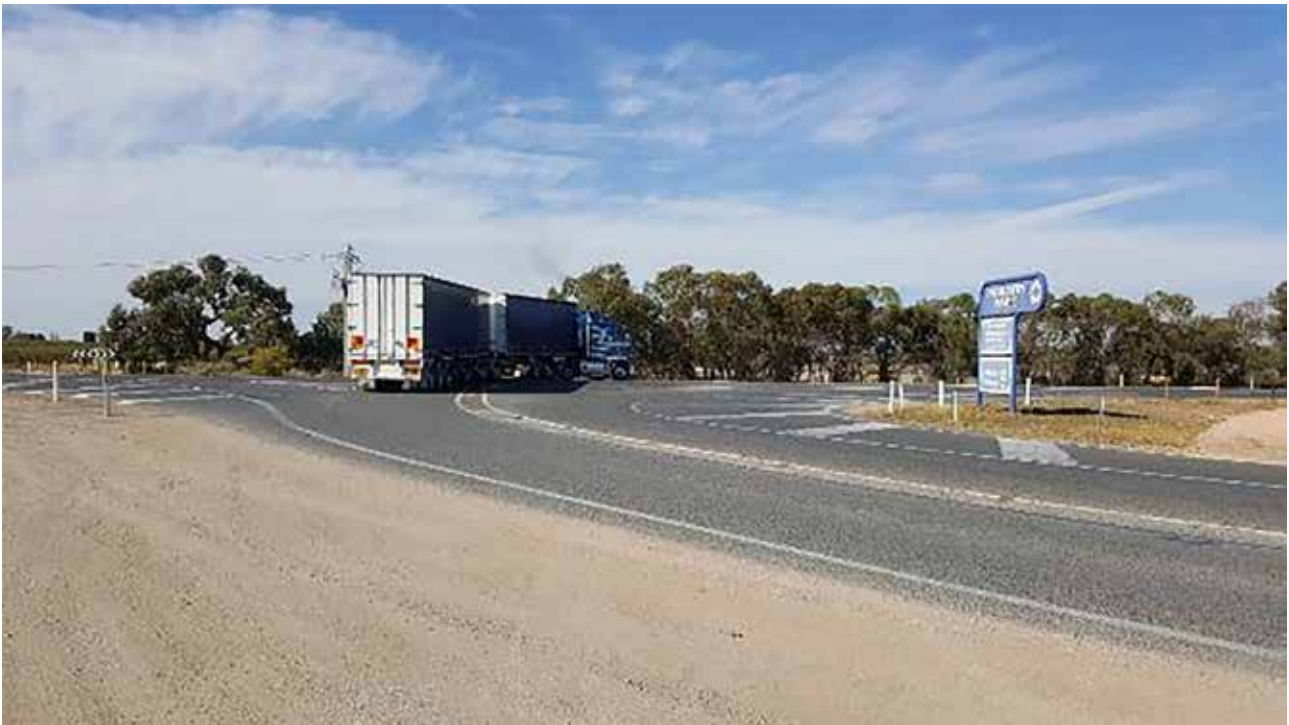
There were not any casualty crashes reported at this intersection between 2012 and 2016, however, freight movements into and out of Airport Road have significantly increased in recent years. There are growing safety concerns from the community regarding safe interactions with freight at this location, especially turning right out of Airport Road.

Freight movements from Airport Road into Sturt Highway are particularly concerning

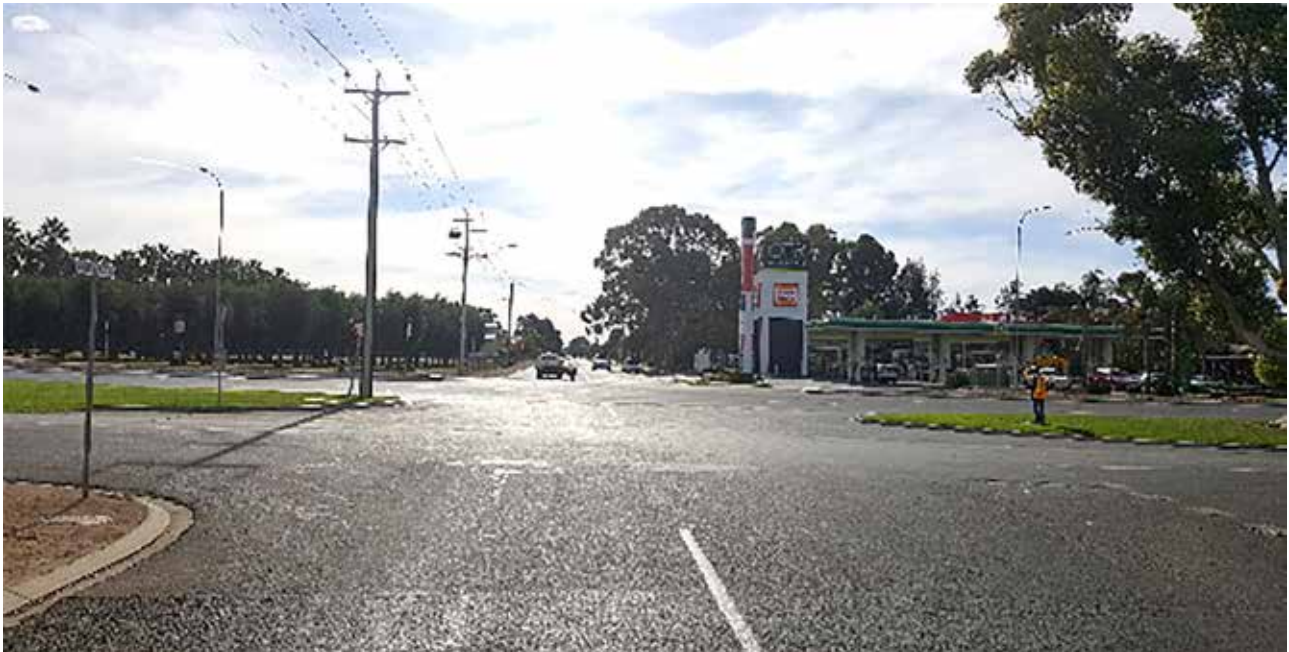
The below image, looking north towards the intersection highlights the partially concealed give way sign. It is also noted that line marking at the intersection is very faded, and the line of stobie poles and trees gives an incorrect visual cue that Twentyfirst Street is the continuing Road. An inattentive driver, or one unfamiliar with the intersection could easily mistake Twentyfirst Street for the continuing Road due to these issues.

The north bound give way sign is particularly concealed by the stable pole and the upcoming give way condition is unclear

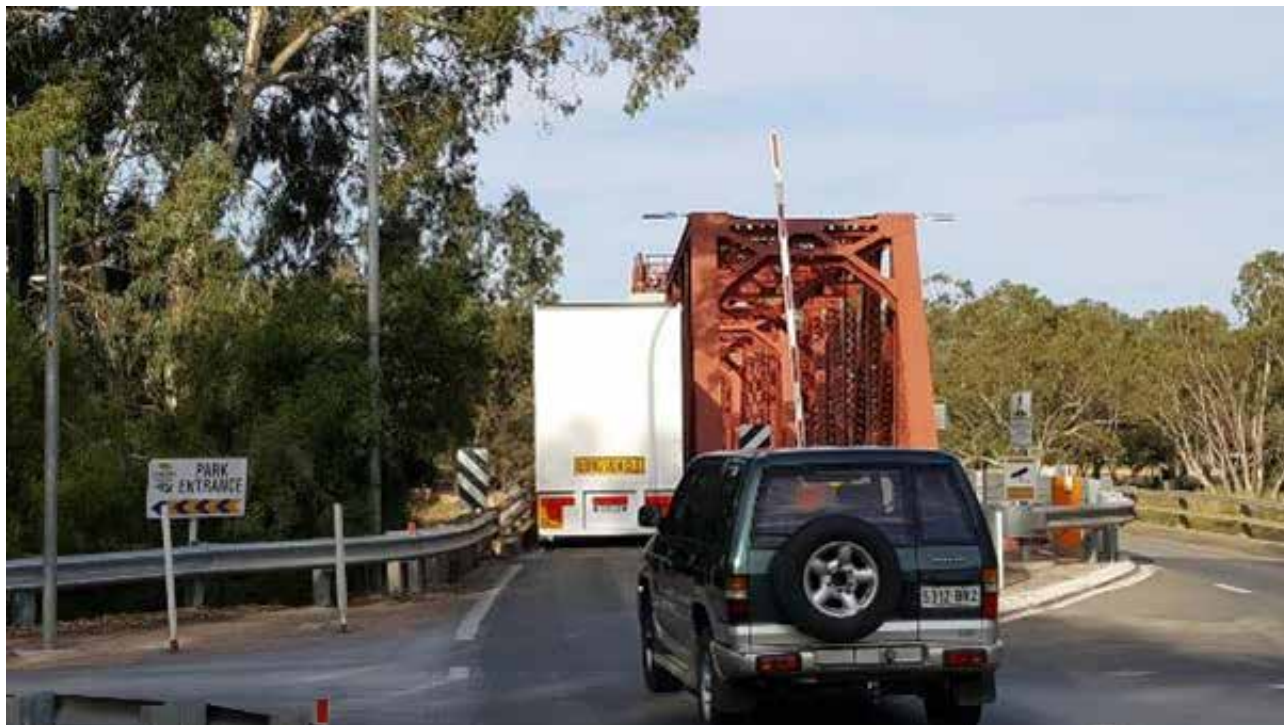
Sturt Highway is generally satisfactory between Renmark and Paringa with the exception of the Paringa Bridge. This bridge was opened in 1927 and designed for very different traffic conditions than those that are faced today. The bridge is controlled by traffic signals that operate when the bridge is required to open and allow large vessels to pass up to two times per day at approximately 9:30 and 14:30. The lanes are very narrow and this restricts the type of vehicle that can pass over the bridge. A 30km/h speed limit has been imposed across the bridge due to the narrow carriageway, however, compliance with this speed limit amongst light vehicles appeared relatively low.

Heavy freight has minimal clearance crossing the Paringa Bridge

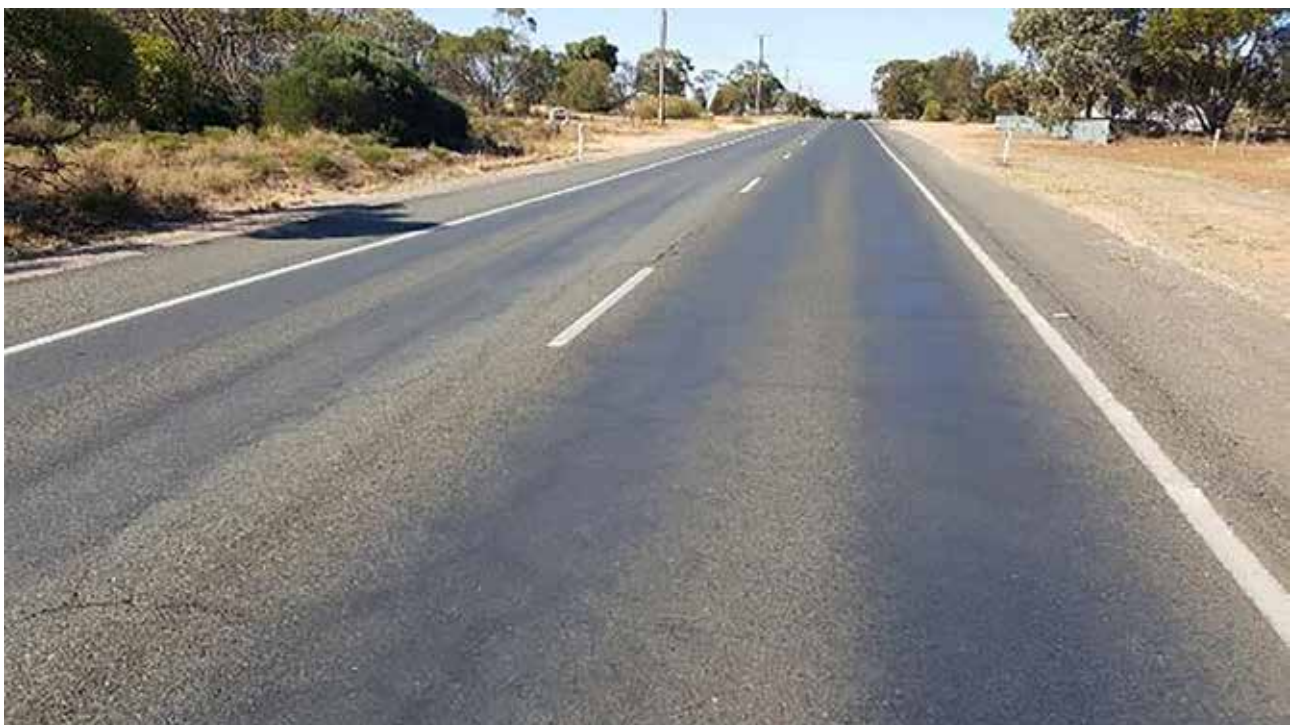
The primary issue identified on Old Sturt Highway was the very poor condition of the pavement along the majority of the highway, with the section between Berri and Barmera the of particular concern. Significant corrugations, heavy polishing, rutting and undulations were noted along the length of the road and it is recommended that Old Sturt Highway is resealed in its entirety.

The surface Of old sturt highway is generally in very poor condition

Old Sturt Highway – Key Recommendations	Authority
● Reseal Old Sturt Highway in its entirety, with priority given to:	DPTI
○ The section between Berri and Barmera.	
○ The section outside Bunnings in Berri.	
● (Following reseal) Ensure RRPM's are installed correctly as specified in the DPTI Pavement Marking Manual, and line marking is accurate and refreshed.	DPTI

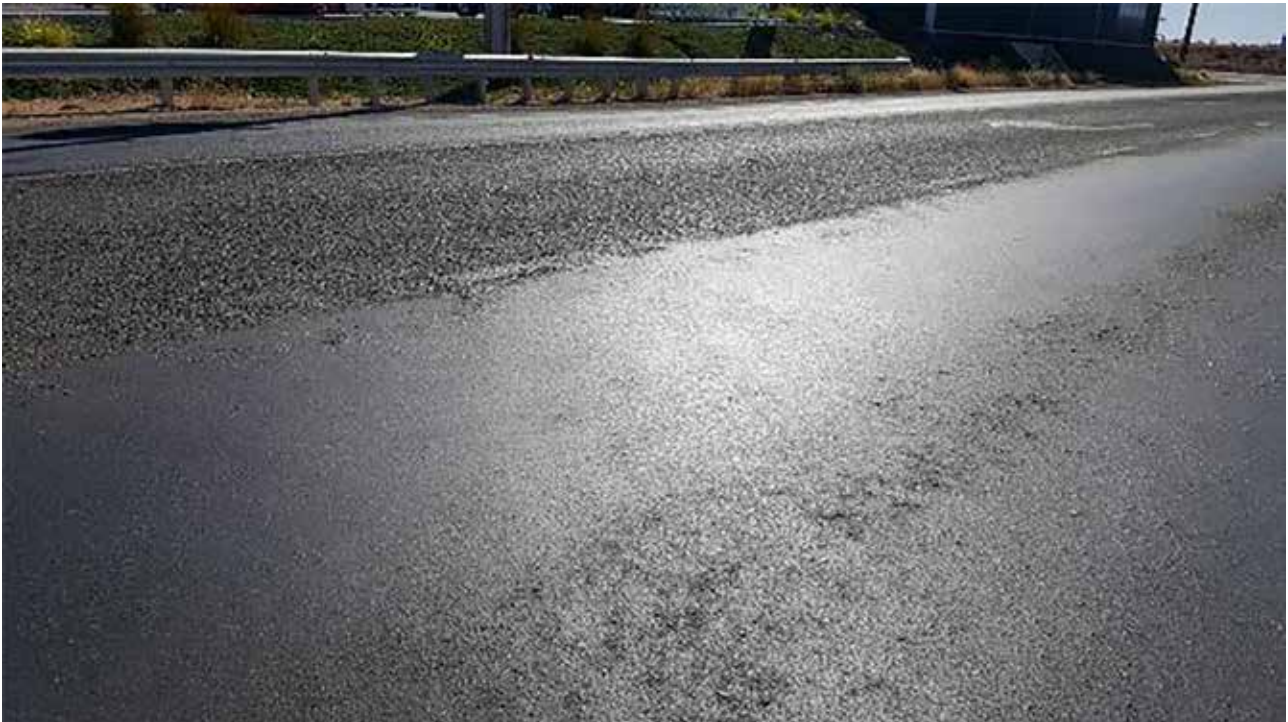
Slippery pavement and very faded line marking is a major safety concern near Bunnings in Berri

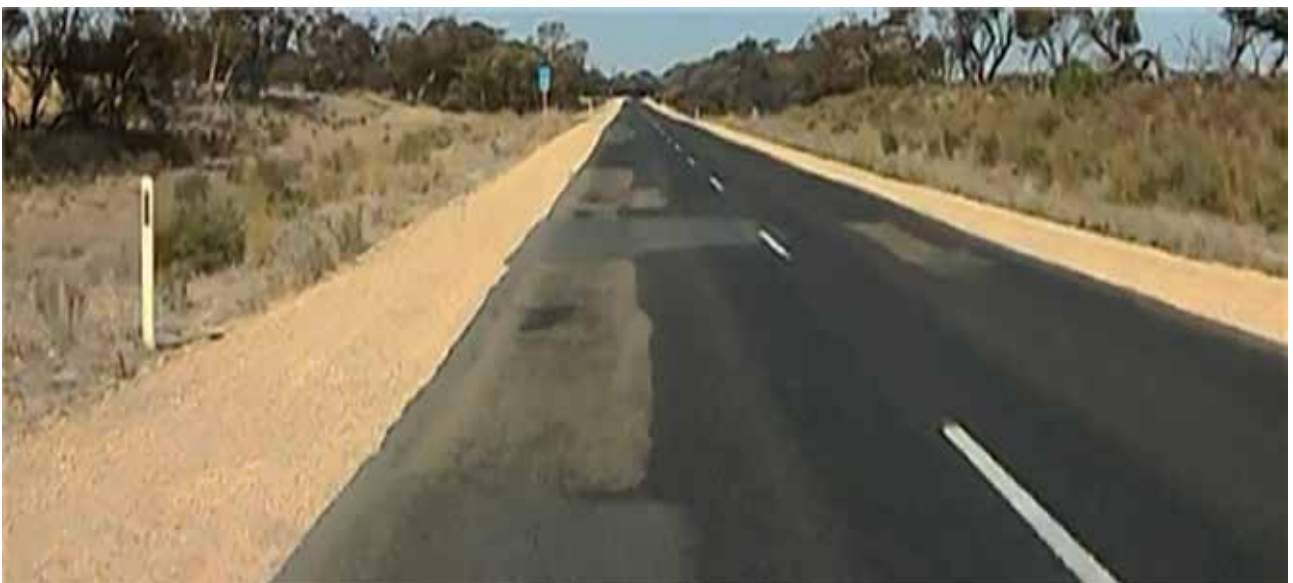
The highway is deteriorating near Pinnaroo

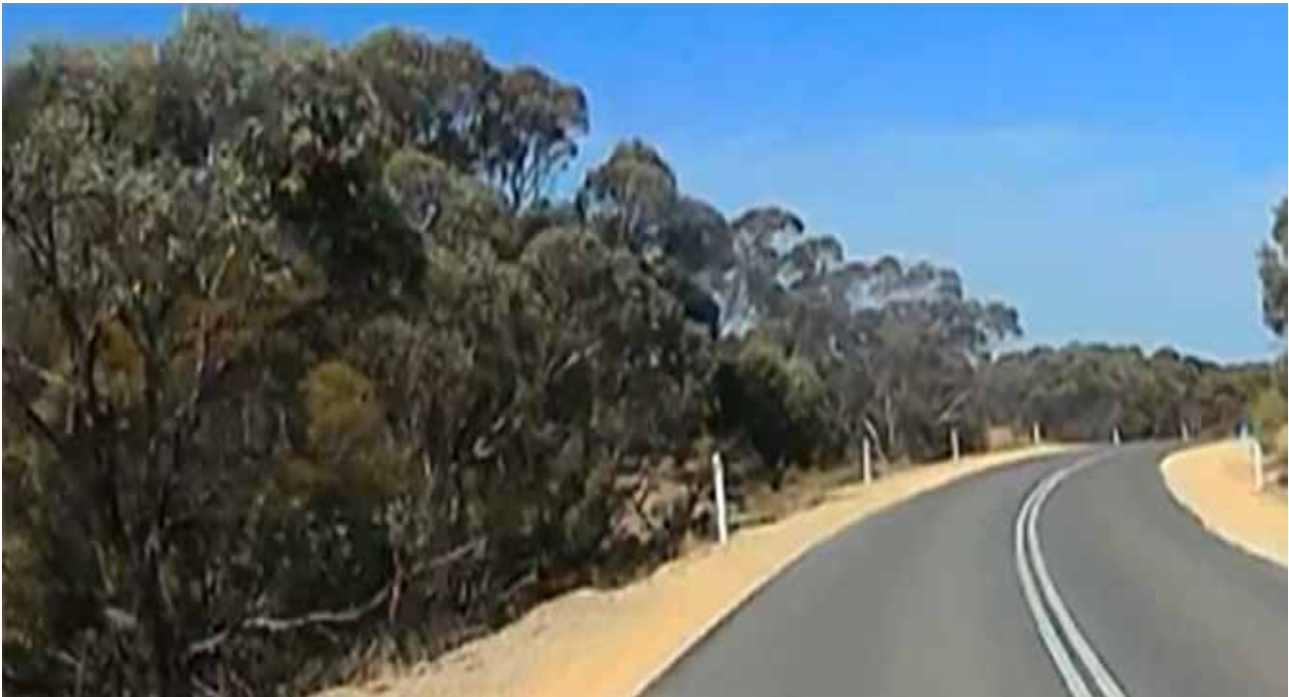
Steep and unprotected drop offs are common occurrences

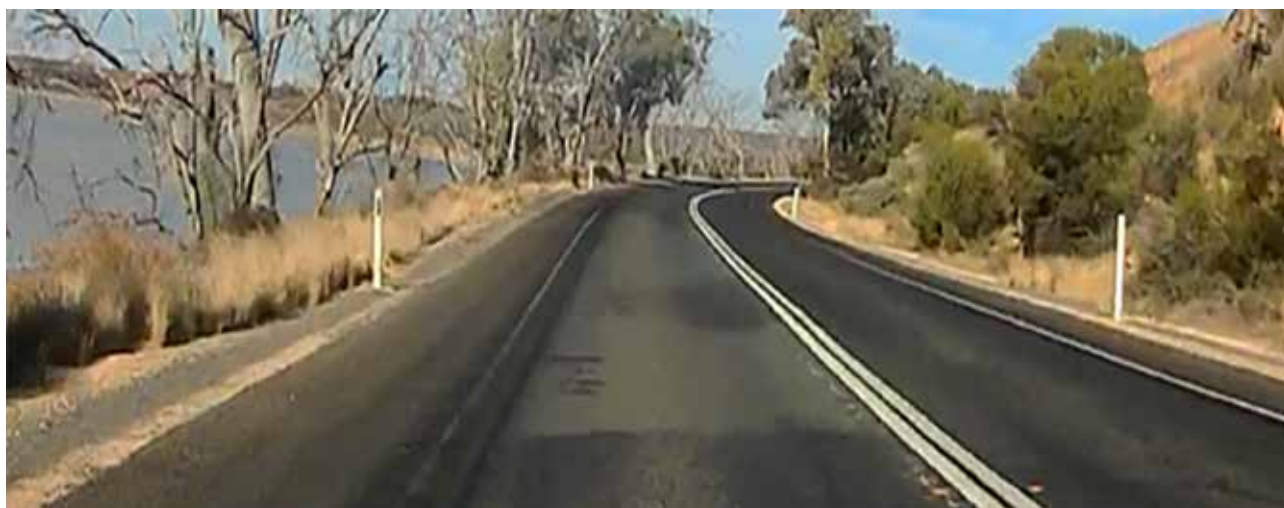
Faded edge lines around curves were common, as were steep drop offs and fixed objects in the clear zone as pictured

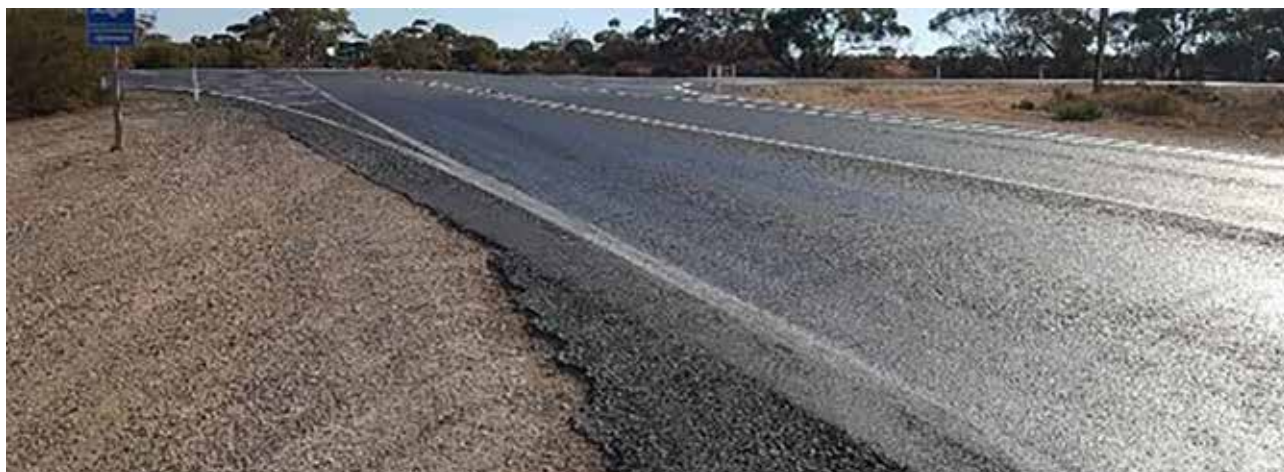
The highly polished surface on Kingston Road on approach to Sturt Highway is likely to perform poorly in wet weather

● Improve the left turn from Kingston Road onto Sturt Highway. Consider extending an acceleration lane for left turners to the overtaking lane to the west of the intersection.	DPTI
● Test skid resistance of pavement on approach to Sturt Highway due to a highly polished surface approximately 40m from the intersection.	DPTI
Bookpurnong Road – Key Recommendations	Authority
● Reseal the poor sections between Edmondson Road and French Road and between Stanitzki Road and Gordon Road in the short term and consider resealing the road in its entirety.	DPTI
● Refresh faded line marking in the vicinity of Edmondson Road.	DPTI
● Install w-beam barrier to protect roadside hazards in the vicinity of Gurra Gurra Creek Bridge.	DPTI
● Consider installing an additional overtaking lane in each direction.	DPTI
● Review heavy vehicle turn paths at the Berri roundabout and consider altering geometry of the southern exit curve to better facilitate b-double access.	DPTI

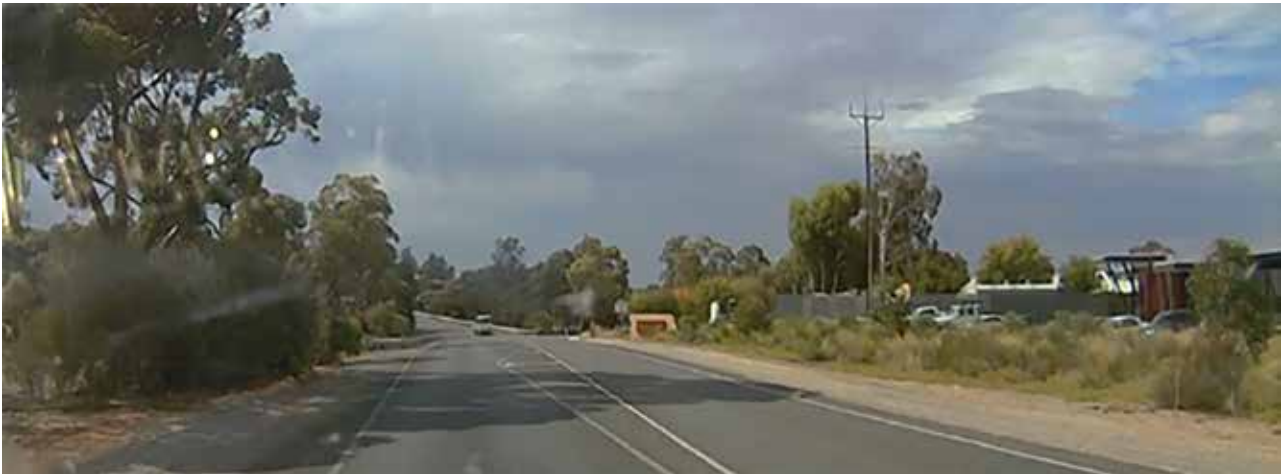
Faded line marking in the vicinity of Edmondson Road

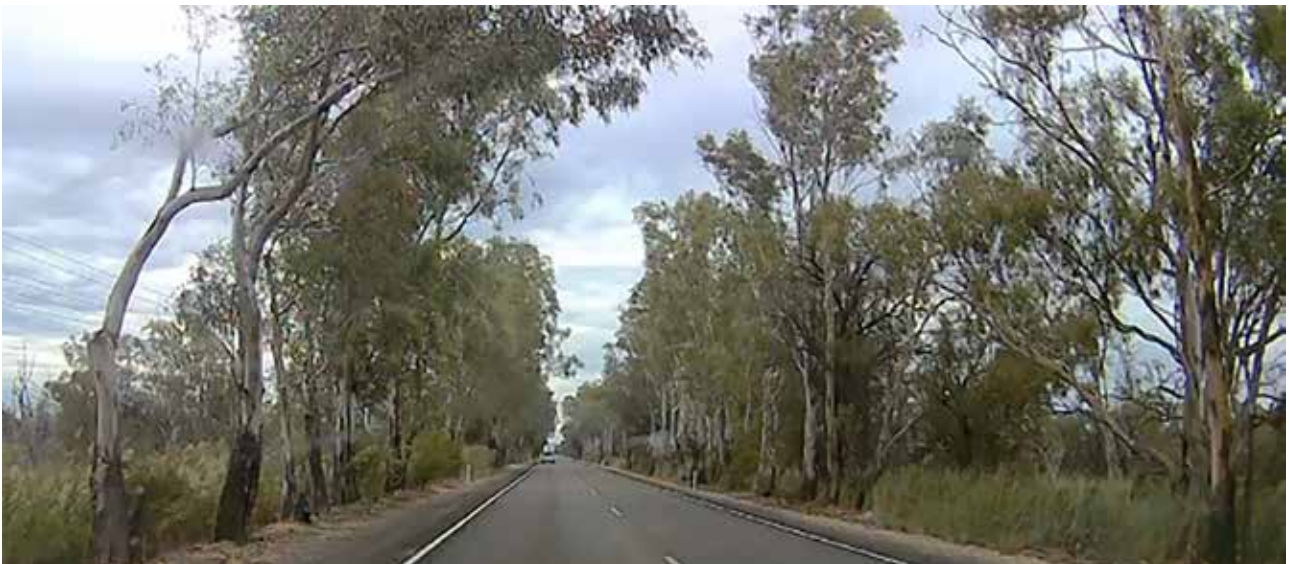
Trees on both sides of the road near Gurra Gurra Creek Bridge

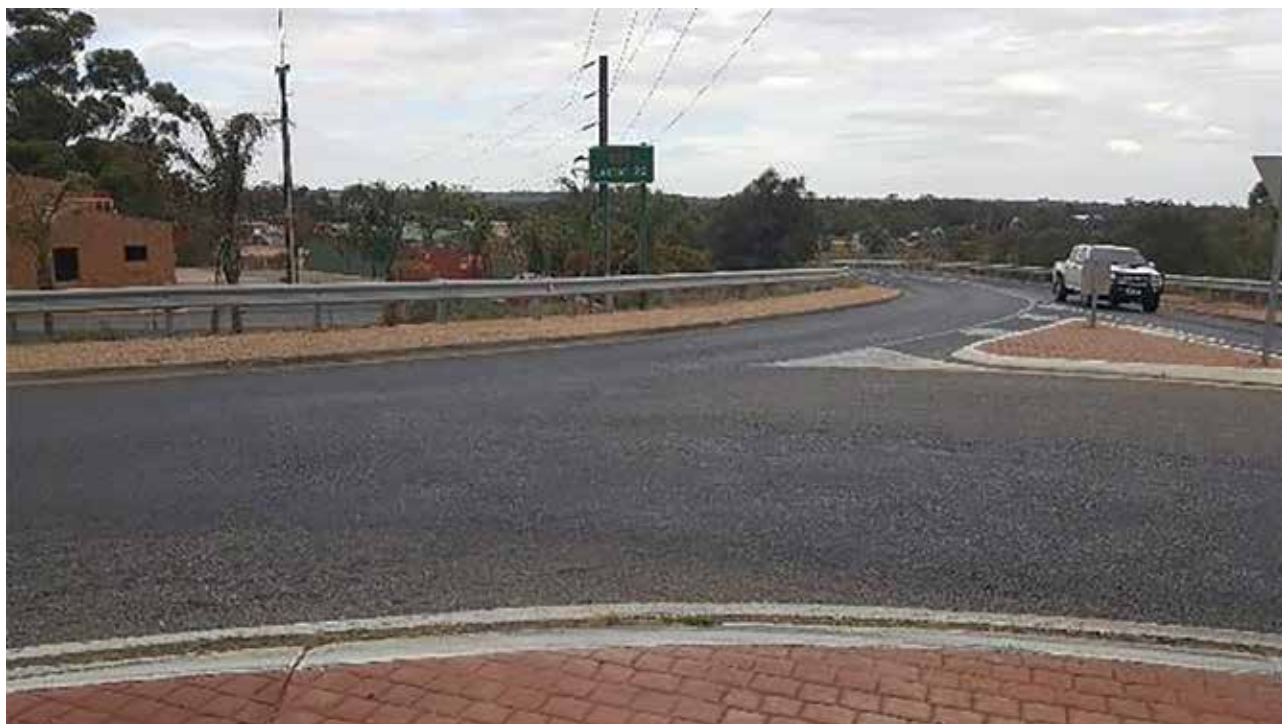
The exit curve of the roundabout in Berri is challenging for heavy vehicles to negotiate.

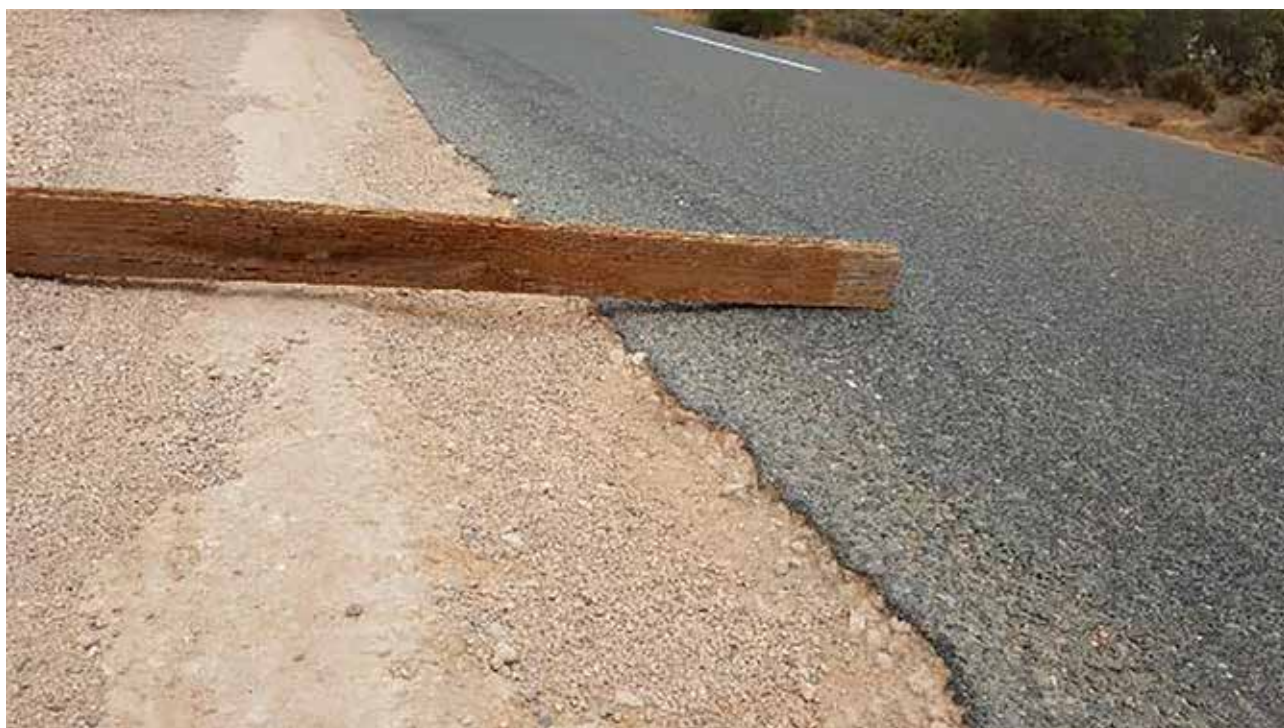
Drop-offs were measured between 50-100mm along most of Stanitzki Road

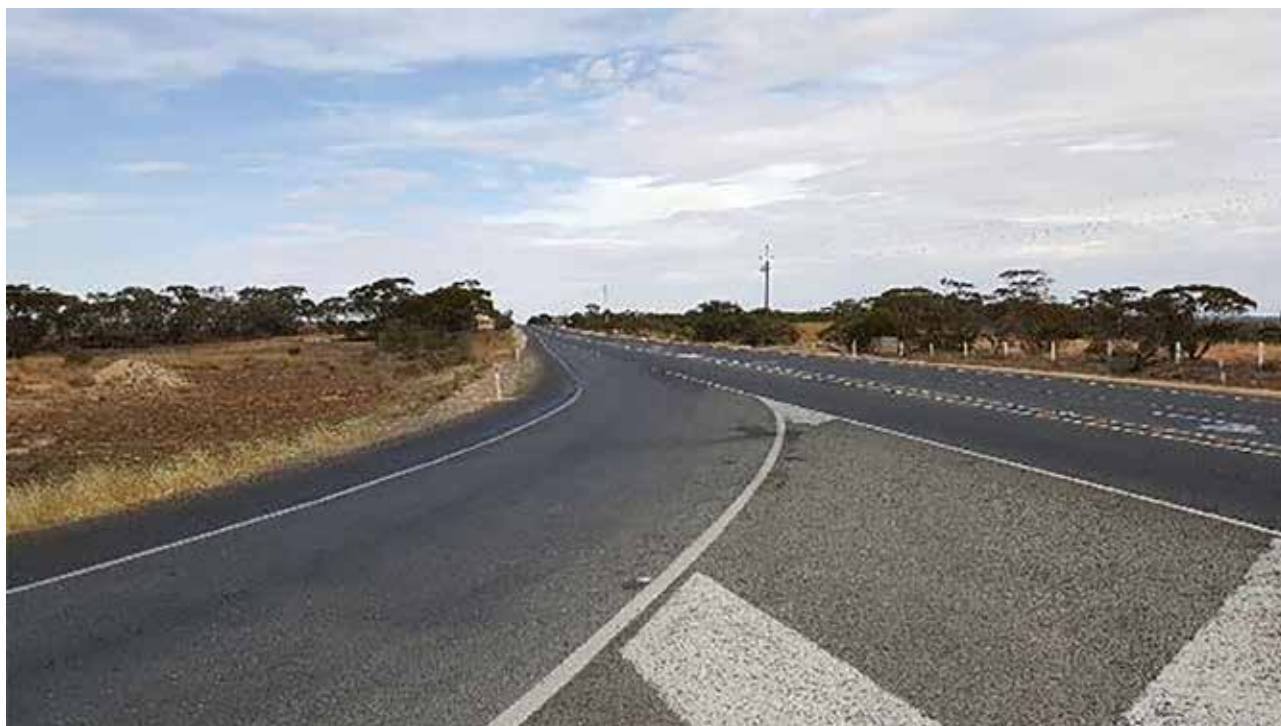
The acceleration lane at the Stanitzki Road/Bookpurnong Road intersection is too short for slower vehicles to safely merge
