Riverland

Regional Road Assessment June 2018

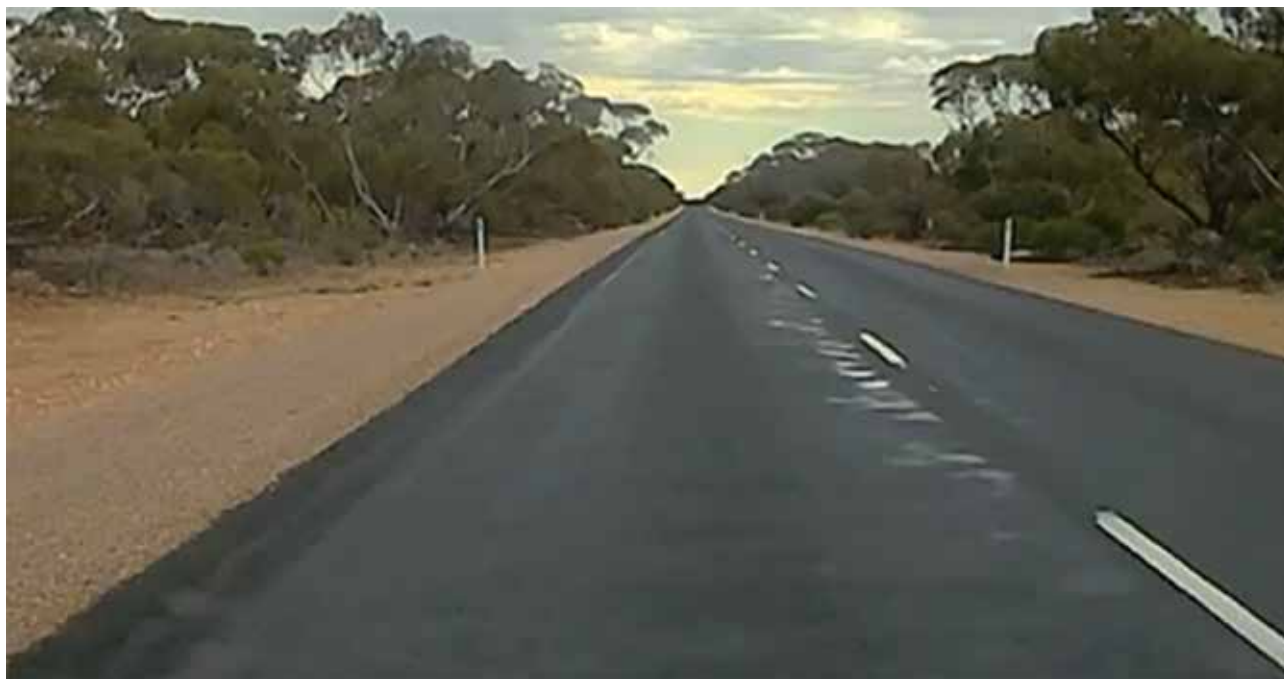
Water ponding on the surface after light rainfall

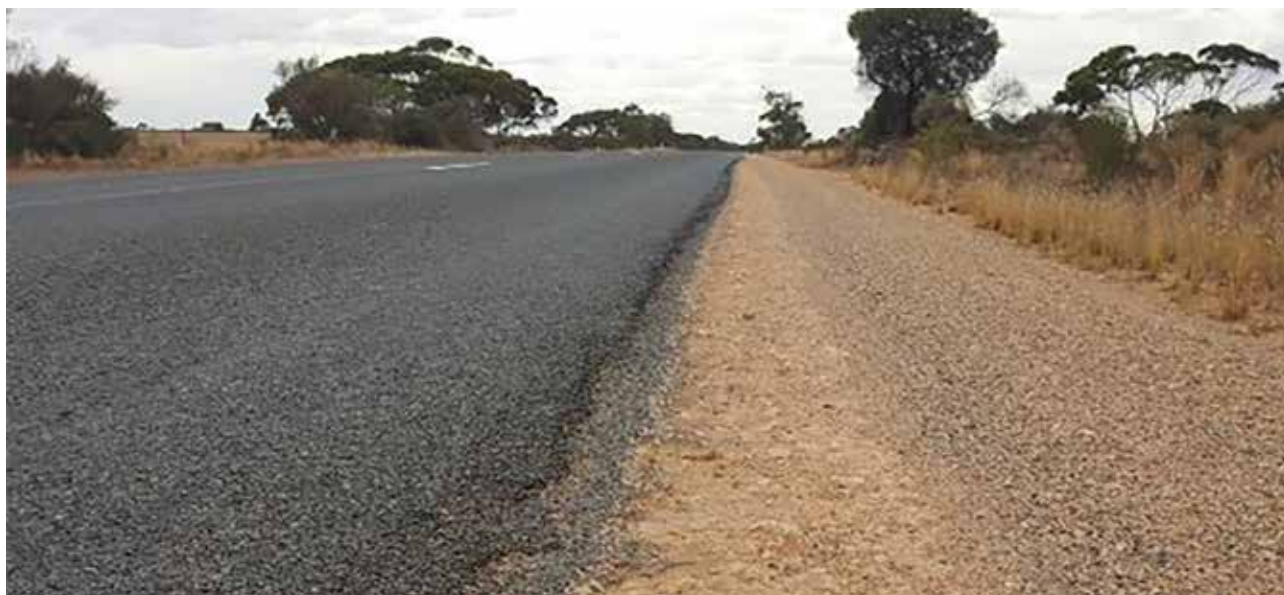
Edge drop off was prevalent in a number of locations

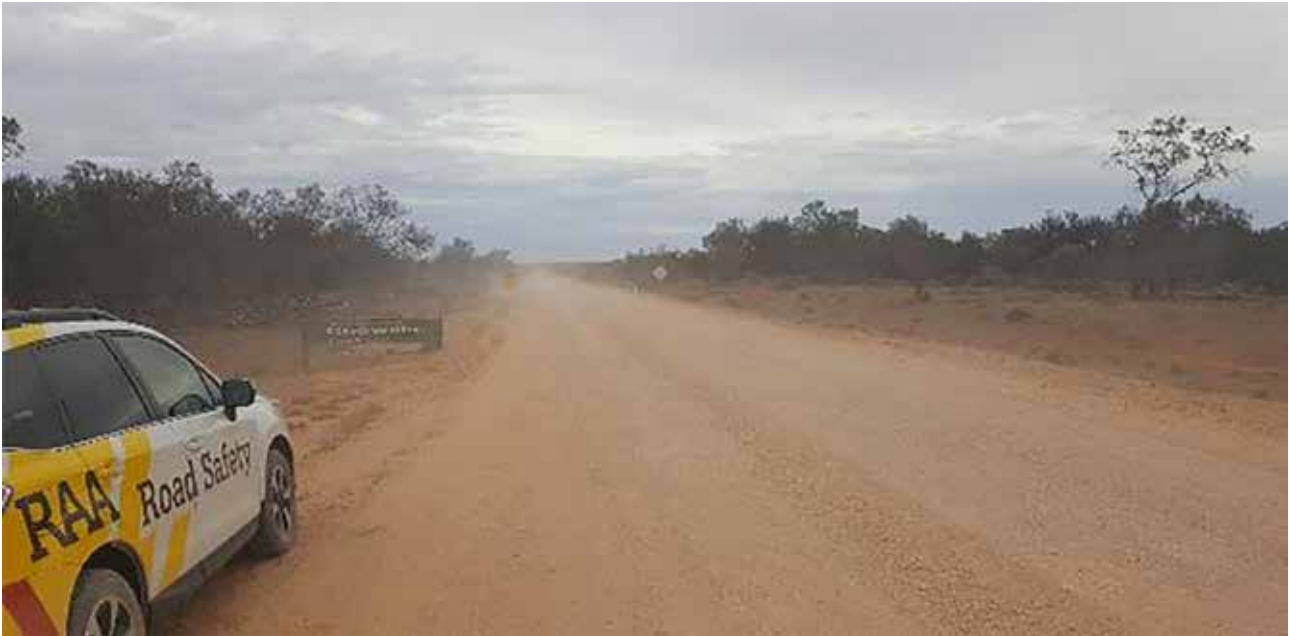
Fine dust was prevalent and lingered, reducing driver visibility

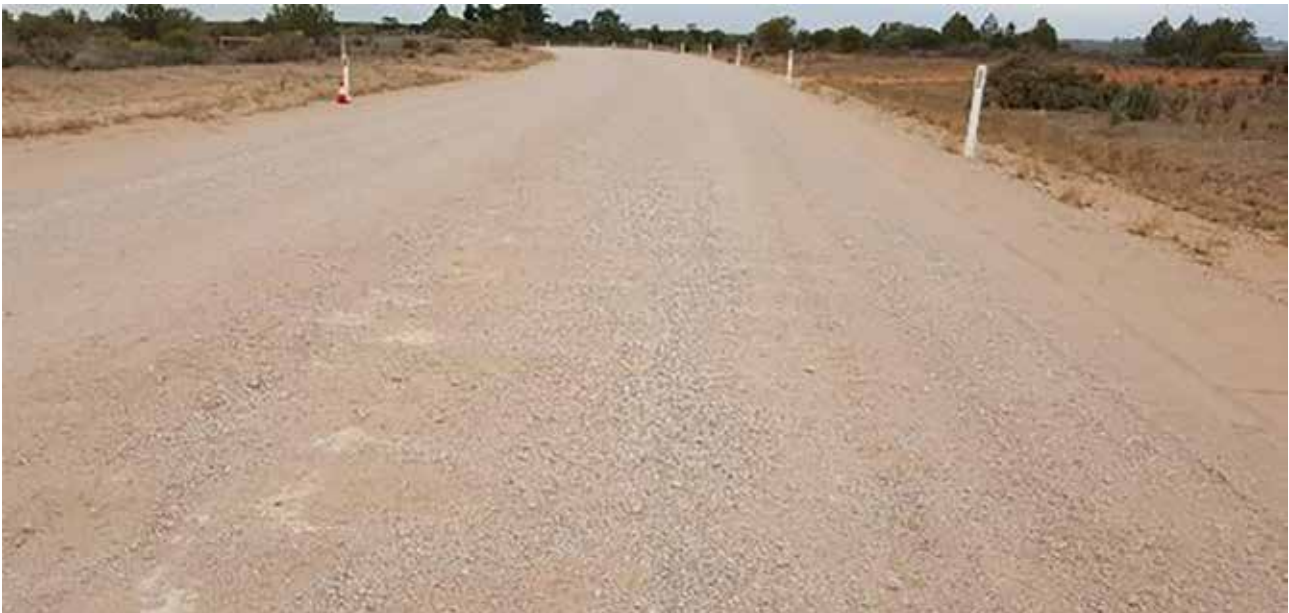
Corrugations on sections of the road, with the protruding rock bed a potential cause of tyre blowouts

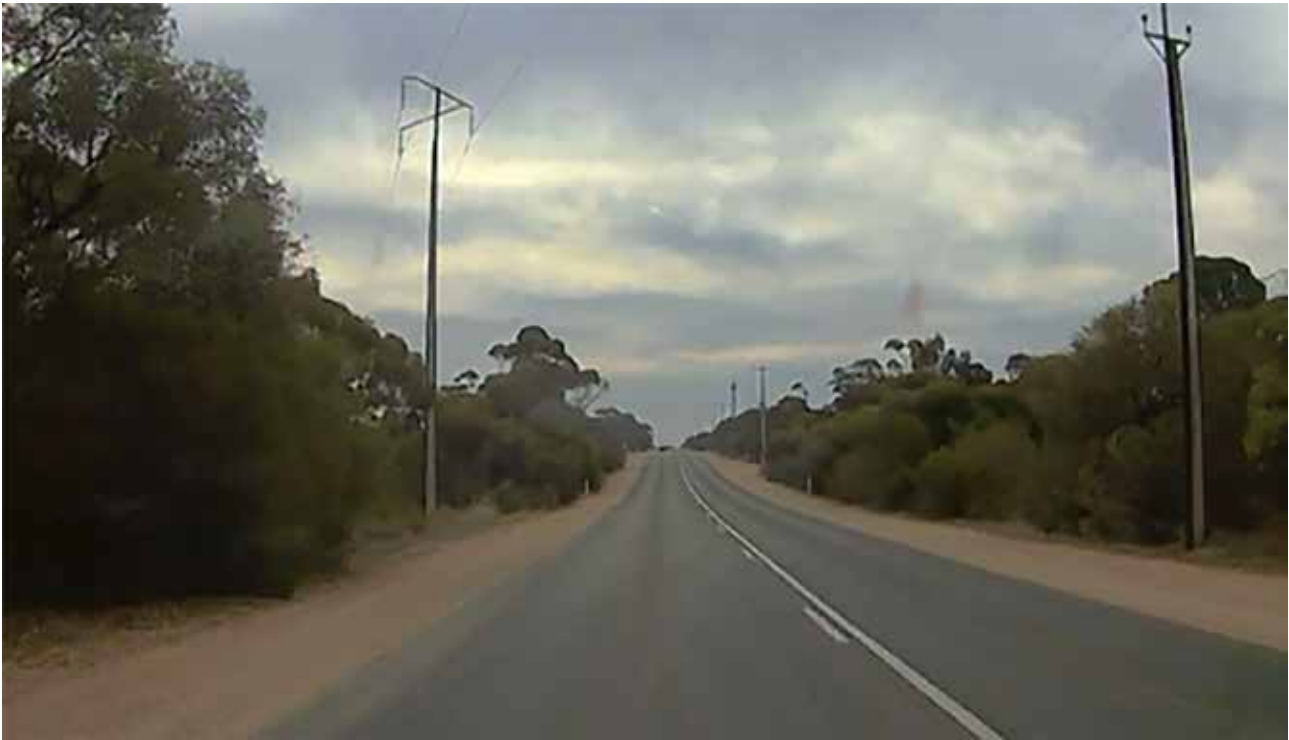
Stobie poles are a regular hazard present on Ramco Road/Cadell Valley Road

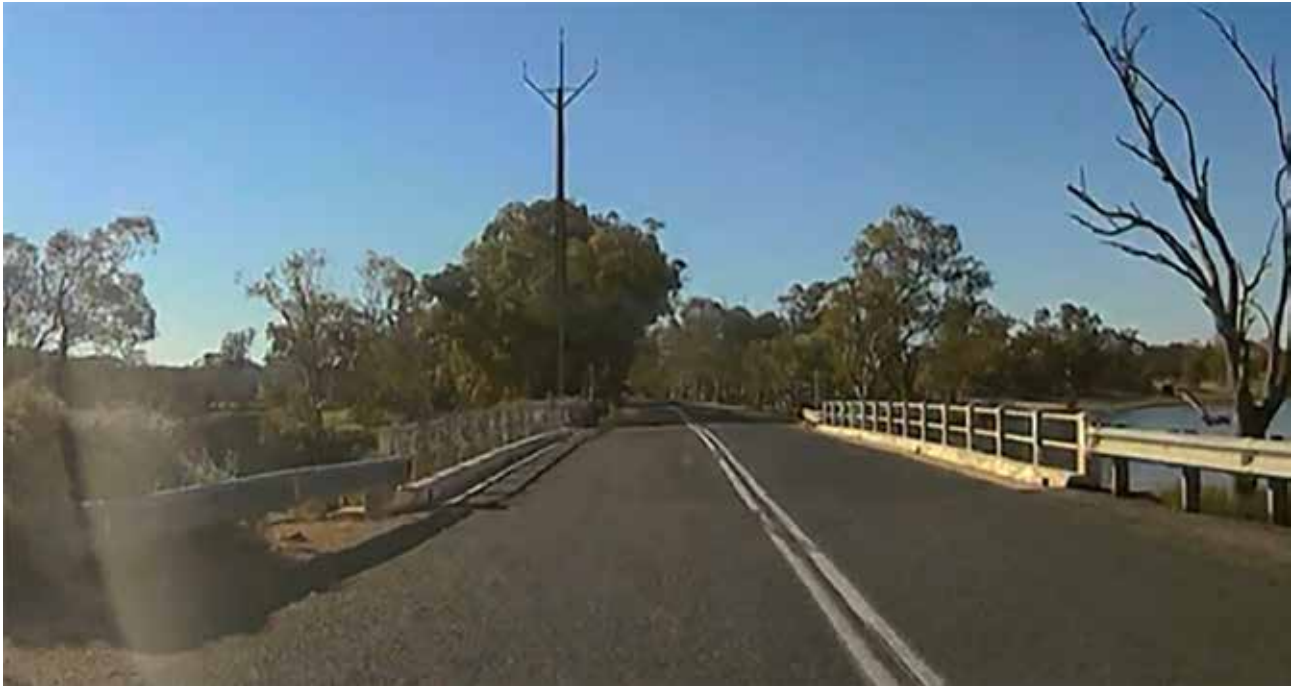
Width markers are not installed to delineate the width of Nappers Bridge

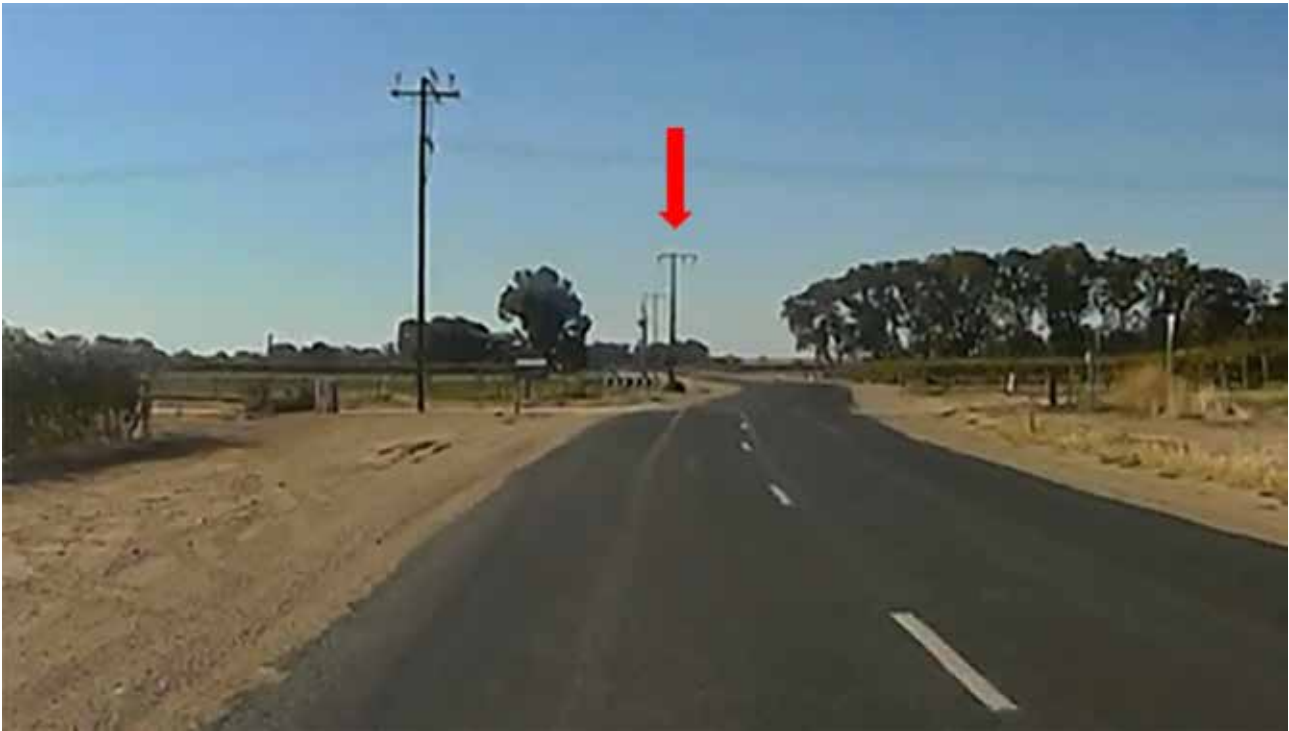
This stobie pole was directly in the path of vehicles.

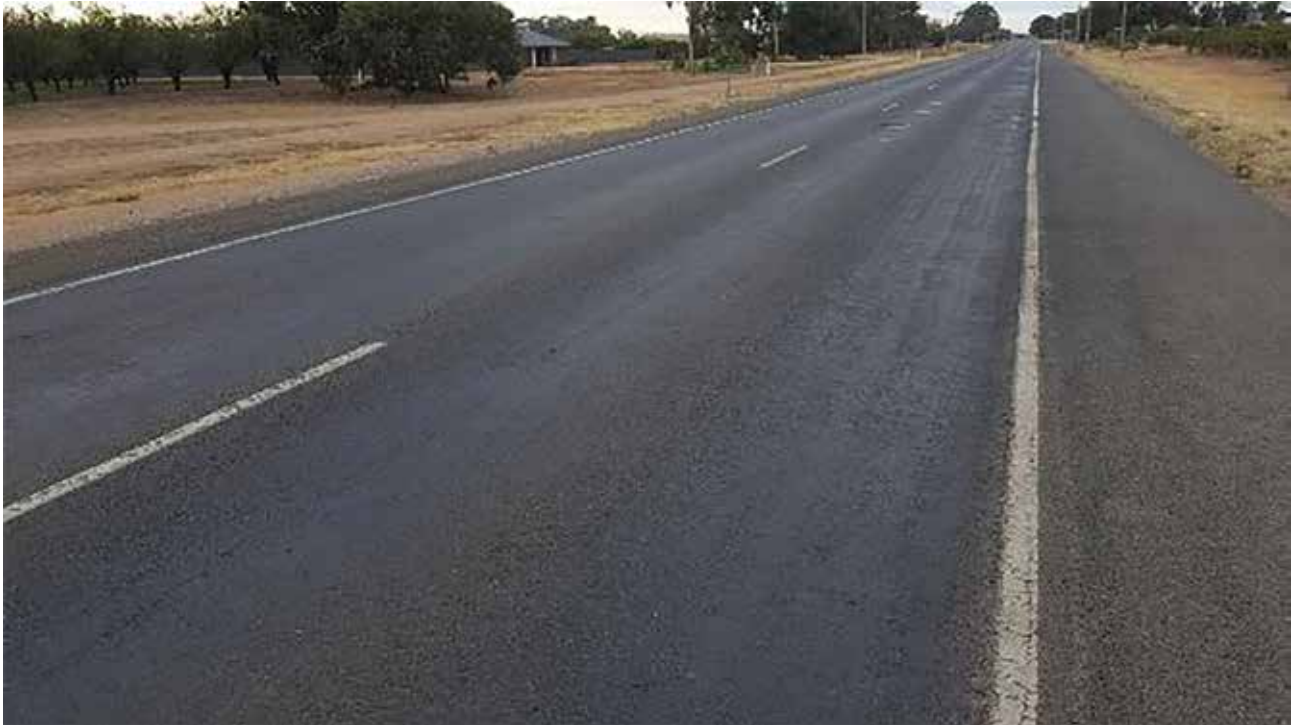
Rutting on Ral Ral Avenue

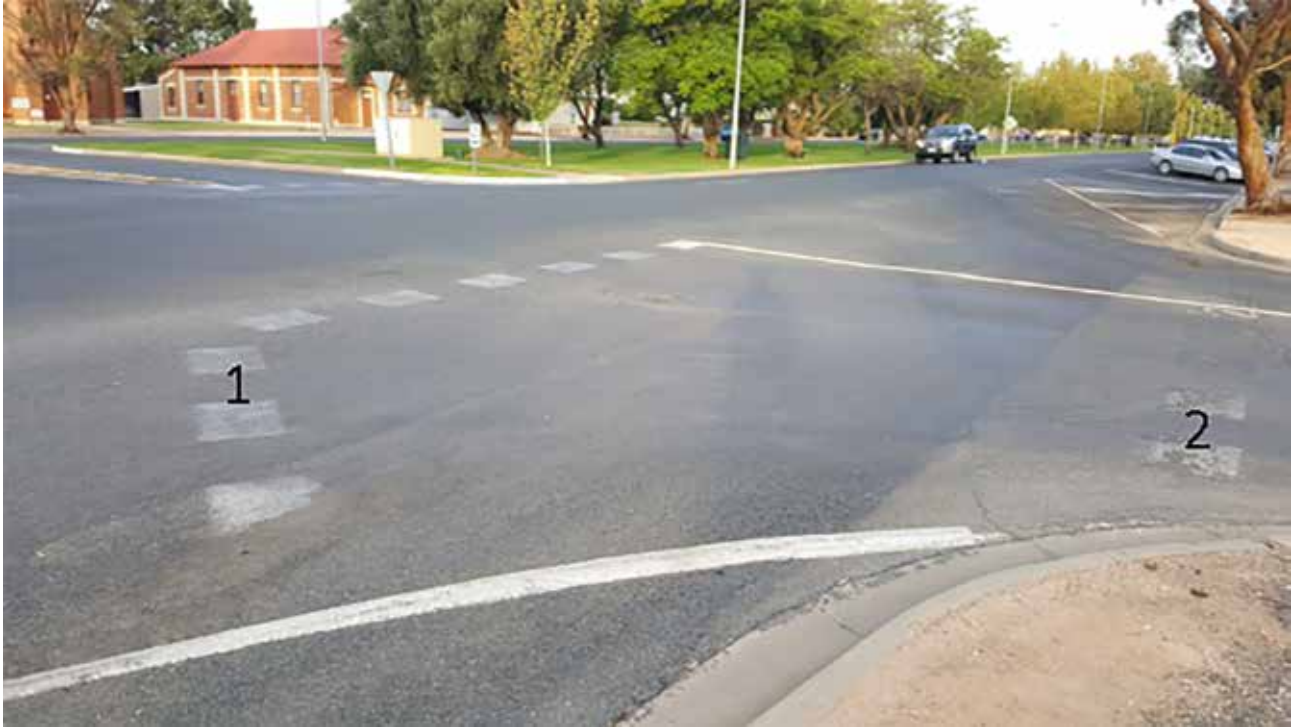
The old give way holding line (2) is still visible

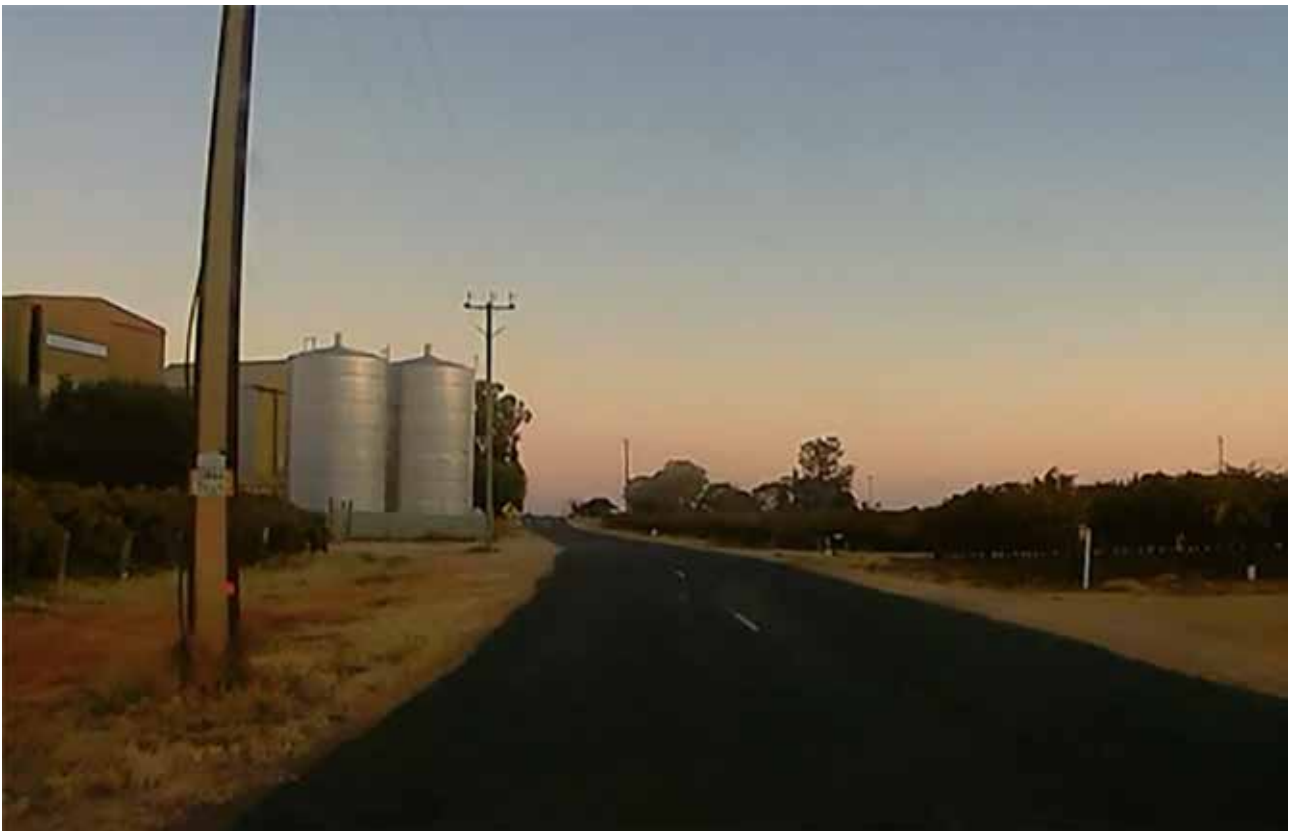
Stobie poles were located very close to the road and poorly delineated

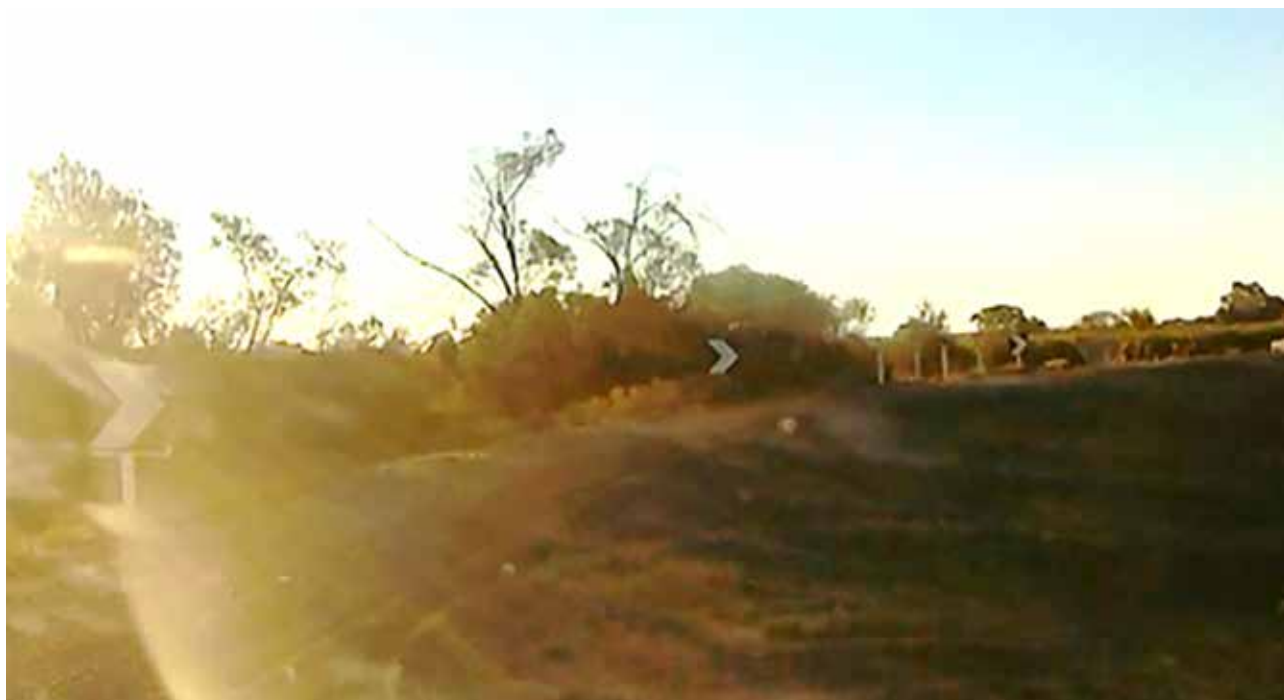
Unidirectional hazards markers were incorrectly used around a number of curves

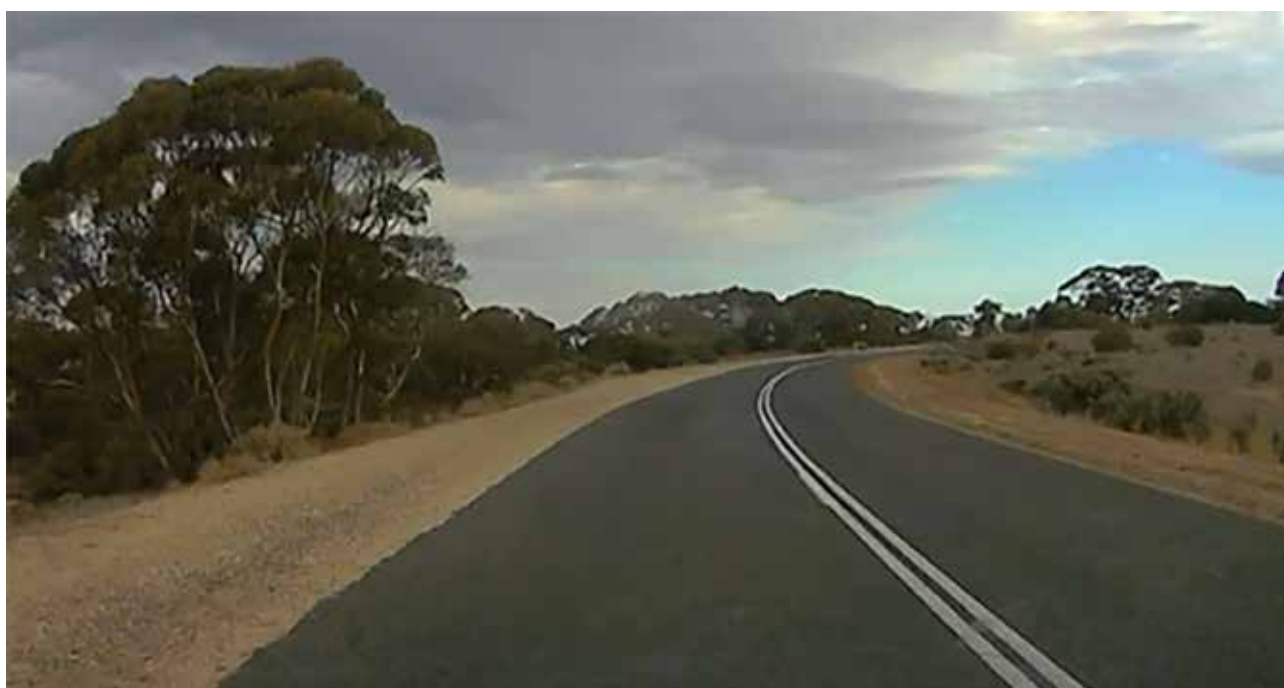
Unprotected drop off on the southern section of Murbko Road.

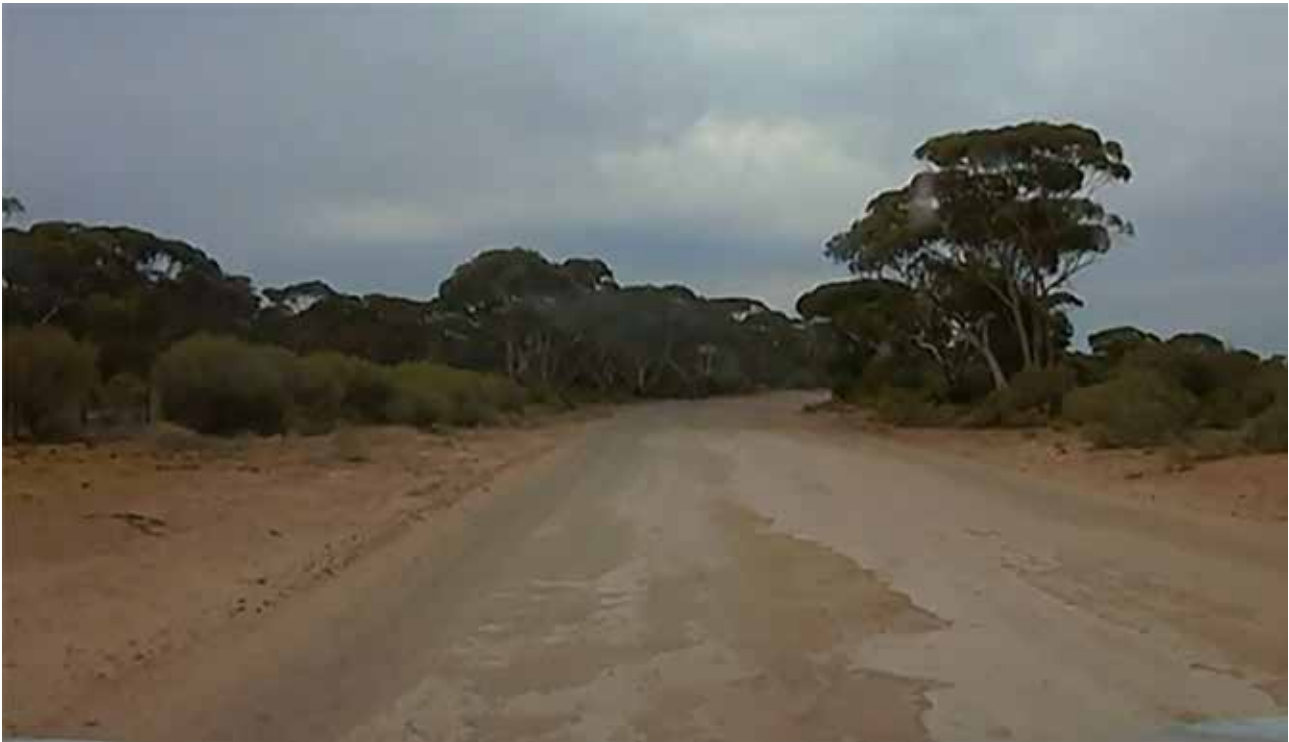
Poor surface conditions on Caddy Road

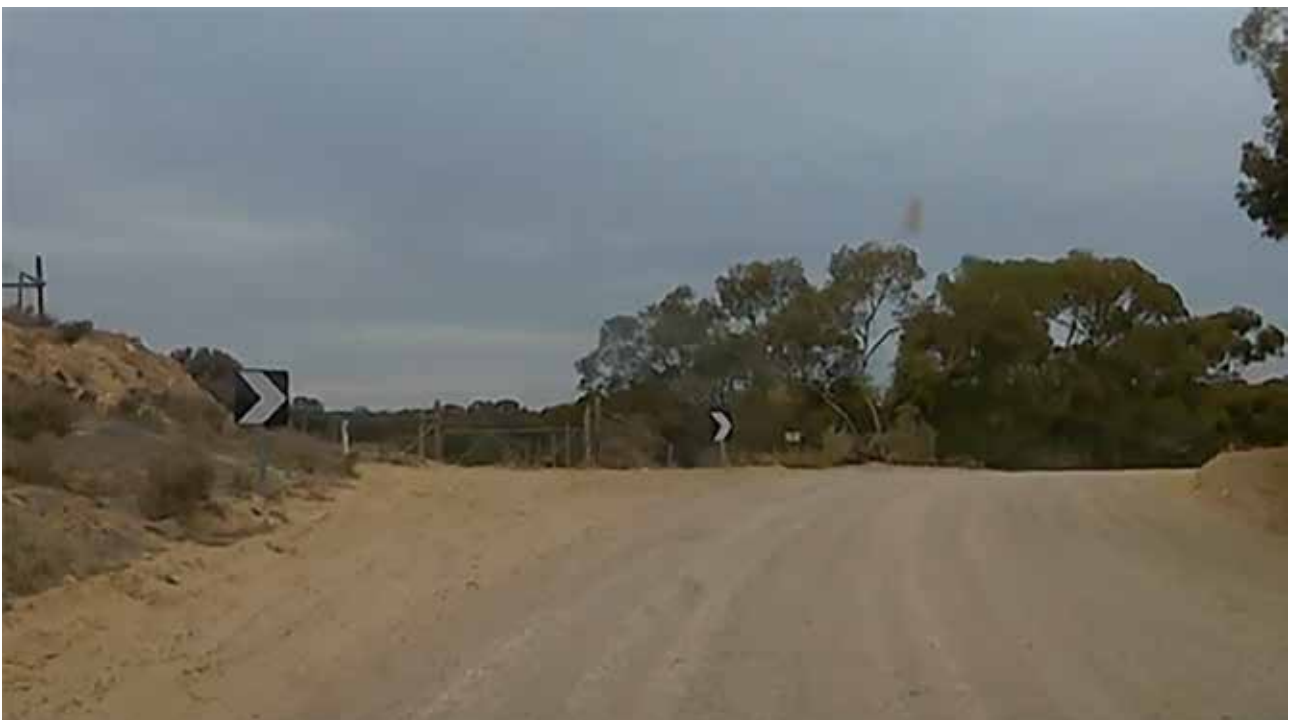
Unidirectional hazard marker boards were incorrectly installed to delineate substandard curves.

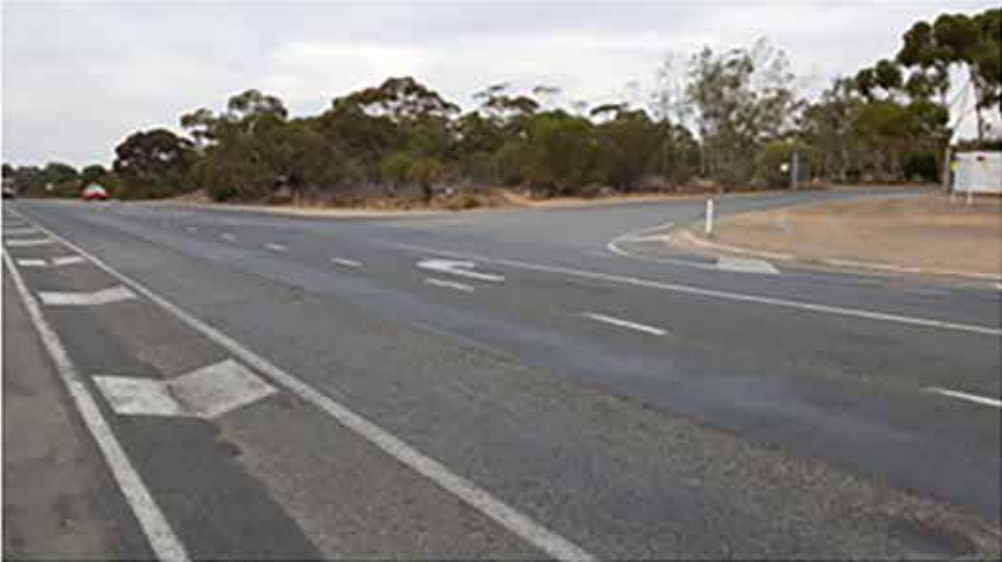
</div> <p data-bbox="368 974 1364 1037">Figure 7: The channelised right turn lane into Growers Wine Group was barely long enough, causing heavy vehicles to drive on the painted median prior to entering the turn lane.</p> <p data-bbox="341 1093 1390 1256">Heavy vehicles turning right into Growers Wine Group drive over the painted median island at high speed prior to entering the channelised right turn lane. This poses a high risk to pedestrians who regularly stand on this painted median when crossing Sturt highway.</p> <p data-bbox="341 1312 1390 1476">It is recommended that the channelised right turn lane is extended to safely accommodate deceleration and right turn movements, and a raised concrete median is installed to restrict vehicles from driving on the islands and increase the level of safety for pedestrians.</p>

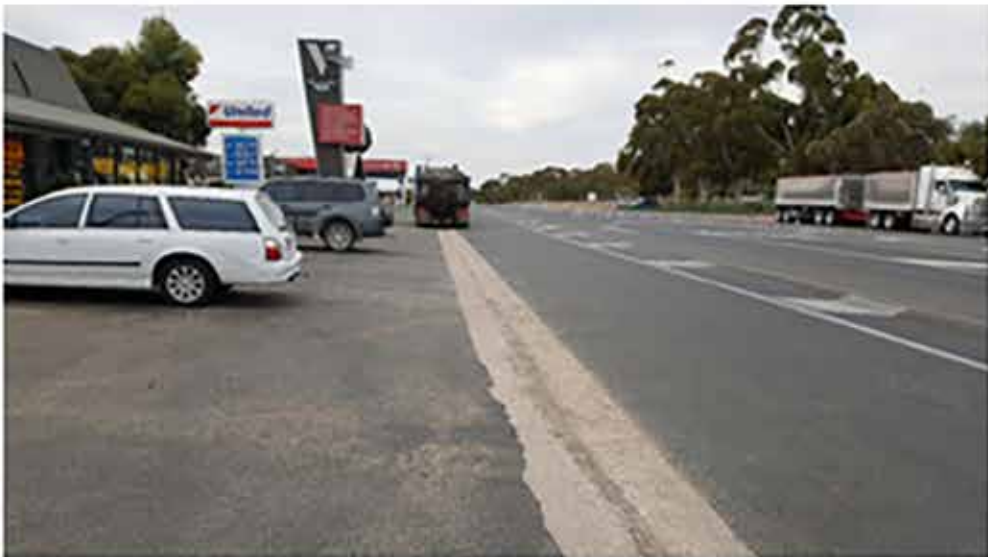
</div> <p>Figure 10: 90 degree parking in front of New Land Bakery causes some vehicles to back out onto Sturt Highway.</p> <p>Current 90 degree parking in front of New Land Bakery requires traffic to back out into the service road but in some cases vehicles are backing straight out onto Sturt Highway. Due to poorly parked vehicles, sight distance to the west is regularly restricted for these vehicles and they are backing out blind.</p> <p>It is recommended that 60 degree angle parking is installed to encourage drivers to back out into the service road rather than backing out onto the major highway. When parking in the area is formalised, sight distance issues for reversing vehicles should be far less common.</p>

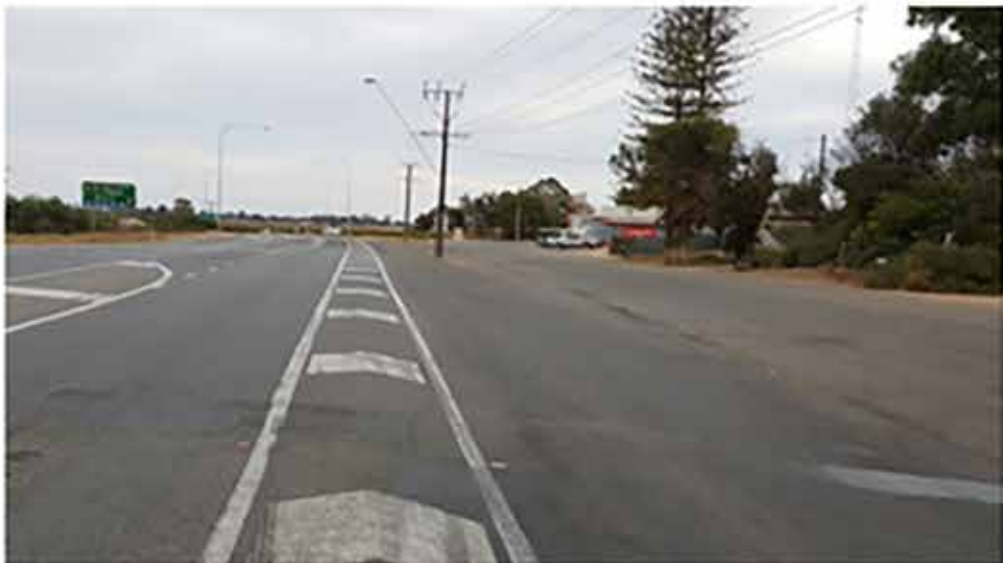
<p>Figure 11: Stobie poles present a hazard and also restrict potential parking locations</p> <p>Stobie poles on site are a crash risk however are generally set back from Sturt Highway. Two stobie poles in particular raise concern, namely the stobie pole opposite Maggea Road and the stobie pole opposite the Growers Wine Group driveway.</p> <p>It is recommended that these two stobie poles are removed and power is undergrounded, with hazard signs installed on stobie poles in the short time. This will provide safety benefits by removing hazardous fixed objects within the clear zone but also provide clear space to consider for additional long vehicle parking spaces.</p>
11	Street Lighting
	<p>A low level of street lighting is currently provided on site. If raised concrete traffic islands are installed, the level of street lighting will need to be reviewed and upgraded as necessary to meet relevant DPTI and Australian standards and provide sufficient visibility of these devices.</p>

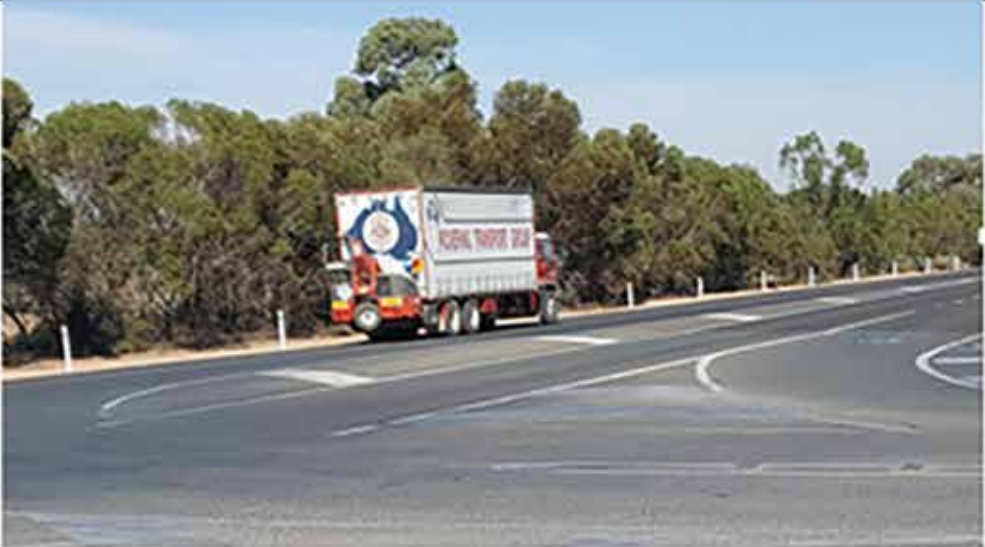
<p>Figure 6: Heavy vehicles currently utilise the wide westbound shoulder to accelerate</p> <p>Turning right from Airport Road is most troublesome turning movement at this intersection and can be frustrating for heavy vehicle drivers due to the high volumes of traffic on Sturt Highway. Risky turn manoeuvres are often made in order to clear the intersection. Drivers currently utilise the westbound shoulder to accelerate to speed.</p> <p>It is recommended that a large roundabout accommodating all freight movements is installed at this intersection to improve safety by reducing frustration and the number of risky turns being made.</p>

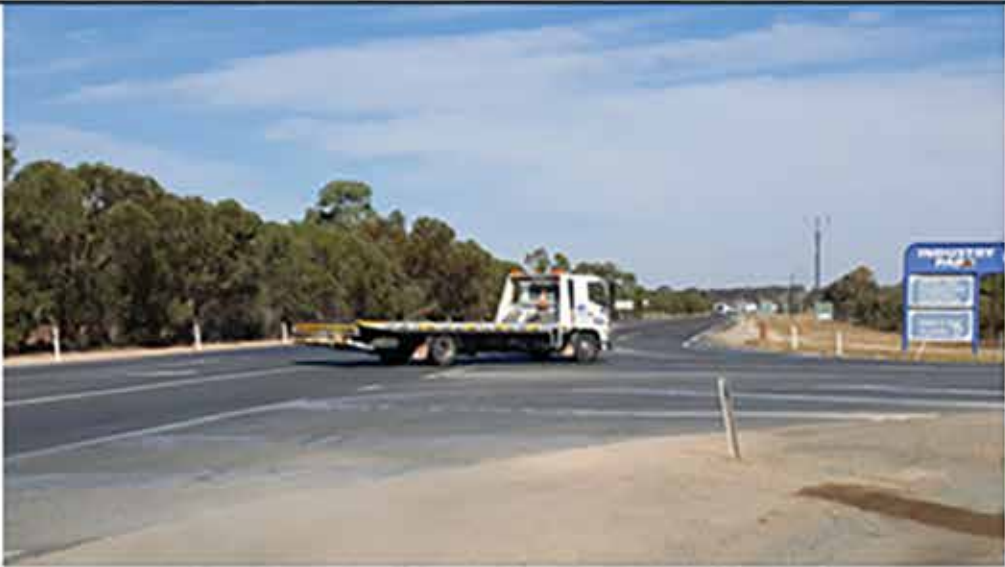
</div> <p data-bbox="544 909 1174 938">Figure 7: Heavy vehicles cut the corner when turning right</p> <p data-bbox="336 983 1385 1234">Heavy vehicles turning right from Sturt Highway onto Airport Road regularly cut the corner, posing a risk to vehicles turning right out of Airport Road. For smaller rigid vehicles this is more down to driver error however the swept path of larger articulated combinations requires this space. It was noted that some vehicles utilised the painted traffic island on the western corner of the intersection to generate additional turning space.</p> <p data-bbox="336 1290 1385 1451">As previously stated in the report, a roundabout is the recommended option and will address this issue. If a roundabout is not supported, in the short term, widening of Airport Road at the apron to create additional space for turning vehicles is recommended.</p>

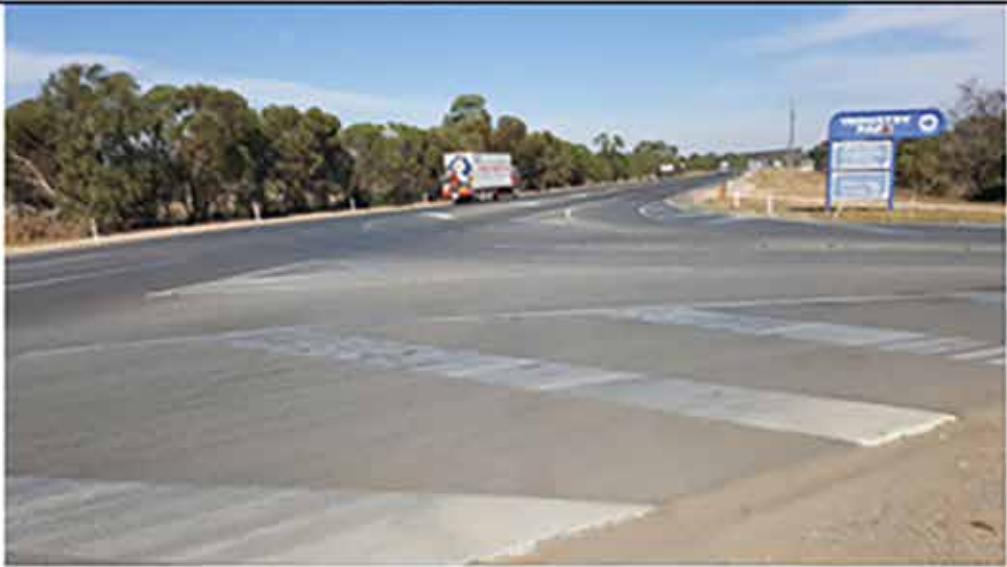
</div> <p data-bbox="531 920 1197 949">Figure 8: Line marking at the intersection is in poor condition</p> <p data-bbox="336 987 1394 1099">Line marking was noted to be in poor condition due to the constant heavy vehicle traffic. It is recommended that line marking is refreshed, and scheduled for refreshing on a more regular basis than it is currently.</p>
