Limestone Coast

Regional Road Assessment September 2019

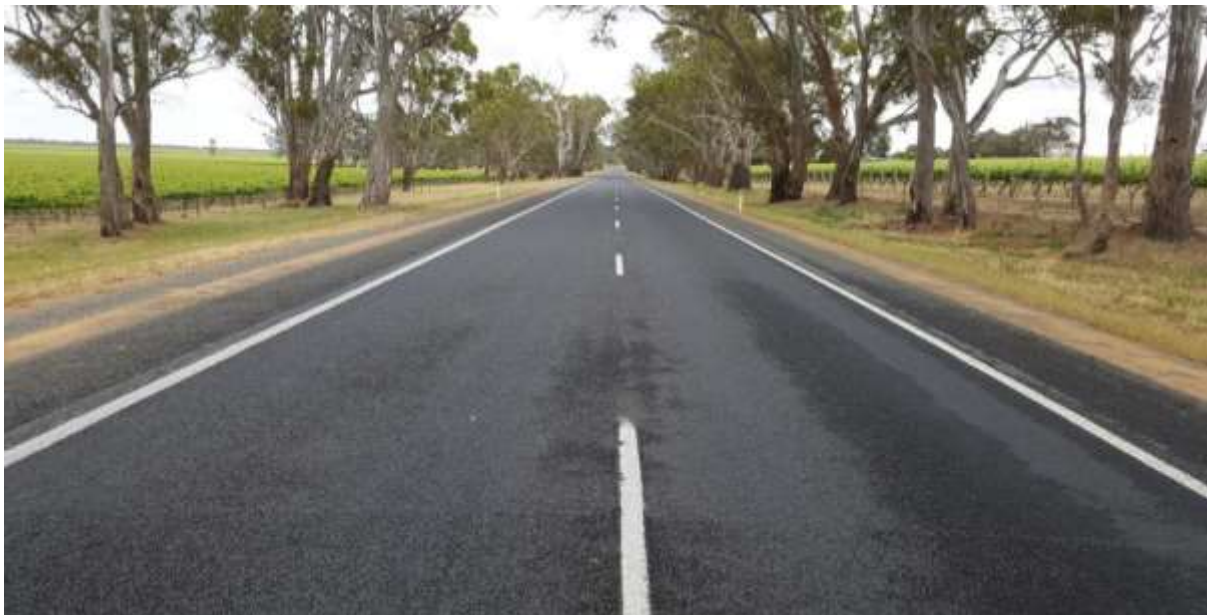
The road surface is generally in serviceable condition with localised defects including corrugations, ruts and minor undulations. There are sections with wide clear zones, and barrier protection has been used in some locations to protect fixed hazards. Numerous locations exist where large trees are unprotected within 5m of the road, and RAA recommends that all fixed hazards within five metres of the highway be removed or protected by barriers. Consideration should also be given to providing barrier protection to other fixed hazards within 10 metres of the road that cannot be addressed by other means.

Trees line the highway south of Padthaway

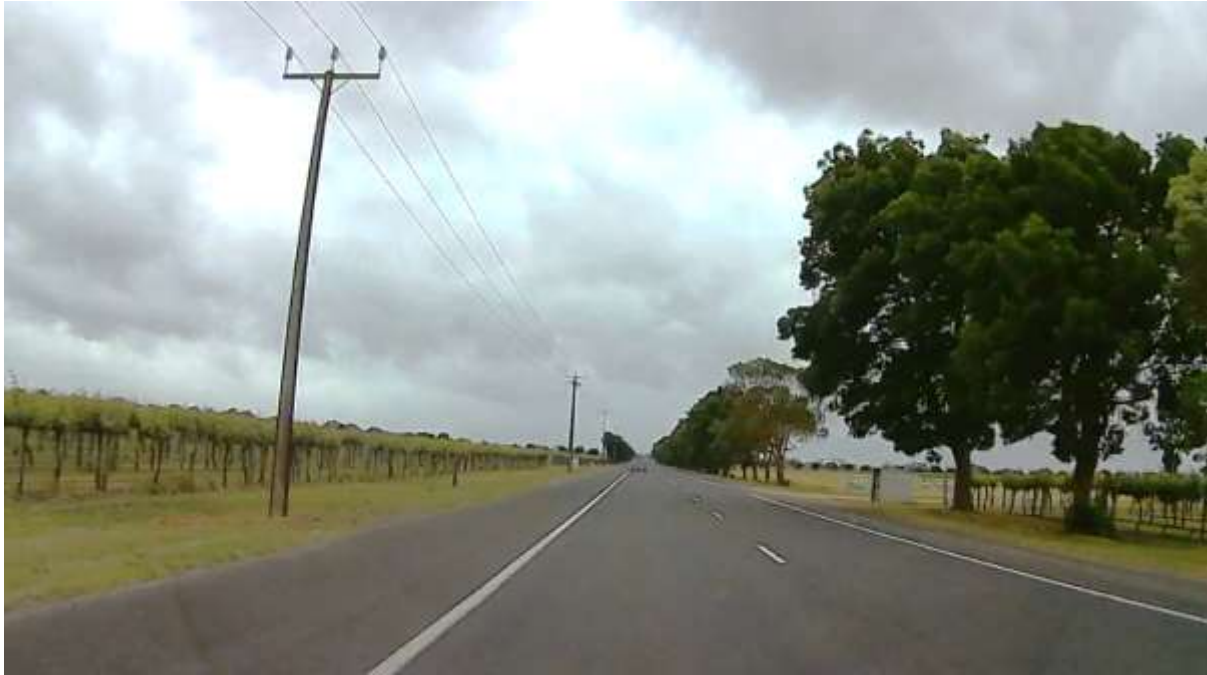
Fixed hazards are located within five metres of the road along most of this section and include trees and stobie poles, particularly in the Coonawarra region where a row of stobie poles is adjacent to the east side of the corridor for 10 kilometres between McLean Road in Coonawarra and the northern entry to Penola. Barriers protect some hazards on the outside of curves, however, RAA recommends that additional hazard removal and protection works be undertaken to further improve safety on this busy highway.

Stobie poles and trees consistently within 5m of the highway in the Coonawarra region

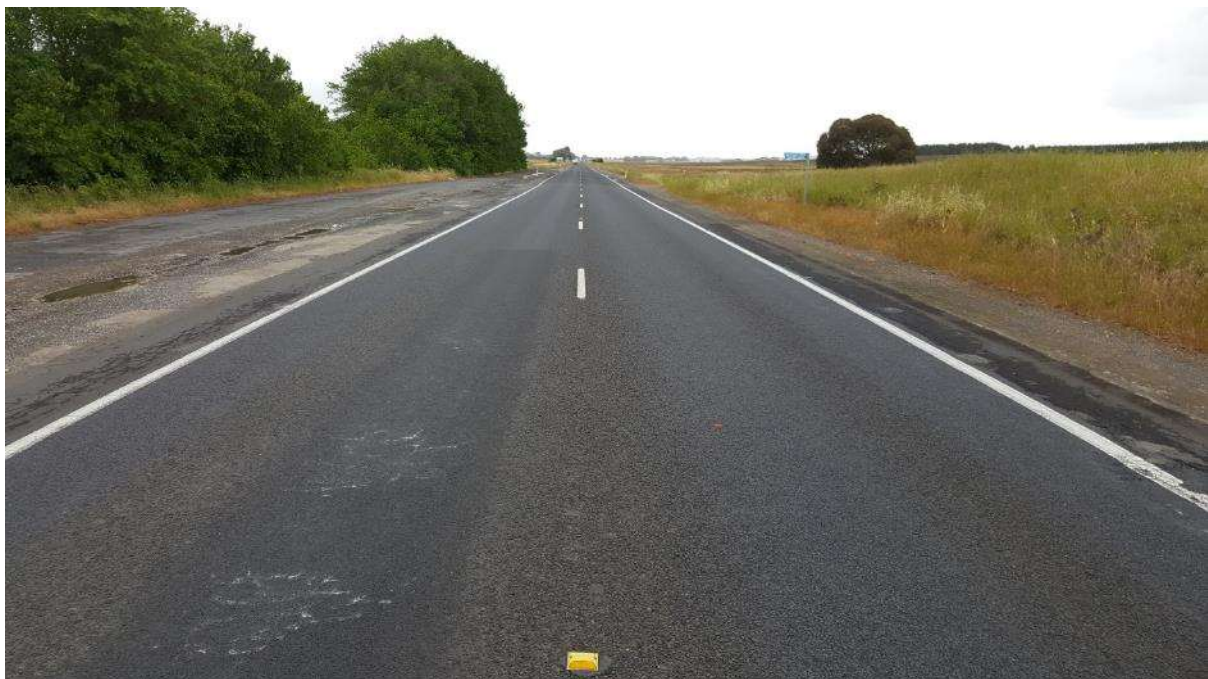
The surface of the road is markedly worse between Penola and Mount Gambier, likely correlating with the high volumes of freight. Ruts were evident along most sections of the road, causing water to pond on the road surface in the wheel paths.

Rutting and cracking in the wheel paths in Mingbool

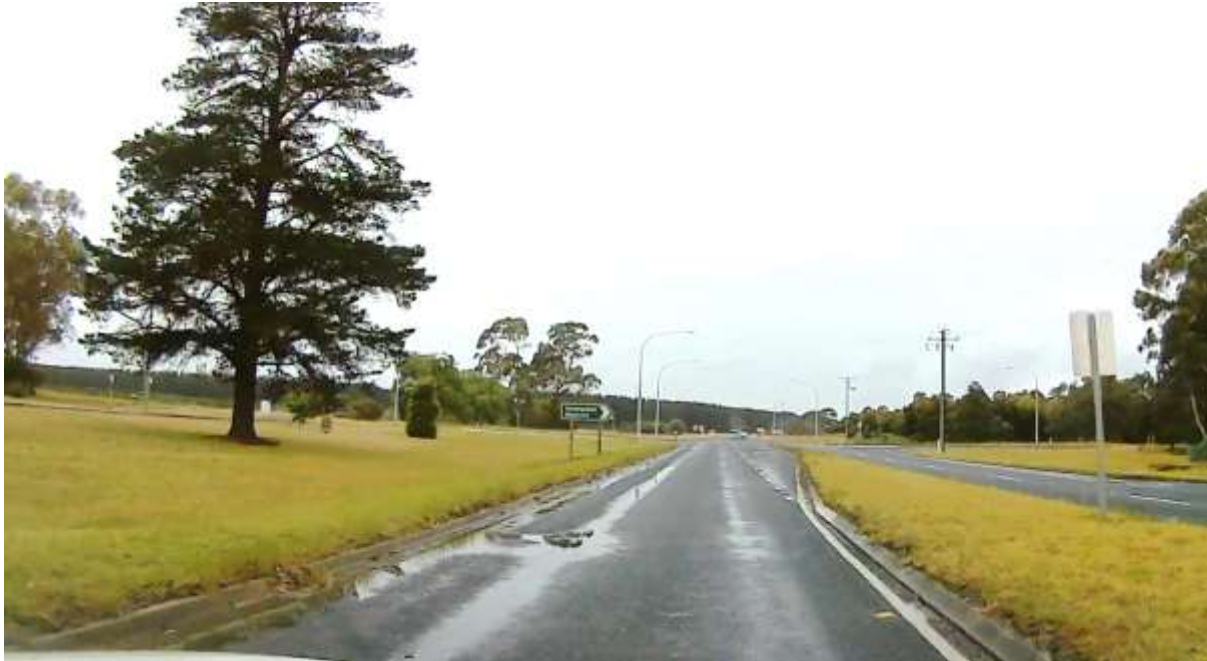
Ruts causing ponding in Nangwarry

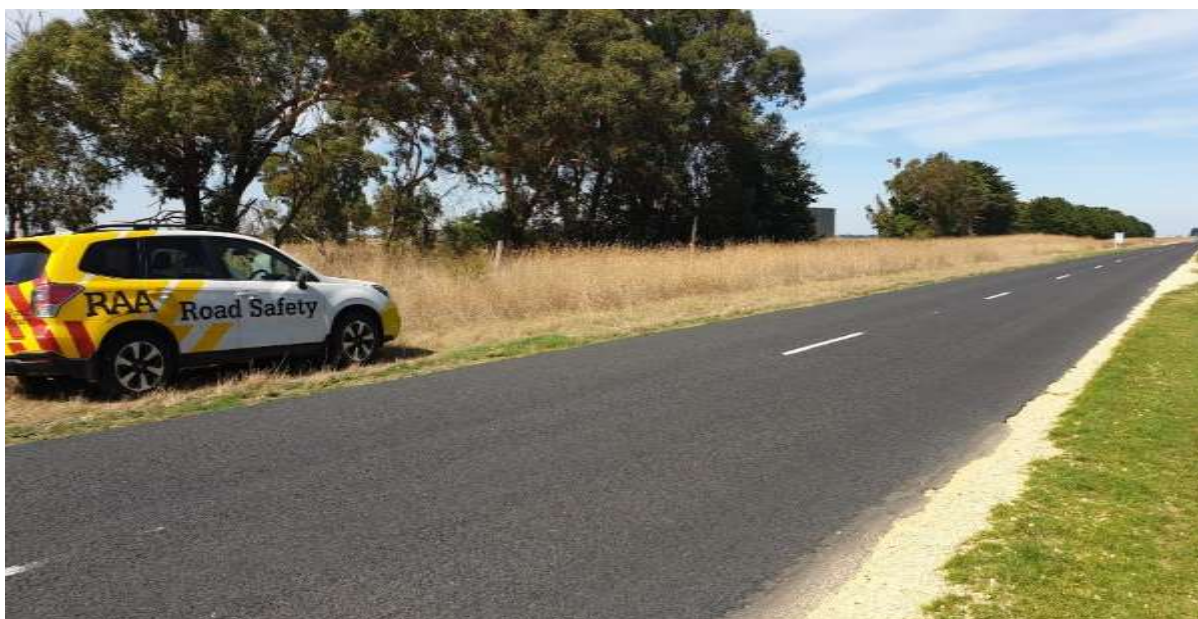
Narrow lanes and lack of shoulder seal south of Clay Wells

RAA recommends that shoulders be sealed to a minimum of 1.0m for the entire corridor, with the section between Clay Wells and Millicent highlighted in the above map prioritised. RAA also recommends that lane widths be widened to 3.5m between Clay Wells and Millicent, and a minimum of 3.3m between Kingston and Clay Wells, based on the higher volumes of logging freight between Clay Wells and Millicent.

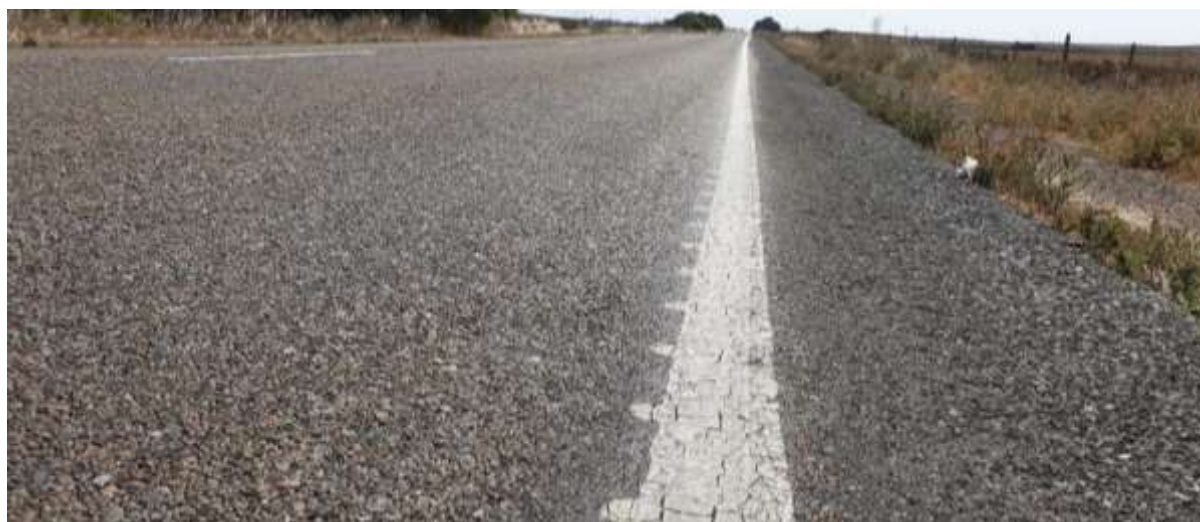
ATLM edge lines have completely worn away for most of Princes Highway between Tailem Bend and Meningie

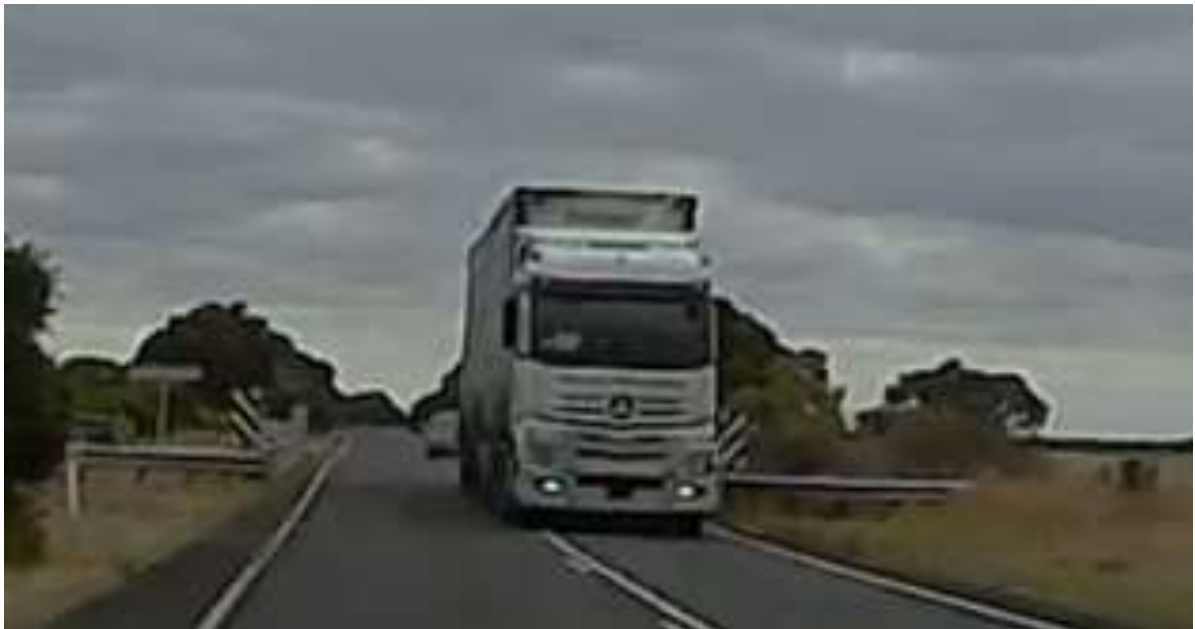
The Blackford Drain Bridge just north of Kingston is narrow and RAA recommends that this be widened to safely accommodate interactions with heavy vehicle combinations in both directions. AADT estimates indicate that an average of 1,200 vehicles traverse the bridge every day, including 180 commercial vehicles.

The Blackford Drain Bridge north of Kingston

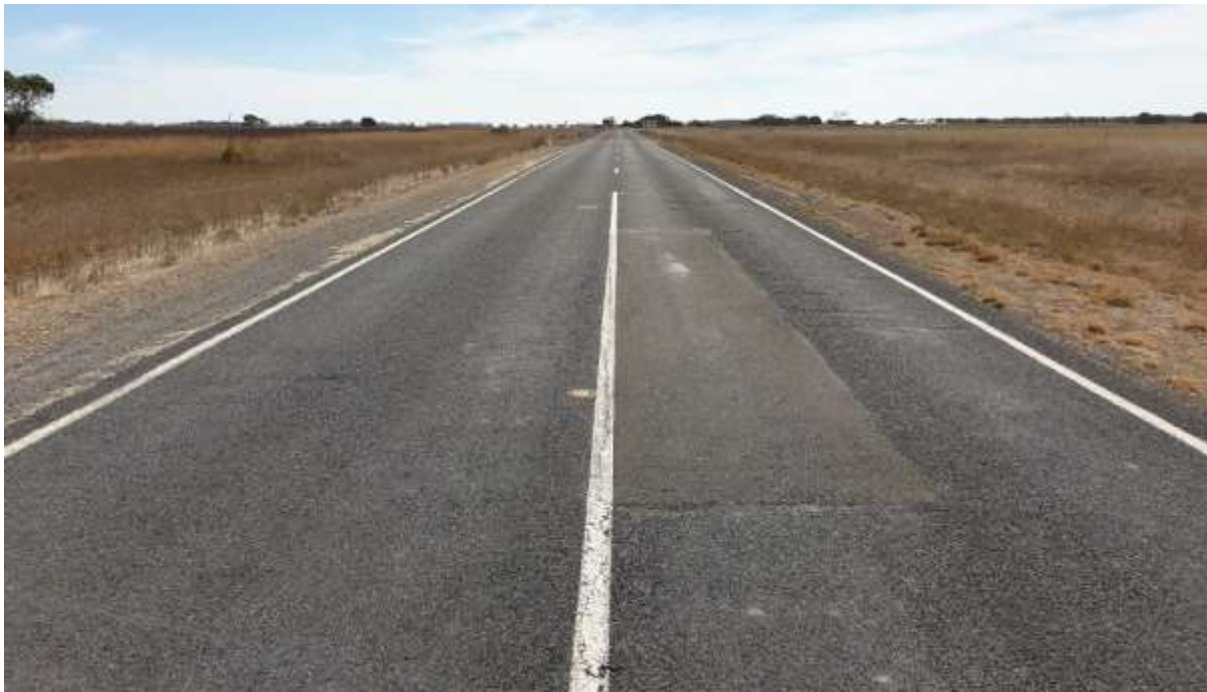
Whilst the surface condition is generally satisfactory, there are sections that are failing and require attention, which should be addressed as part of routine maintenance, particularly near the intersection with Clay Wells Road. Edge breakup and drop off is also present along narrow sections of the corridor south of Clay Wells, however, this can be addressed by sealing shoulders and widening lanes.

Poor surface condition north of Clay Wells Road

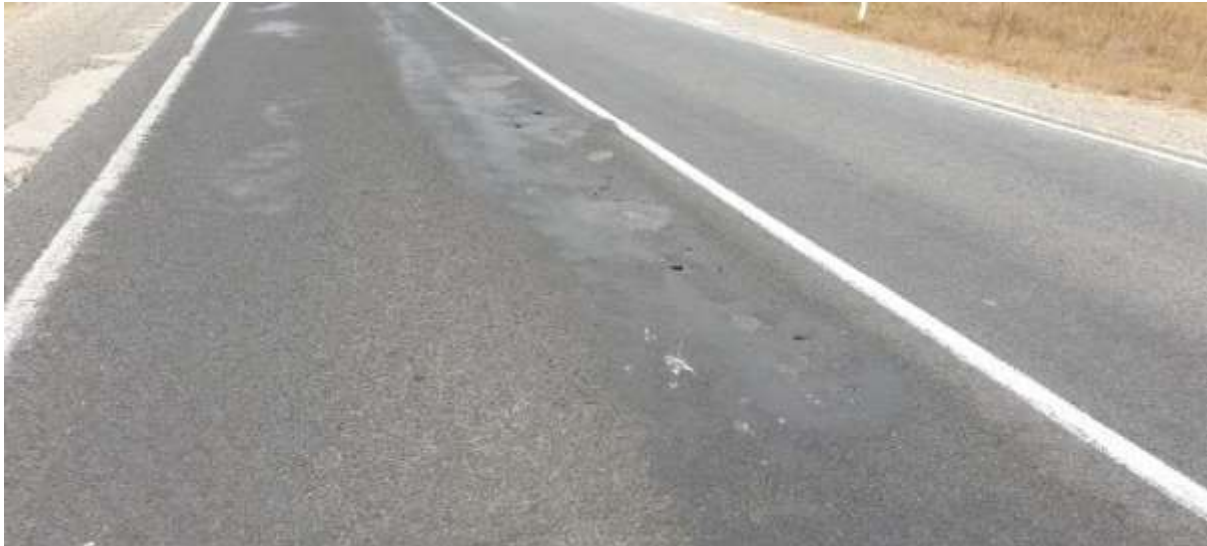
The road surface of Princes Highway between the Clay Wells Road intersections was also very poor, with potholes and rutting prevalent. RAA recommends a reseal and road widening be undertaken through this intersection as a priority, and preferably in conjunction with additional safety upgrades as specified above.

Princes Highway is in a very poor state of repair between the two Clay Wells Road intersections

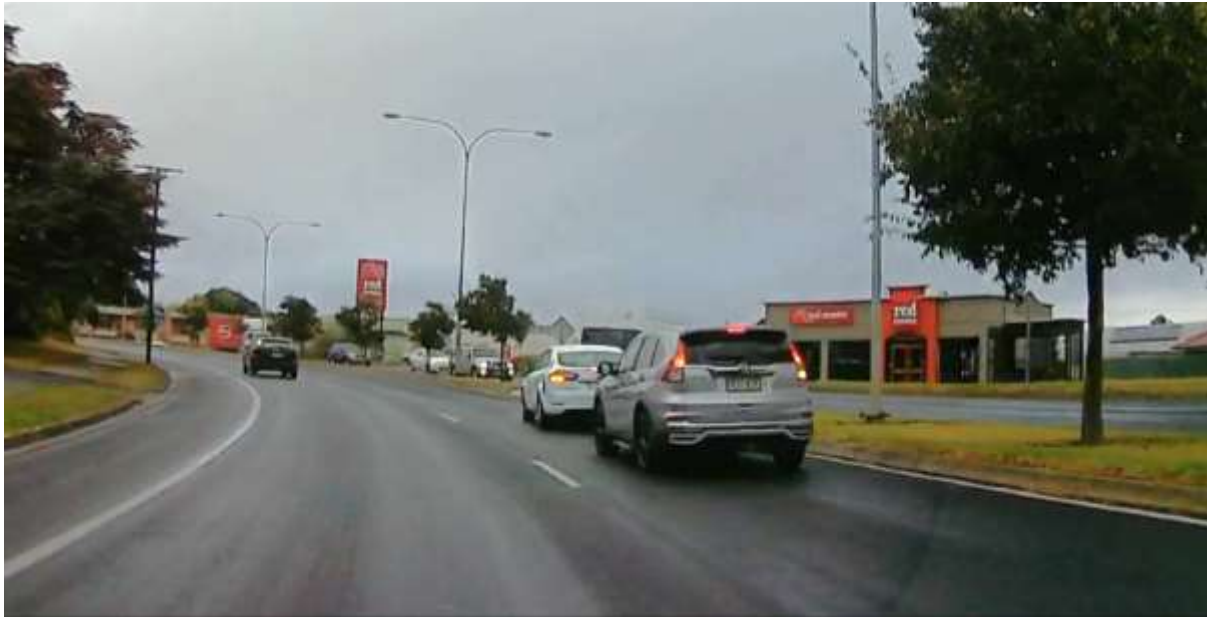
median for vehicles to perform U-turns, and these are utilised regularly. As the breaks in the median offer storage space for only one vehicle, often these overflow with multiple vehicles performing U-turns.

Vehicle queueing to make a U-turn frequently block the right lane of Jubilee Highway

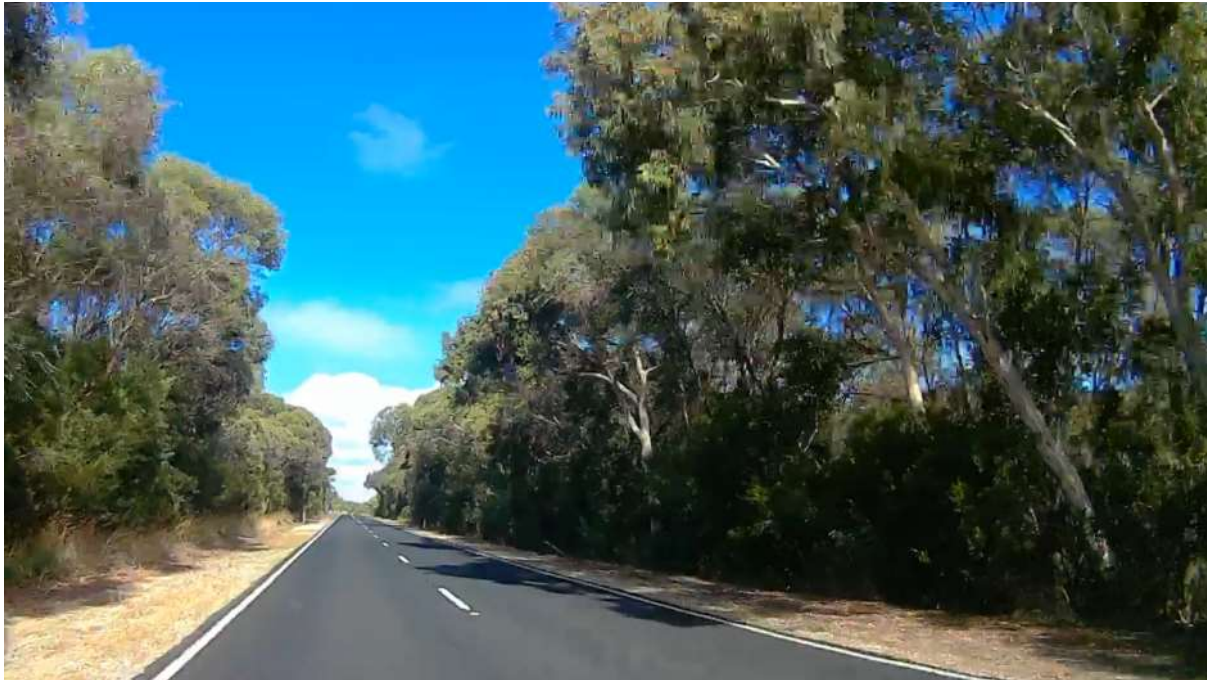
Clear zone widths vary along the length of Southern Ports Highway, with some sections wide and relatively hazard-free, and others with dense vegetation on both sides of the road. It was clear that local government regularly maintain vegetation overgrowth to approximately three metres, particularly between Robe and Beachport.

Widening of the clear zone on Southern Ports Highway would be a welcome improvement

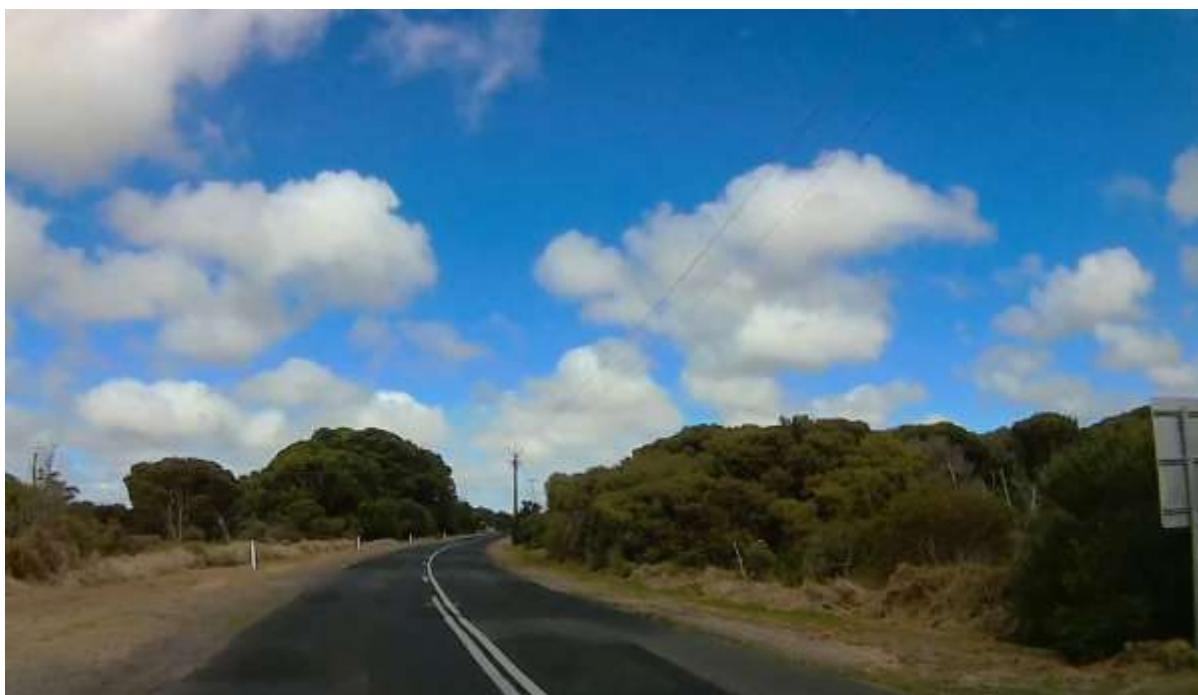
The narrow and undulating surface between Robe and Clay Wells Road

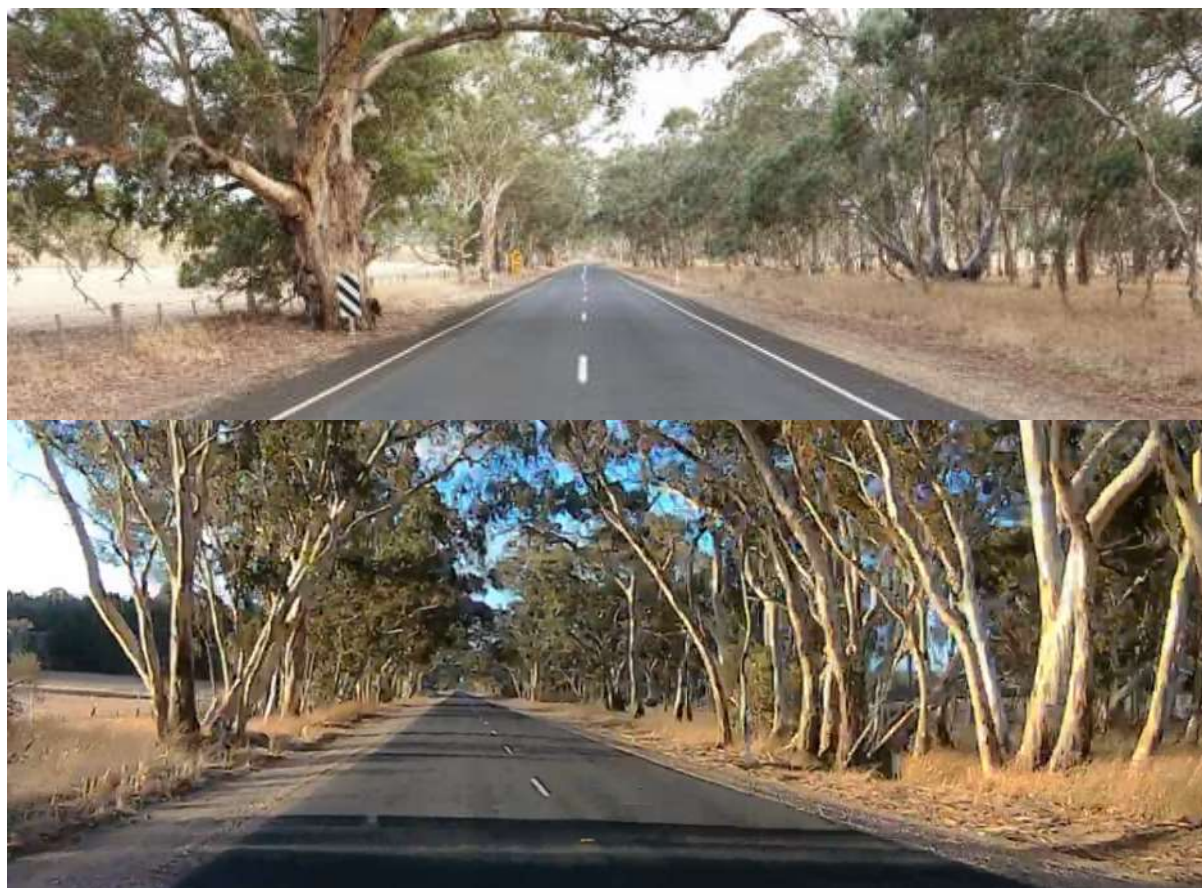
Unprotected vegetation presents a major hazard on Naracoorte Road

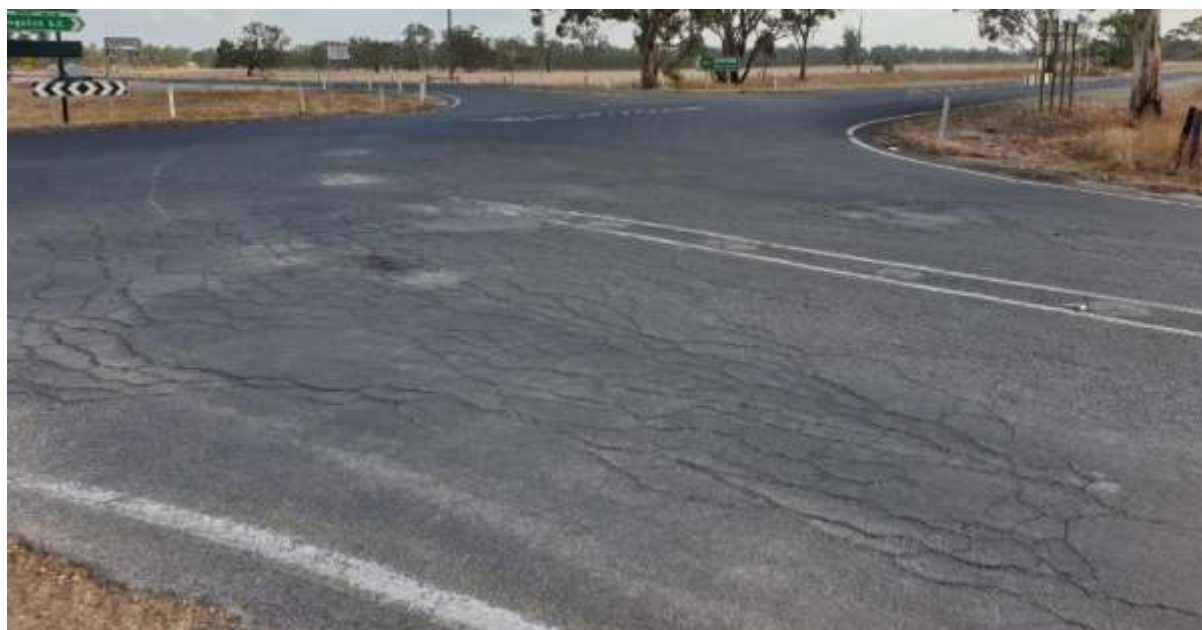
Cracking at the intersection of Meatworks Road and Naracoorte Road

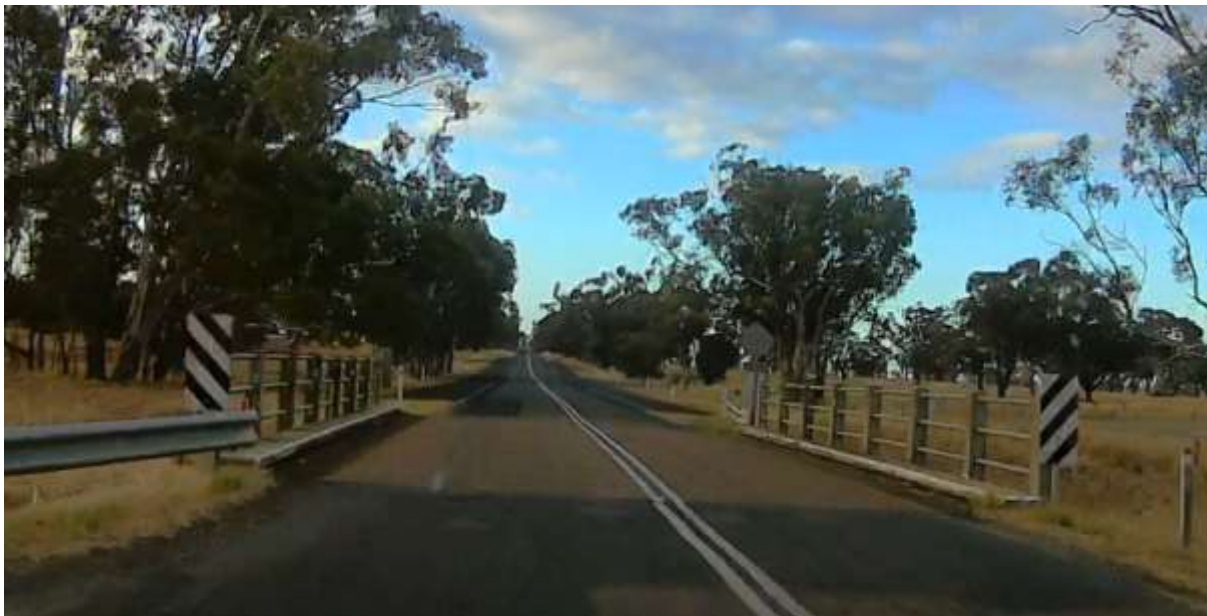
The narrow Nalang Creek Bridge

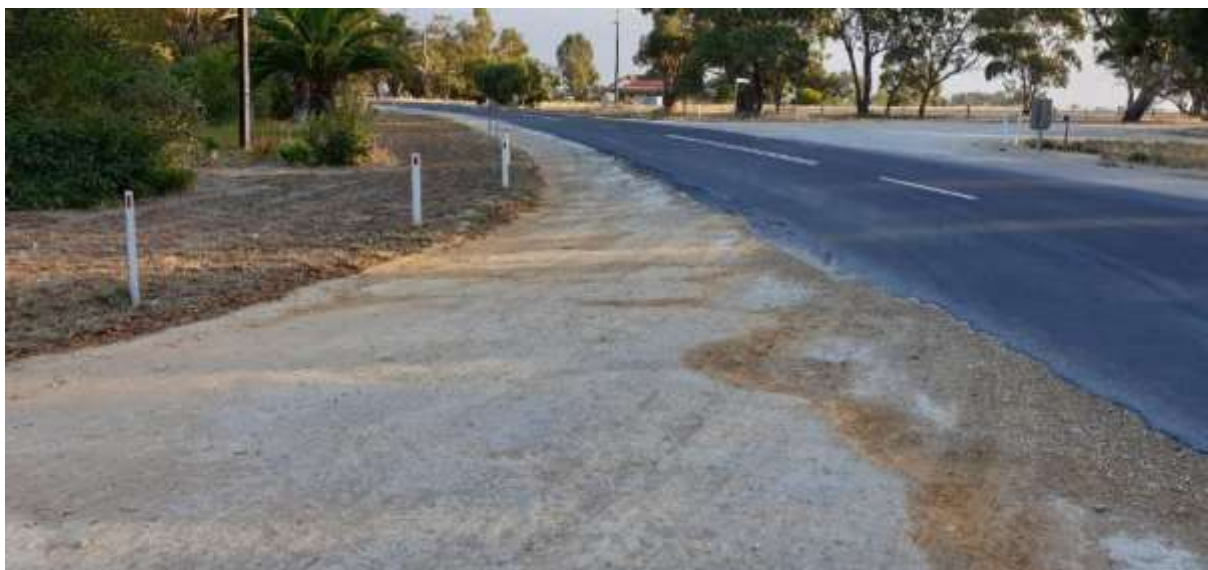
Sight distance to the north from Stott Road is poor

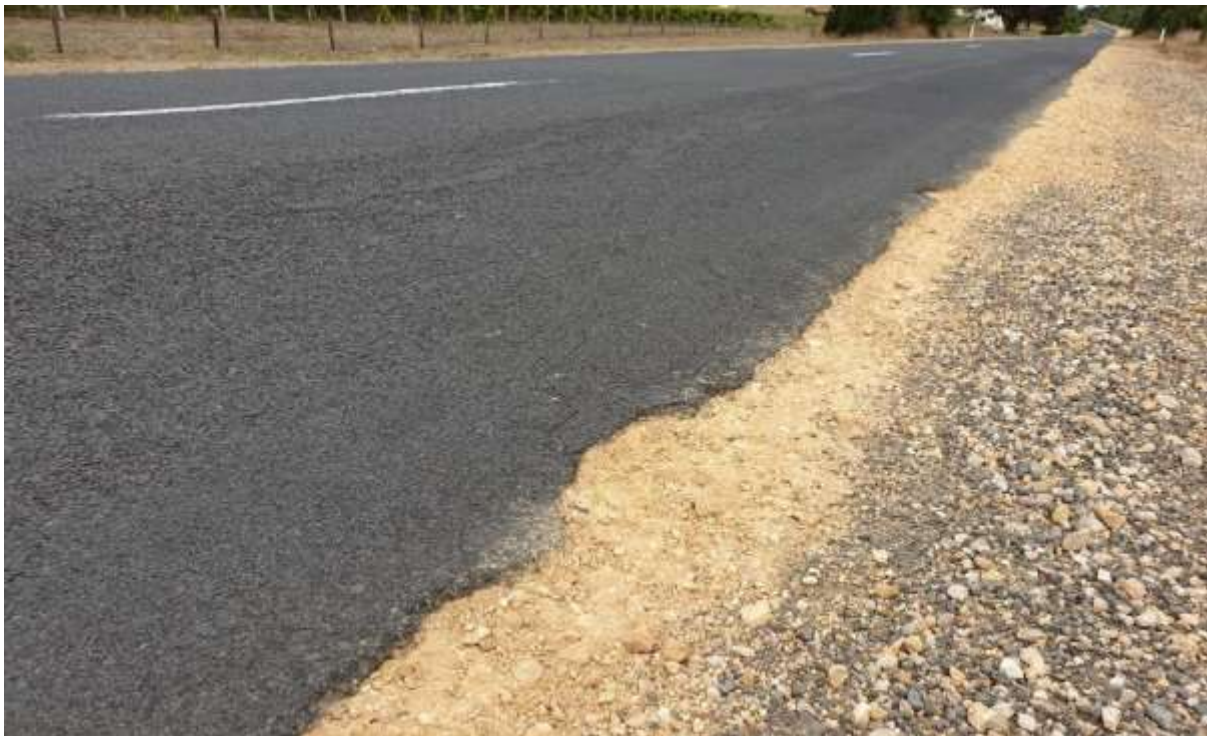
Edge drop off and breakup between the Southern Ports and Princes Highways.

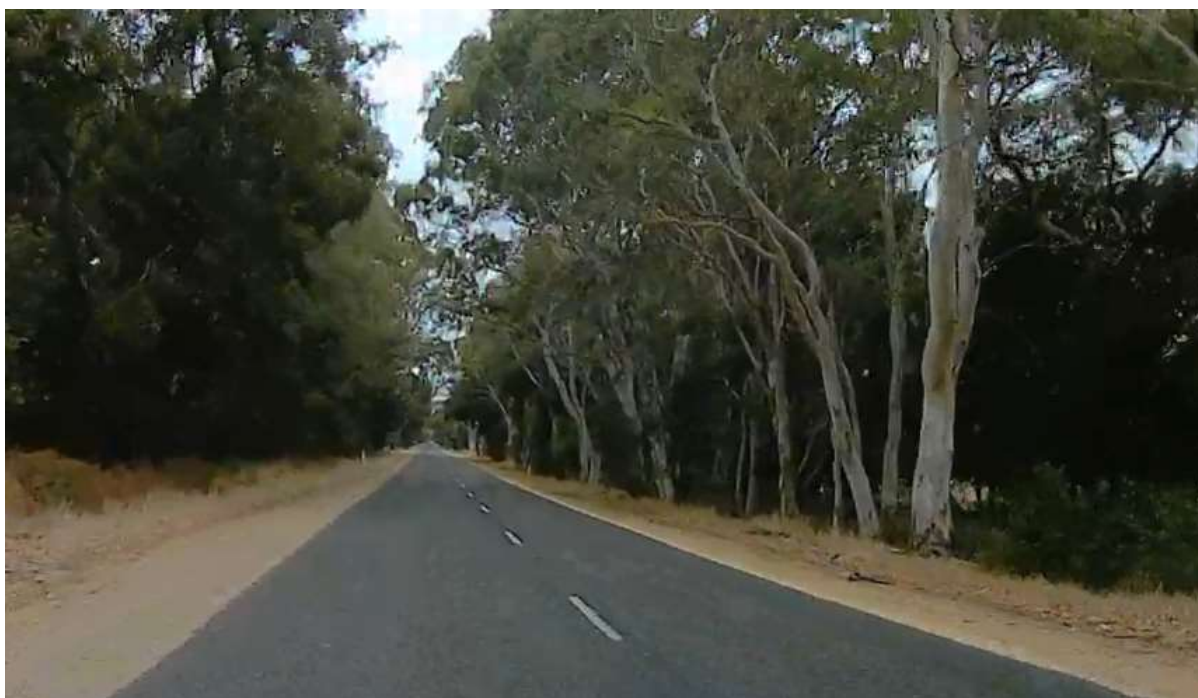
Trees in close proximity to Clay Wells Road

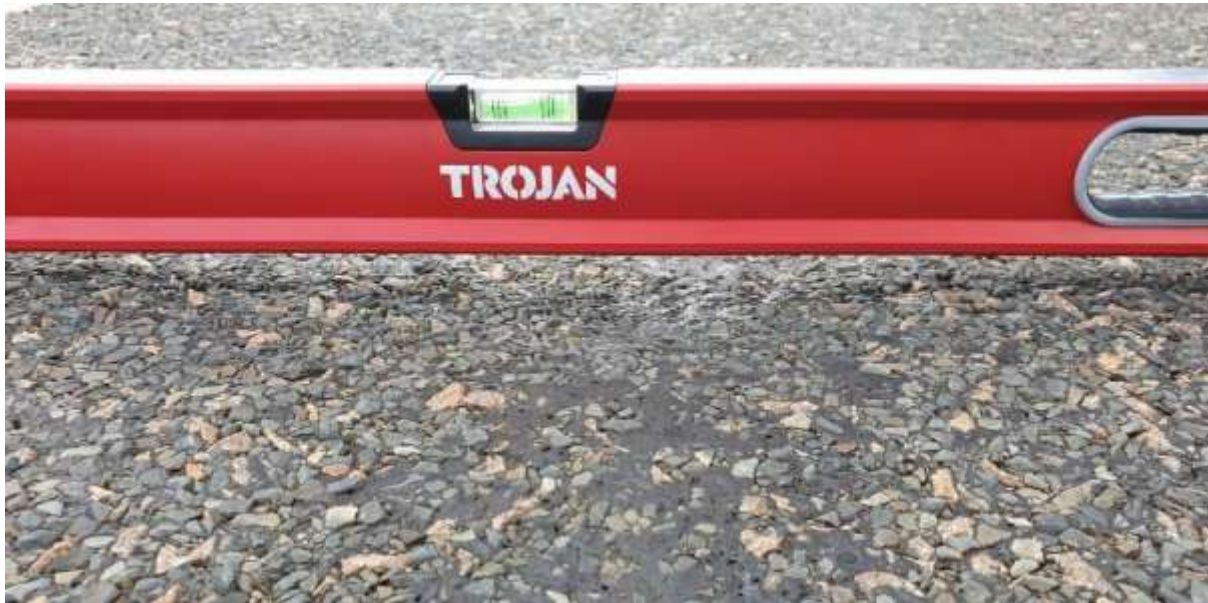
Rutting is prevalent on Ngarkat Highway

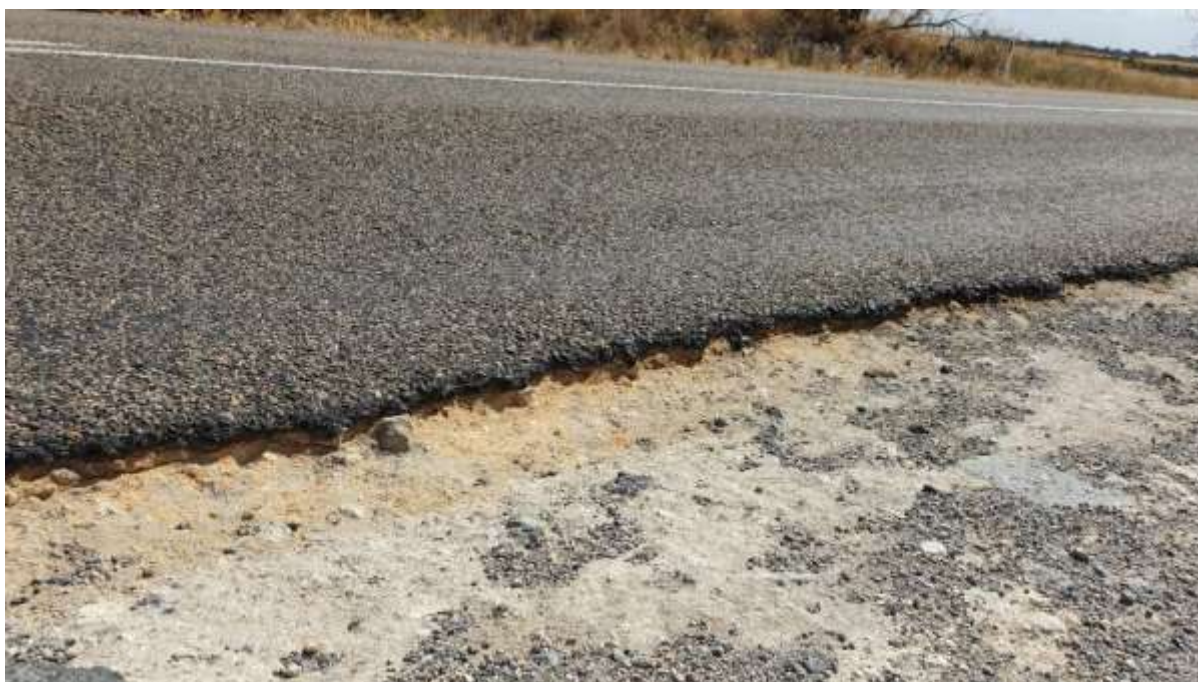
Breaking edges and associated edge drop-off persistent along Ngarkat Highway

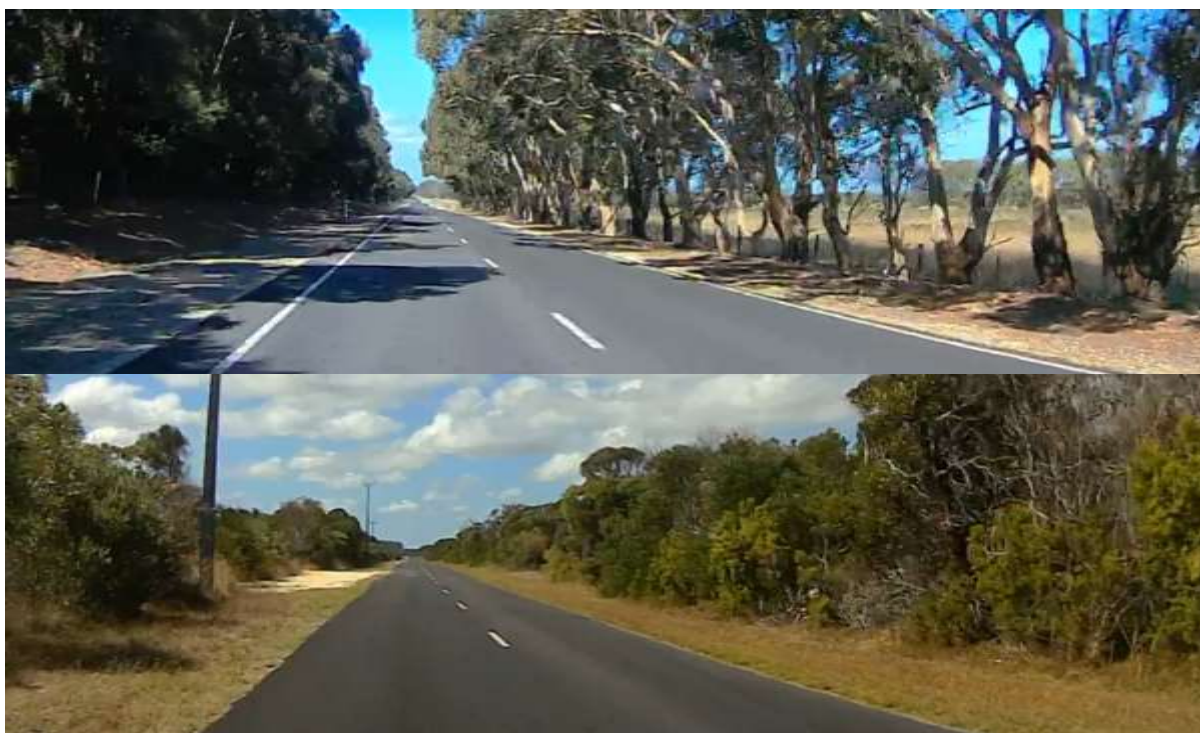
Roadside hazards on Carpenter Rocks Road include trees and stobie poles

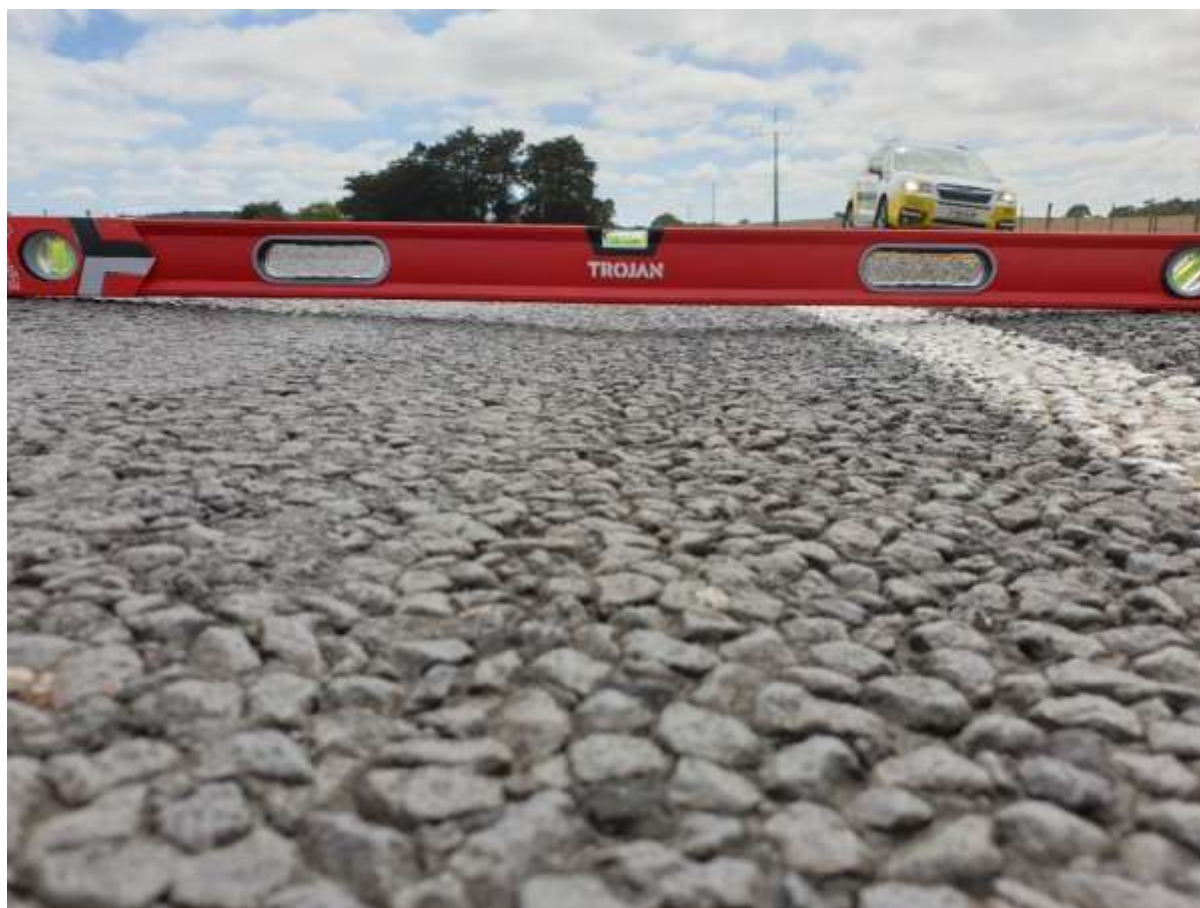
Rut depths measured on Glenelg River Road at Ob Flat

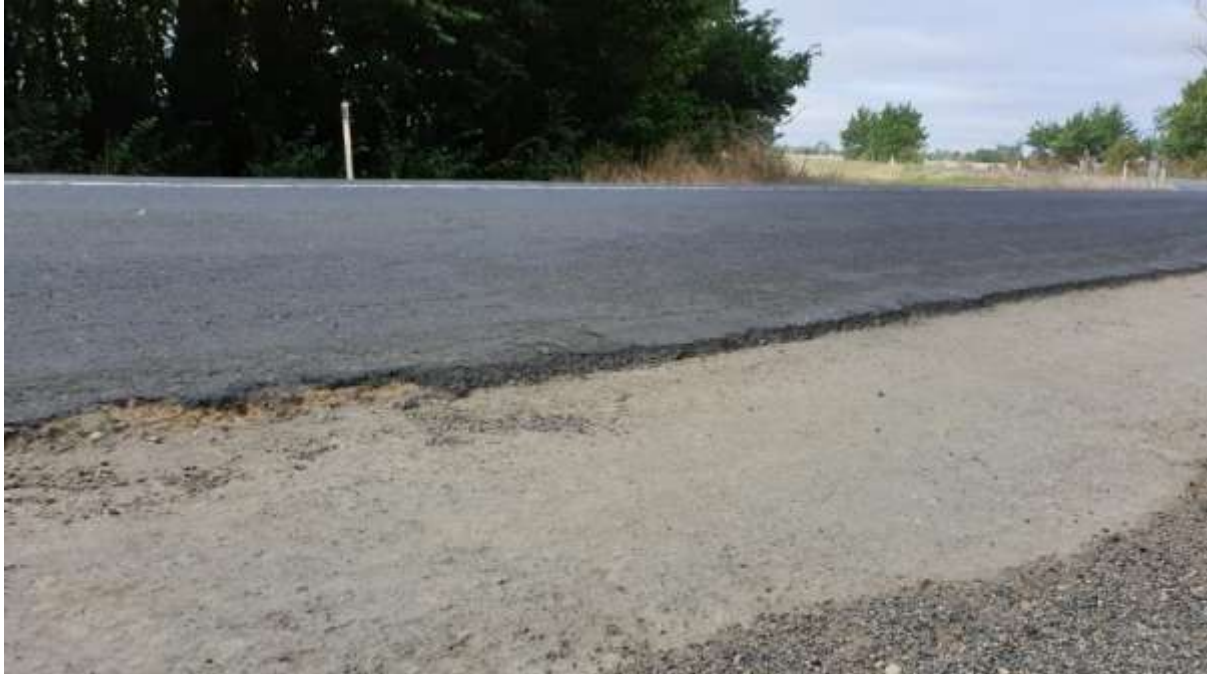
Broken edges and drop-offs on the narrow section between Penola and Wattle Range

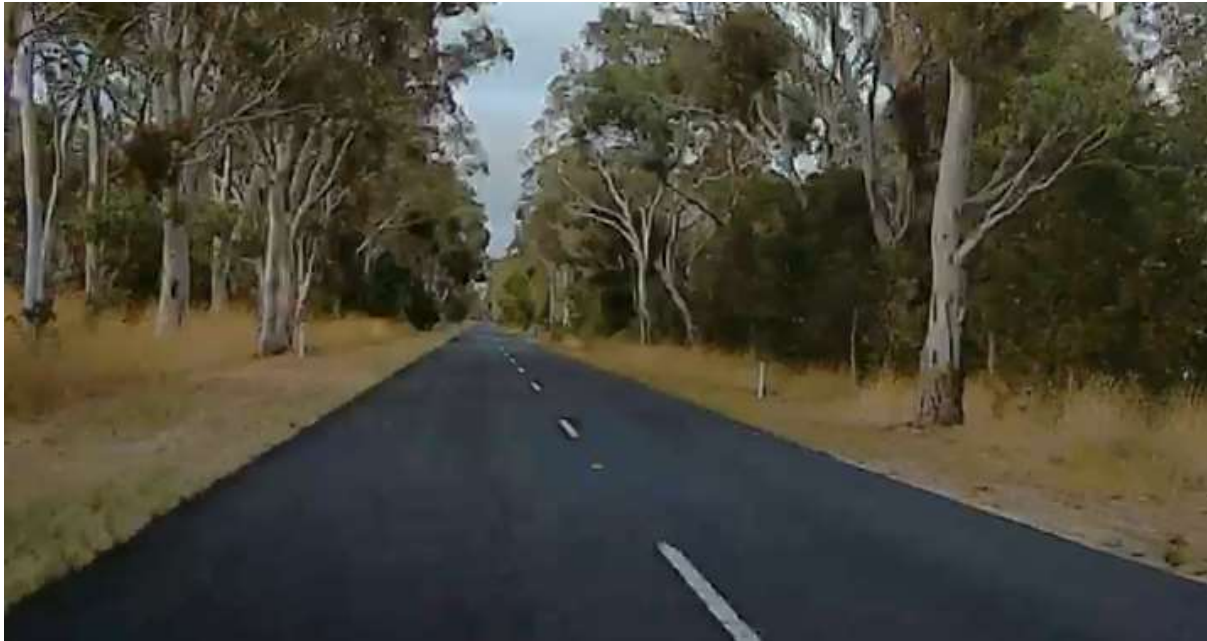
Trees growing in close proximity to the road edges pose a substantial risk in run off road crashes.

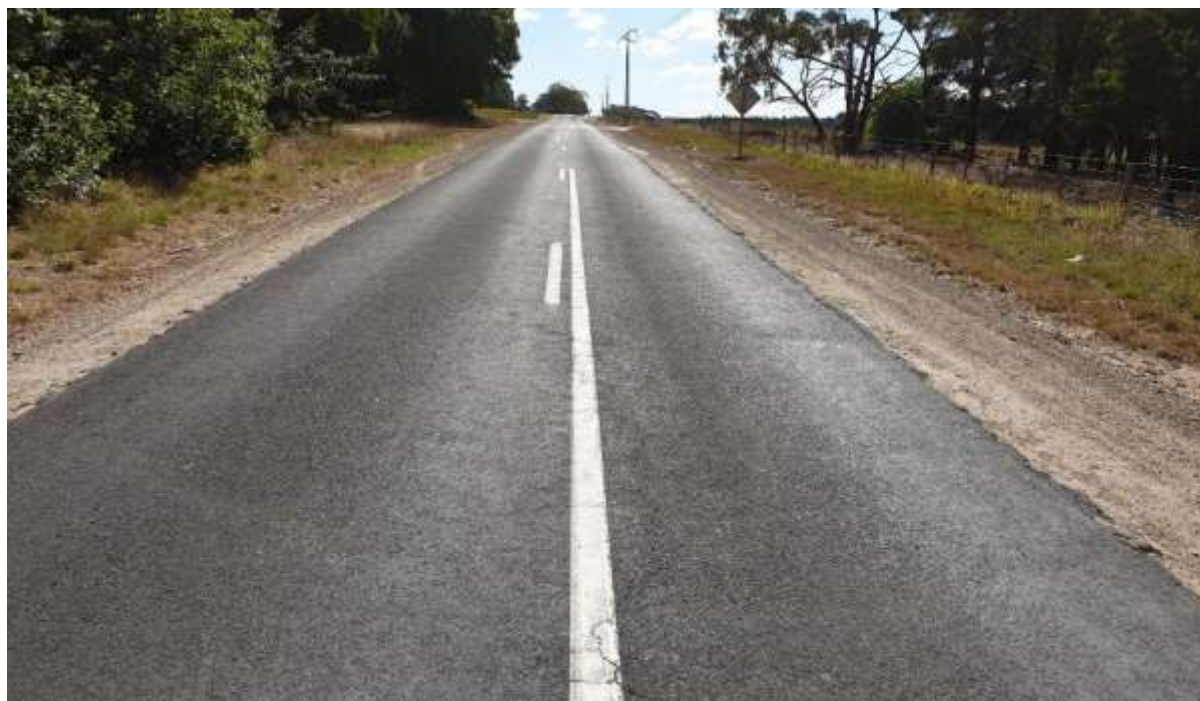
Kangaroo Flat Road is very narrow with a seal width of 5.0m measured

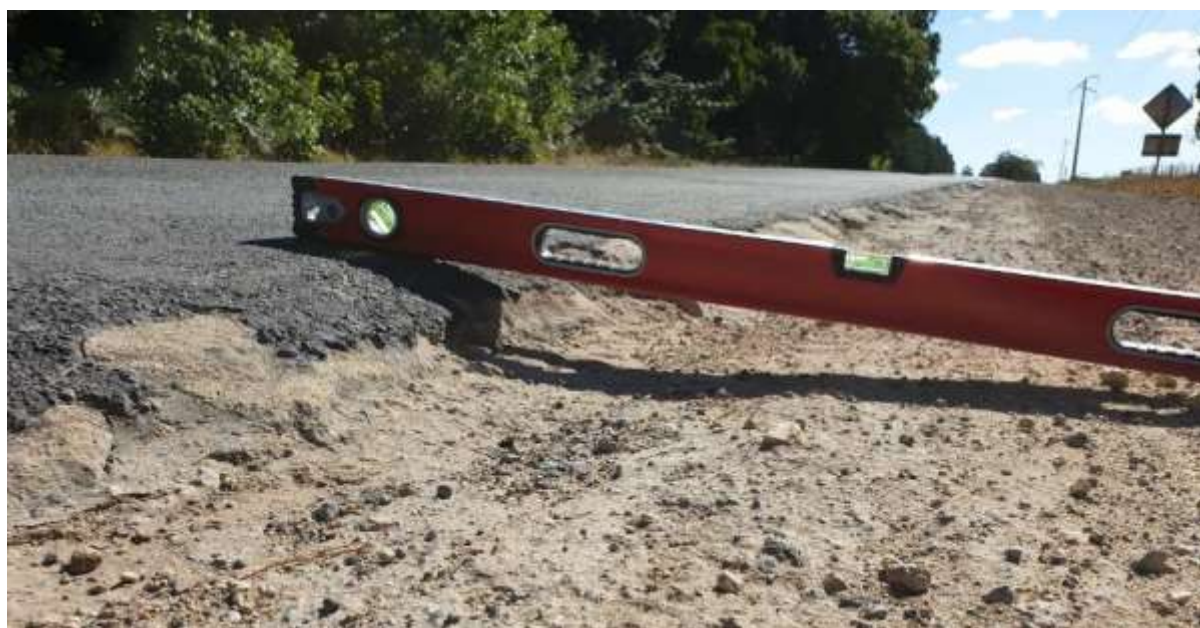
Edge break up and drop off on the southern end of Kangaroo Flat Road

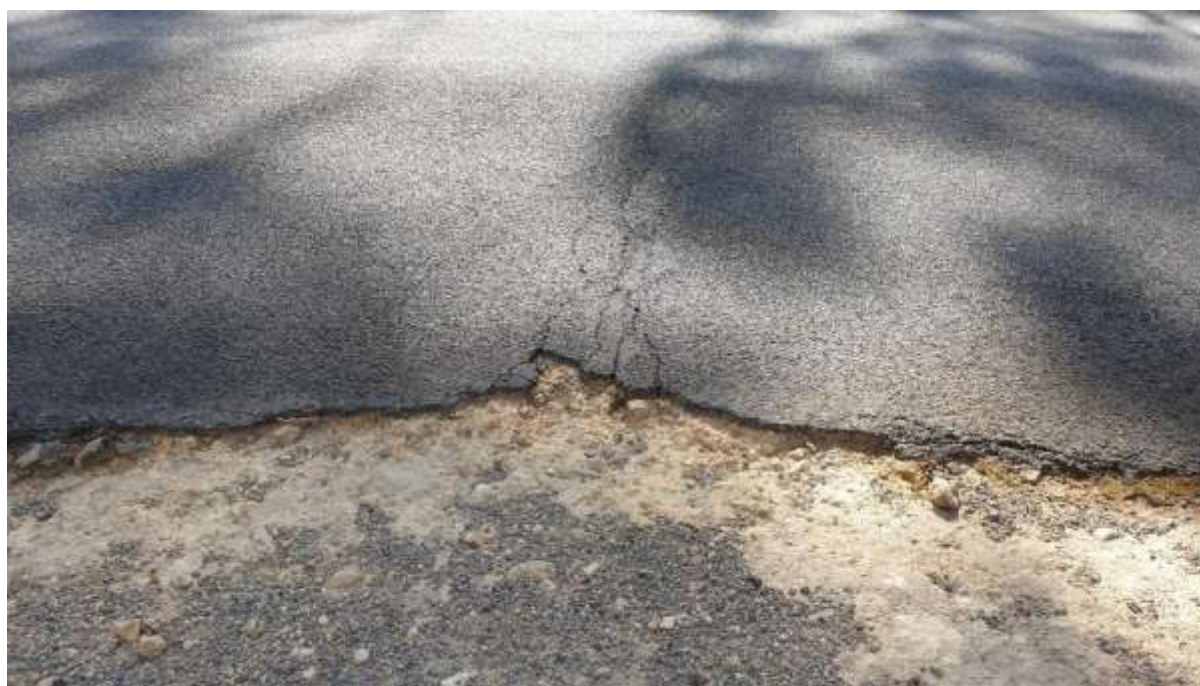
Poor condition of road edges and unsealed shoulders on Casterton Road
