Limestone Coast

Regional Road Assessment September 2019

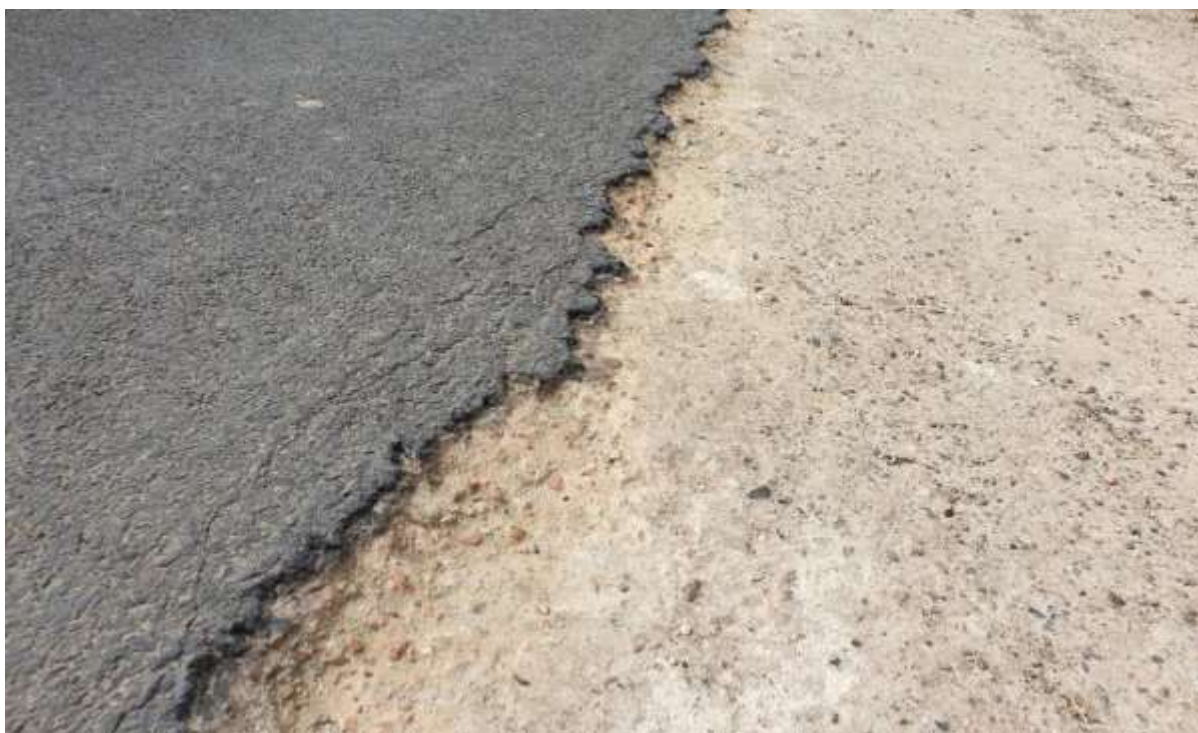
Broken edges and drop off on Tillers Road

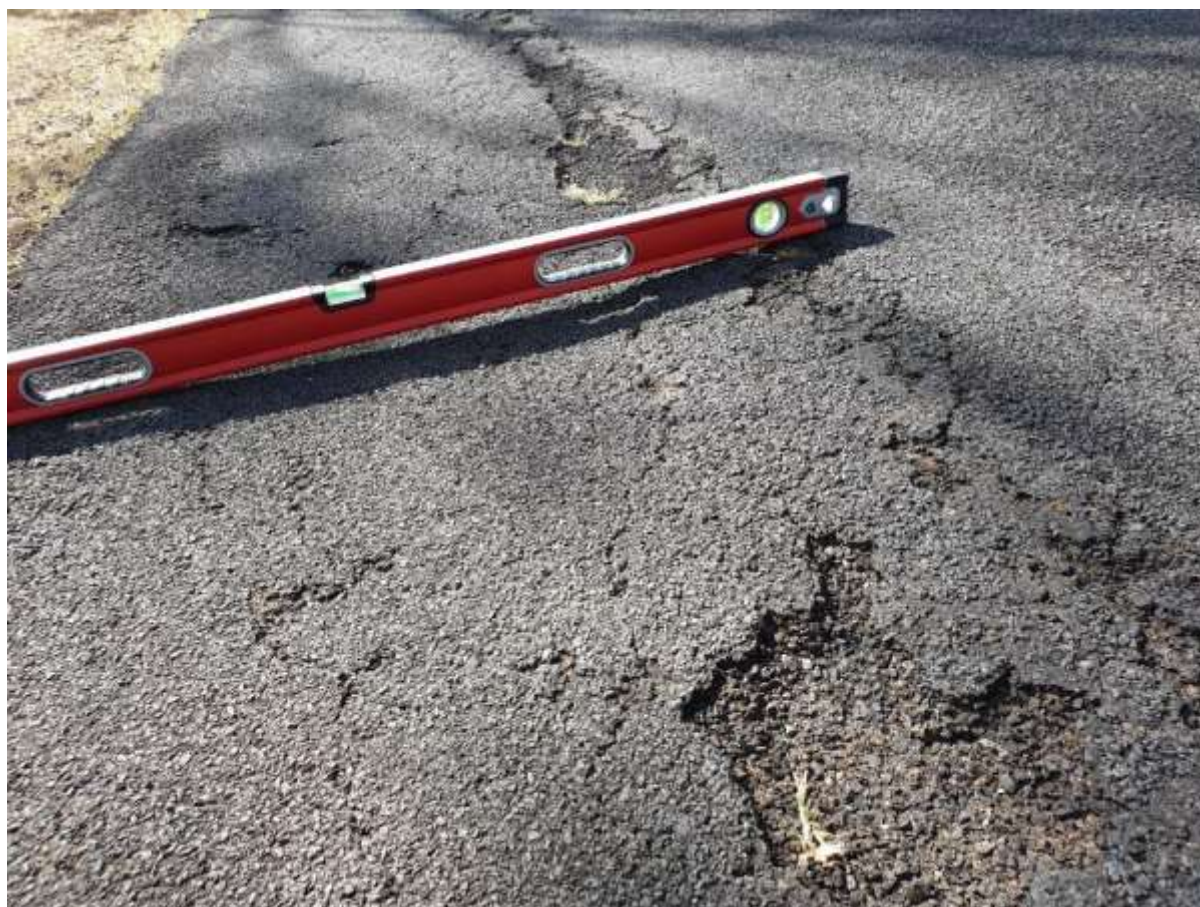
Callendale Road is in need of maintenance

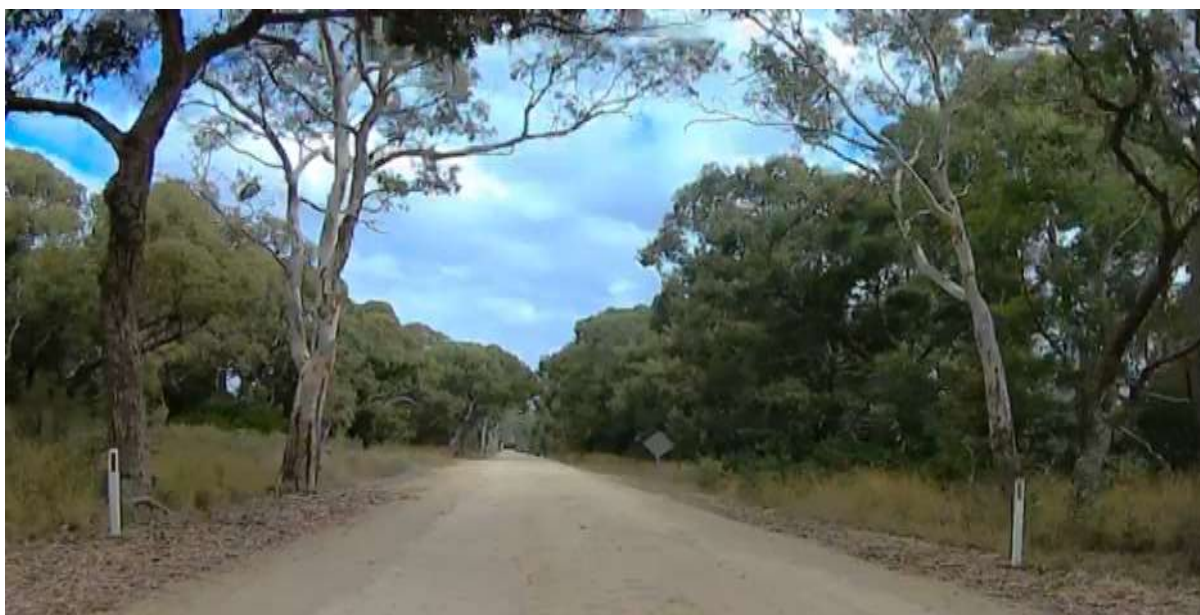
Trees having setback less than a metre on Wattle Range Road

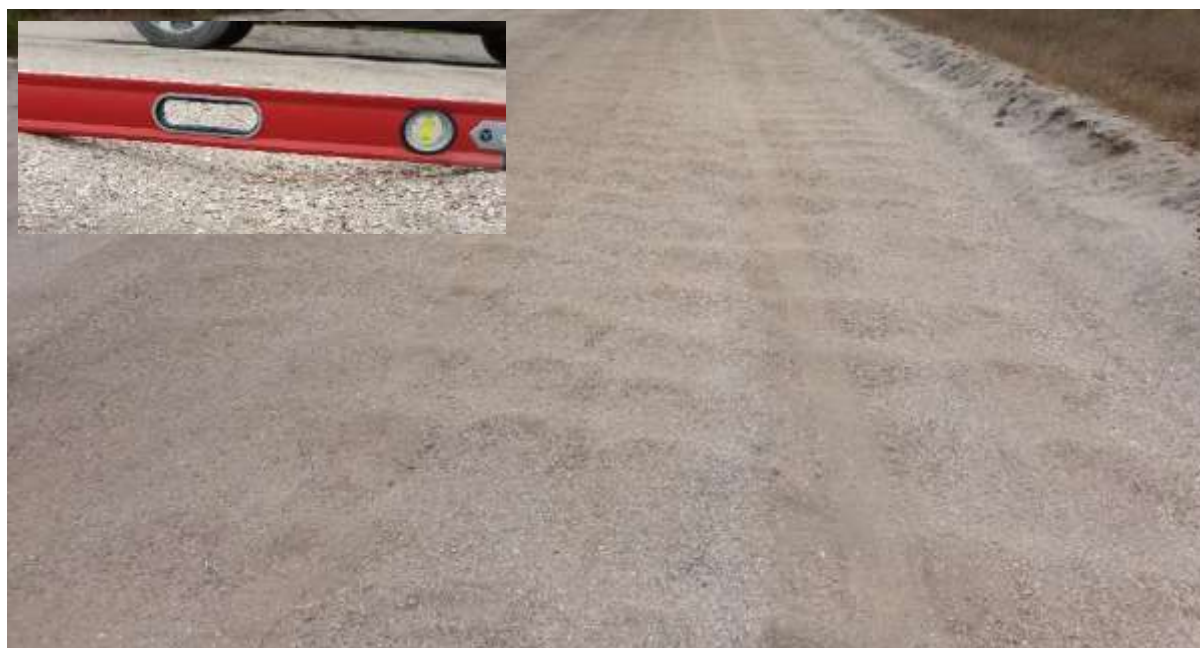
Corrugations and a slippery surface are the primary issues noted on Bog Lane

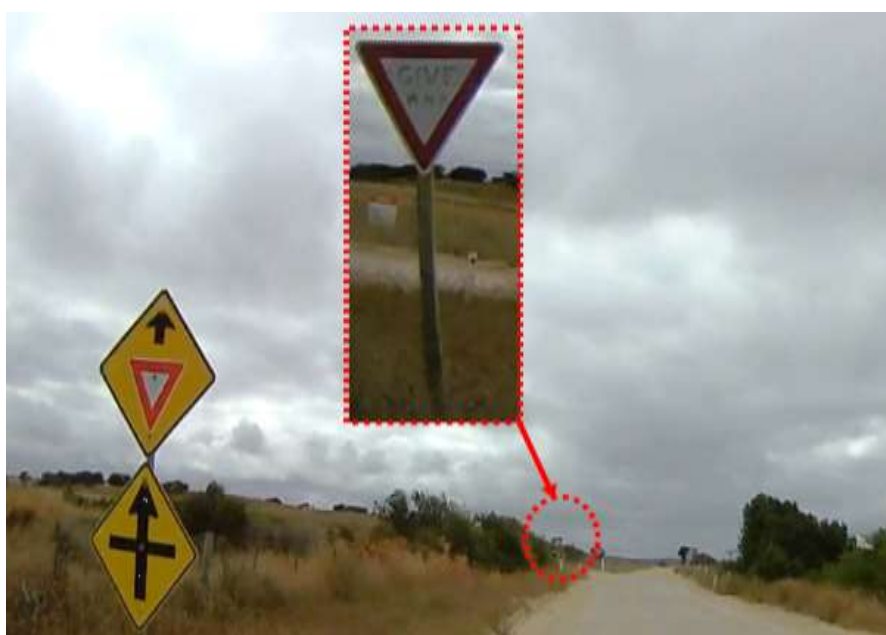
Conflicting 'give way ahead' and intersection warning signs on Nora Creina Road, and faded give way sign (inset)
