Yorke Peninsula

Regional Road Assessment
April 2019

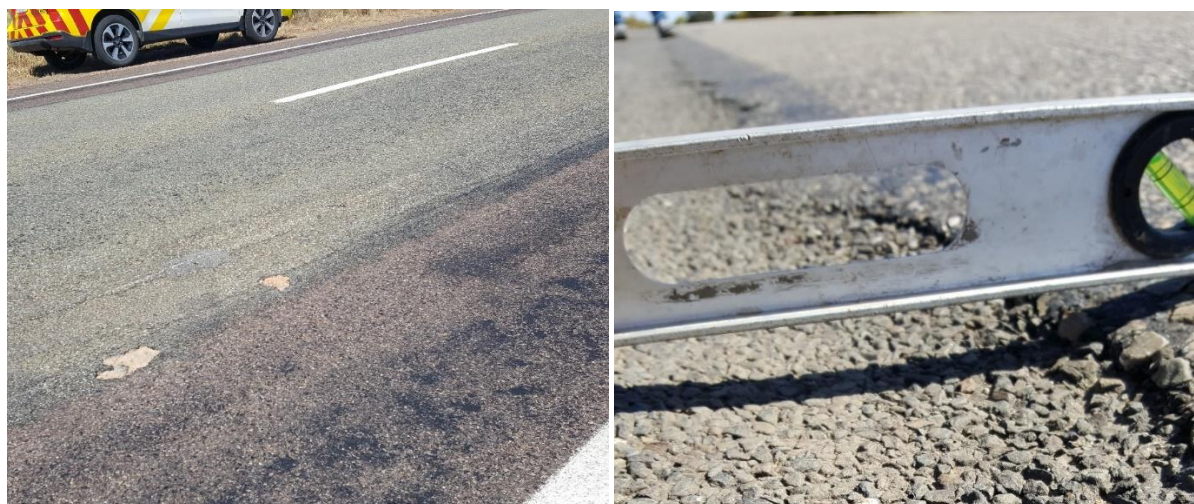
Across the region, it is noted that in areas where shoulder seal had been applied to an existing road seal, the join of the shoulder seal and existing seal was often located in the wheel path. This is already a weak point on the pavement due to the additional loading, and there were many incidences of potholes forming and water ponding in the join created where shoulders are sealed.

Examples of poor joins between shoulder seal and existing pavement

Key Recommendation	Authority
RAA recommends that the shoulder sealing process is reviewed on a case by case basis to ensure the join is not in the wheel path and does not have a negative impact on drainage, especially on freight routes. DPTI specifications should be updated to reflect this, where necessary.	DPTI

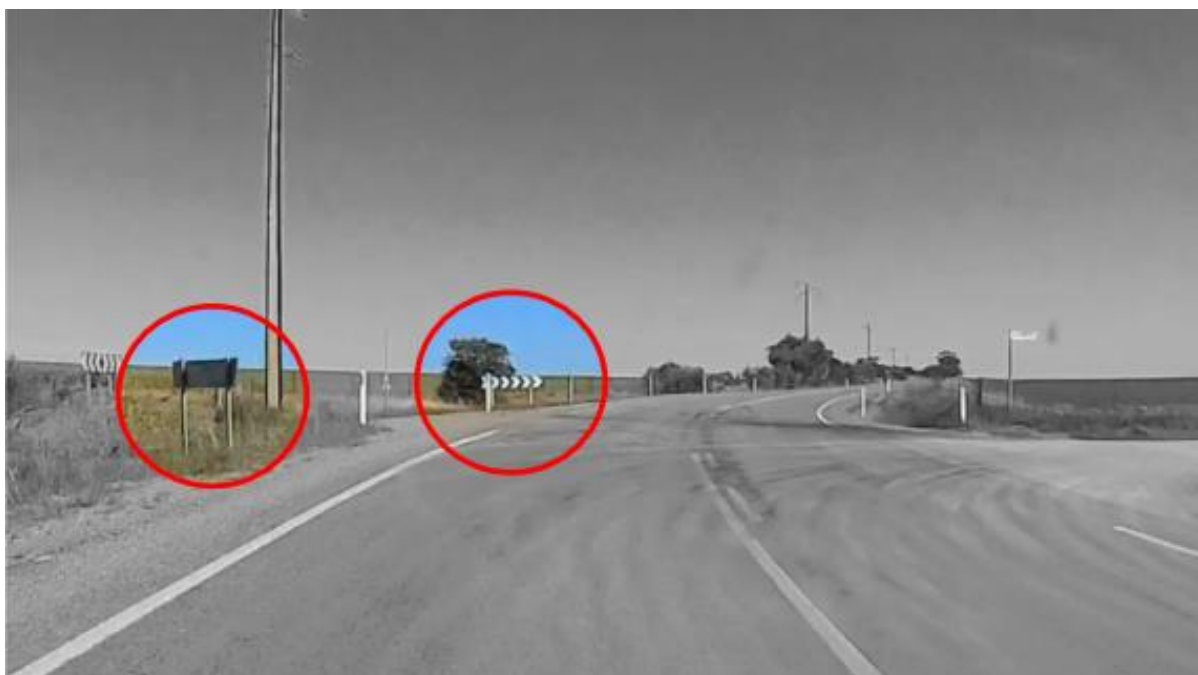
Upper Yorke Road – near the Sand Pit Road intersection (Bute – Kulpara)

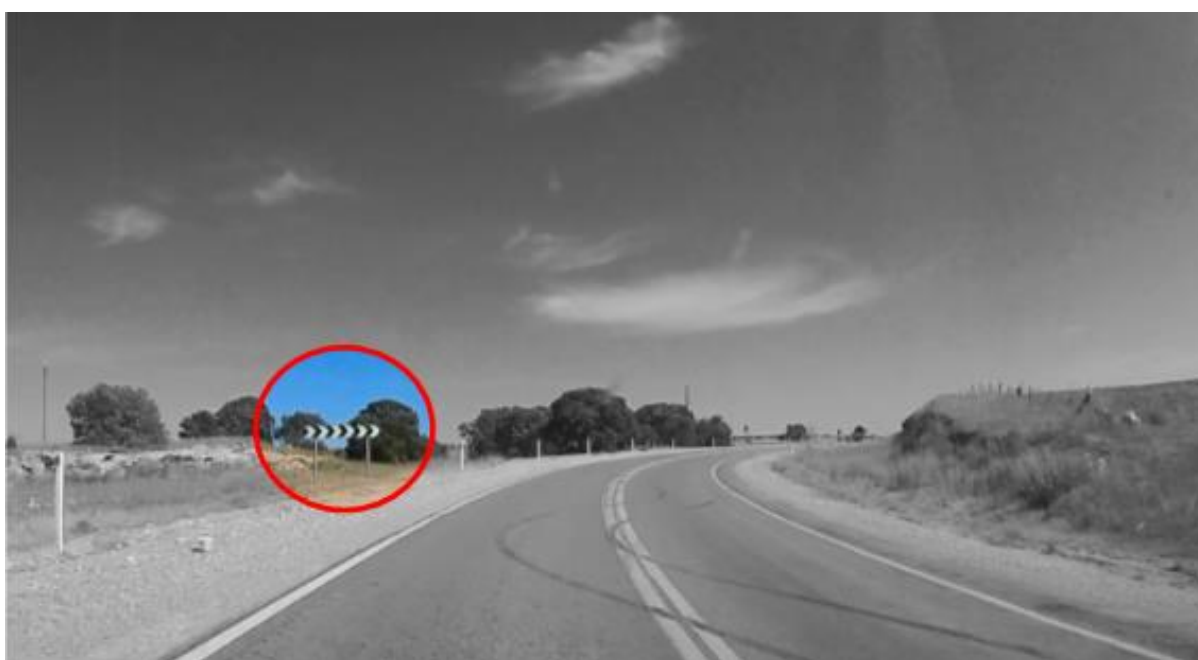
St Vincent Hwy – between the Black Gate Road and Old Saltworks Road intersections (Yorketown – Warooka)

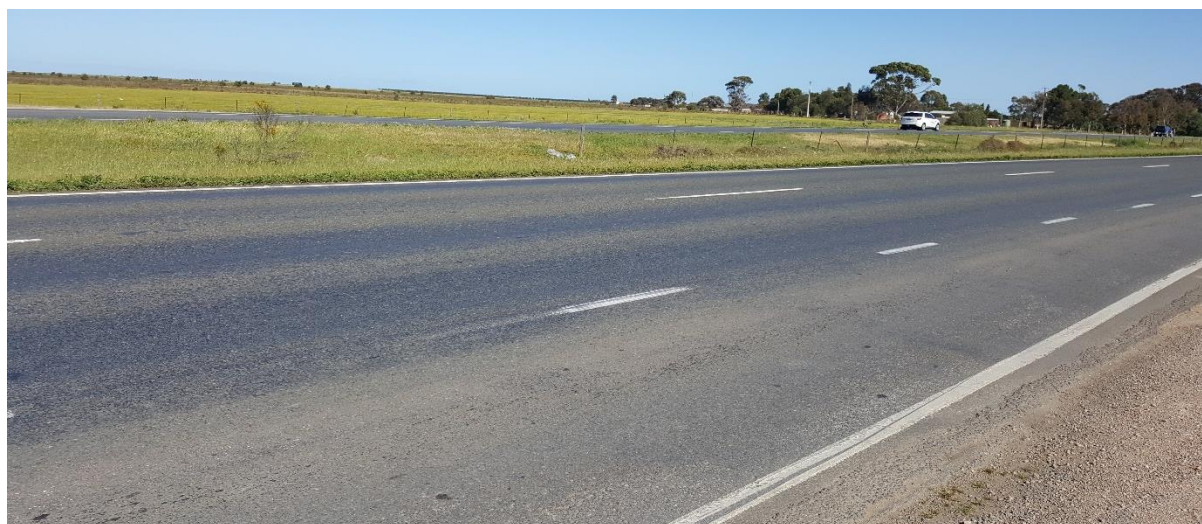
Port Wakefield Road has good geometry but the surface is failing in a number of locations

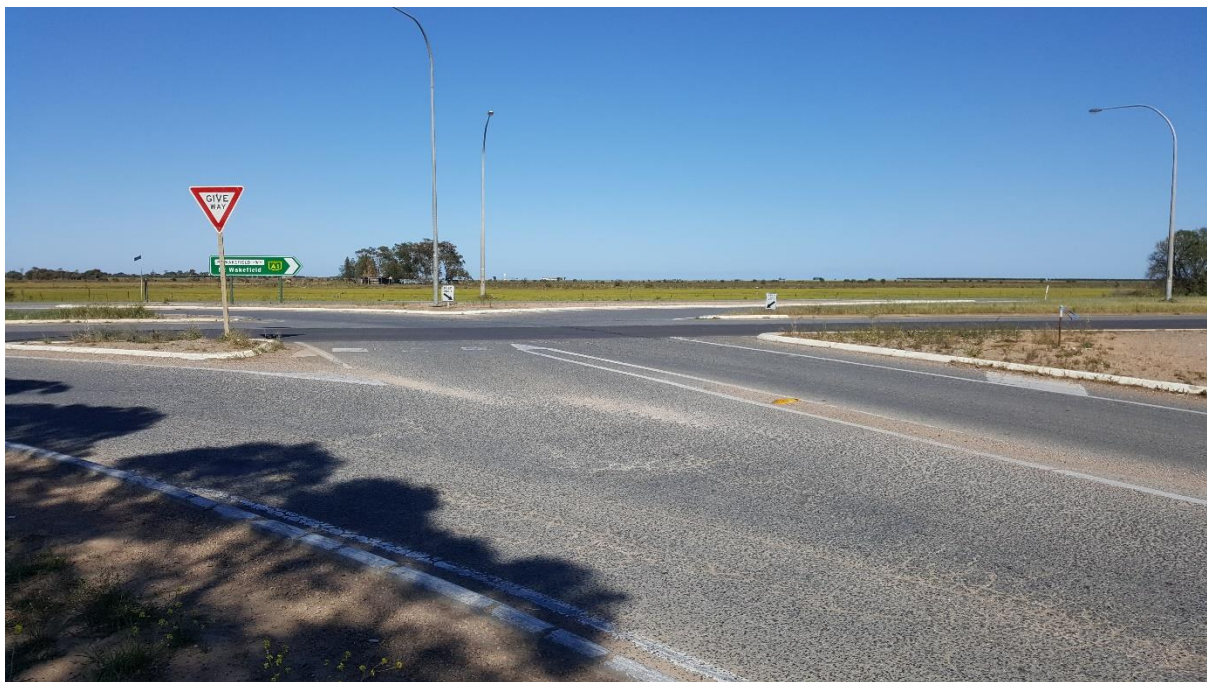
Line marking is faded at the intersection with Mallala Road

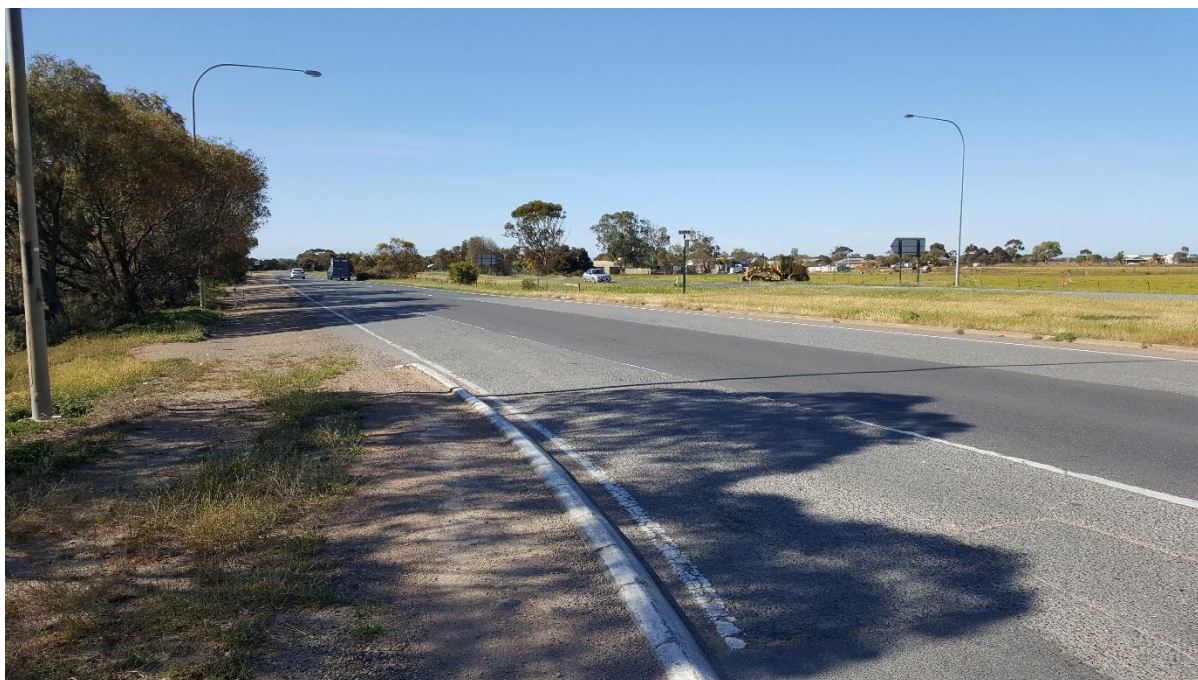
Other acceleration and deceleration lanes at the intersection were also far below minimum standards and did not allow for safe and efficient access and egress to Mallala Road. RAA recommends that all acceleration and deceleration lanes at the intersection be extended to allow safe entry and egress to Mallala Road.

The length of the left turn acceleration lane is far too short

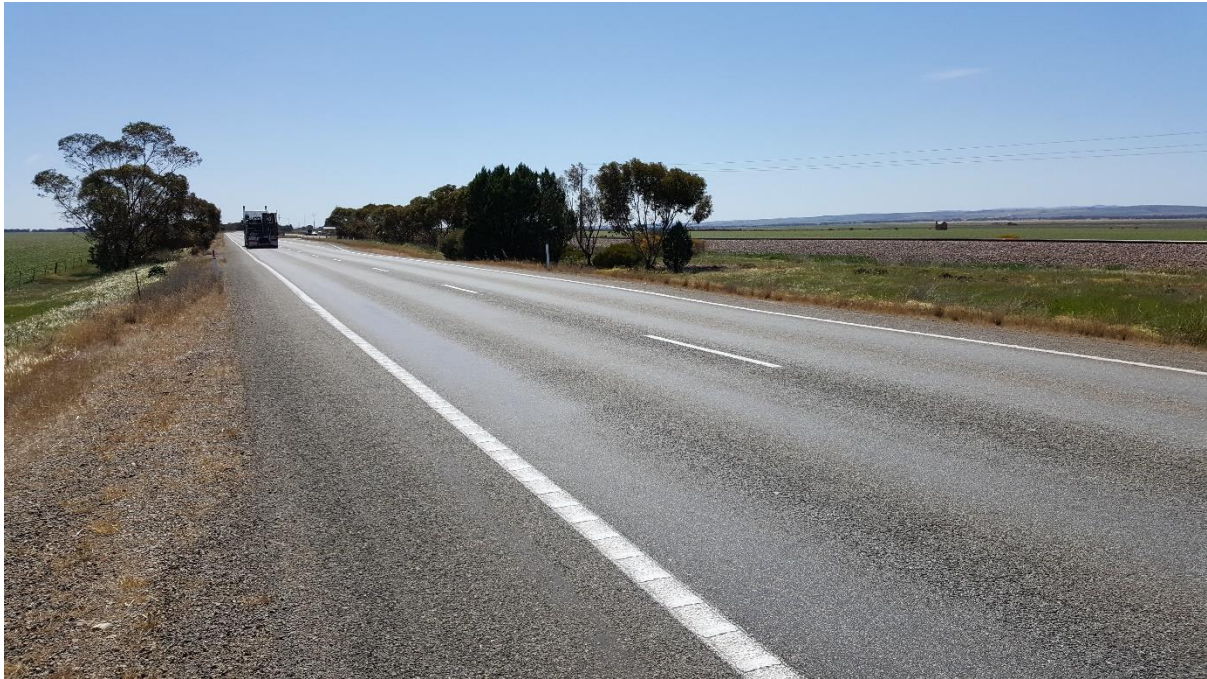
Road geometry on Augusta highway is good for a two-lane two-way road (polishing in the wheel paths is evident)

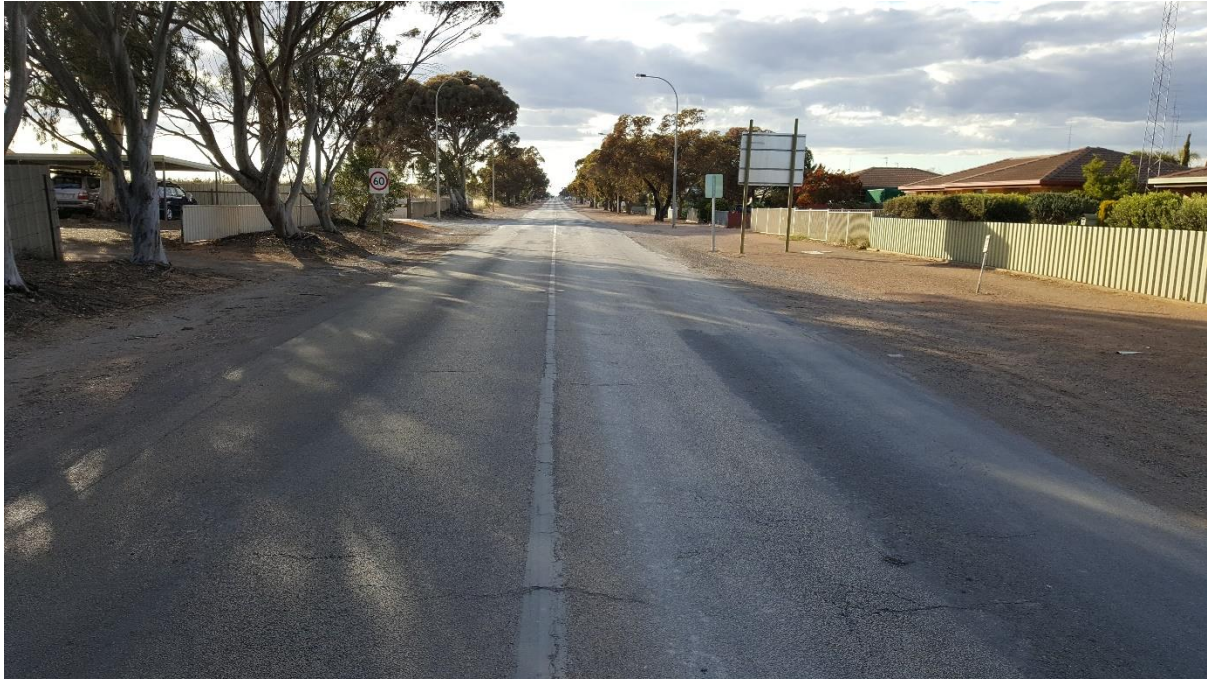
The pavement is failing west of Beare Street in Wallaroo

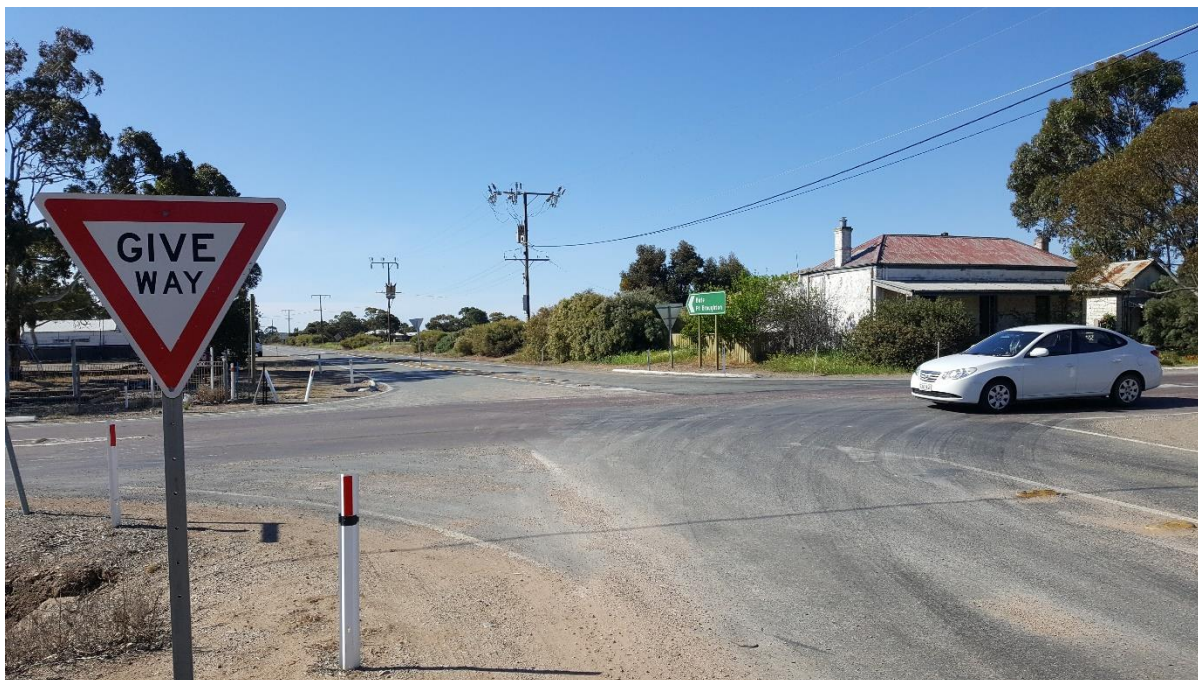
Line marking at the intersection with Copper Coast Highway and Upper Yorke Road is deteriorated

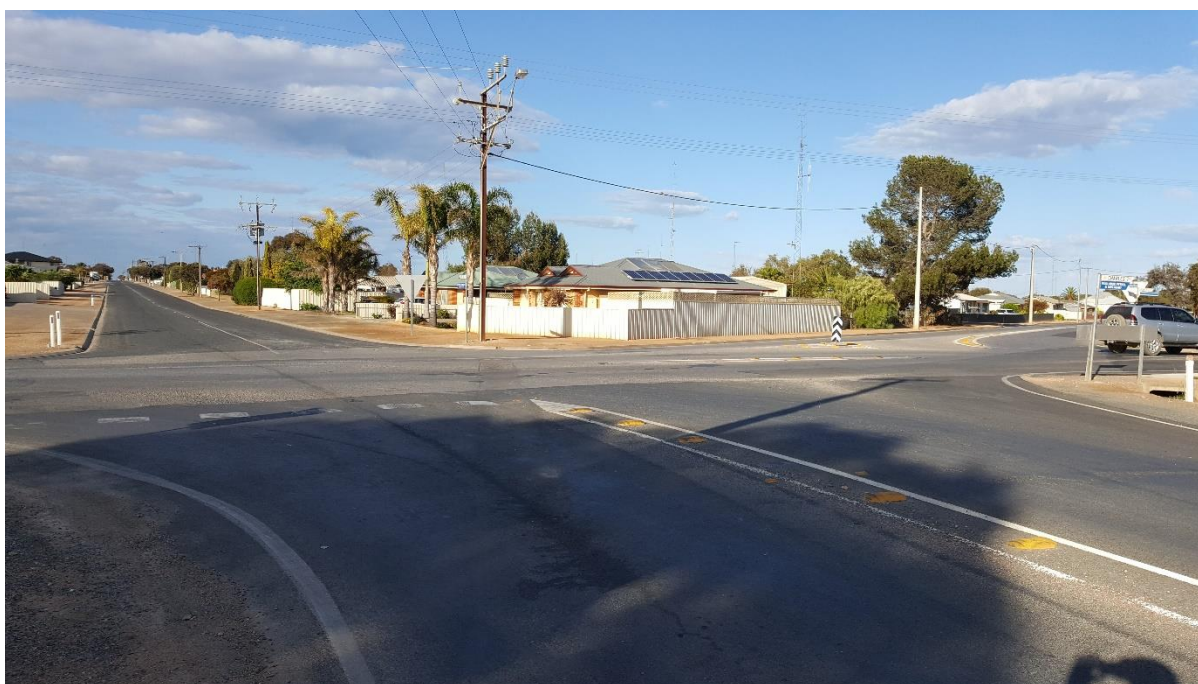
Line marking is faded and the layout is somewhat confusing

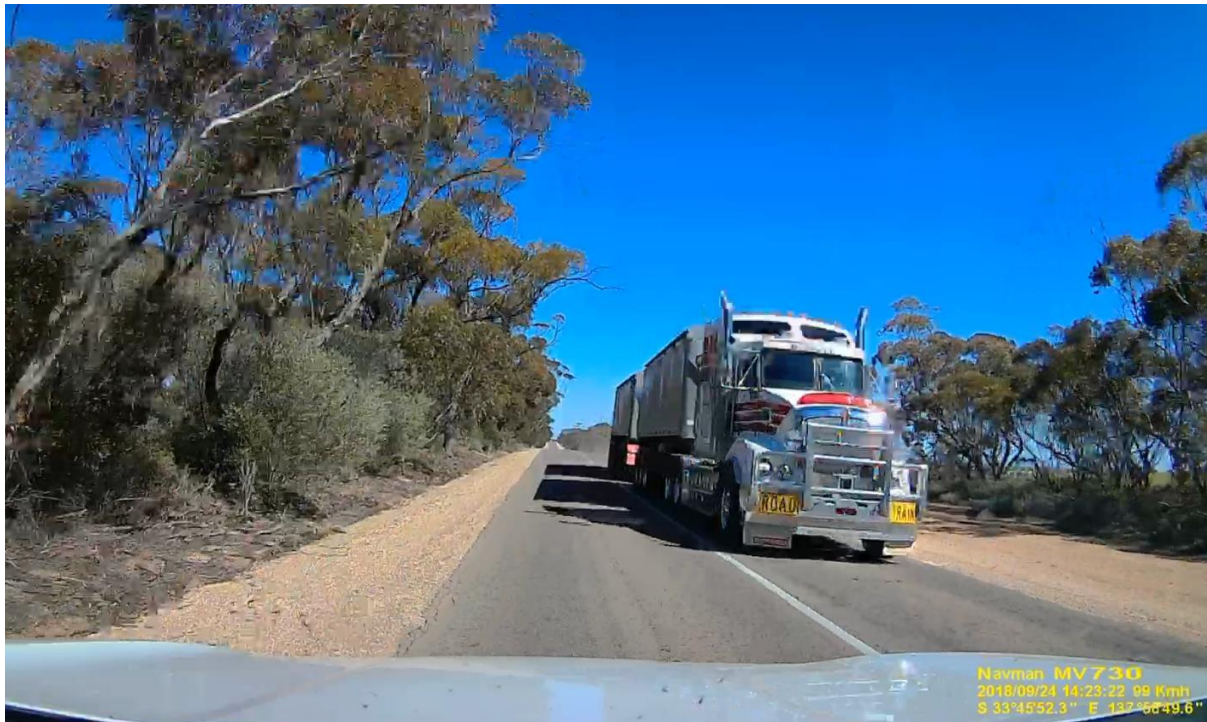
Freight interactions were tight between Port Broughton and Bute

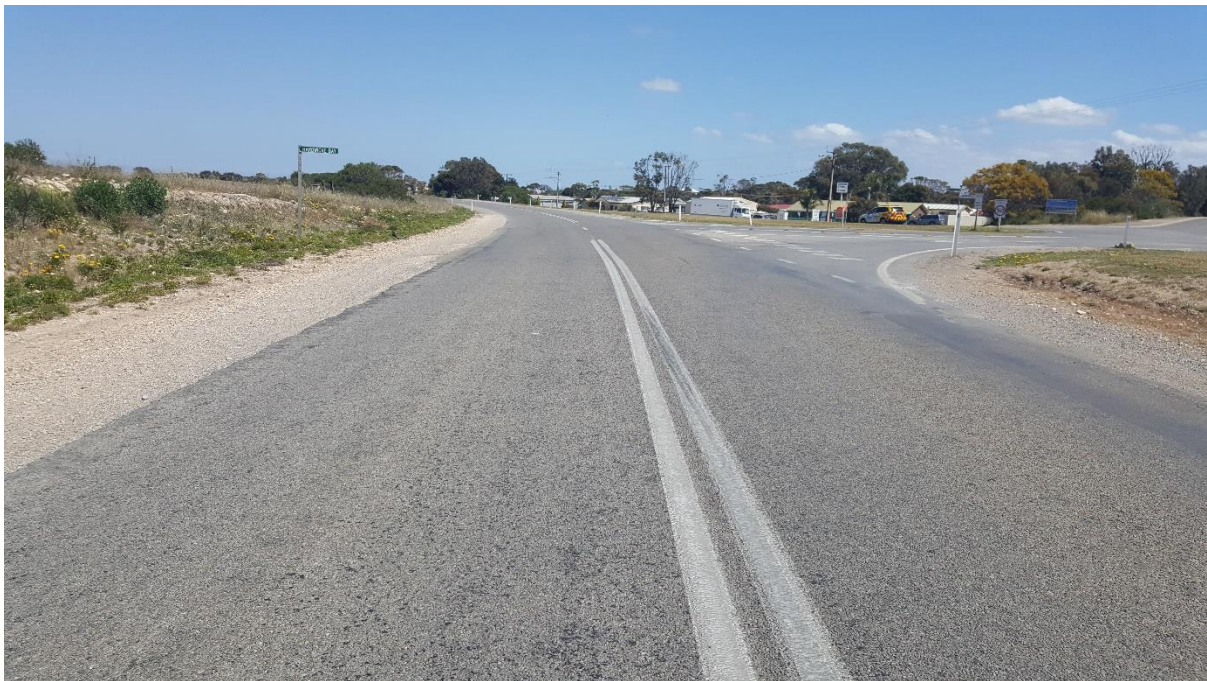
Poor sight distance turning right into Hardwicke Bay (North of the intersection, looking south)

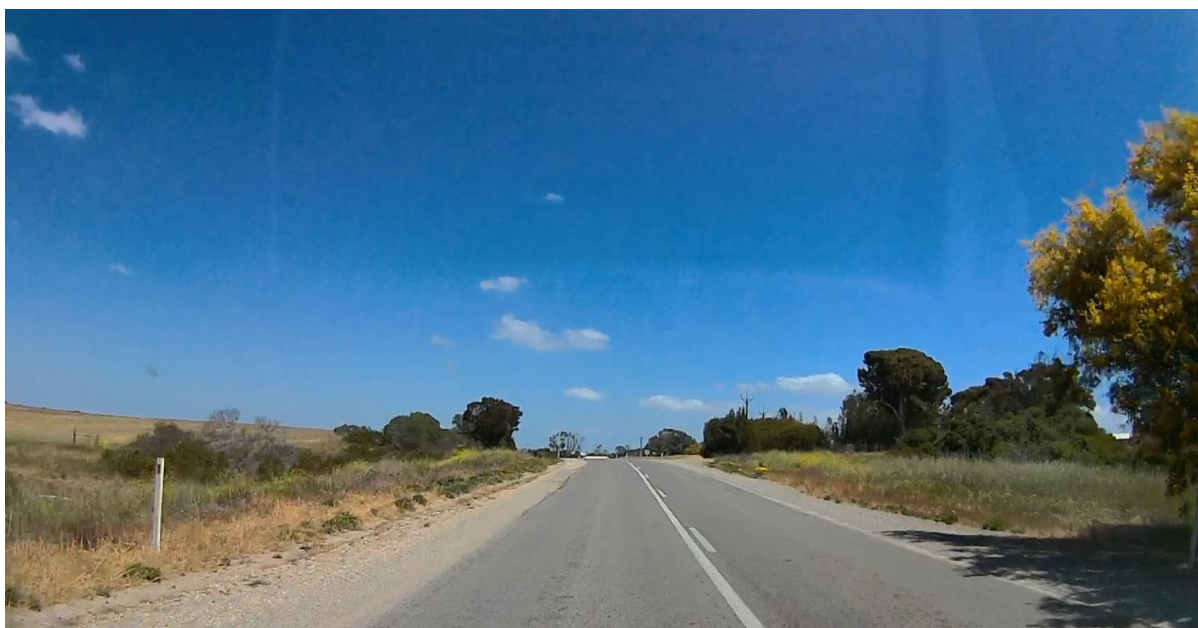
Vehicles stopped on the road turning right may be concealed by the of crest and left hand curve combination (150m north of the intersection, looking south)

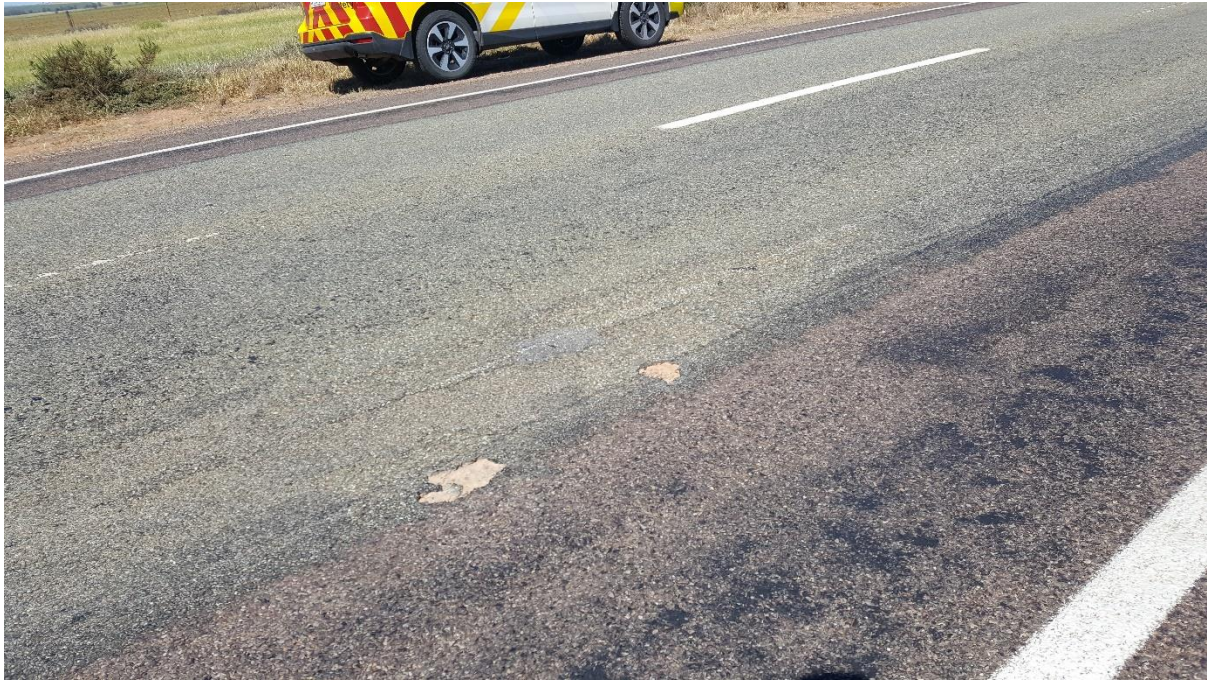
Potholes forming on the join between the shoulder seal and previous seal

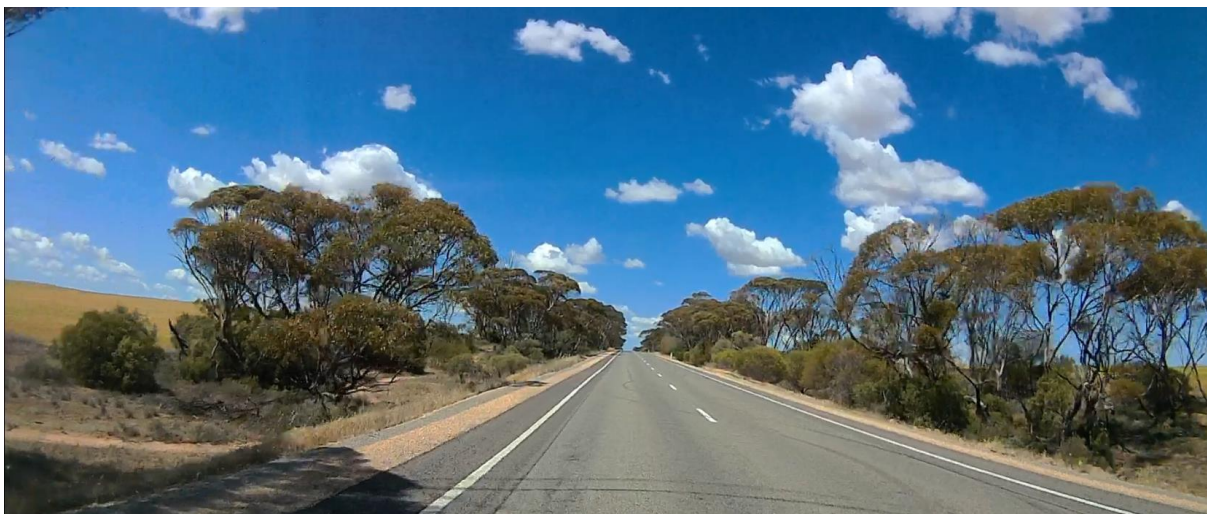
Steep drop offs on both sides of the highway just south of Port Broughton

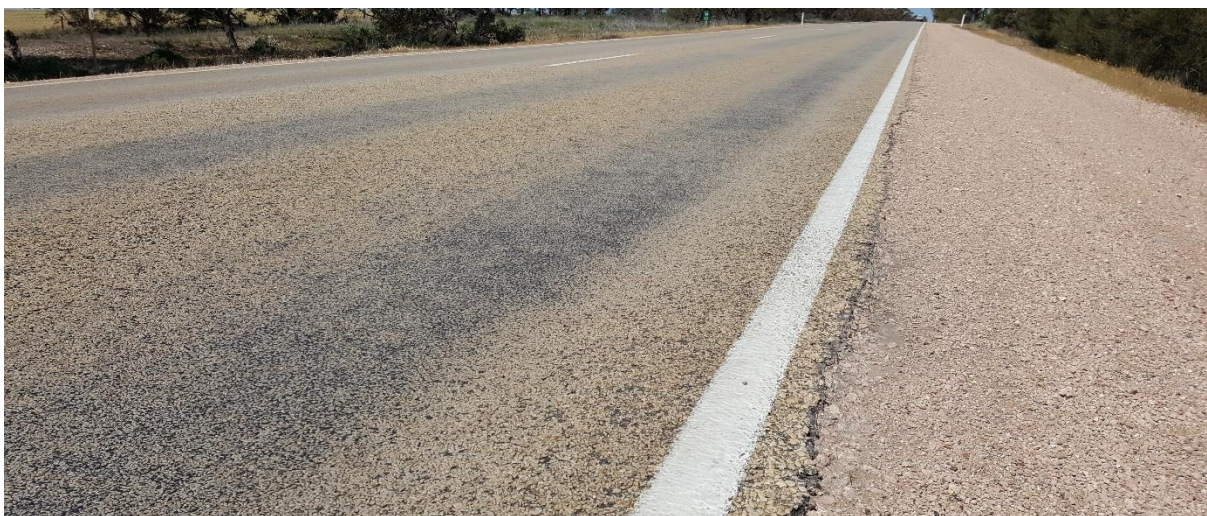
A typical section of Spencer Highway (Wallaroo – Moonta) with wide lanes, narrow shoulder seal and ruts

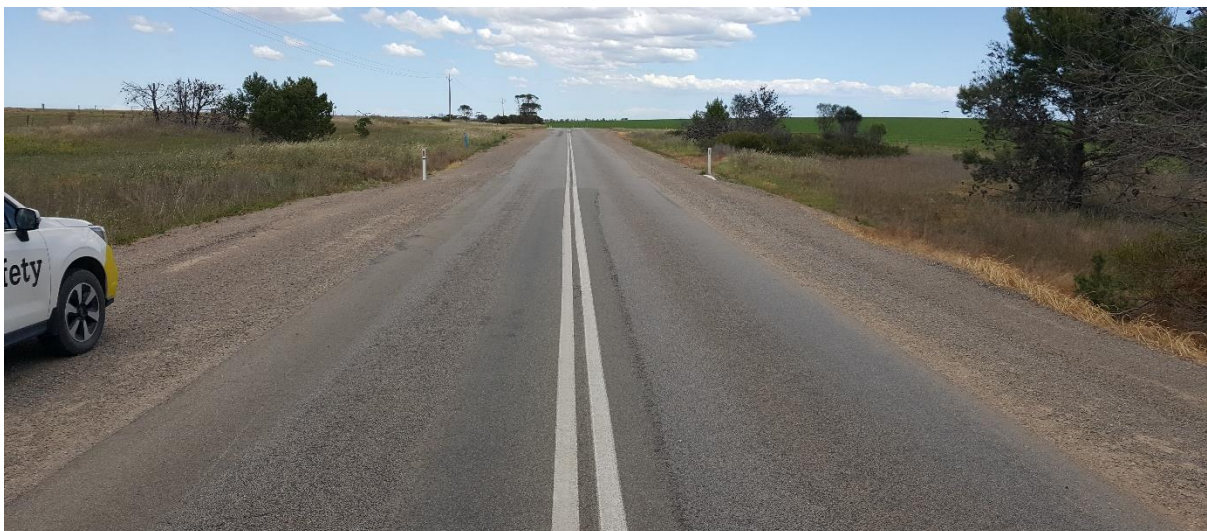
A very narrow carriageway and deteriorating surface are the primary issues between Maitland and Minlaton

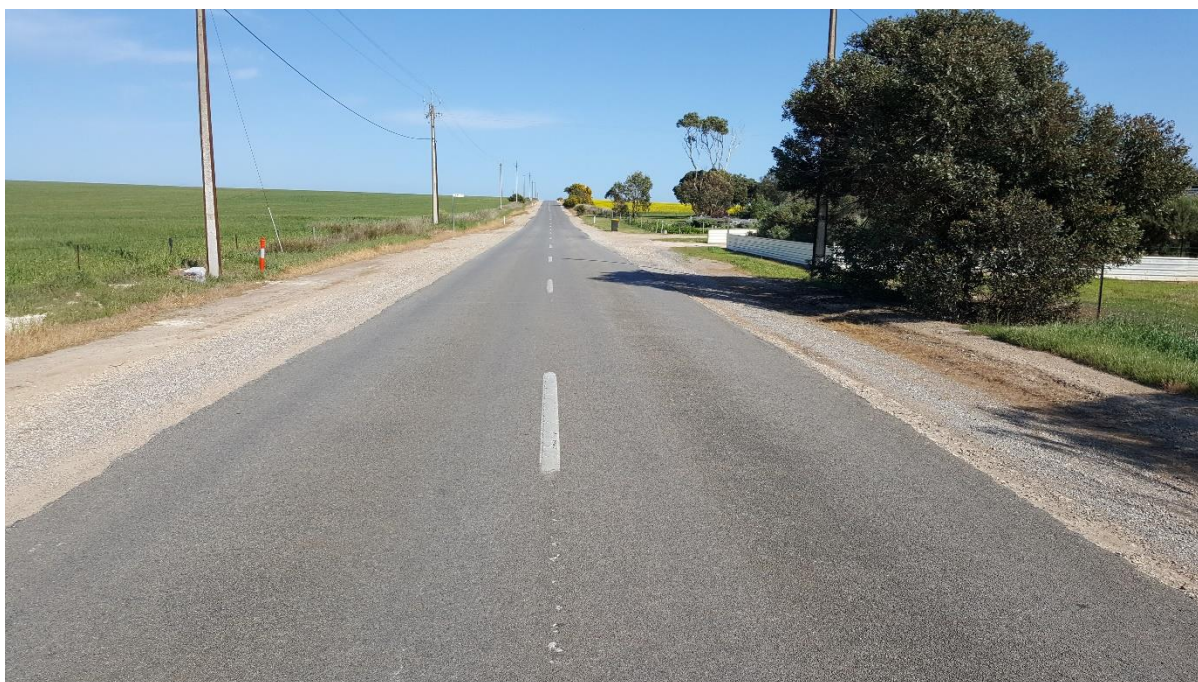
The very narrow carriageway just west of Edithburgh

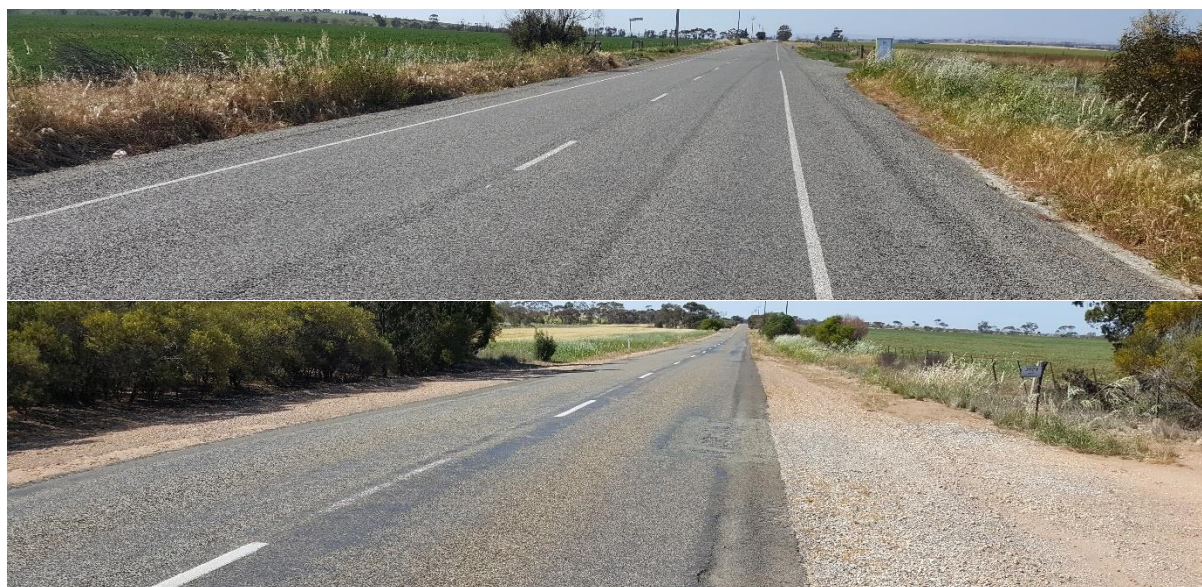
The recently upgraded 7 kilometre section of Owen Road in stark contrast to the untouched 20 kilometre section.

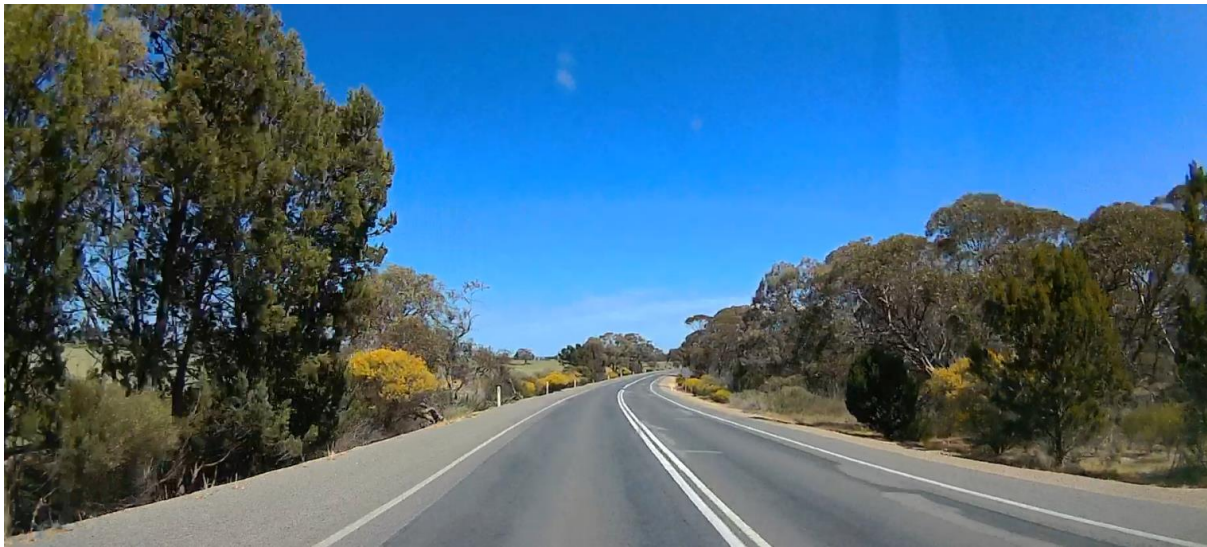
Unprotected drop-off and dense roadside vegetation east of Balaklava

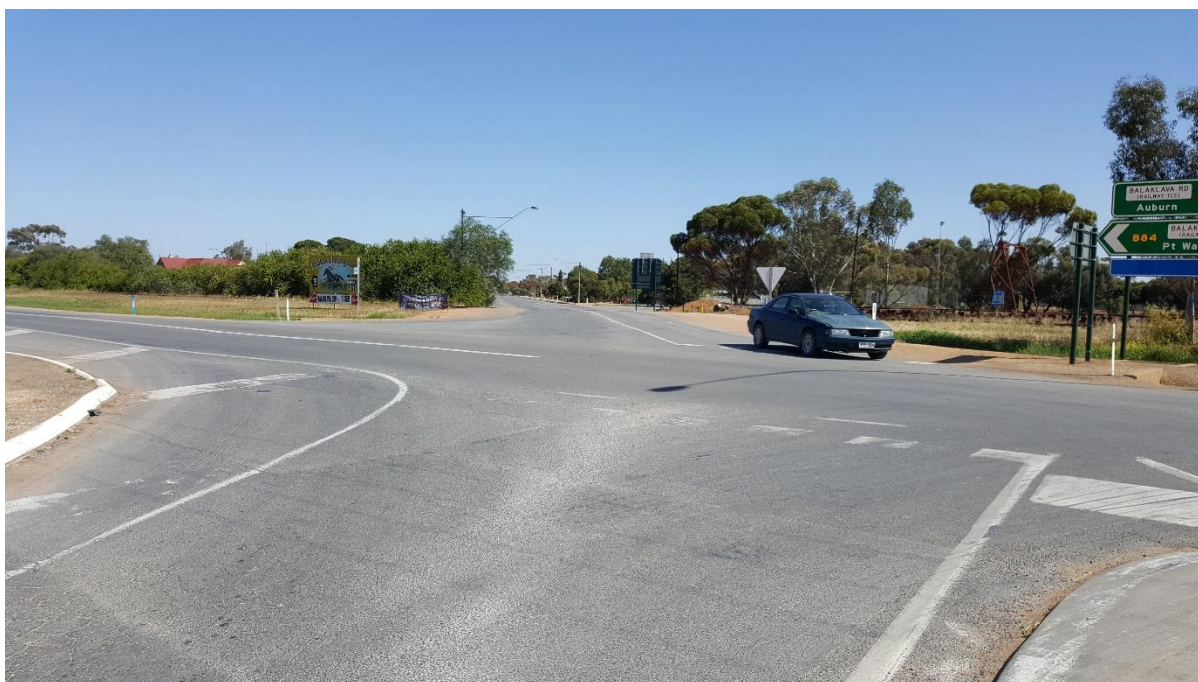
Line marking in poor condition at the Gwy Terrace intersection.

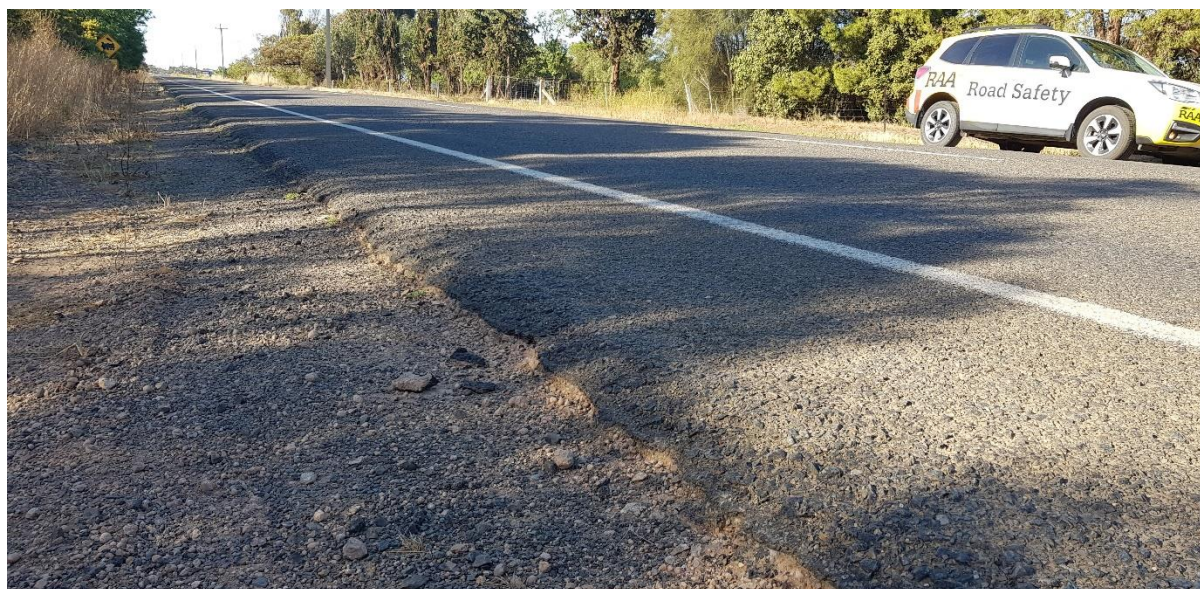
Substantial edge drop-offs were prevalent south of the Korunye rail crossing.

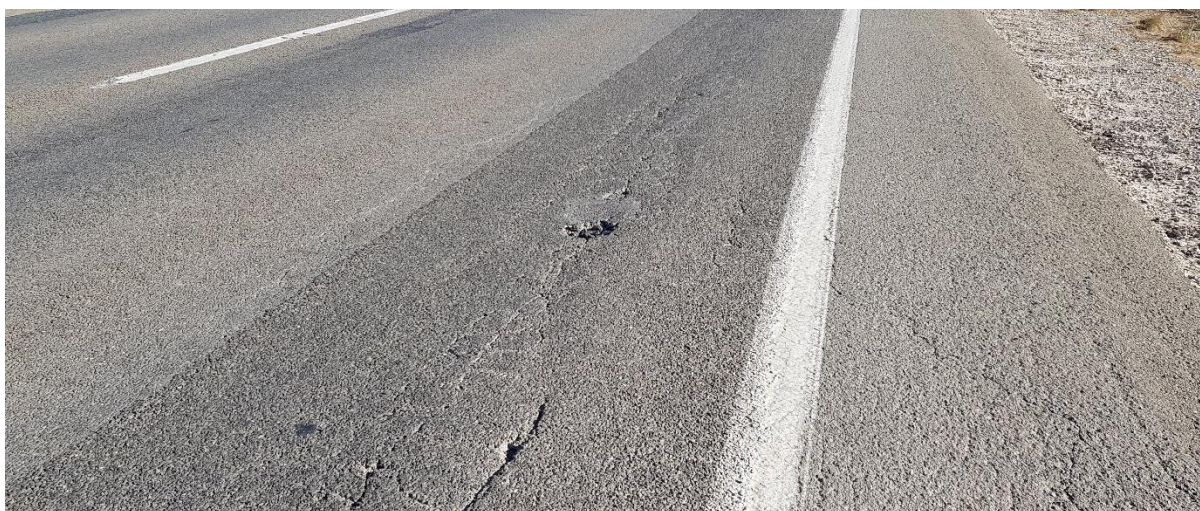
Cracking in the ruts is leading to the formation of potholes when water builds up

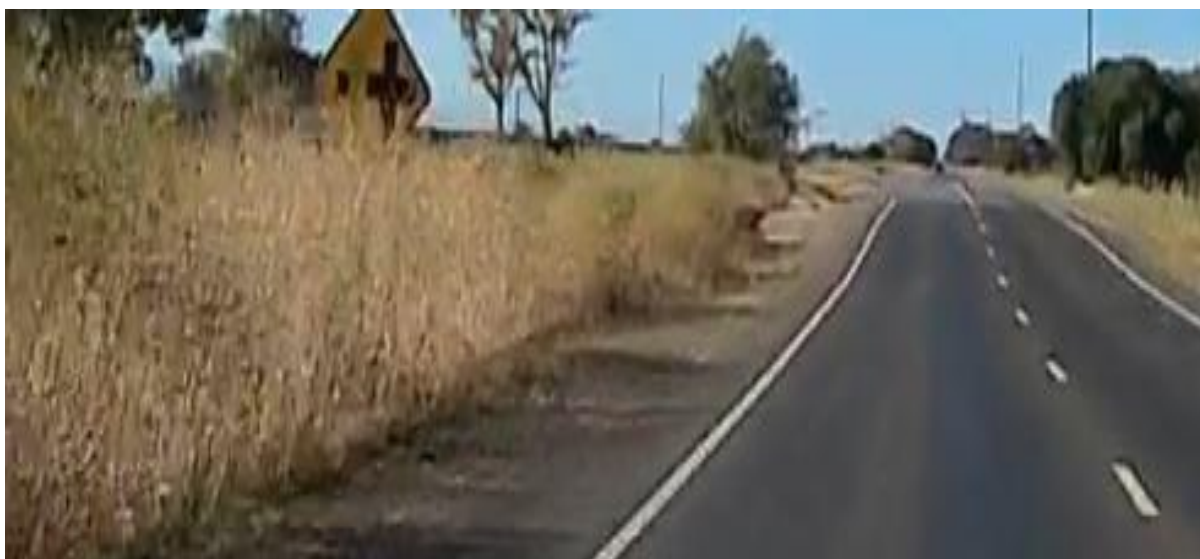
Long grasses concealing signs and guide posts

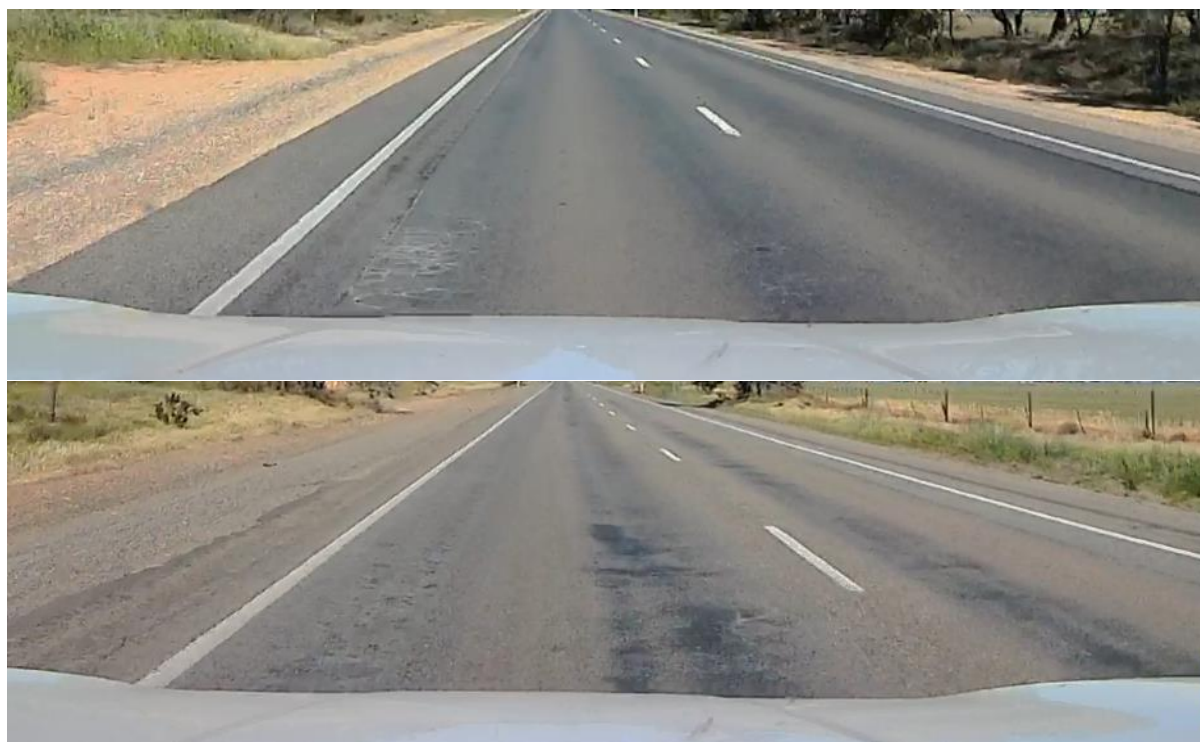
The generally poor surface south of Balaklava

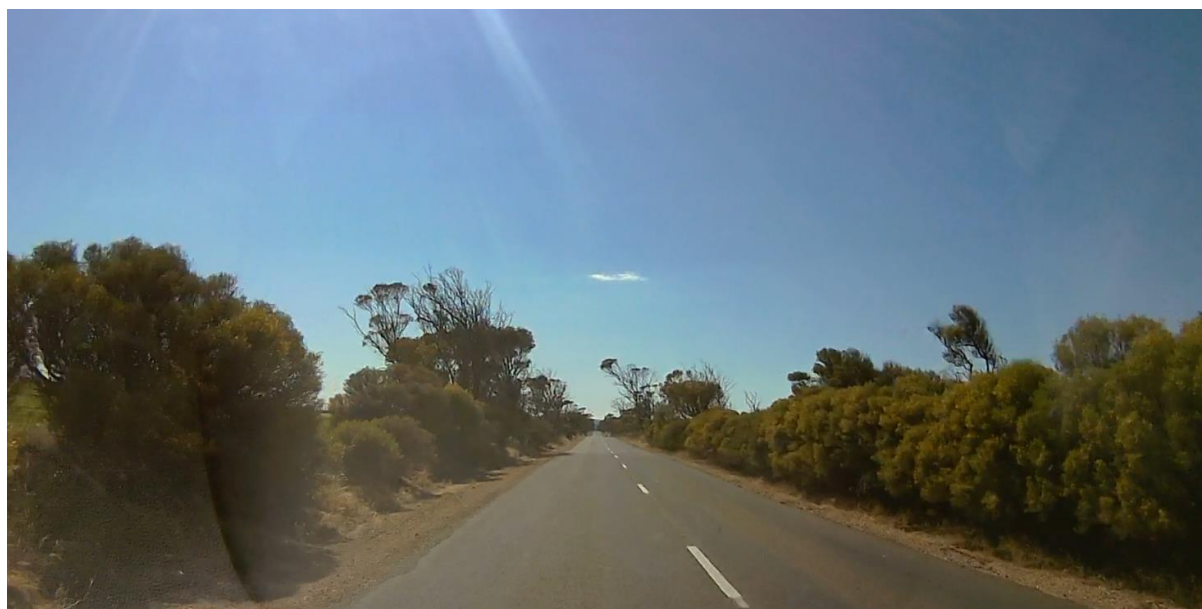
Vegetation encroaching on the shoulders of Bute Road

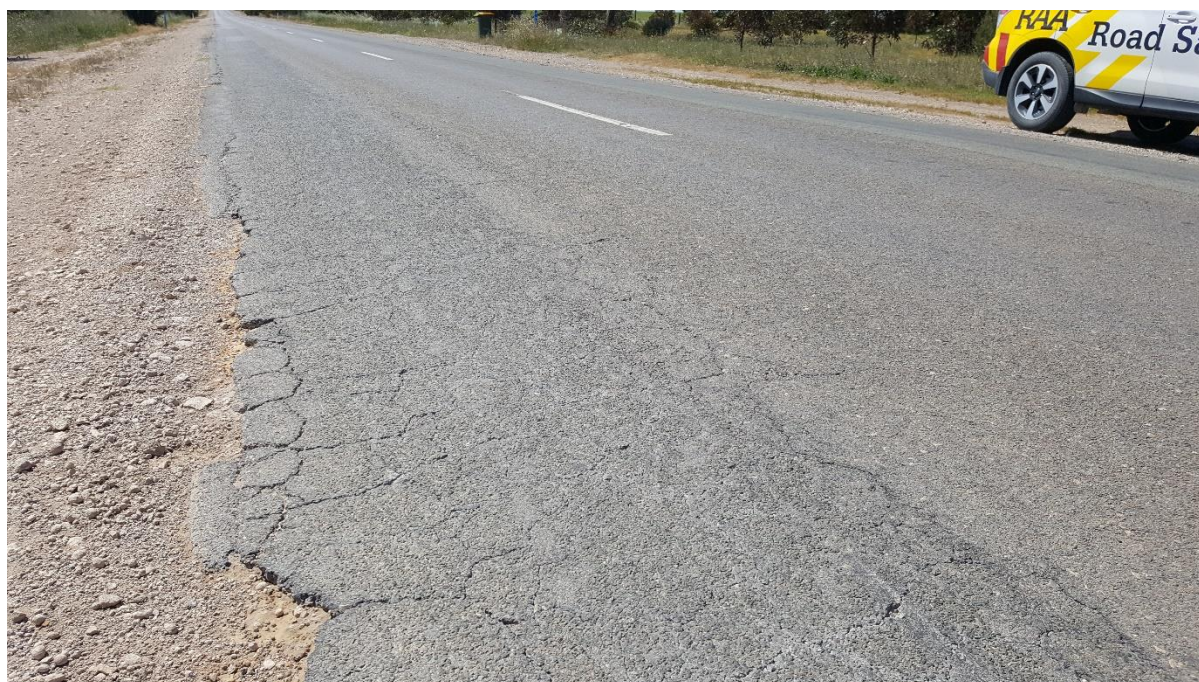
Failing section of Harry Butler Road (northbound lane)

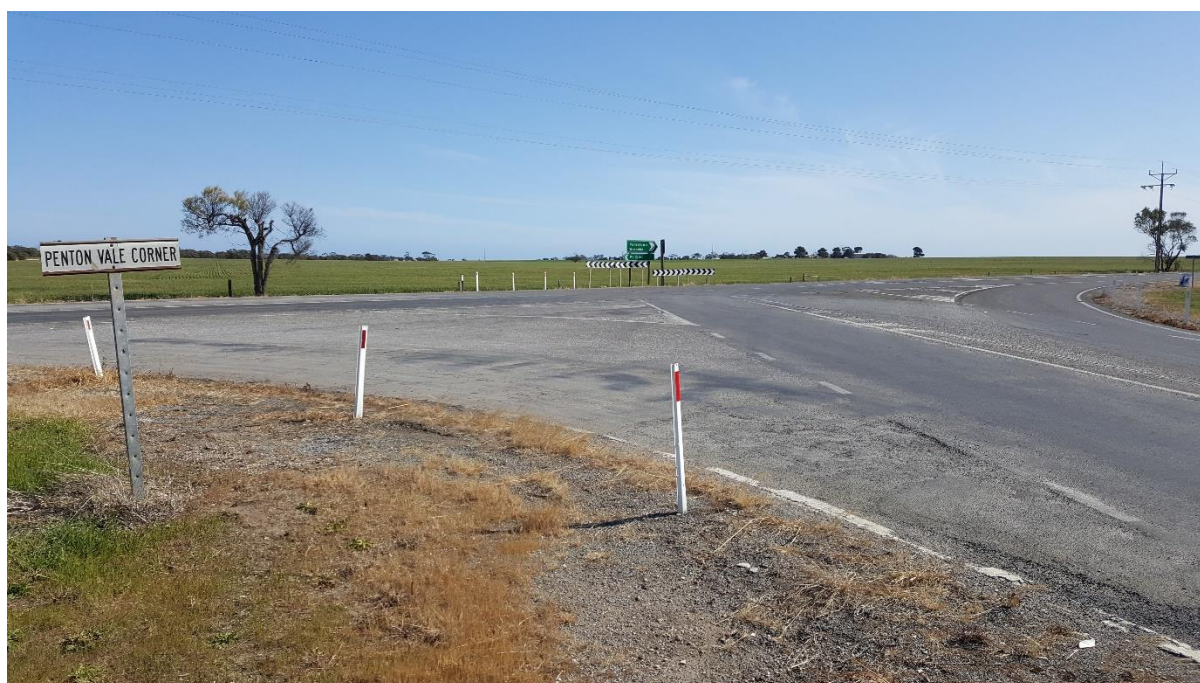
RAA have a number of safety concerns at the intersection with Stansbury Road and Port Giles Road

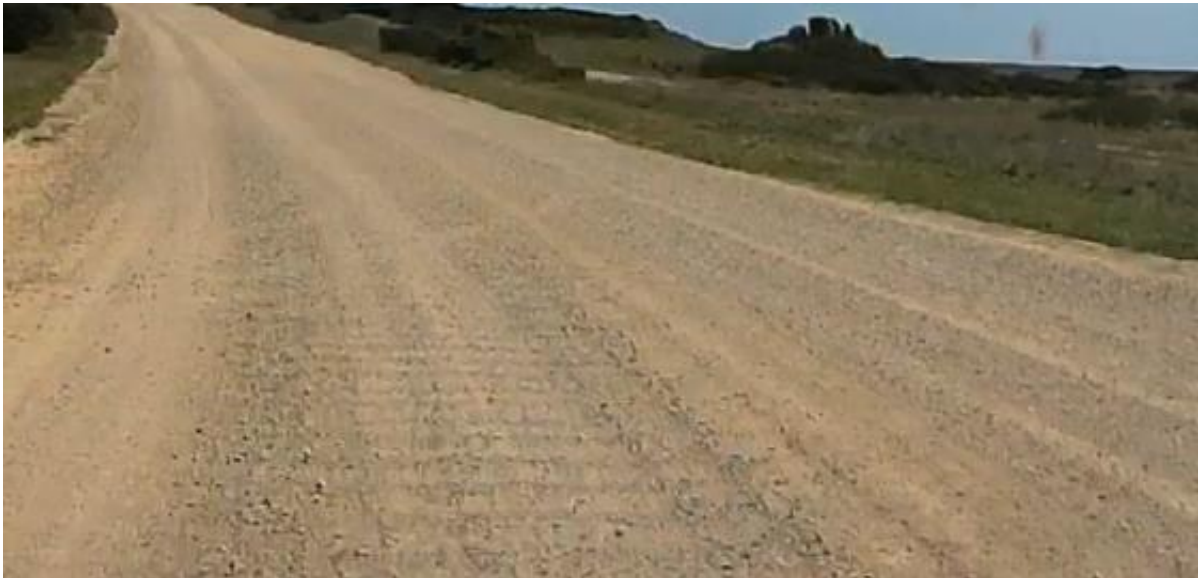
Corrugations on North Coast Road, and a build-up of loose surface material around a curve
