Yorke Peninsula

Regional Road Assessment
April 2019

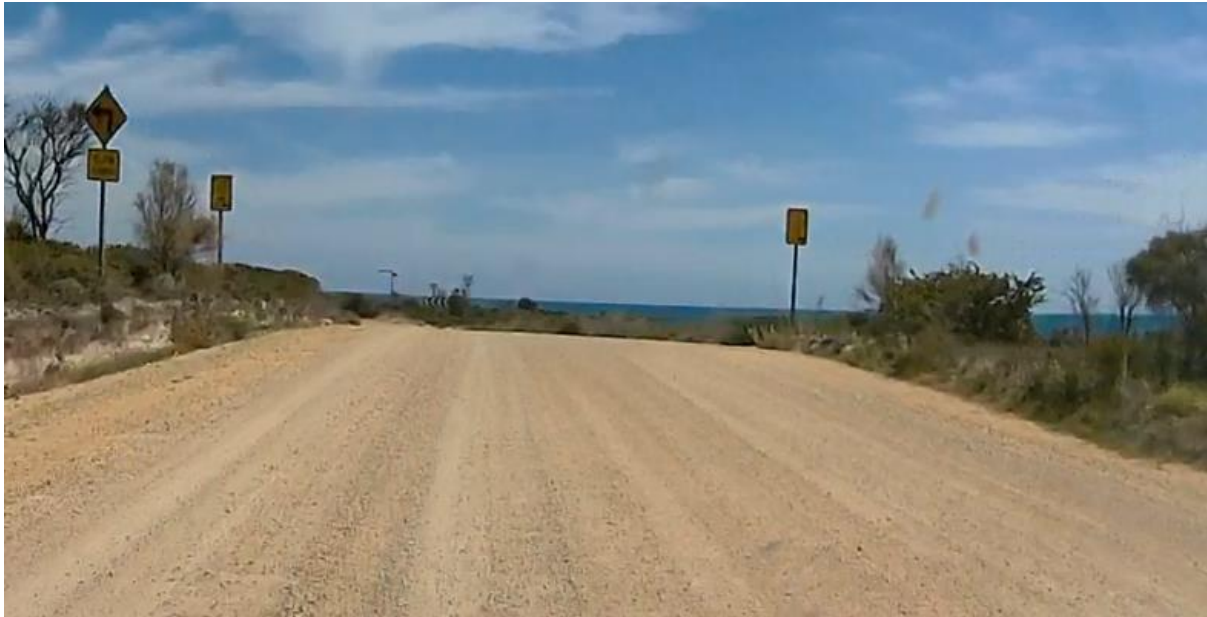
The 90-degree corner is still inconspicuous from less than 100m away (westbound).

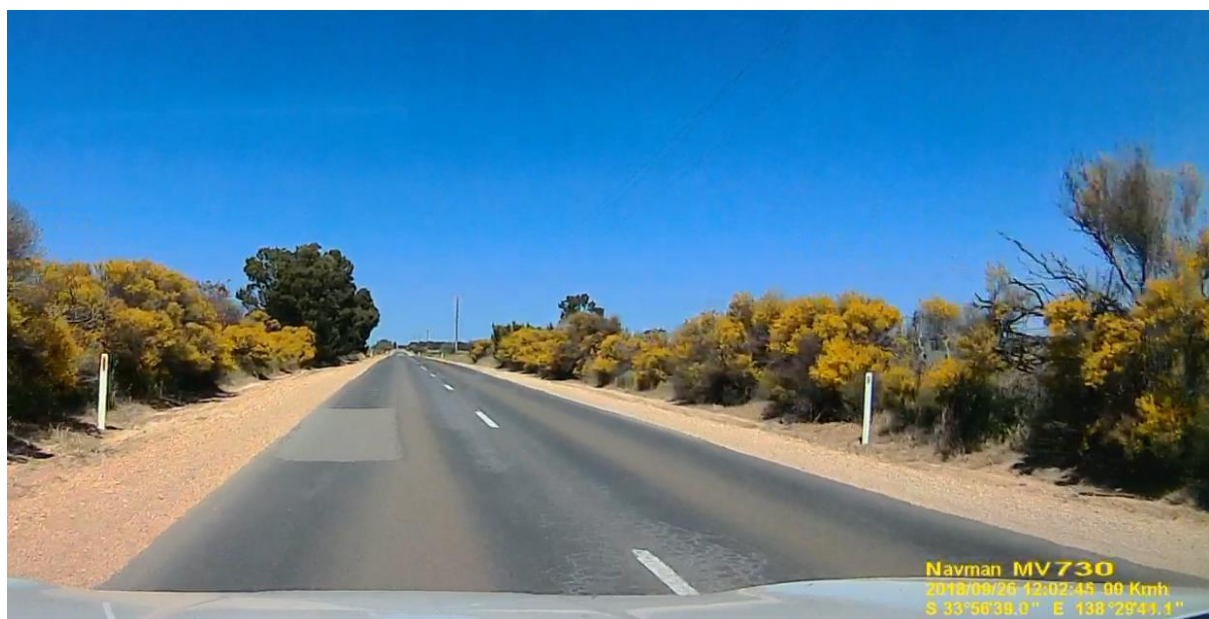
The surface of Blyth Plains Road has significantly deteriorated since the beginning of 2018.

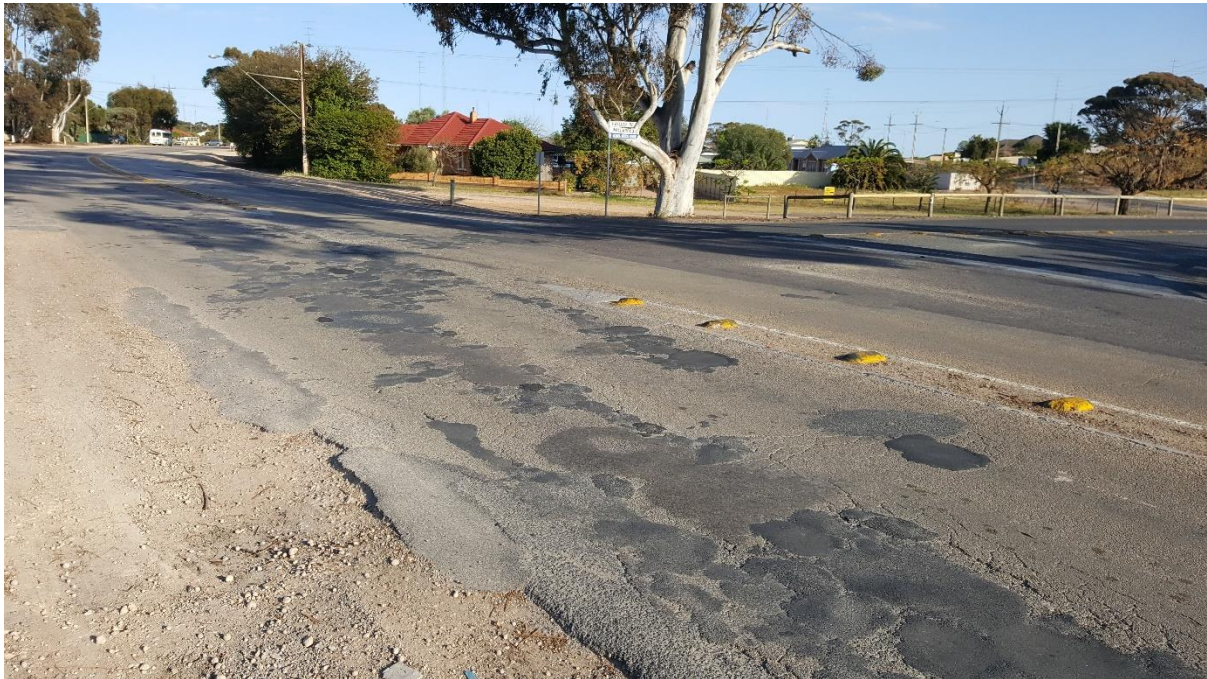
Bay Road is currently in very poor condition

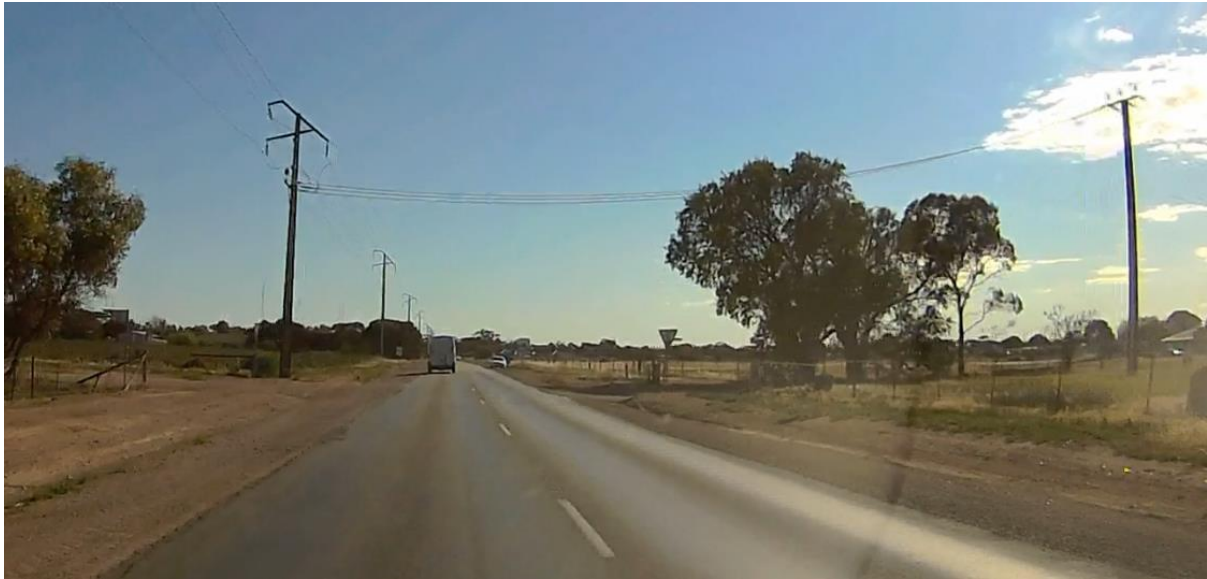
The section in Kadina is narrow and undulating

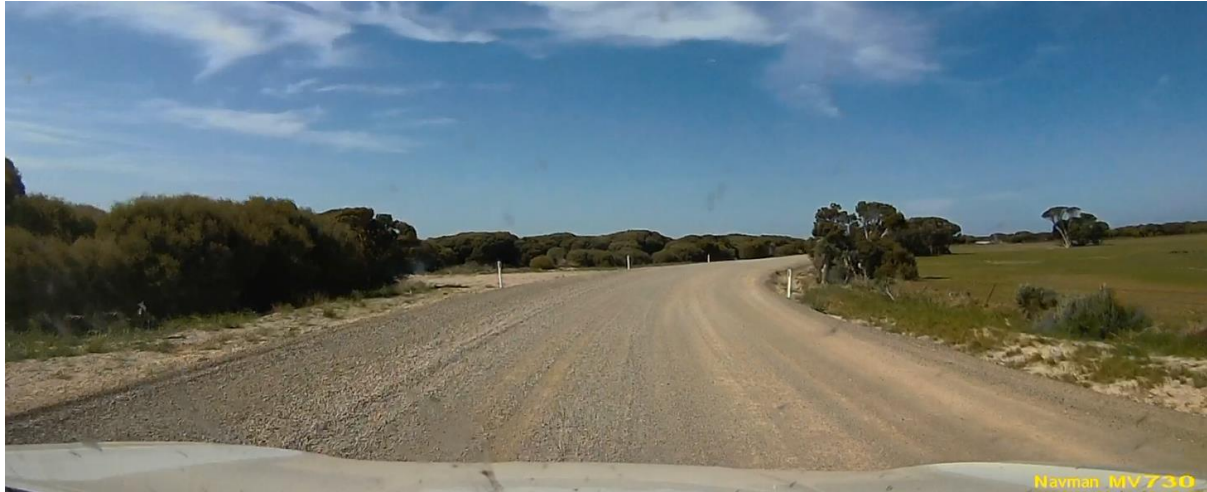
Ridges of loose material are prevalent on some sections of South Coast Road

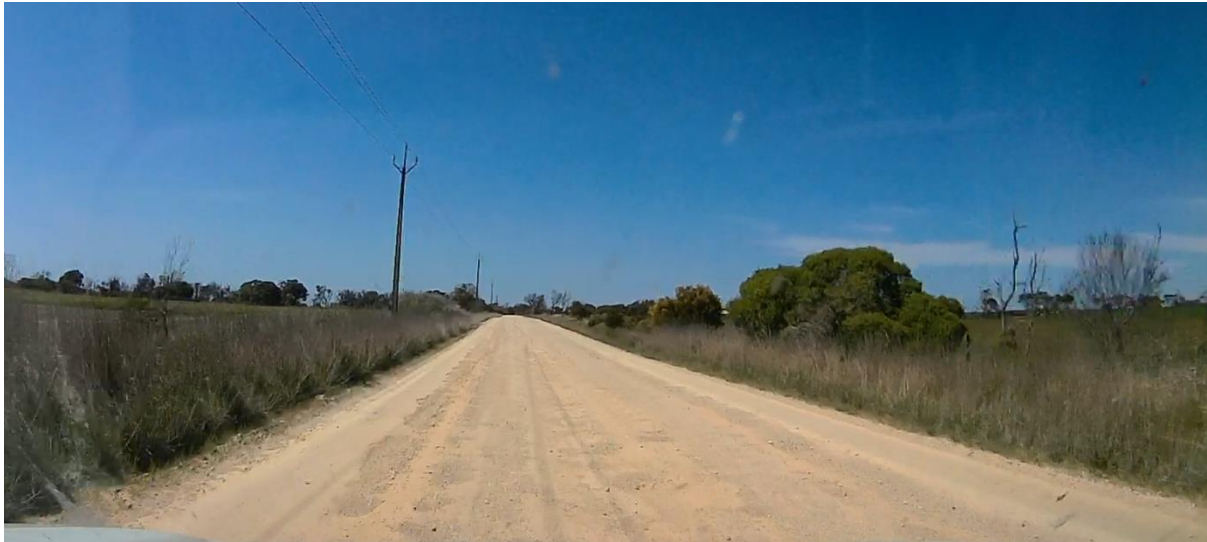
Many shallow potholes littered the surface of sections of Corny Point Road.
