Regional Road Assessment: Fleurieu Peninsula and McLaren Vale

Report: August 2021

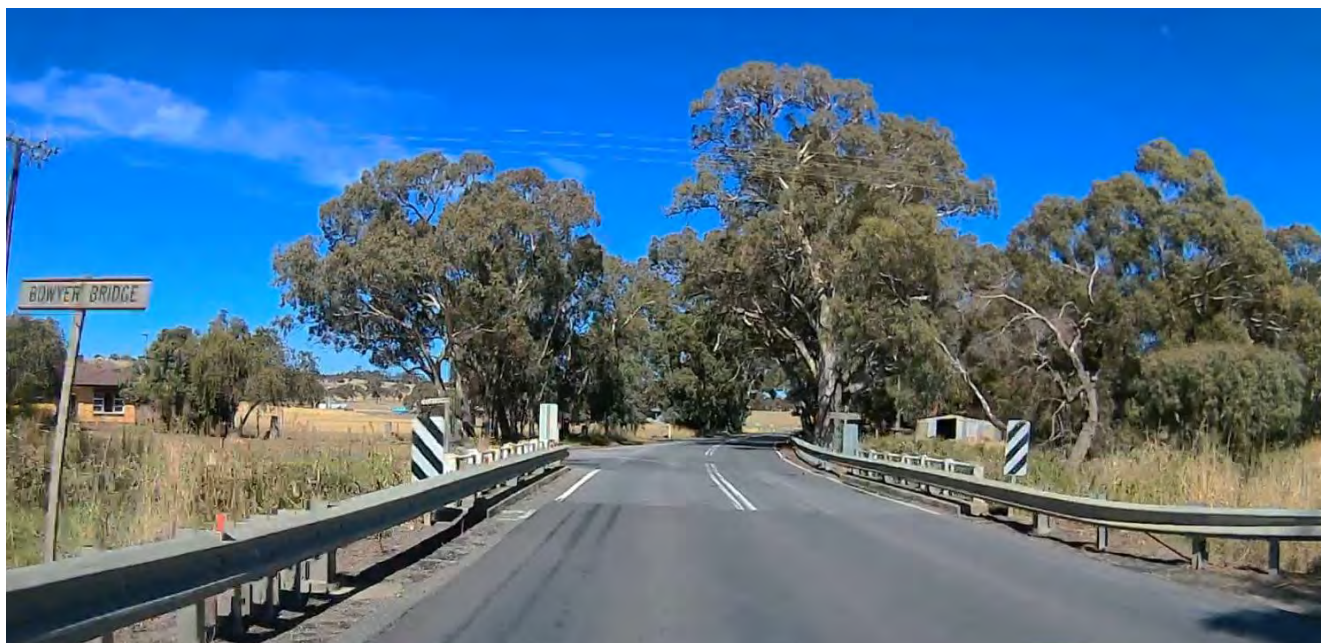
Figure 32: The Bowyer Bridge in Wattle Flat is one example of a narrow bridge along Main South Road

Review and prioritise the identified narrow bridges for widening between Myponga and Second Valley.

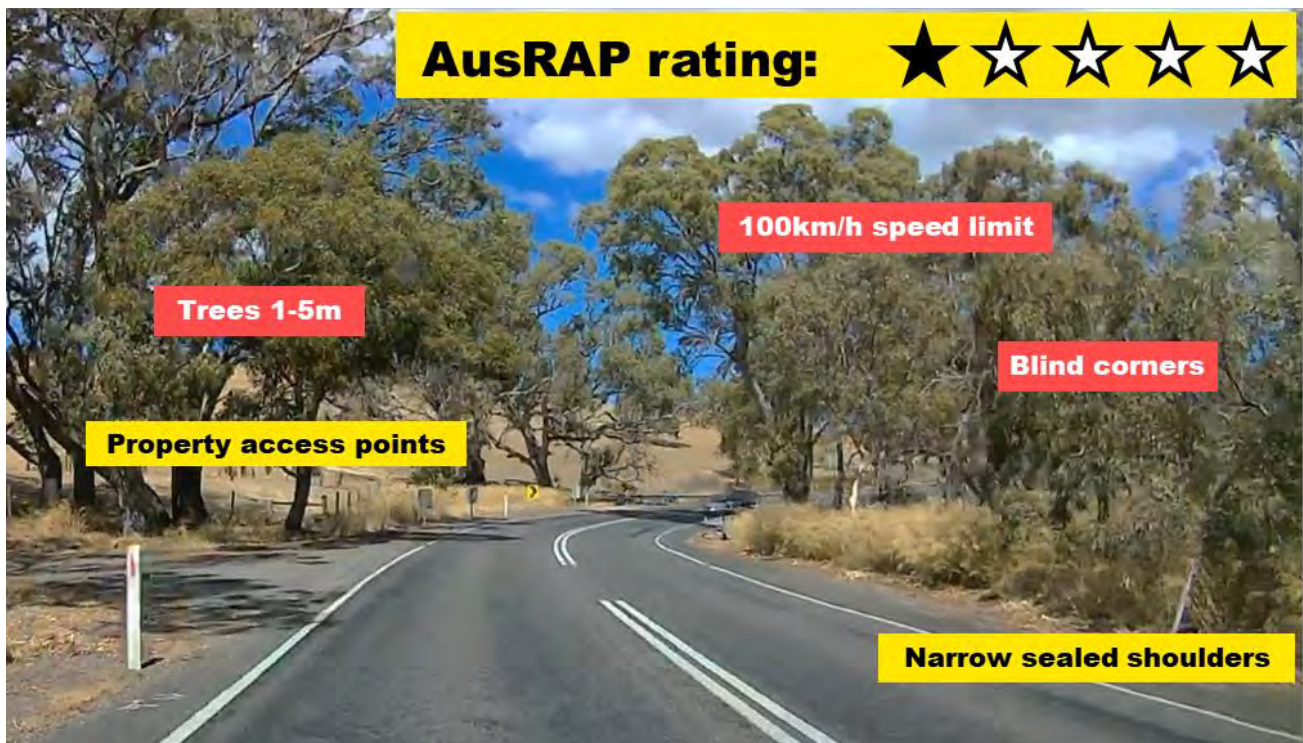
The AusRAP star rating of Main South Road typically varies between one and two stars, with some three-star sections present along the corridor. For a section to be rated three stars, it typically must be free of fixed hazards other than safety barriers, and on a moderately curving, or straight road section.

Figure 34: Example of a one-star AusRAP star rated section on Main South Road

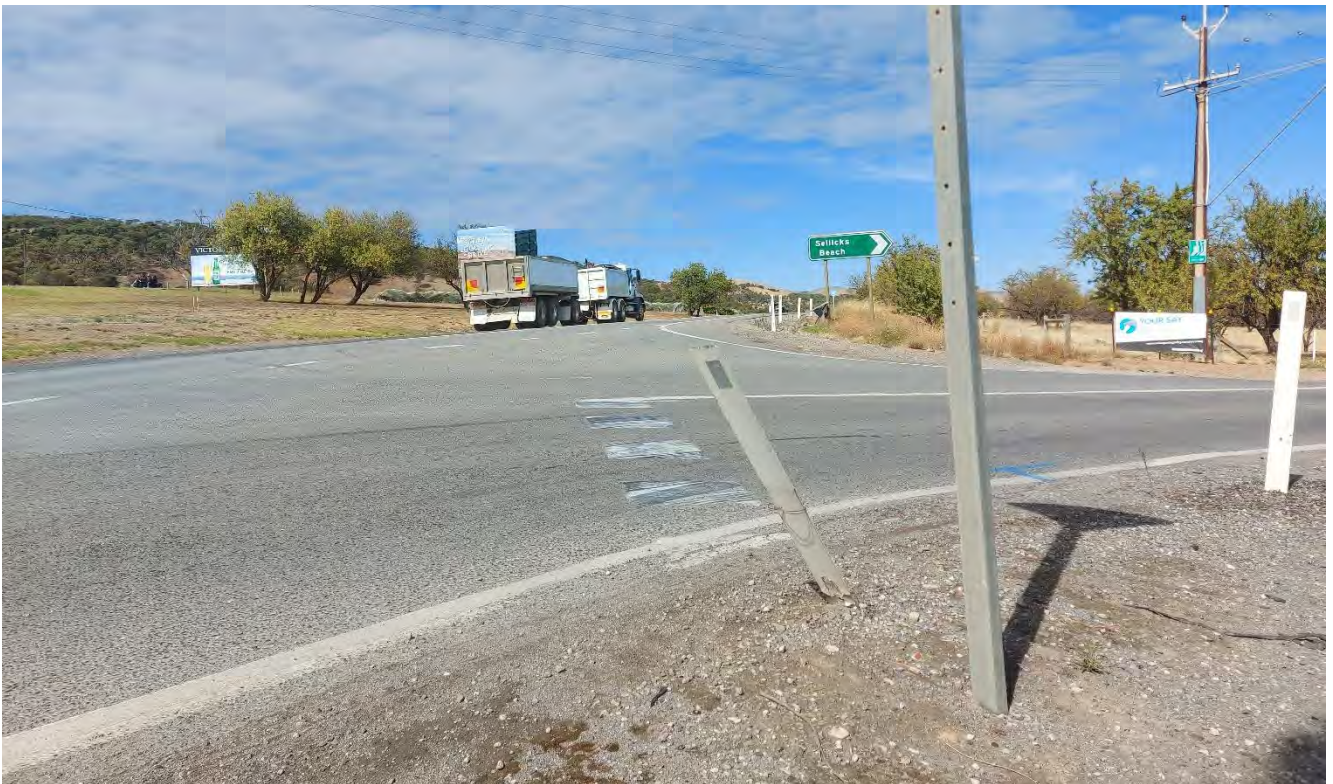
Figure 39: Poor sight distance from Sellicks Beach Road to the southwest

Upgrade the intersection with Main South Road and Sellicks Beach Road to improve safety by increasing sight distance and installing channelised turn lanes.

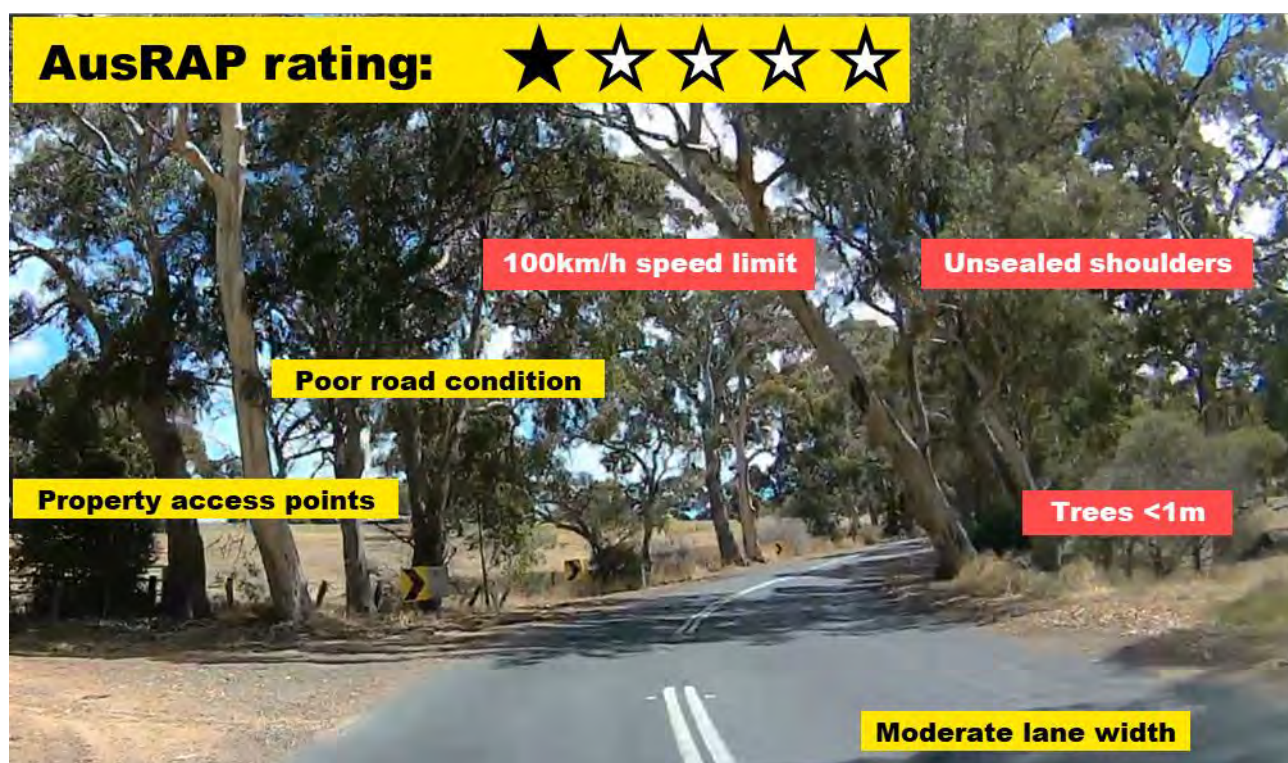
The section pictured below is located between Inman Valley and Yankalilla and is a low one star rated road. In this case, a speed reduction to 80km/h would still result in a one star rated road. Barriers on both sides of the road and 1m wide sealed shoulders would give this a two-star rating, and the rating would increase to three stars if improvements were made to the road surface. Our recommendations for Inman Valley Road in this report would result in a consistent, minimum three star rated road, and significantly reduce the amount of trauma occurring on Inman Valley Road.

Figure 43: Typical AusRAP star rating on Inman Valley Road

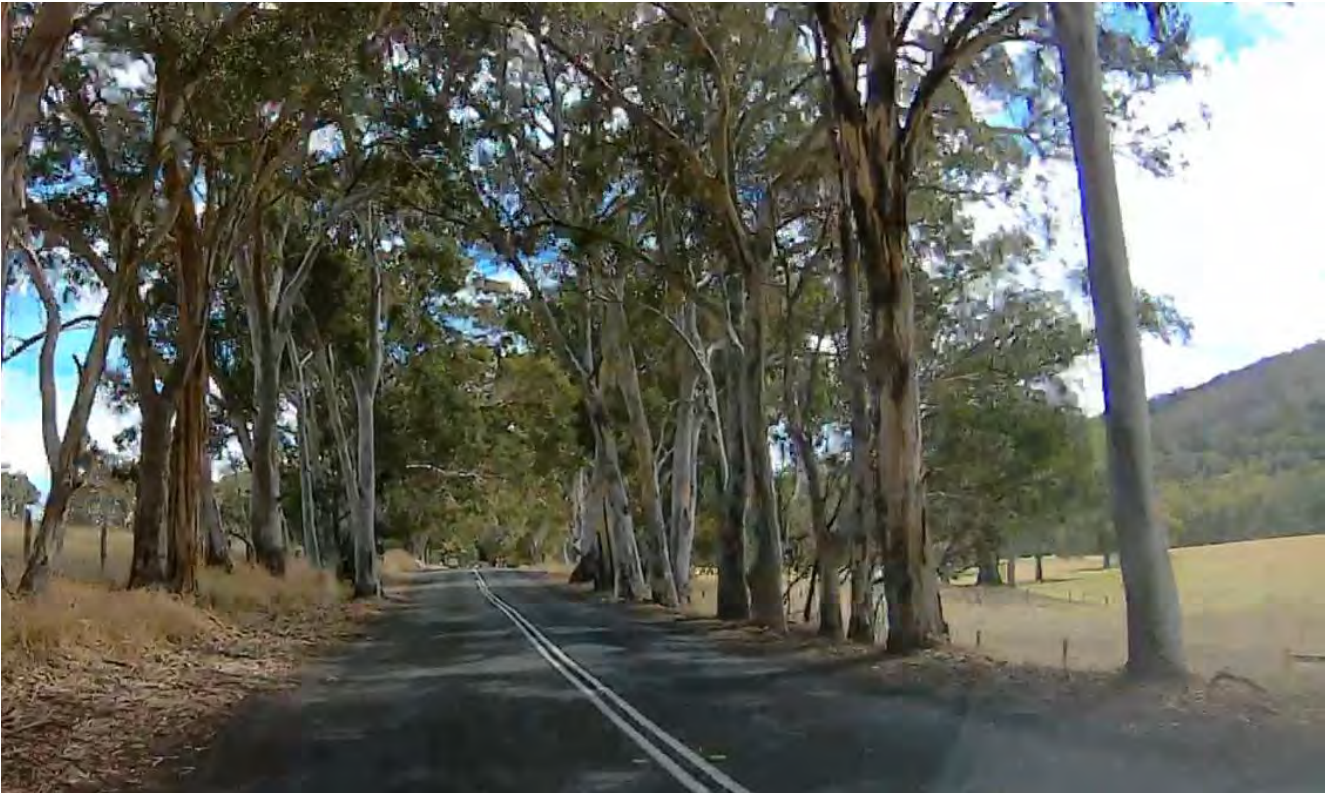
Figure 44: Trees on the roadside present the most significant hazard to users of Inman Valley Road

Retrofit motorcycle underrun to existing barriers on Inman Valley Road.

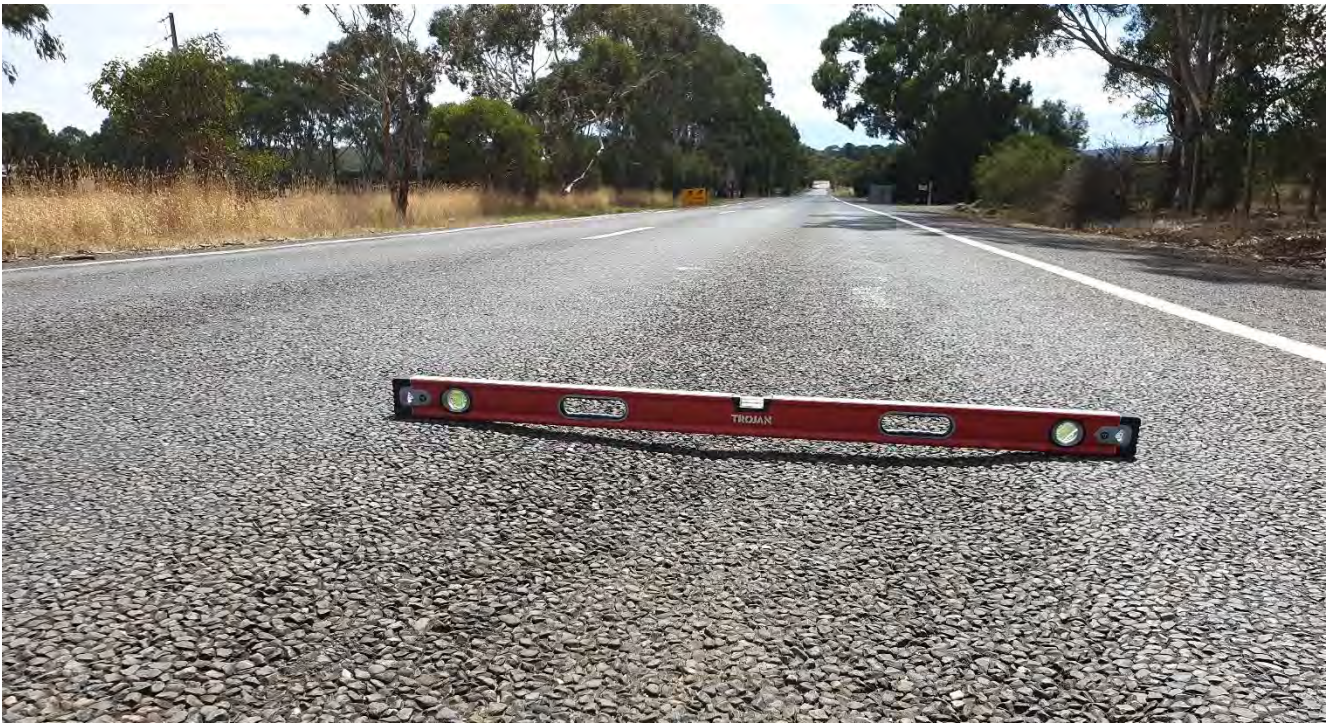
Figure 45: Rutting on Inman Valley Road

Localised pavement rehabilitation/reconstruction to address undulating and sections and rutting between Victor Harbor and Yankalilla.

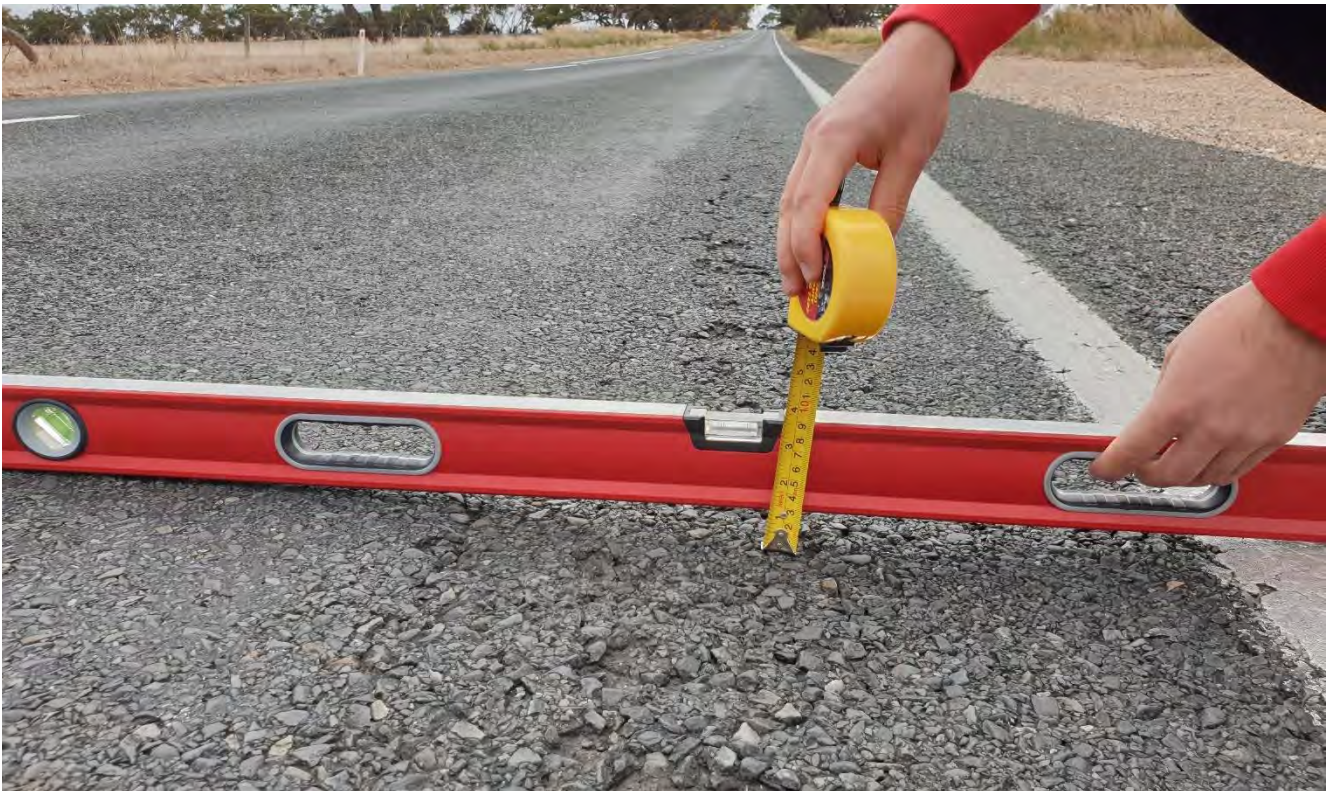
Figure 52: 30mm deep ruts and surface ravelling in Sandergrrove

Undertake localised pavement rehabilitation and microsurfacing to address failing sections of pavement and rutting, including a reseal between Airport Road and Goolwa.

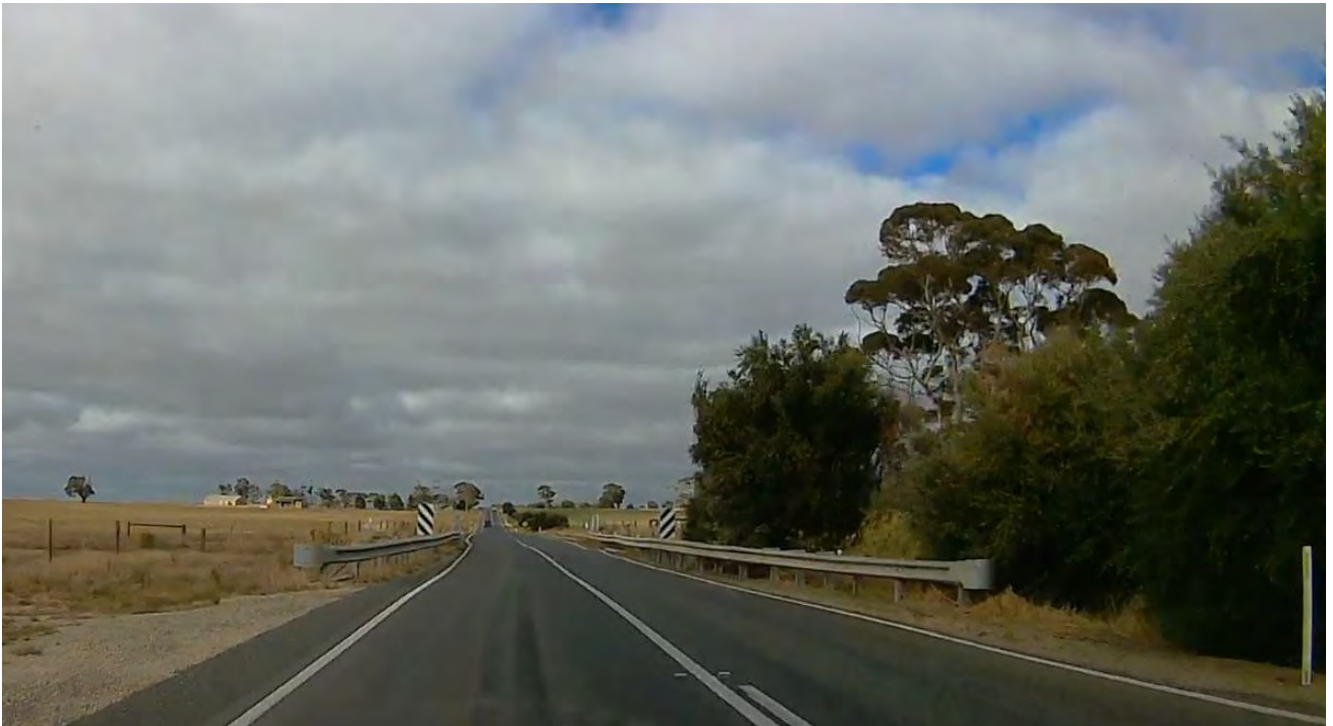
These six bridges are narrow to moderate in width, with some located on curves or near intersections which pose additional safety hazards. The two bridges in Sandergrove are located on straight sections of road, which poses a higher risk when overtaking manoeuvres are being undertaken. Whilst the route is already gazetted for b-double use, RAA considers this to be highly risky whilst these bridges remain along the route. As a minimum, 3.3m wide lanes and 1.0m wide sealed shoulders should be provided over bridges.

Figure 53: Narrow bridge 590m northeast of Wattle Flat Road in Sandergrove

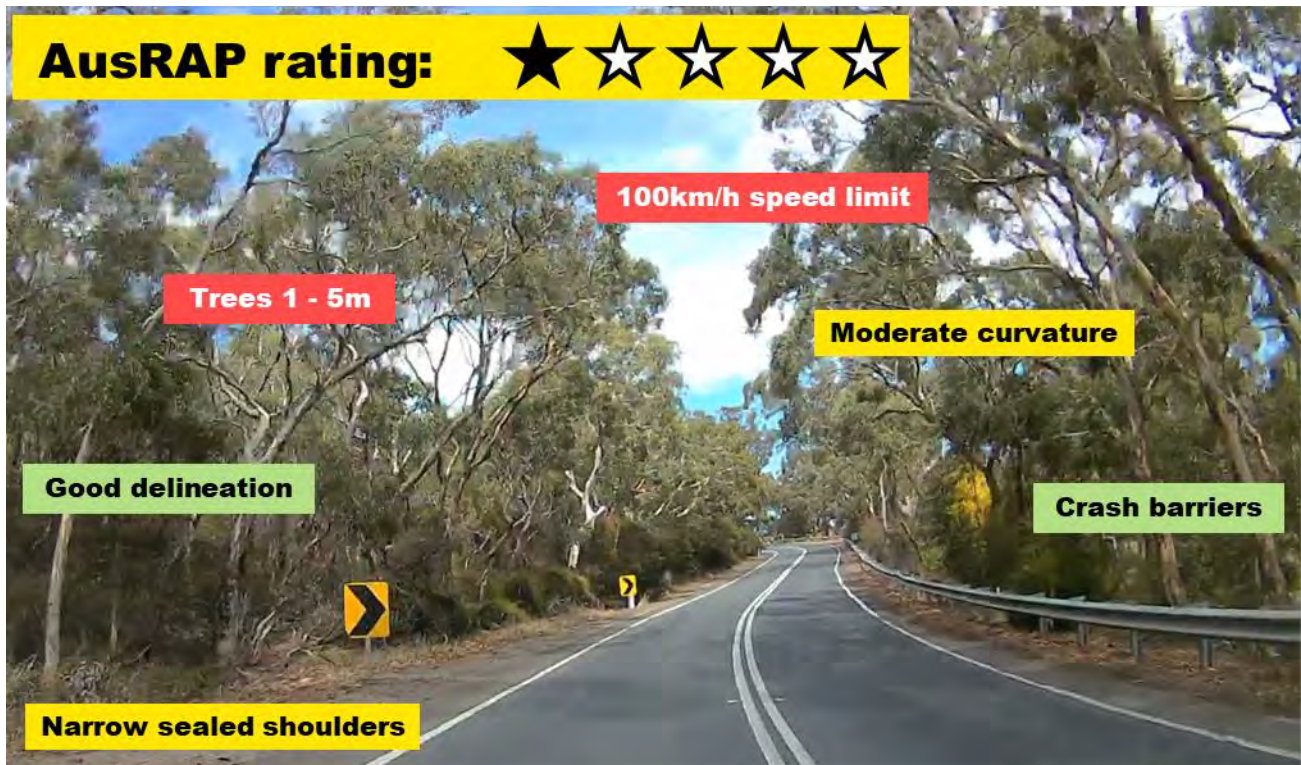
Goolwa Road is typically rated one star under AusRAP star rating protocols. This is largely due to the frequency and proximity of roadside vegetation, curves and crests in the road, and the 100km/h speed limit. Sections with clear roadsides or adequate barrier protection are typically rated between two and three stars, however these occur less frequently than the one-star sections of road.

Figure 59: Typical AusRAP star rating on Goolwa Road

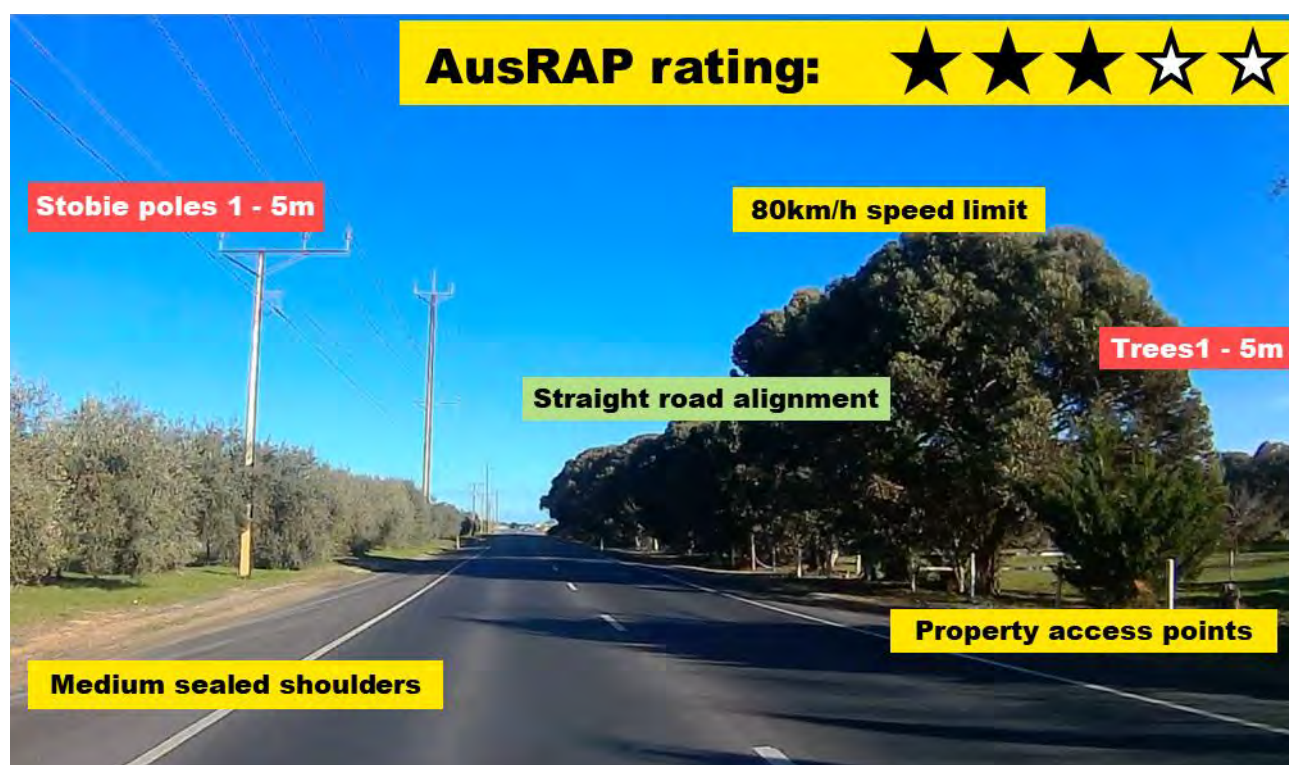
Aldinga Road is typically rated three stars under AusRAP star rating protocols due to its generally good geometry and straight alignment, with most fixed hazards located beyond three metres from the road edges. Intersections are typically rated one star due to the lack of channelisation, and potentially high impact speeds and angles.

Figure 61: Typical AusRAP star rating on Aldinga Road

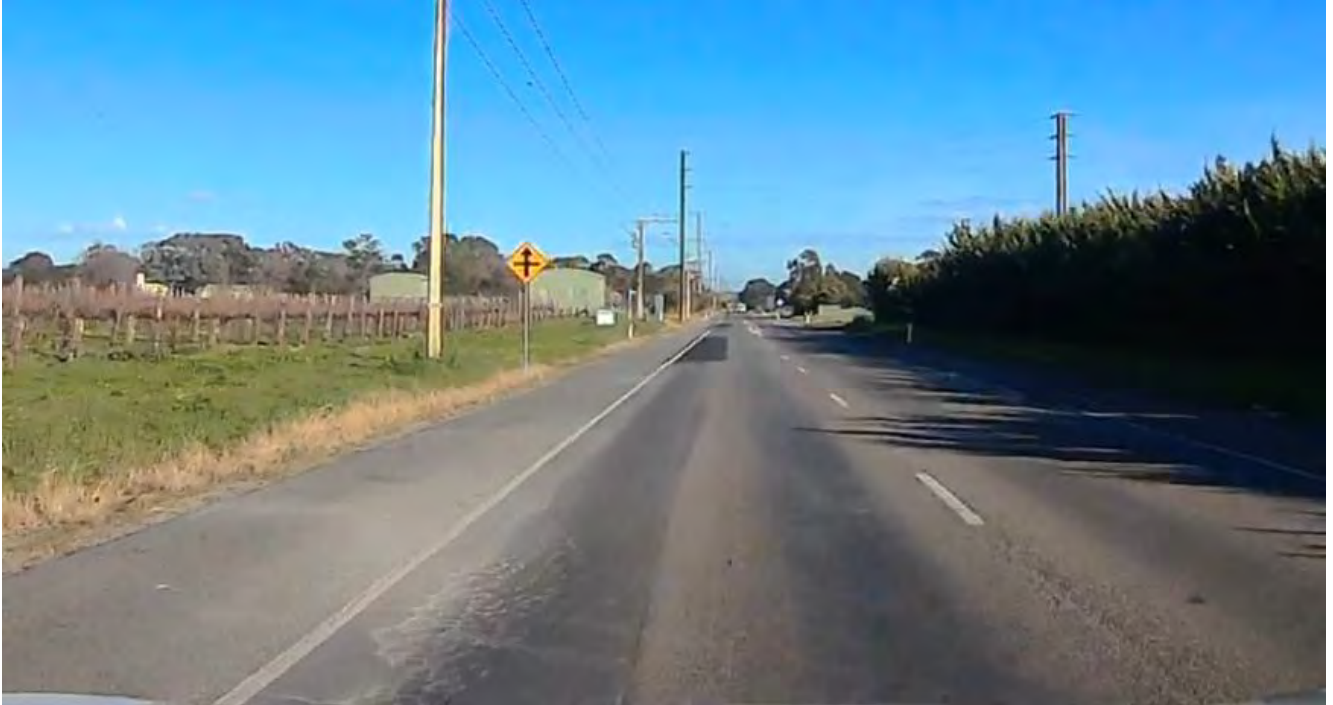
Figure 62: Fatigue cracking just east of the intersection with Almond Grove Road

Undertake additional pavement rehabilitation works, particularly between Almond Grove Road and Willunga.

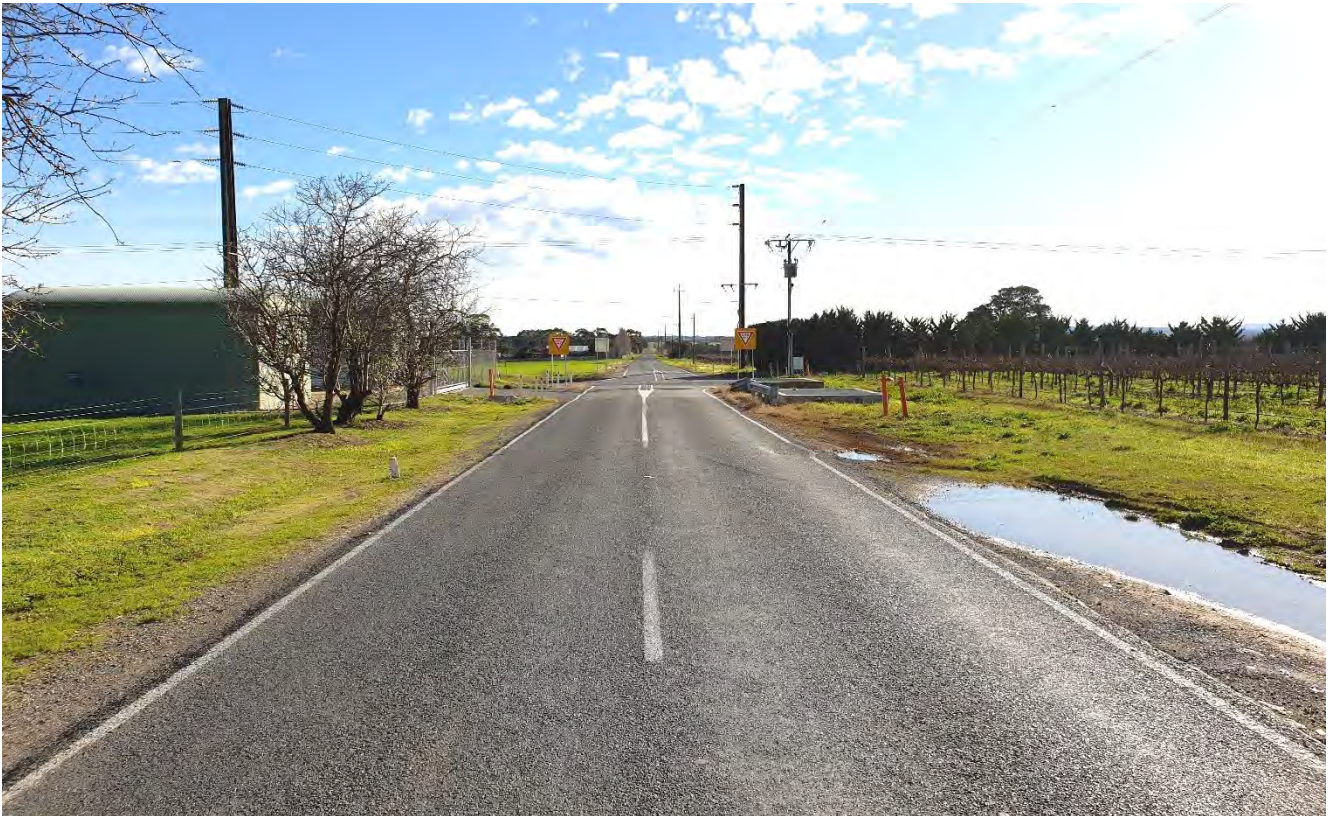
in Figure 63, which was taken only 70m from Aldinga Road. Other than give way signs, there are no other visual cues that an intersection is present.

Figure 63: When approaching the intersection from the minor road approach, it can appear to drivers as though they are on a continuing road.

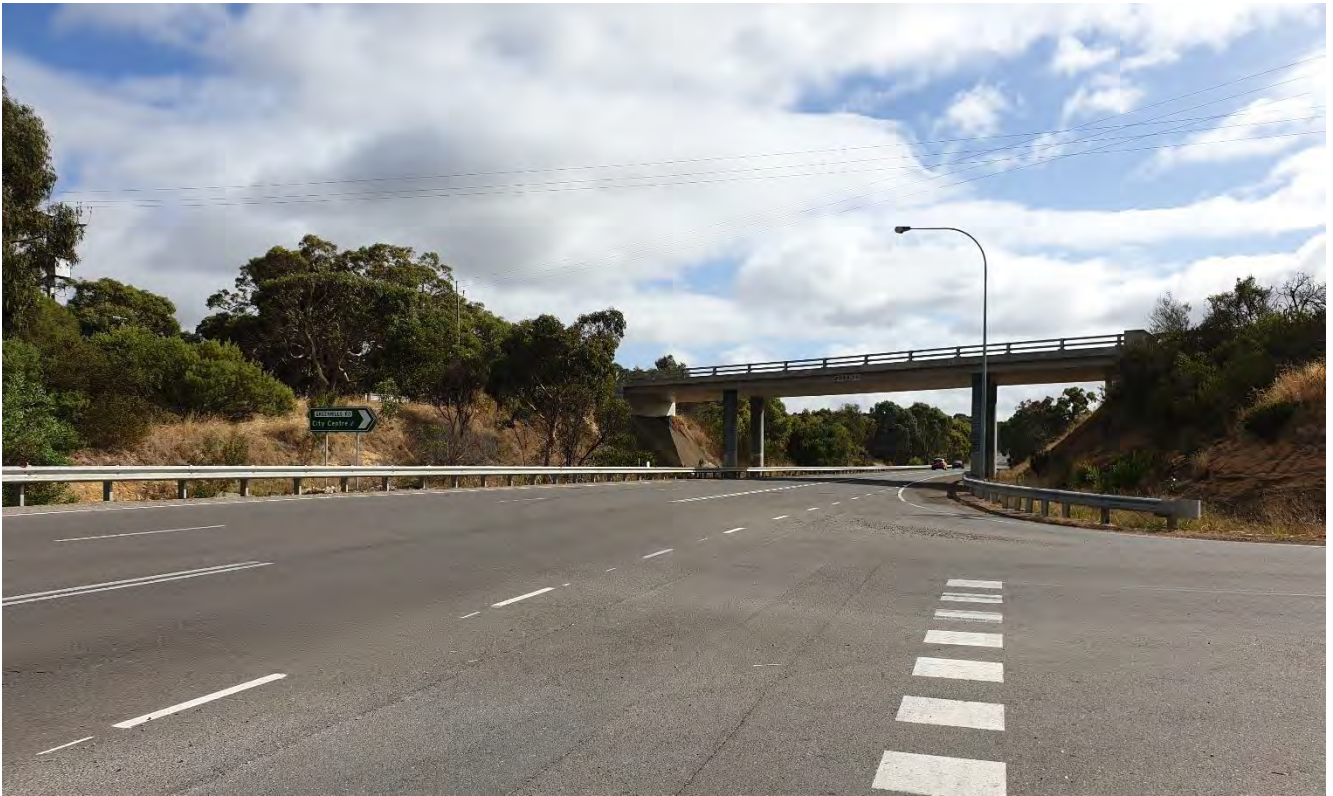
Figure 65: Sight distance to the north is obscured by the Greenhills Road bridge pylon

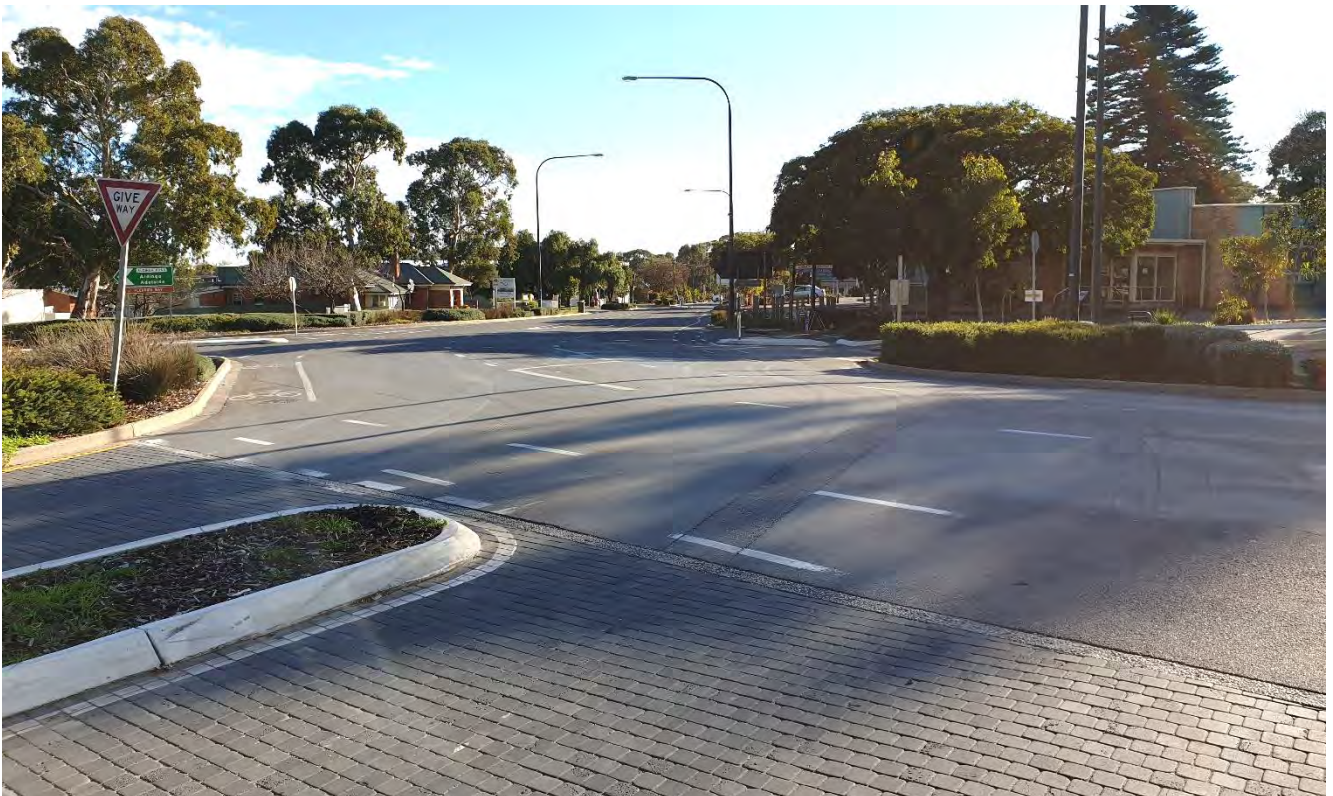
Figure 70: The intersection with Main Road, Aldinga Road and High Street is complex and has a history of cyclist crashes.

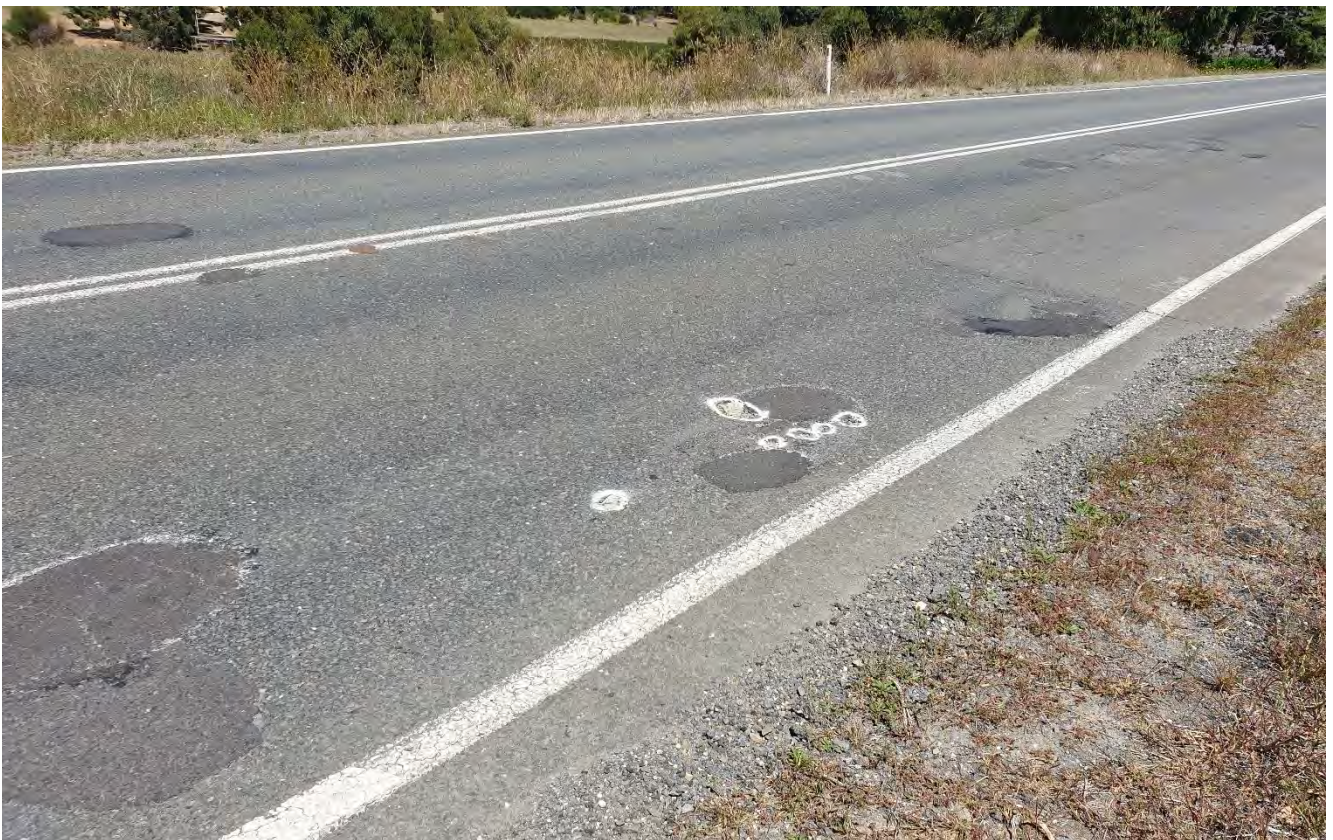
Figure 75: New potholes forming around recently repaired potholes.

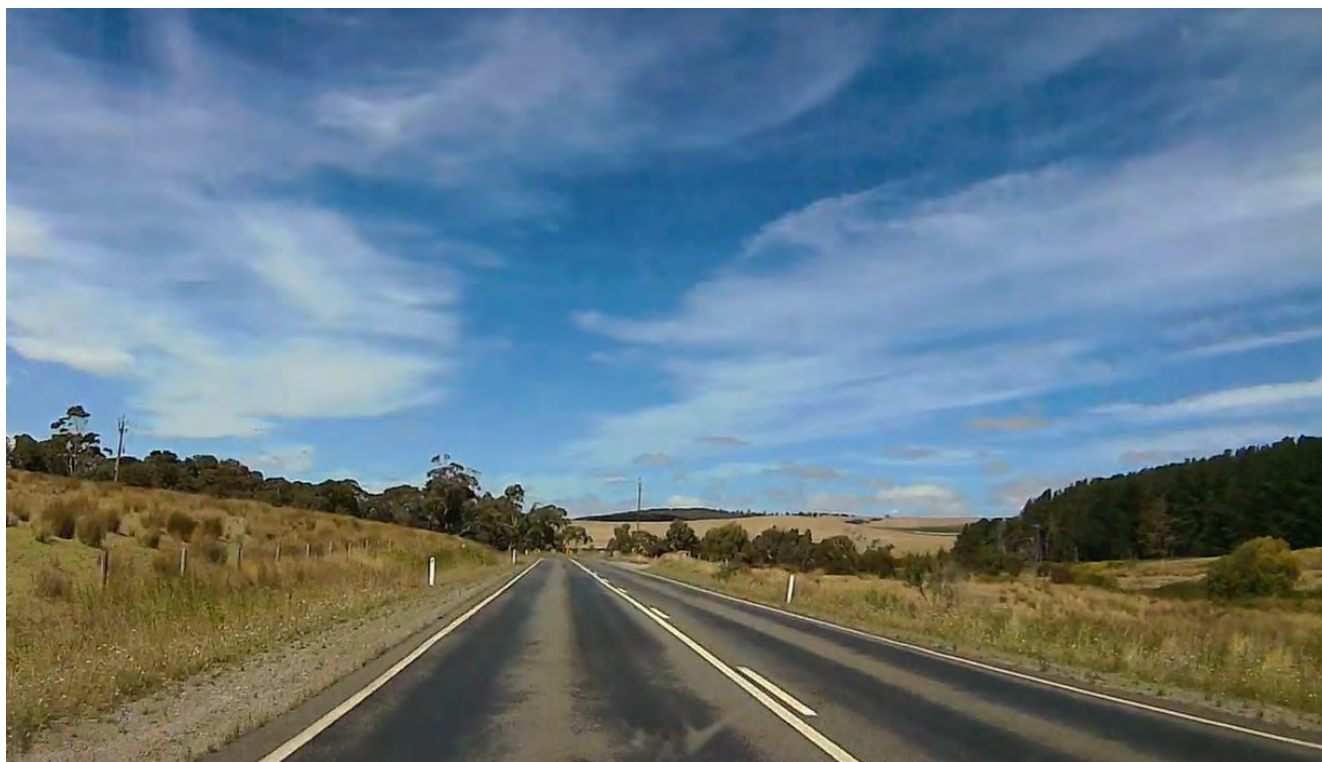
Figure 76: Asphalt binder bleeding is prevalent, particularly on the western end of Nangkita Road

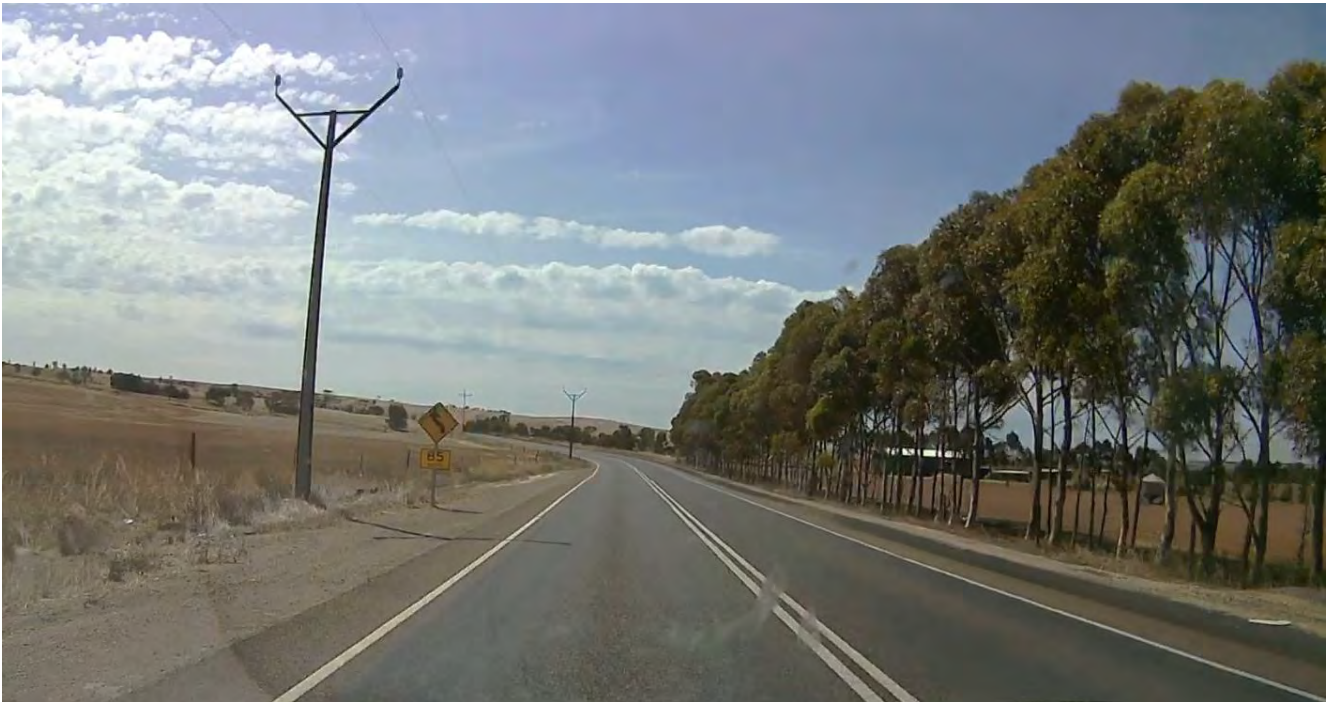
Figure 77: Typical cross-section of Callington Road

Install additional crash barriers on Callington Road.

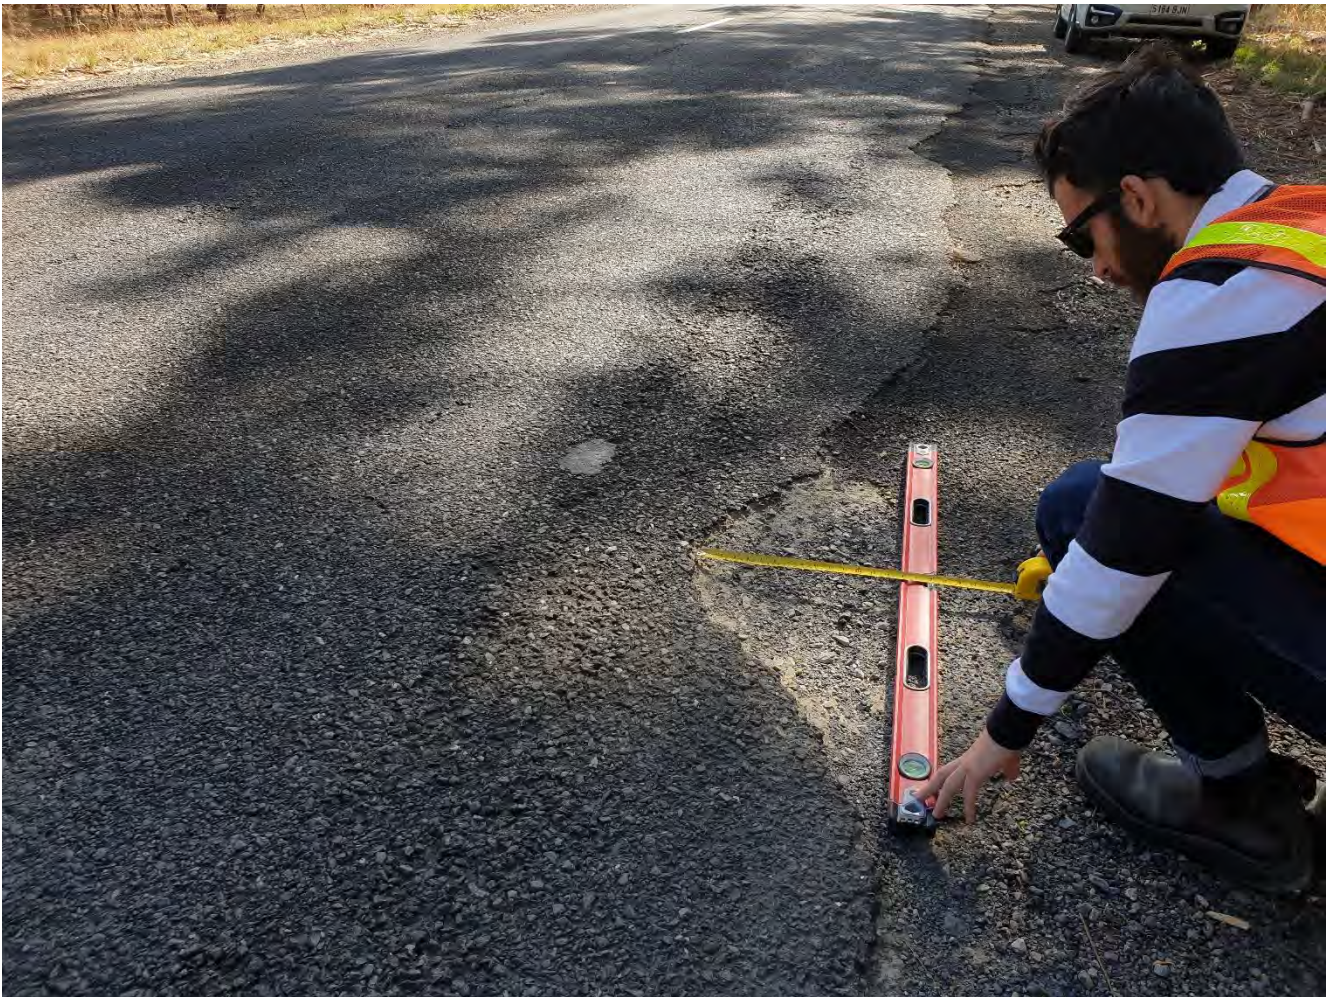
Figure 78: Edge break up on the eastern end of Range Road

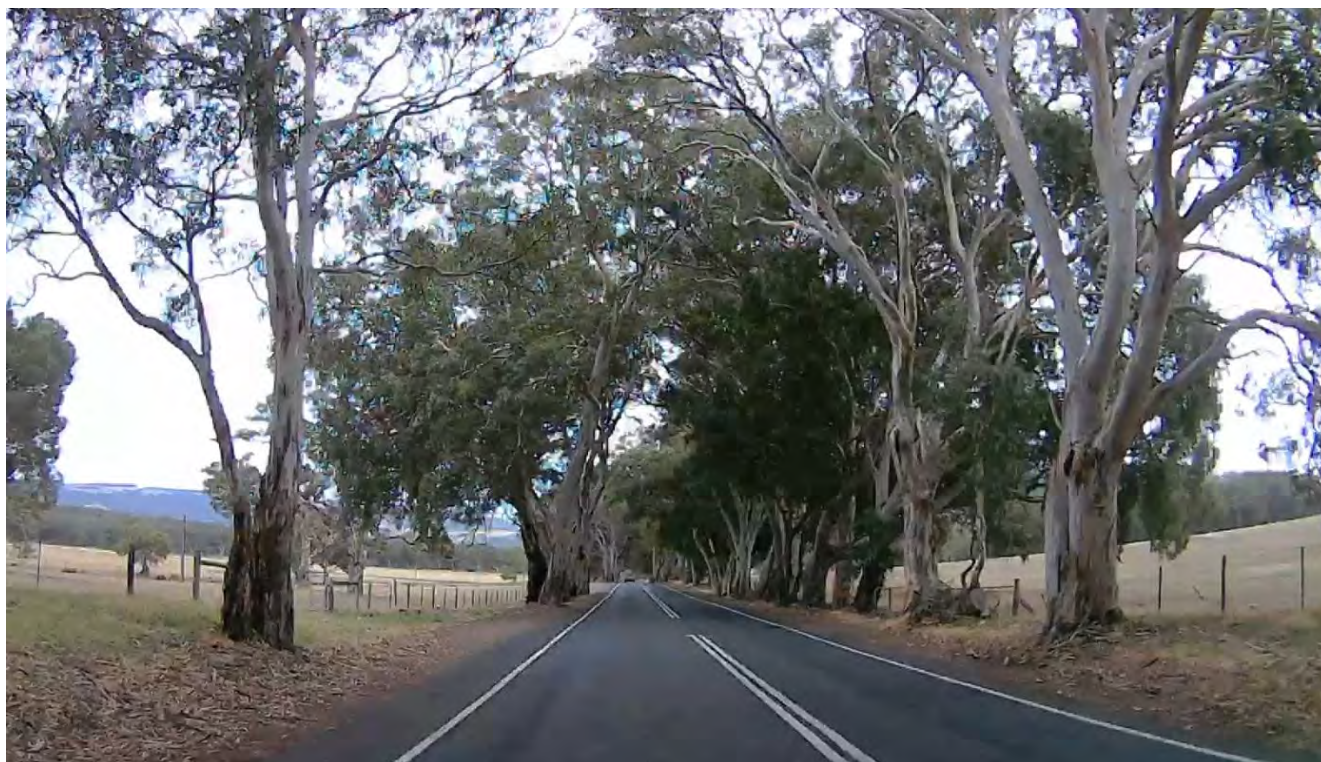
Figure 79: Large gum trees line the edges of Hindmarsh Tiers Road constitute a significant hazard

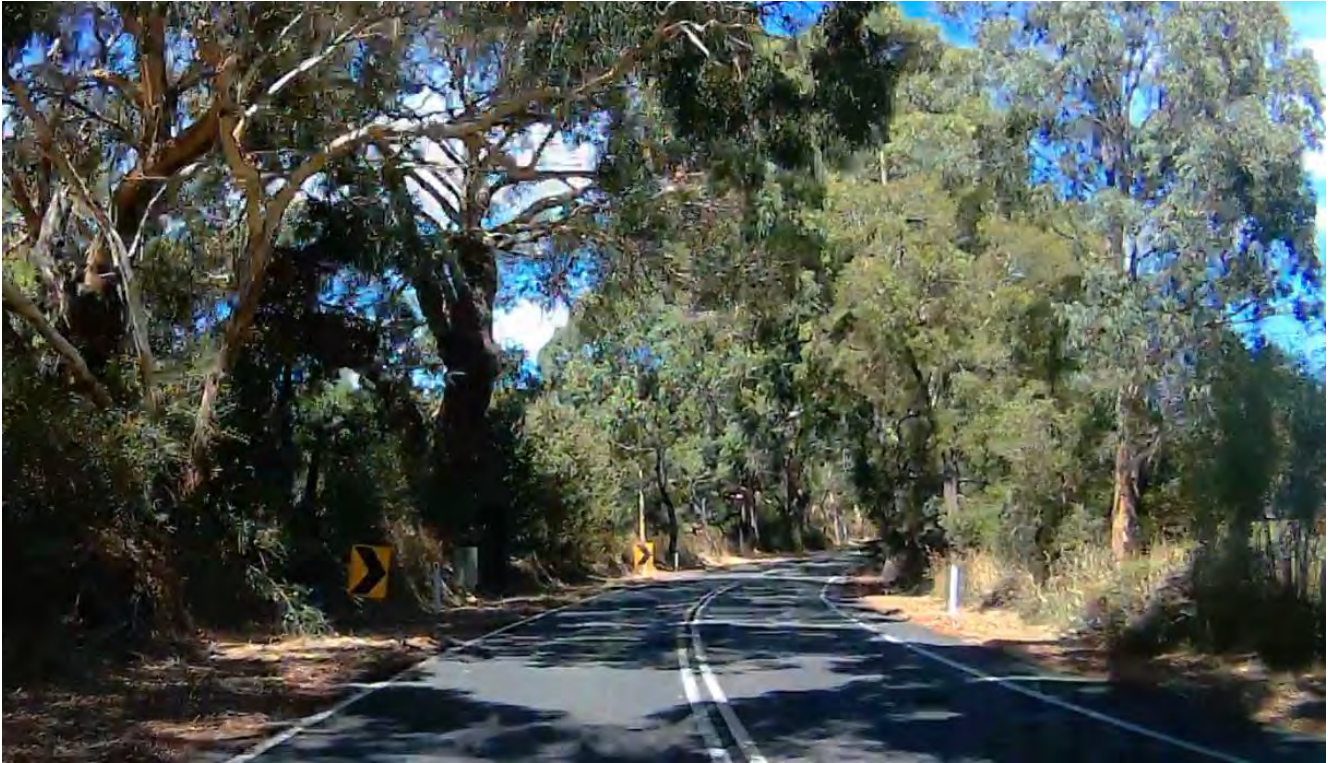
Figure 81: Large exposed trees on the outside of curves present a significant road safety risk on Bull Creek Road

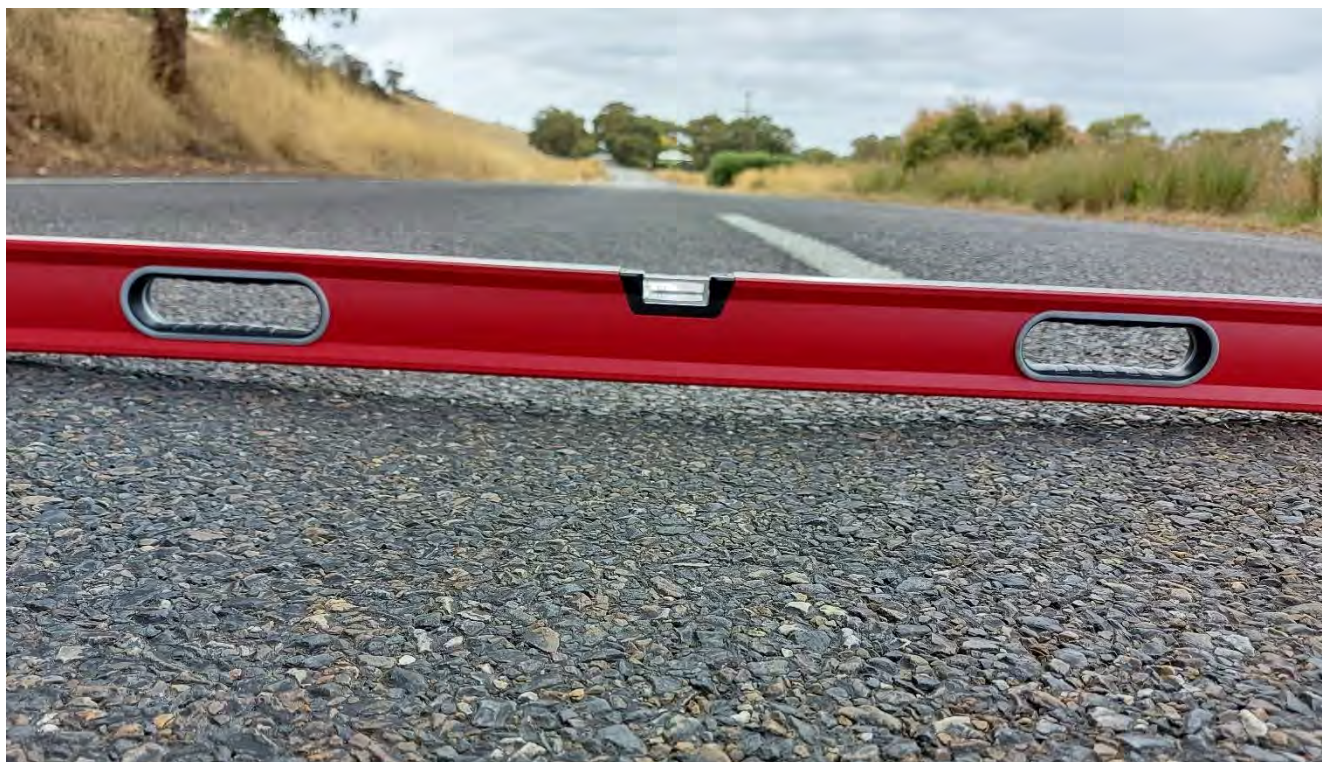
Figure 82: Rut depth on Pages Flat Road
