Regional Road Assessment: Fleurieu Peninsula and McLaren Vale

Report: August 2021

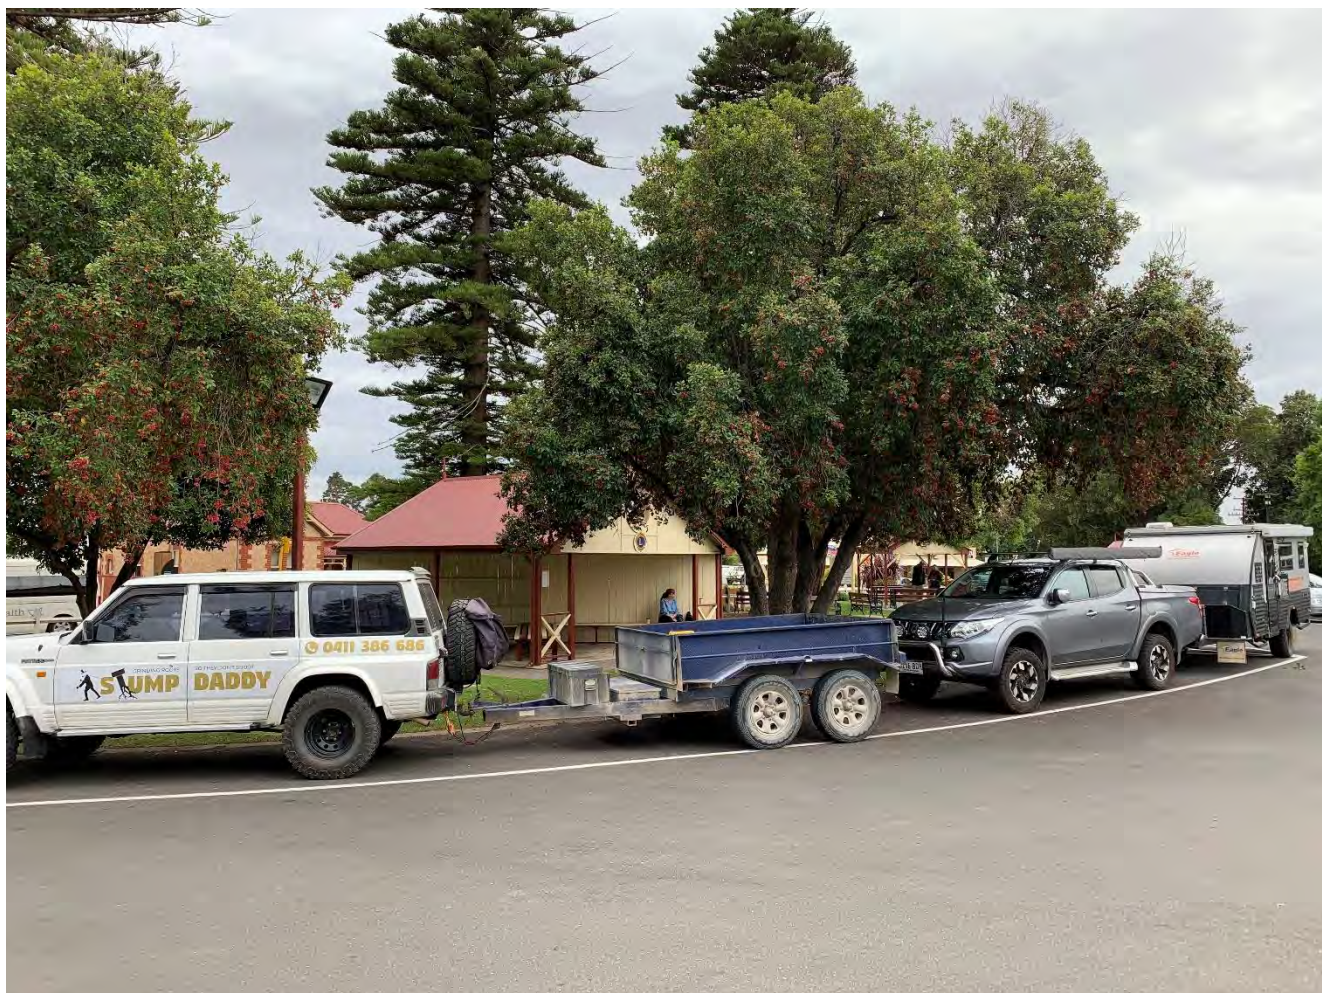
Figure 85: Parking bays at Strathalbyn's Visitor Information Centre are suitable for large vehicles but are neither signposted nor restricted to large vehicles only

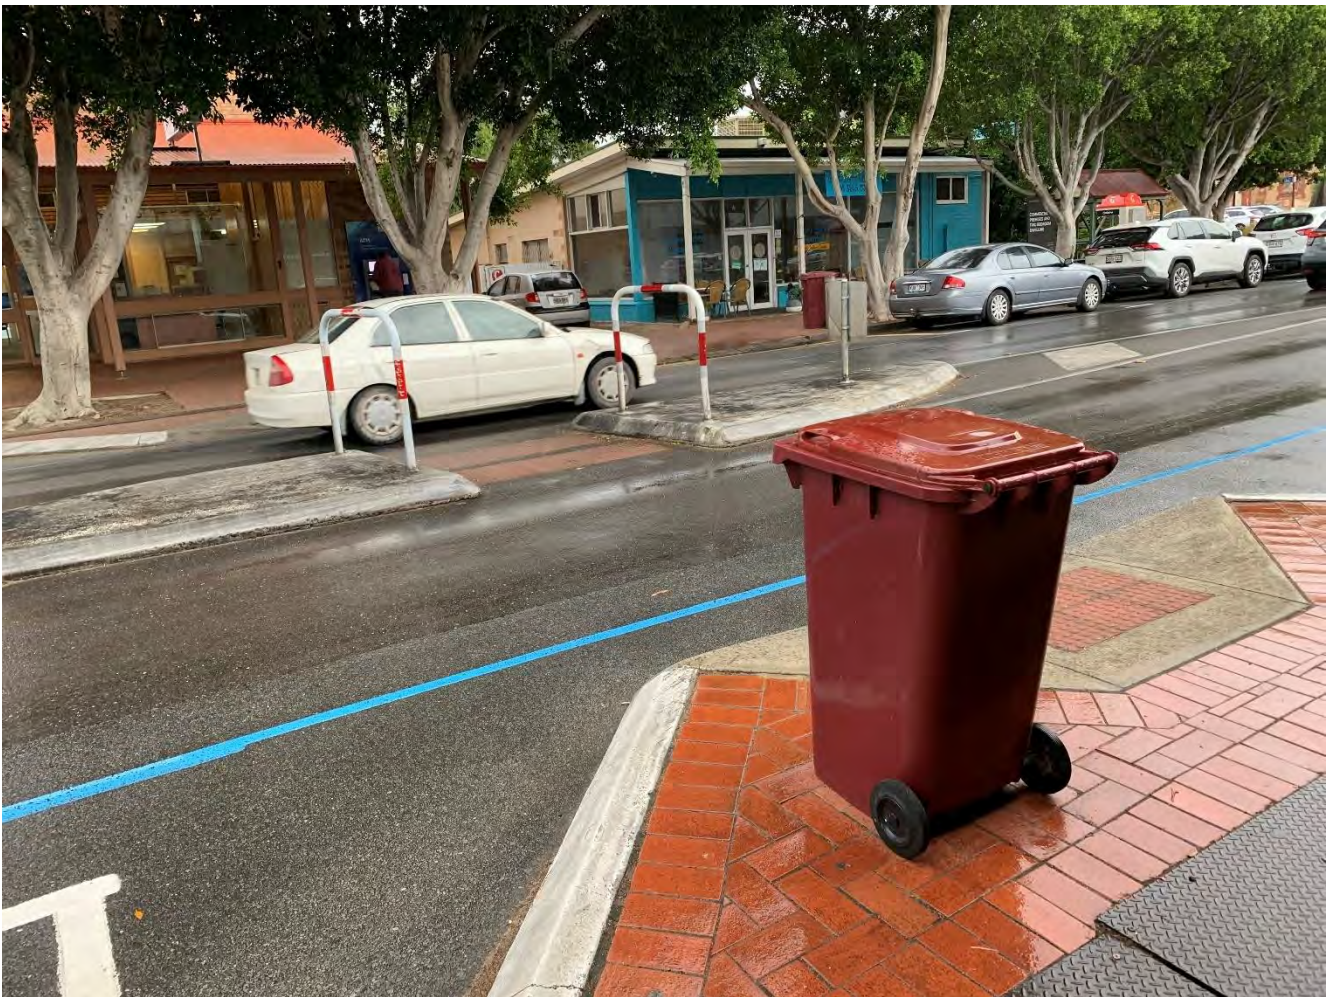
Figure 87: Public bins on Cadell Street cannot be used hands-free and do not offer recycling options

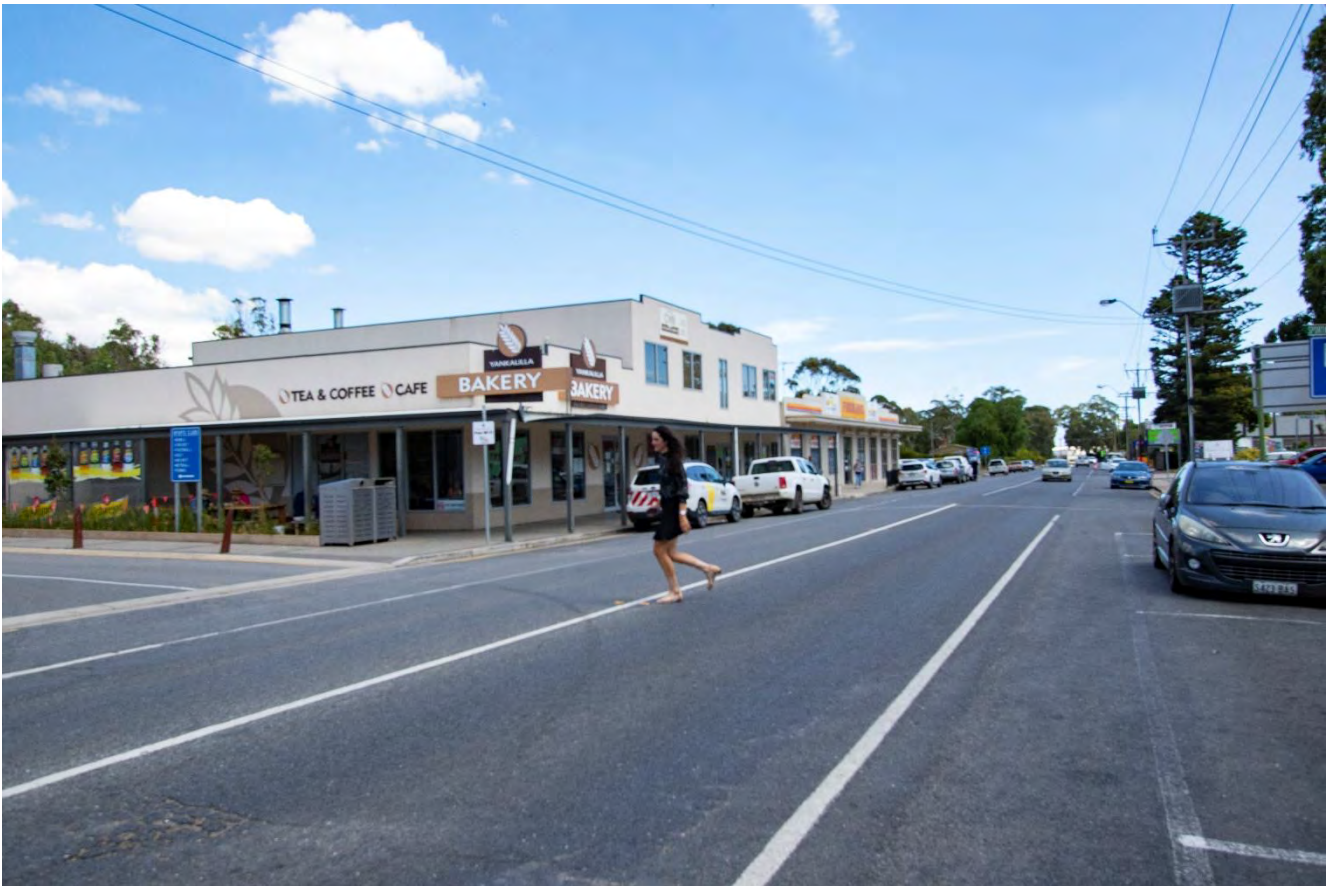
Figure 93: There is no pedestrian crossing infrastructure on Main South Road in Yankalilla
