RAA's key recommendations for **Victor Harbor Road**

RAA's key recommendations for **Victor Harbor Road** (continued)

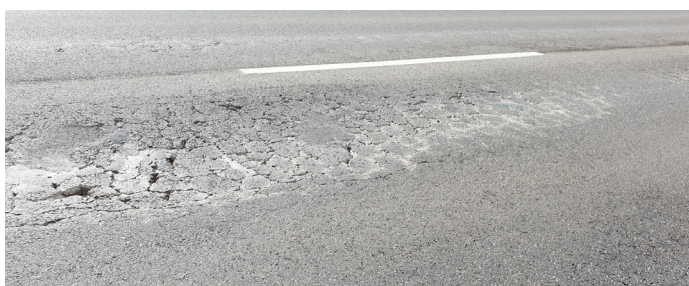
Fatigue cracking and rutting between McLaren Vale and Willunga.

4. Undertake additional pavement rehabilitation works between McLaren Vale and Willunga to improve the section of the road not currently included in the \$3m works already announced.
5. Plan and prepare for the future duplication to Mount Compass.

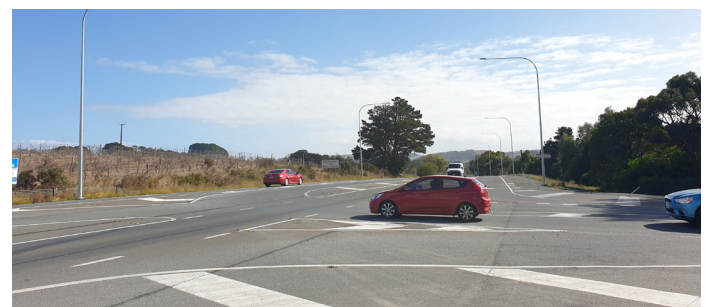
Goolwa Road intersection, looking north.

10. Install a roundabout. (High priority recommendation)

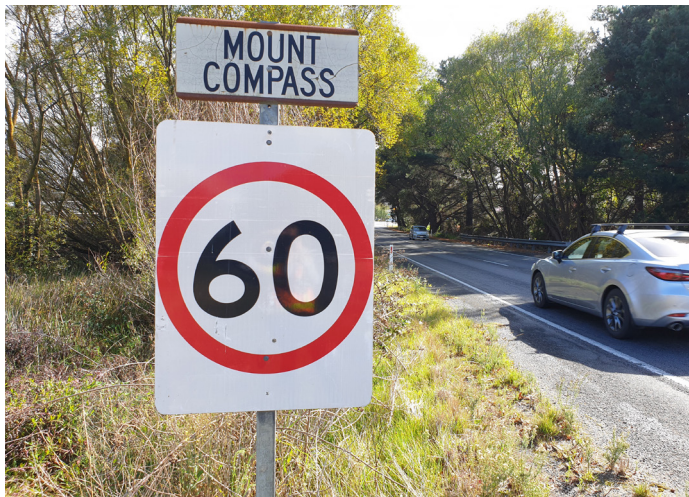
60km/h speed limit in Mount Compass.

- 14a. Extend the northern 80km/h zone in Mount Compass to improve safety at the intersection with Sand Mine Road and at the exit from Roadman's Reserve.
- 14b. Extend the Mount Compass 60km/h speed zone by 100m to the north to improve safety at the intersection with Tay Road.
