Highway Assessment: Victor Harbor Road

Report: May 2021

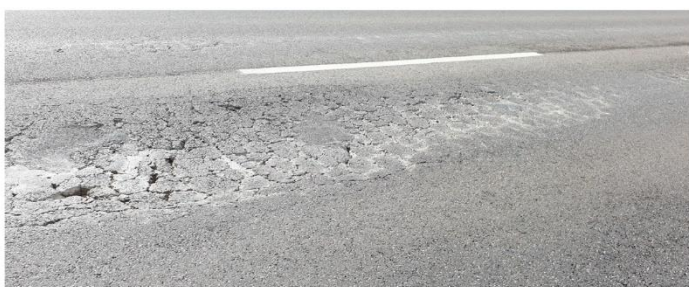
Fatigue cracking and rutting between McLaren Vale and Willunga.

4. Undertake additional pavement rehabilitation works between McLaren Vale and Willunga to improve the section of the road not currently included in the \$3m works already announced.
5. Plan and prepare for the future duplication to Mount Compass.

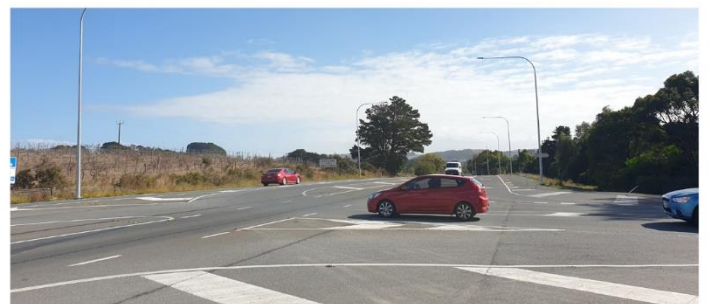
Goolwa Road intersection, looking north.

10. Install a roundabout. (High priority recommendation)

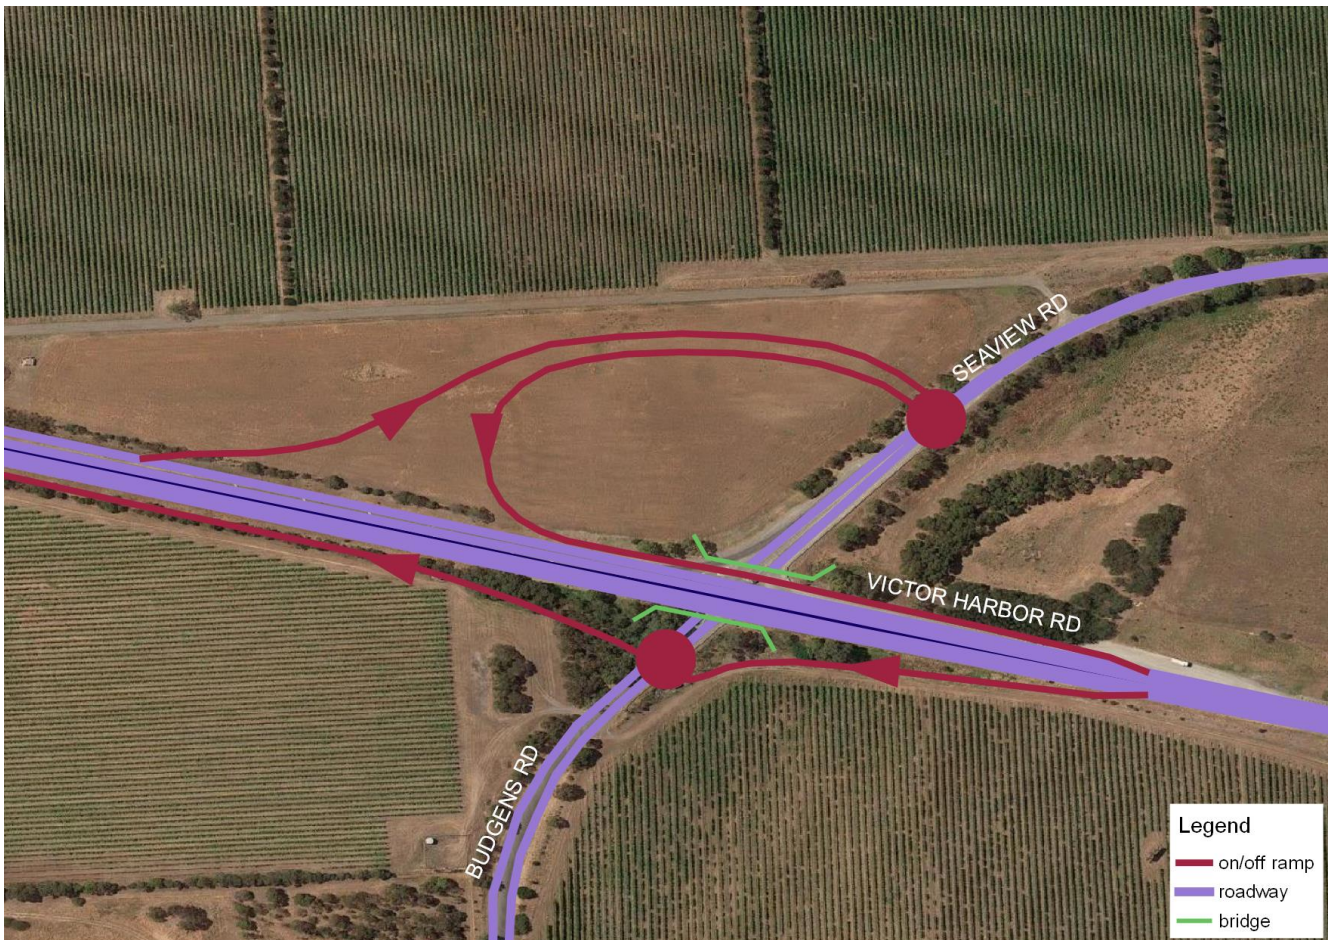
RAA considers it highly unsafe for this to remain as an at-grade four-way intersection and proposes that this intersection be grade separated to eliminate conflict between vehicles turning right from Seaview Road and Victor Harbor road traffic. The landscape appears to be more conducive of Seaview Road/Budgens Road passing under Victor Harbor Road, but detailed site and geotechnical investigations will be required to suitably determine a preferred option.

Figure 6: Potential layout of a grade separated Seaview Road/Victor Harbor Road intersection

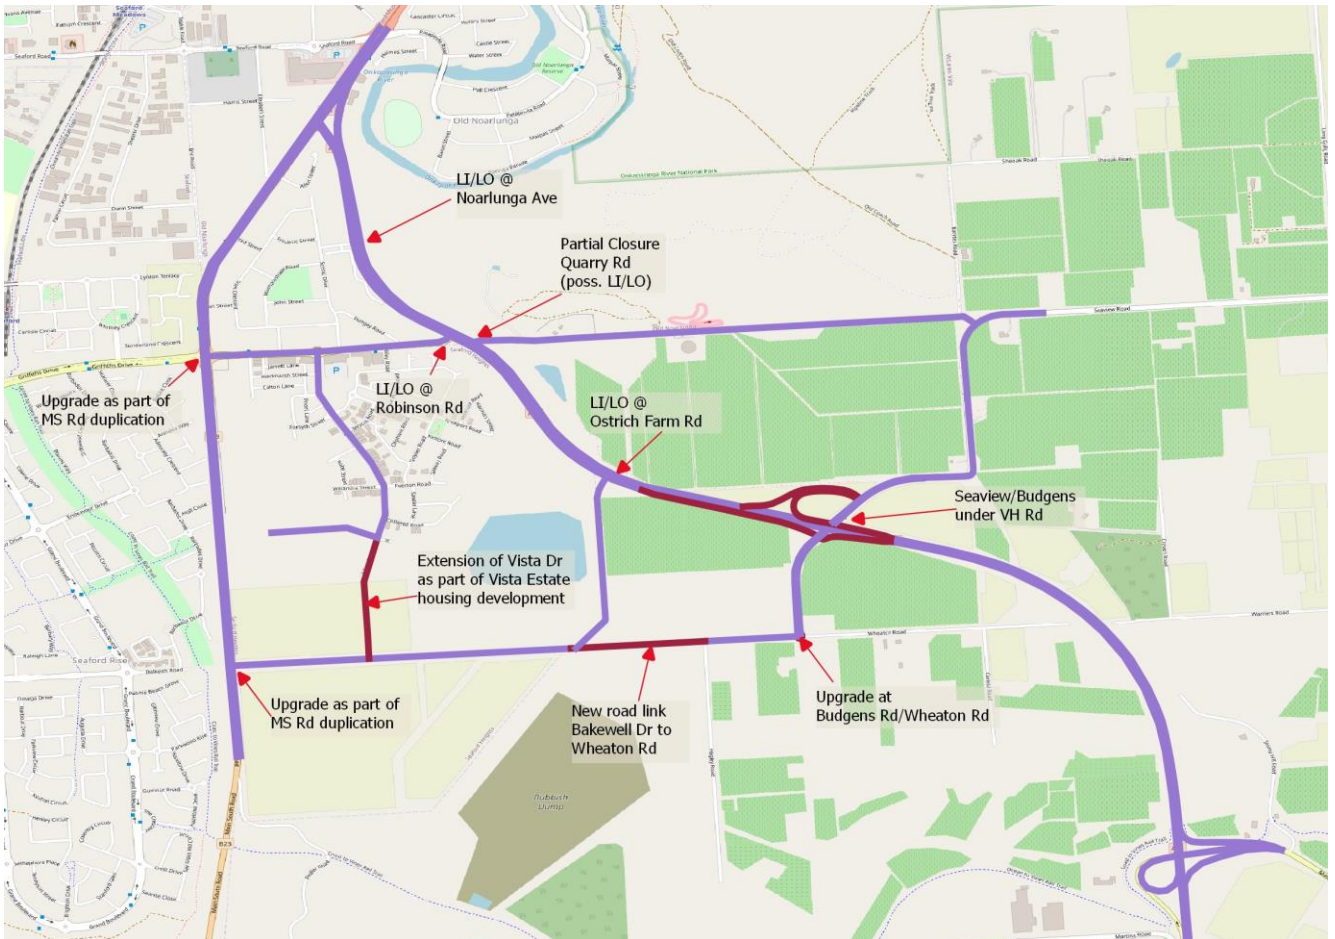
Figure 7: RAA’s traffic management proposal for the Victor Harbor Road duplication project

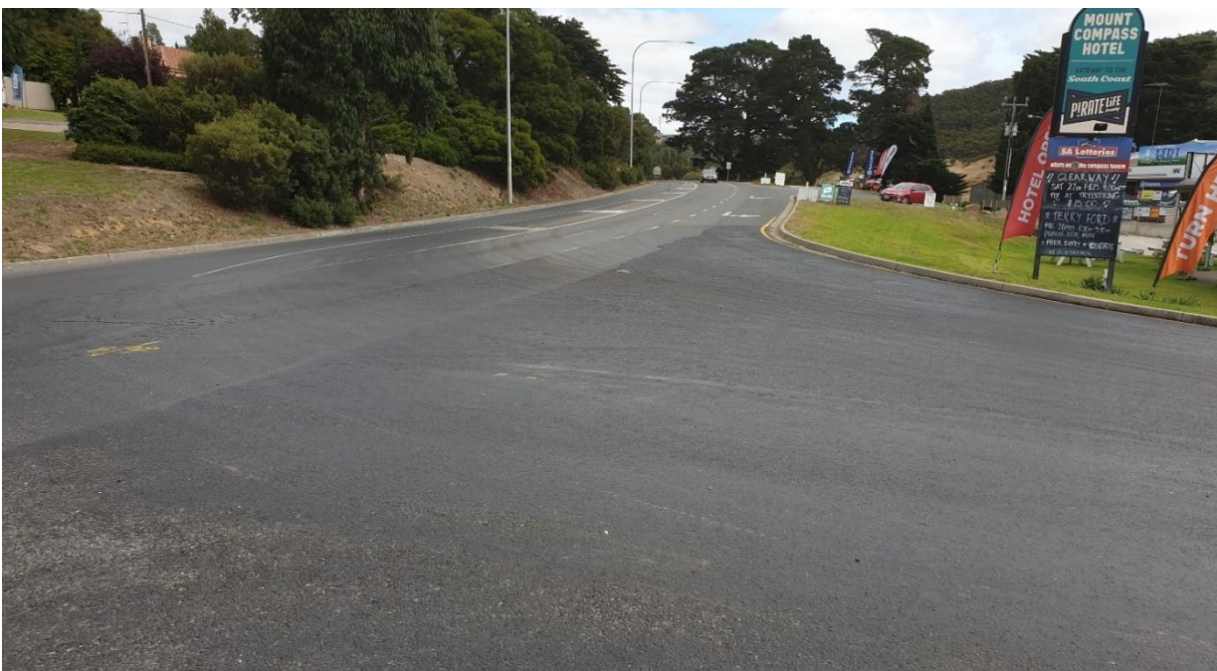
RAA reviewed the intersection with Nangkita Road in Mount Compass. Line marking was faded to the point where it is scarcely visible, and RAA recommends that line marking be refreshed to reduce confusion, improve delineation and emphasise safe holding points at the intersection.

Figure 9: Faded line marking at the Intersection with Nangkita Road in Mount Compass

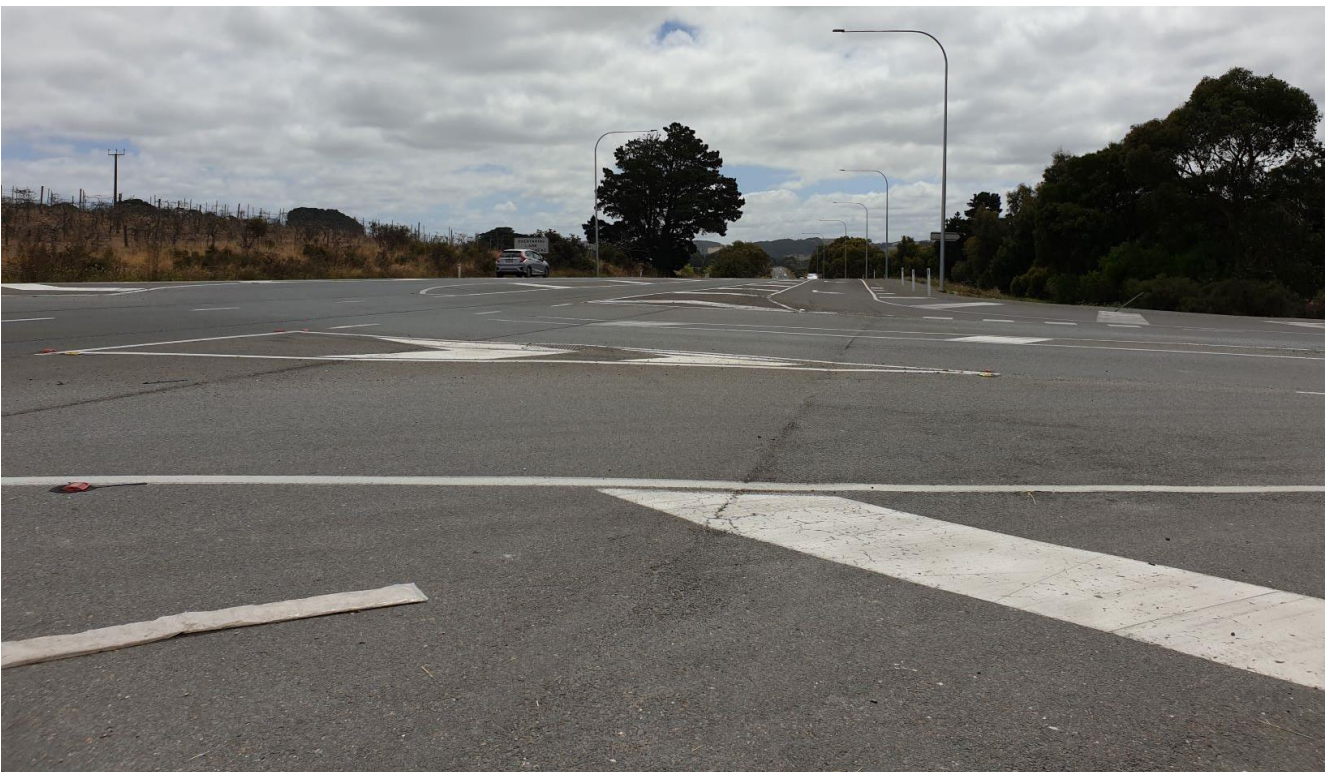
Figure 11: Goolwa Road intersection looking north, after the 2020 upgrade (Image: RAA, 2021)

Whilst this upgrade is welcome, it did not address sight distance issues posed by the crest directly north of the intersection or deficiencies with a seagull intersection in a high-speed rural setting. As seen in Figure 11, which was taken from a typical driver's eye height 1.2m above the road surface, the crest obscures the presence of southbound vehicles travelling through the intersection. Whilst minimum sight distance requirements are still met in the revised layout, rural seagull intersections tend to have a higher than expected crash rate involving vehicles turning right from the side road into the path of through vehicles on the nearside.

RAA recommends a large roundabout be installed at this intersection, which would further improve safety by reducing travel speeds in the immediate vicinity of the intersection whilst improving impact angles. A speed limit of 80km/h between Mount Compass and the intersection would need to be applied to ensure travel speeds around the roundabout were appropriate, sight distance to the roundabout is adequate and to allow for a smaller roundabout footprint. Similar examples of roundabouts in a rural setting include the Victor Harbor Road/Waterport Road roundabout in Victor Harbor, the Copper Coast Highway/Yorke Highway roundabout on the Yorke Peninsula or the Onkaparinga Valley Road/Woodside Road roundabout in the Adelaide Hills, which have all significantly improved safety at their respective locations.

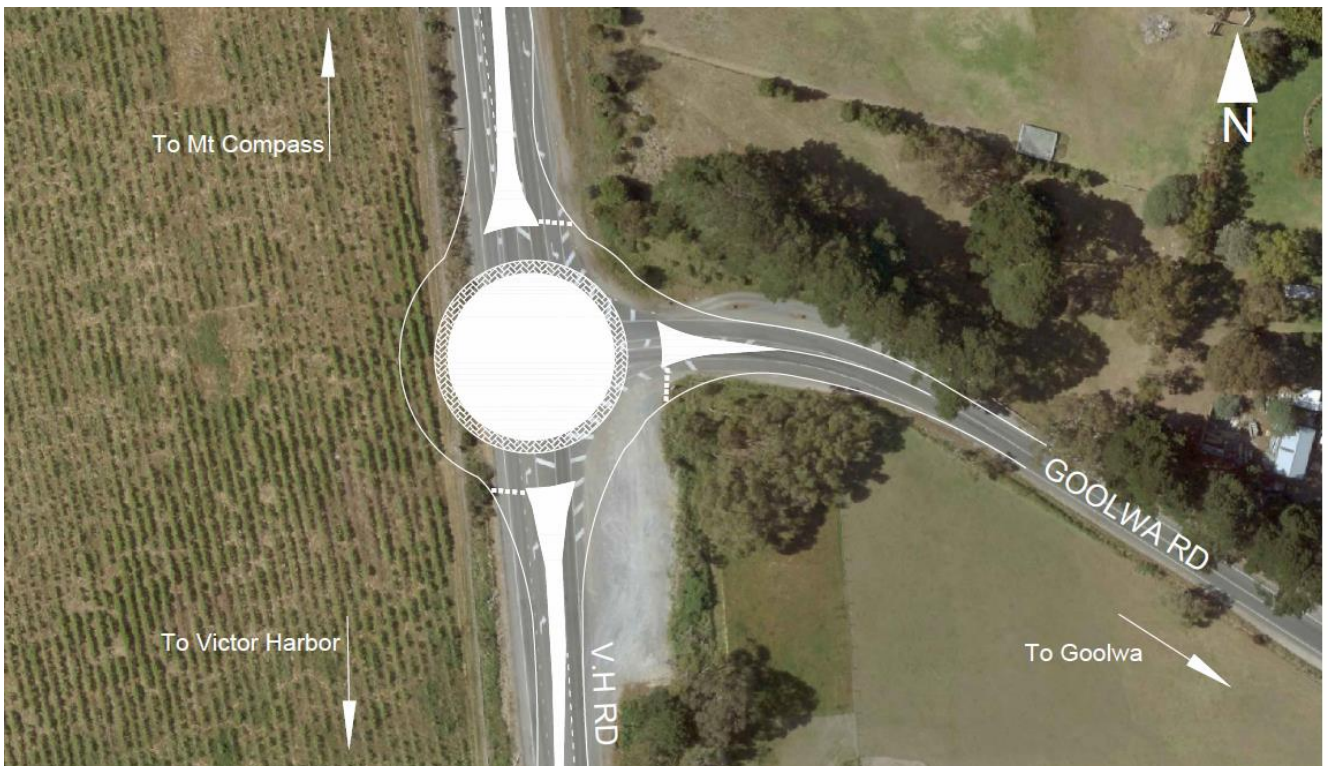
Figure 12: RAA concept sketch of a roundabout at the Victor Harbor Road/Goolwa Road intersection (22m central island radius used)

Realignment of Goolwa Road and Saleyard Road to create a four-way roundabout should be explored as part of this process, to provide safer access and egress to Saleyard Road and the Mount Compass Saleyards.

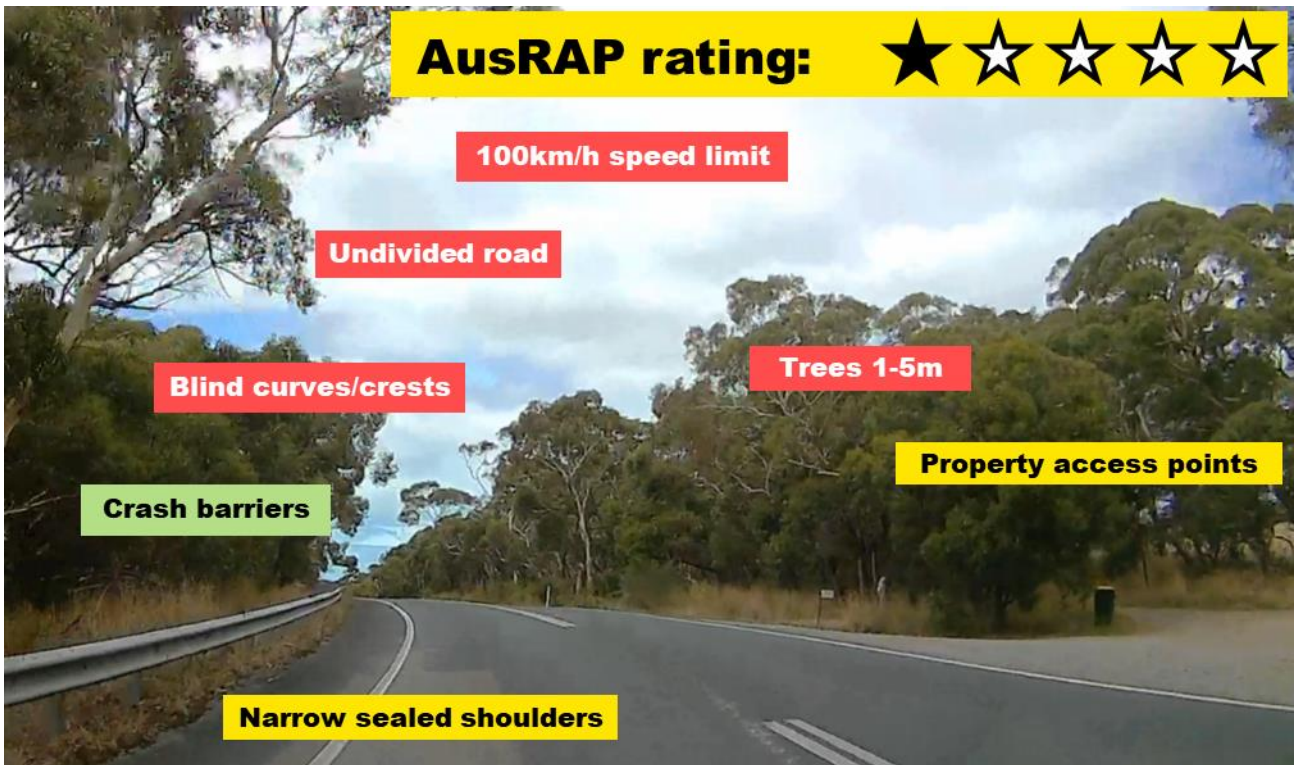
Figure 13: Example of a one star AusRAP star rating on Victor Harbor Road in Mount Jagged

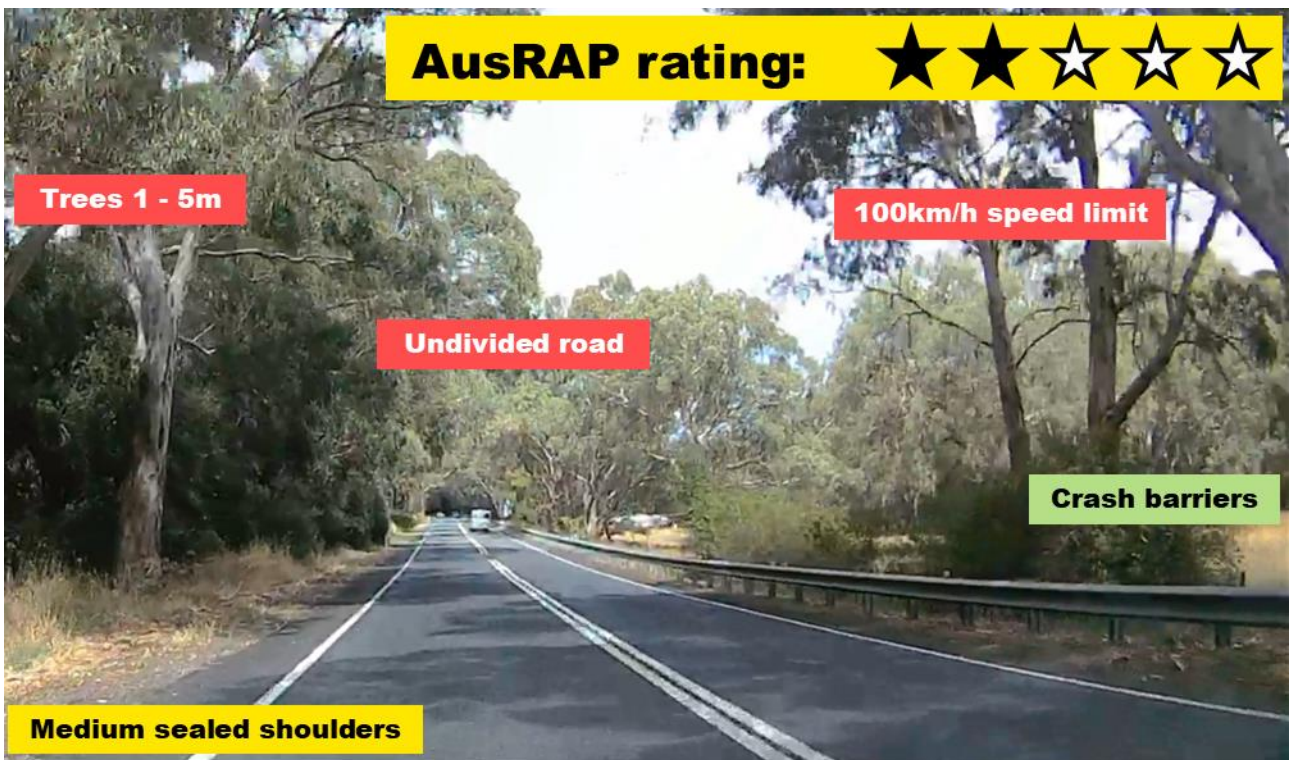
Figure 14: Example of a two star AusRAP star rating on Victor Harbor Road in Hindmarsh Valley
