# Corn Street, Old Reynella

## Road Safety Audit

April 2016

**RAA**

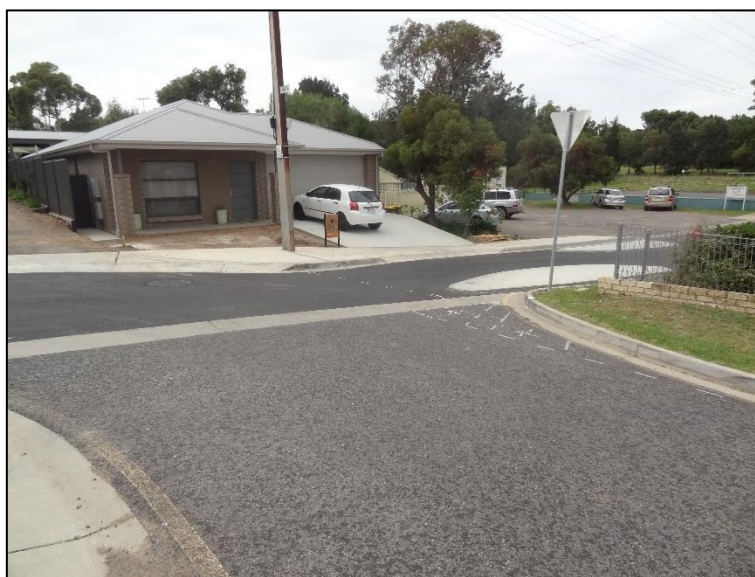
- a) Chicanes constructed at the intersections of Olive Street and Mill Street are likely to cause both a road safety and traffic management issue. Vehicles on Olive and Mill Street have the priority turning onto Corn Street but since Corn Street is restricted to one lane of traffic through the chicane, there is the potential for a vehicle turning into the path of an oncoming vehicle approaching the Give Way hold point on Corn Street. For vehicles already at the Give Way hold point, the vehicle on either Olive or Mill Street cannot enter Corn Street and must give way to the traffic on Corn Street. RAA are unclear as to why the priorities were changed as it isn't intuitive with normal driving practice. RAA understand that the priorities were changed to accommodate the turn paths of heavy vehicles however under the new arrangement, particularly on Olive Street, there is a greater crash risk if the motorist approaching on the side streets understands the changes in place while a motorist continuing on Corn Street does not. During both audits, the team witnessed vehicles failing understand the scheme despite the signage in place. We therefore recommend that the priorities are changed so that traffic on Olive or Mill Street must to give way to vehicles in either direction.

Figure 2 – Chicane at the intersections of Mill Street (pictured) and Olive Street could cause safety and traffic issues for vehicles turning into the chicane while vehicles approach from the opposite direction.

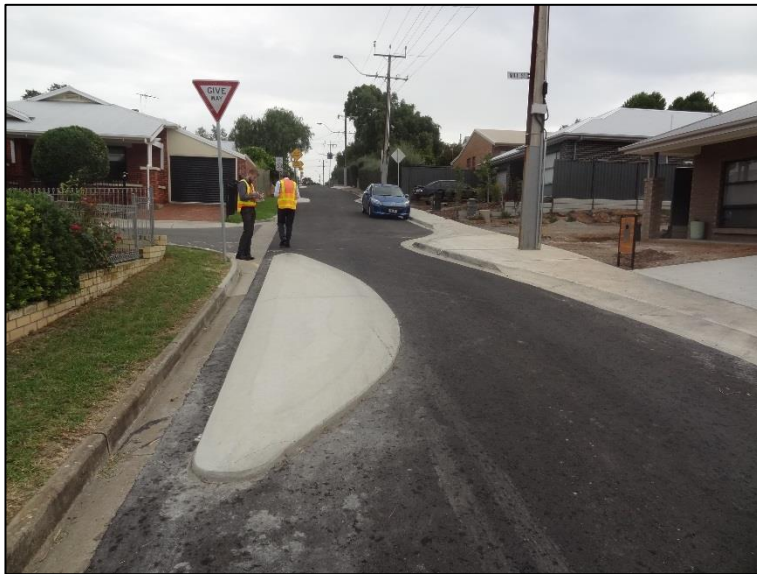
**Figure 3 – Approaching the Mill Street / Corn Street intersection on Corn Street.**

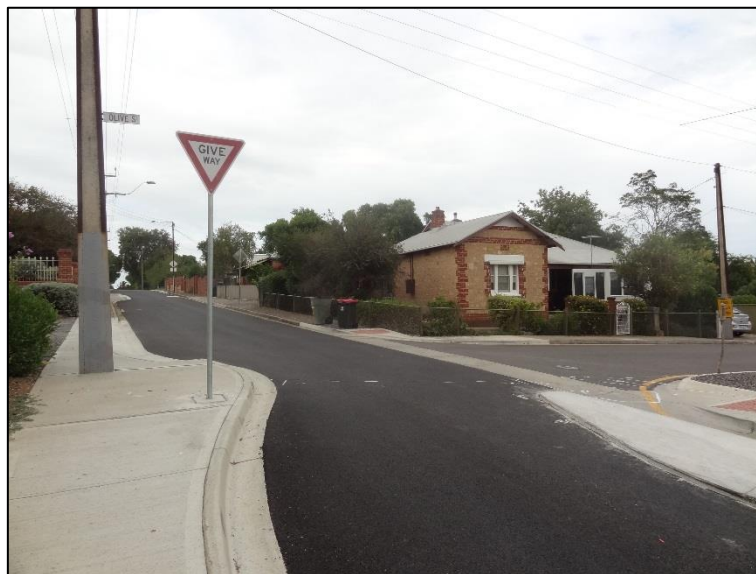
**Figure 4 – Approaching the Olive Street / Corn Street intersection on Corn Street.**

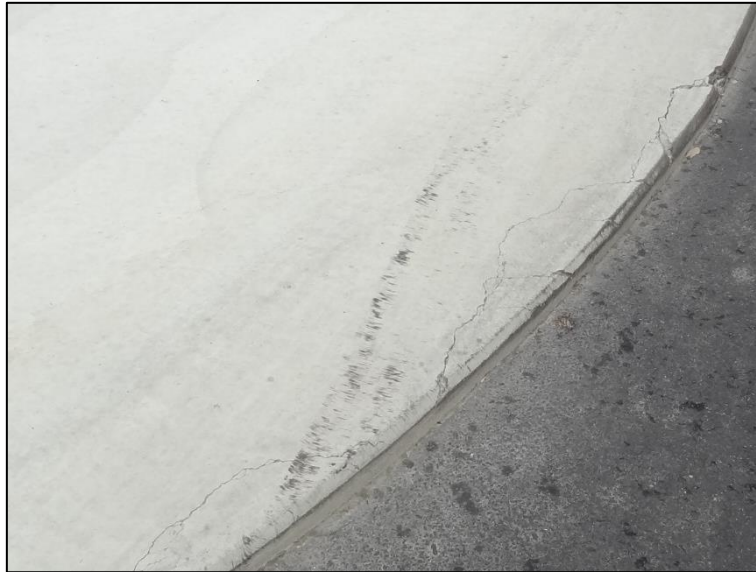
- b) Concrete islands are beginning to break at the edges. The narrow geometry of the chicane is evident by the damage already visible on the concrete islands. Although the islands have been designed to be mountable by larger vehicles, the edge damage suggests that many vehicles are clipping the islands. This may pose a safety issue in the near future. As the concrete breaks out, the exposed surface is rough and if vehicles continue to brush against the exposed surface, tyre damage may occur. It is recommended that the islands are monitored for damage and remedial performed where necessary.

**Figure 5 – Concrete islands are already starting to crack and break away at the edges.**

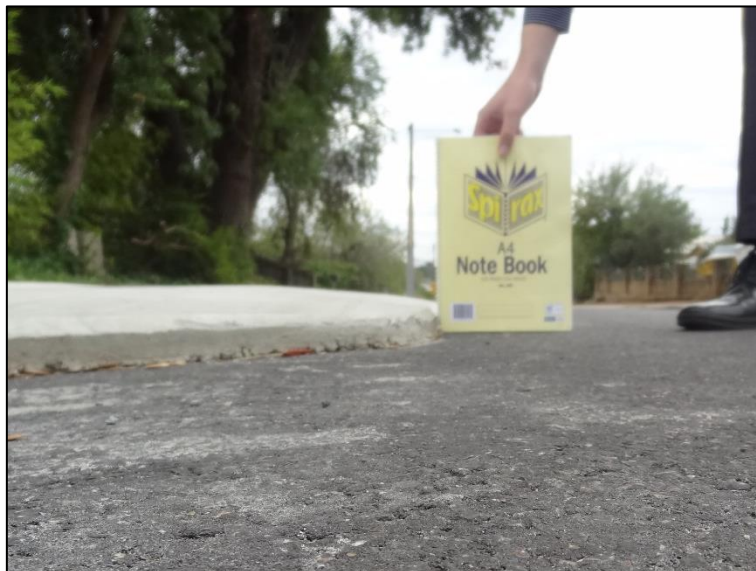
- c) The height of the concrete islands throughout the scheme is inconsistent. Some of the islands are of sufficient height and edge gradient that would enable a light vehicle to mount the island, while others are higher and have steeper edge gradients. The key concern is that when driving, it can be difficult for the driver to judge the height. If the driver was to mount a lower island, there may be a misconception that all islands are easily mountable, resulting in a risk of loss of control of the vehicle when attempting to mount a higher island as steering may be deflected.

**Figure 6 – Example of a shallower island, almost half the height of that shown in Figure 7.**

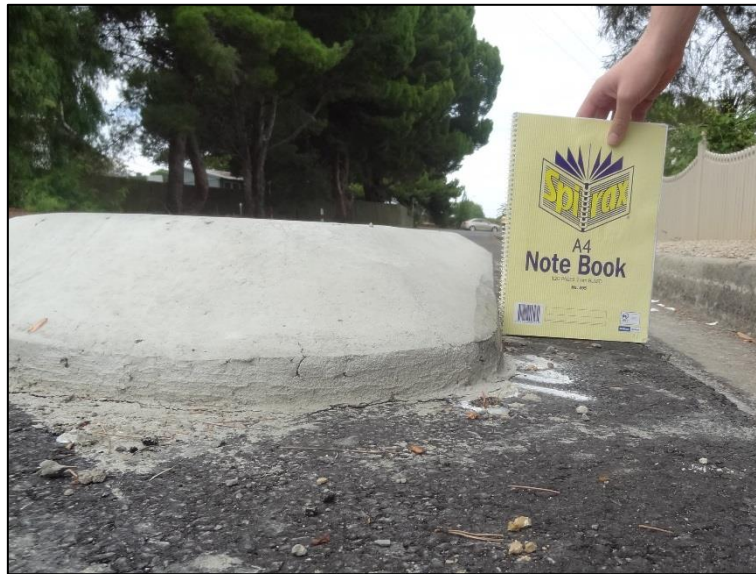
Figure 7 – Example of a steeper island, almost double the height of that shown in Figure 6.

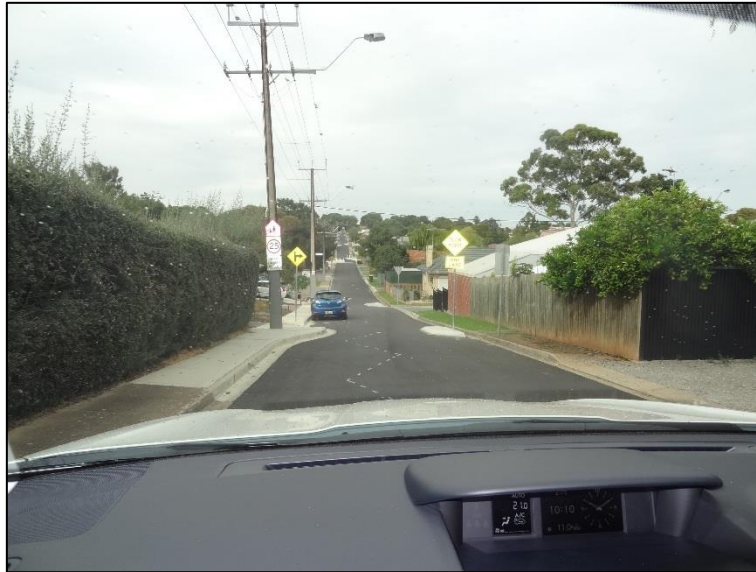
- a) Change of priorities at Olive Street and Mill Street. The change of priorities at either intersection is concerning since it is counterintuitive to what a motorists would expect to find at a T-intersection, despite the fact that it has been signed. The auditors spoke to two separate residents during the audit, both of whom were completely unaware of either the Give Way sign or warning sign showing the road continuing to the left / right. This reflects local familiarisation with the historic road network and suggests that any signage should be more prominent through either increasing sign sizes and / or duplication. It is however recommended that the previous priorities are reinstated since motorists would expect this arrangement. This would also solve the risks associated with vehicles turning into chicane at the intersection (refer to item 3.1(a)).

Figure 8 – The change of priorities are counter intuitive to the road user. The number of “Slow Point” warning signs may result in the “Road continues left/right” warning signs being disregarded. Priority signage (Give Way & warning signs) should perhaps be more prominent.

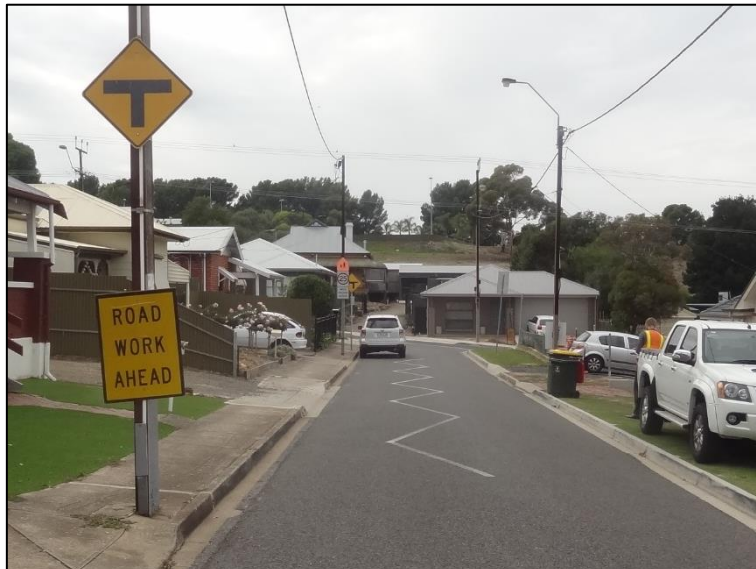
- b) Conflicting warning signs, Mill Street – When approaching the Corn Street intersection on Mill Street, there is a T intersection warning sign followed by a route continues to the left warning sign. These signs contradict each other and could cause confusion. If the proposed arrangement is to remain, the T intersection warning sign should be removed.

Figure 9 – T intersection warning sign conflicts with the road continues to the left warning sign in the background.

b	Conflicting warning signs, Mill Street	<ul style="list-style-type: none"> <li>If priorities are to remain unchanged, remove T intersection warning sign.</li> </ul>	3
<b>3.3 – Line Marking &amp; Delineation</b>			
a	Absence of centre line around curve on Mill and Olive Street.	<ul style="list-style-type: none"> <li>Mark centre line around corner.</li> </ul>	2

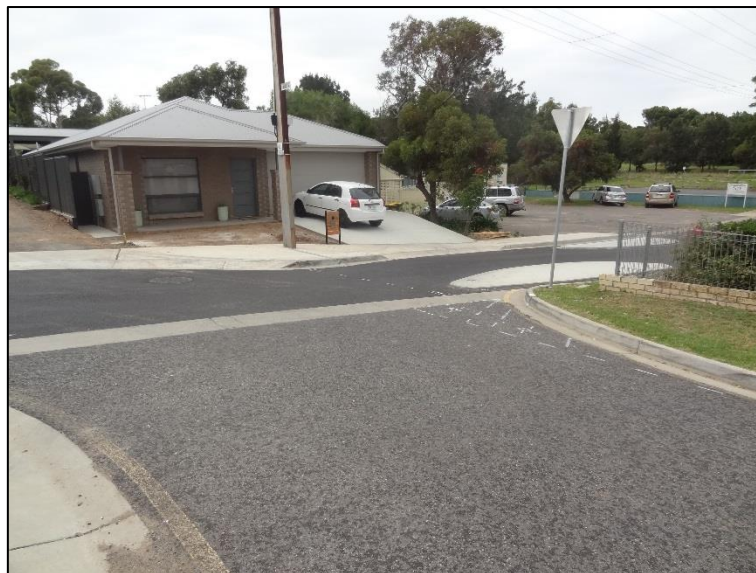
- a) Absence of centre line around curve on Mill and Olive Street. The absence of centreline marking around the proposed curve from Olive and Mill Street onto Corn Street results in ambiguity of the intended priority. A centre line would reinforce to the motorist that the road continues to the left or right and the intersection should not be treated as a T intersection. As previously outlined in the audit, it is recommended that the former priorities are reinstated however if the arrangement is to be maintained, it is recommended that a centreline be applied.

**Figure 10 – Absence of centreline marking at Mill Street does not clearly indicate that the road continues to the left. Note – photo was taken during the first audit in March however centreline was absent during second audit in June.**
