Little Sahara Dunes Complex Access

Road Safety Audit

March 2017

RAA

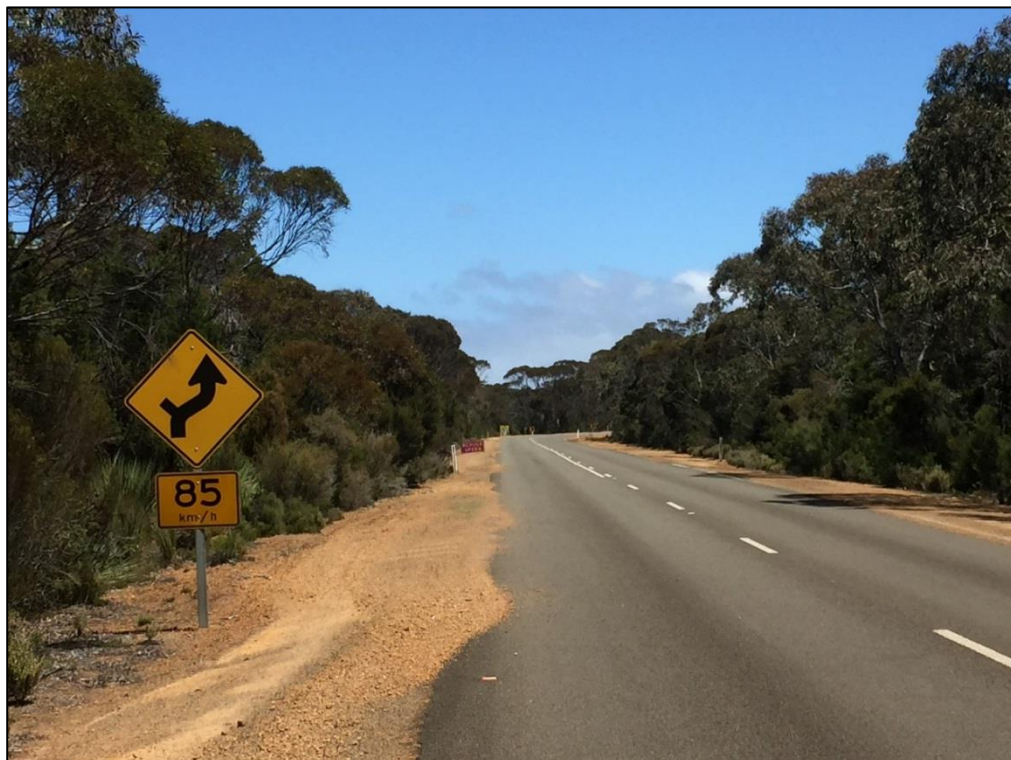
- a) The speed advisory and side road intersection on outside of curve sign is some 300m back from the curve, as a result, there is a risk that motorists may not adopt the recommended speed for the curve. It is therefore recommended that the sign is relocated closer to the curve, in accordance with the requirements outlined in AS 1742.2.
- b) No advanced warning for the Little Sahara tourist attraction has been provided, so there is potential for motorists to brake hard and without warning prior to the bend. This increases the risk of rear end crashes and any vehicle that turns into the complex at too high a speed may lose control on the unsealed access. It is recommended that the access is sealed and advanced tourist information signs are installed.

Figure 2 – Speed advisory sign back too far from the corner and should be relocated. No advance warning of major tourist attraction so vehicles have adequate time to slow down and passing traffic aware of the driveway and possible traffic movements.

Item No.	Risk / Hazard Description	Recommendation	Priority
3.1 – Signs			
a	Speed advisory sign too far from the corner and driveway access point	<ul style="list-style-type: none"> Relocate speed advisory sign closer to the curve and driveway access to comply with the requirements of AS1742.2 	2
b	No advance warning of major tourist attraction, so vehicles do not have adequate time to slow down and turn. Vehicles may not be aware of traffic turning out of the complex.	<ul style="list-style-type: none"> Install advance destination signs "Little Sahara Dunes Complex 500m" 	1
c	Sequencing of signage could result in driver not realising the radius of the approaching corner and that 'Reduce Speed' pertains to the Little Sahara Dunes Complex access driveway rather than approaching corner	<ul style="list-style-type: none"> Remove temporary 'reduce speed' sign 	5
d	CAMS do not adequately inform the approaching driver of the radius of the corner.	<ul style="list-style-type: none"> Install additional CAMS to comply with AS 1742.2. 	3

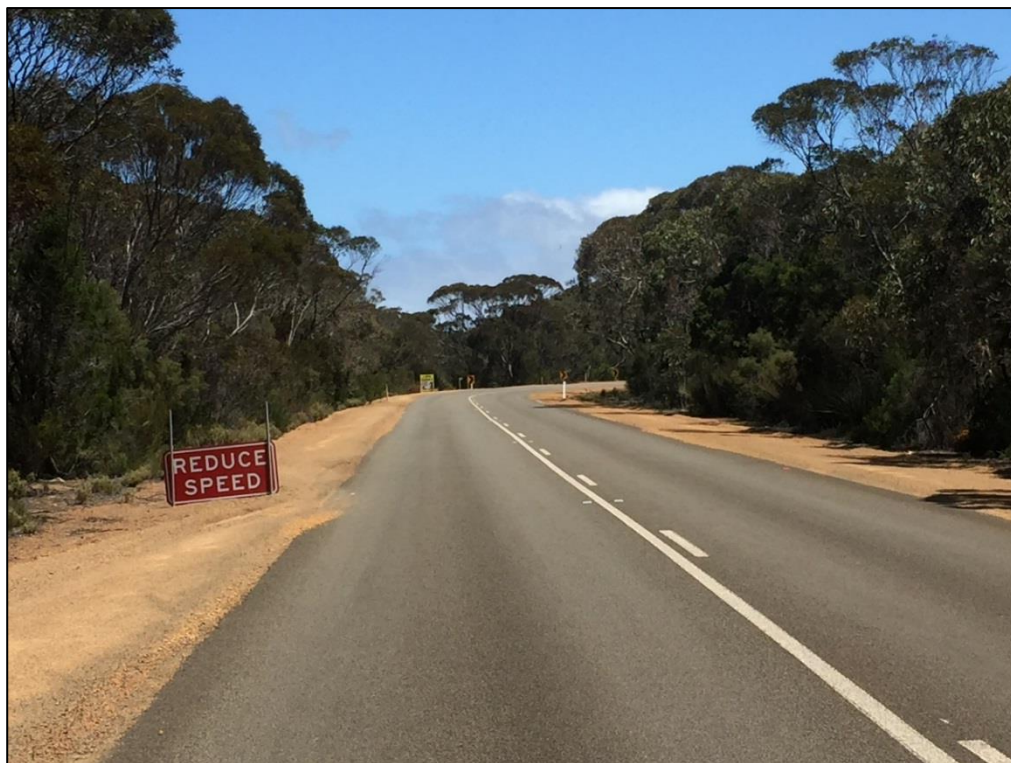
- c) On approach to the S-curve, the radius of the corner is unclear with a temporary 'Reduce Speed', a 'Little Sahara Dunes Complex' sign and a CAM located within close proximity. The configuration of this signage could result in the approaching driver interpreting the 'Reduce Speed' sign pertains to 'Little Sahara Dunes Complex' rather than the approaching corner and not slow down. It is recommended the temporary "Reduce Speed" sign is removed to avoid confusion and focus the motorists' attention on safely negotiating the curve.

Figure 3 – Sequencing of signage could result in the driver not realising the radius of the approaching curve and that 'Reduce Speed' pertains to the Little Sahara Dunes Complex access driveway rather than the curve.

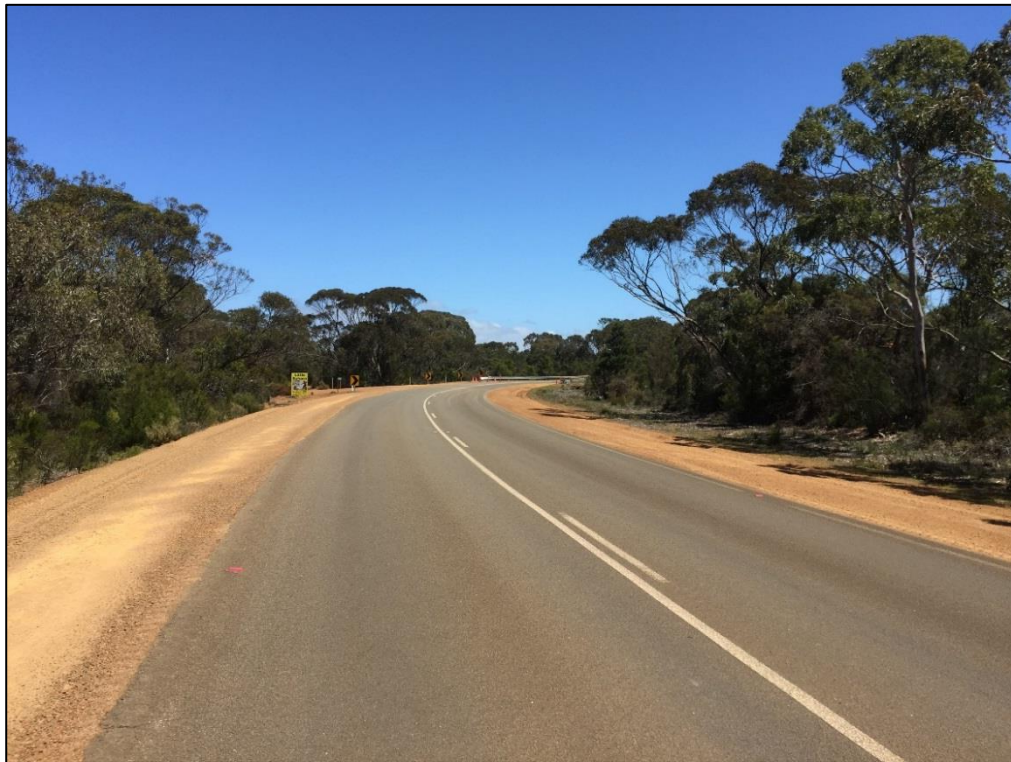
- d) The first CAM is positioned after the start of the curve and does not provide the approaching driver with adequate warning prior to the start of the curve. There is an increased risk of run-off crashes if drivers are not made aware of the substandard curve. It is recommended that additional CAMs are installed in accordance with AS1742.2.

- e) There is no advance warning of the Little Sahara Attraction. The existing sign is small and unreadable until the motorists arrive at the intersection. As a consequence, there is a risk of motorists en route to little Sahara braking hard when they become aware of the access, or turning into the access at high speed. This increases the risk of rear end crashes or loss of control when turning. It is recommended that advanced tourist attraction direction signs are installed to provide adequate warning of the turn off.

Figure 4 – CAMs do not adequately inform the approaching driver of the radius of the curve. Distinctive arrow on ‘Little Sahara Dunes Complex’ entrance sign should be incorporated to provide further clarification to approaching drivers.

e	The Little Sahara entrance sign is small and difficult to read by approaching drivers.	<ul style="list-style-type: none"> Upgrade Little Sahara entry sign to include a distinctive arrow in accordance with AS1742.15 for directions signs. 	4

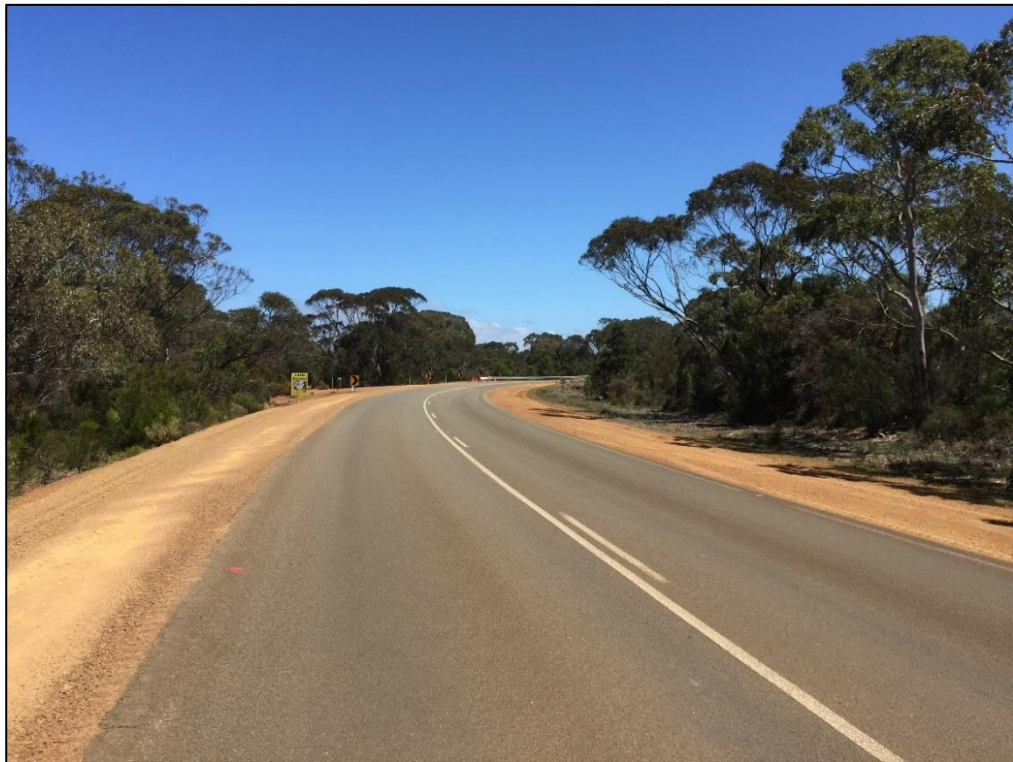
- a) Edge line marking has faded to non-existent and should be reinstated to provide further visual cue as to the radius of the approaching corner.
- b) If a driver takes this corner too fast and goes wide, a lack of a sealed shoulder with loose stone material (ironstone) encroaching onto the carriageway could cause the vehicle to skid, particularly if brakes are applied or if the driver oversteers.

Figure 5 - Faded edge line marking to be reinstated.

3.2 – Line Marking & Delineation			
a	Edge line marking has faded and is not visible so does not provide a visual cue for the radius of the approaching curve.	<ul style="list-style-type: none"> Reinstate edge line marking and raised retroreflective pavement markers. 	2
b	Vehicles that drift onto the shoulder are likely to lose control since the surface has very loose material.	<ul style="list-style-type: none"> Seal shoulders in both directions 	1

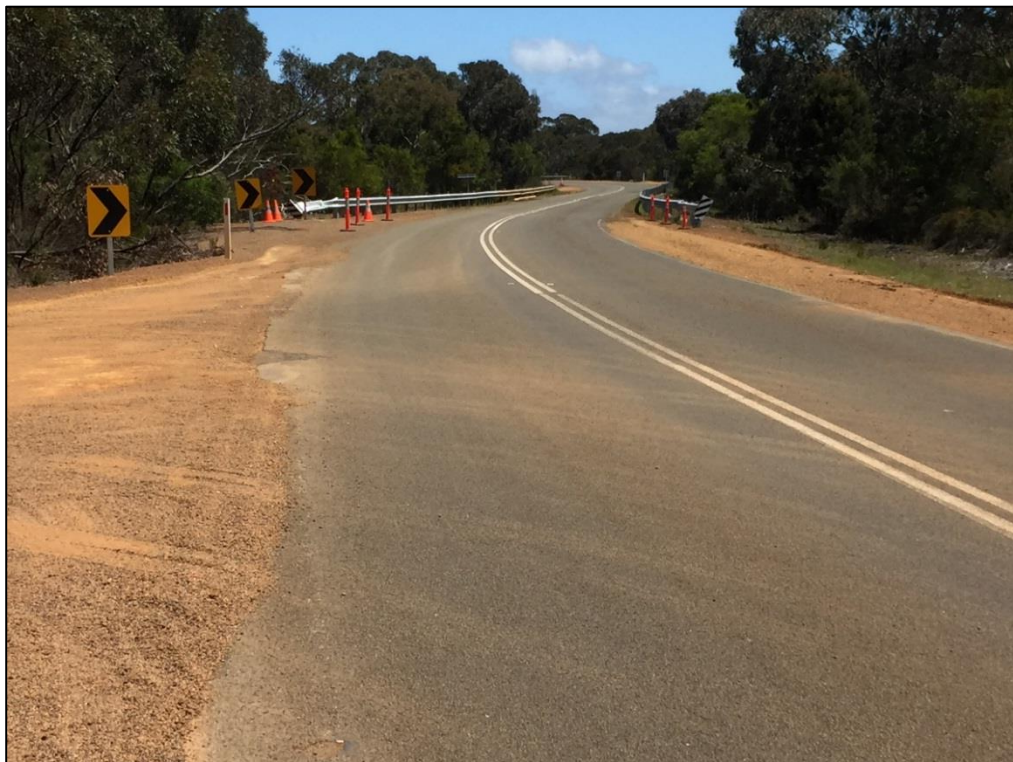
Figure 6 – The shoulders are unsealed and present a risk of vehicles skidding should the vehicle drift out of the traffic lane.

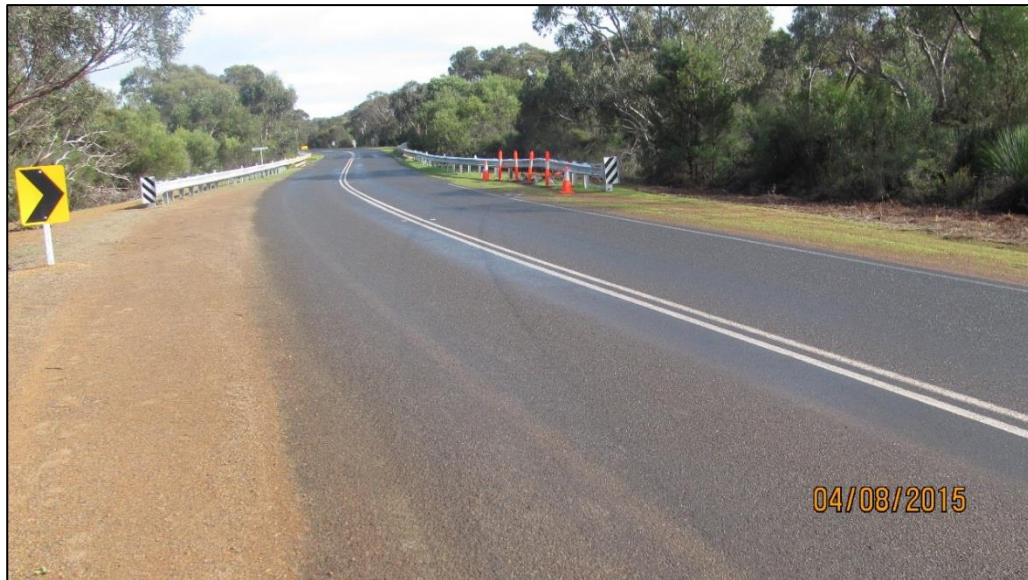
- c) Crash barriers commence too late into the curve. The photo below shows the skids marks of a vehicle that has overcorrected. In the over correction occurred sooner, the vehicle would have crashed into the vegetation behind the barrier on the right hand side. Similarly, vehicles may run-off road and pass behind the barrier on the left. This increases the severity of a crash. It is recommended that the barriers are extended on both sides of the road.

Figure 7 – The crash barrier commences late into the curve and provides limited protection to vehicles that drift off the road at the curve transition.

Item No.	Risk / Hazard Description	Recommendation	Priority
c	Barriers are of insufficient length and there is a risk a vehicle may crash into vegetation before the barrier commences.	<ul style="list-style-type: none">▪ Extend w-beam barriers to protect roadside hazards.	3
