Pig's Head Corner

Road Safety Audit

**Pig's Head Corner
Road Safety Audit**

Date 13/10/2016

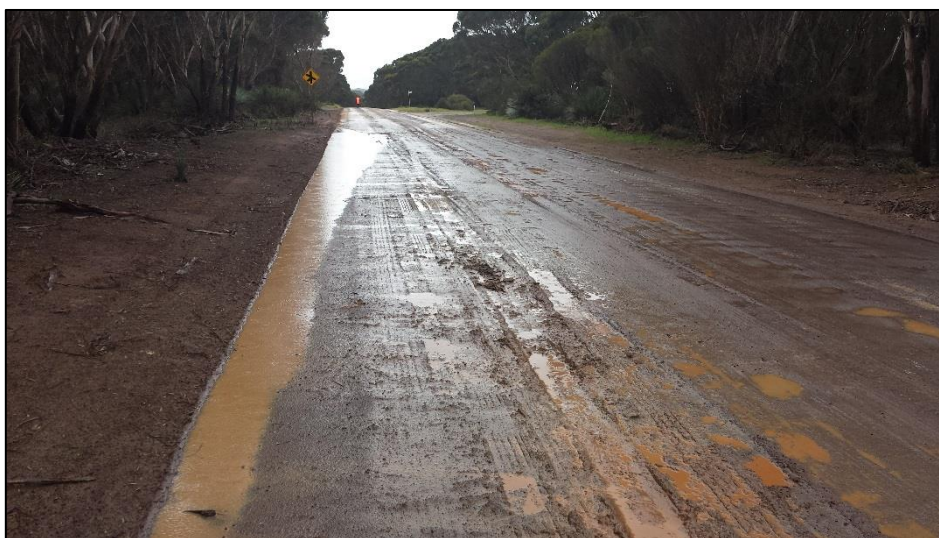
- a) The pavement appeared to offer a poor trafficable surface when wet with many saturated and boggy areas. A high level of fine material, made the pavement noticeably slippery under foot where water had been laying. RAA undertook a Pavement Friction Assessment (Appendix B) which confirmed a poor level skid resistance. Poor skid resistance may result in vehicles overshooting the intersection or failing to come to a stop before a hazard. It is recommended that the approaches to the intersection are sealed. Additionally, advance warning signs on all approaches should be considered to provide sufficient notice to allow the vehicle to safely stop.

Figure 2 – A poor surface when wet results in reduced skid resistance.

The results indicate a very poor level of skid resistance. A comparison of typical results expected from different pavement surfaces in wet weather is shown in Table 2. It is likely that the poor results observed are a combination of the marble-like shape of the Ironstone material together with the high percentage of saturated fines.

The RTA/VicRoads have defined SCRIM intervention levels for various infrastructure sites. According to the correlated values, maintenance is required on approach to intersections when the coefficient of friction is found to be 0.45 or below. Pigs Head Corner therefore falls well below the recommended intervention levels and pavement upgrades should be considered for the intersection.

It is therefore recommended that the pavement is sealed, to significantly increase the coefficient of friction necessary for effective braking. If sealing the pavement is not economically viable, the use of different unsealed materials (such as limestone) on the approaches could significantly improve braking performance.

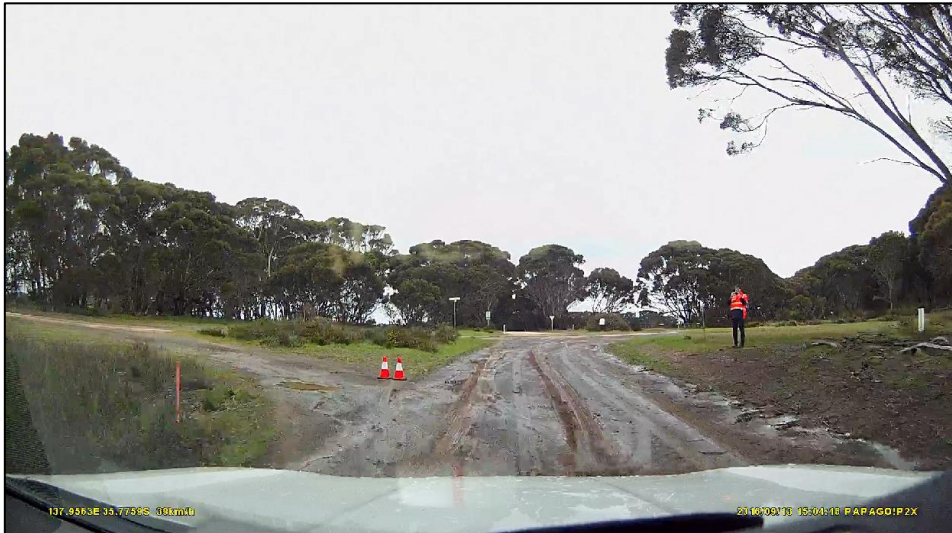
- b) The intersection has many arms converging within a short distance of each other, increasing the number of potential vehicle conflicts. The proximity of Blue Gums Road and Doug Road is a particular issue. When vehicles indicate to turn into either of these roads, it is not clear which of the roads the vehicle may be turning into and may increase the risk of right angle crashes. It is recommended that the intersection is realigned to reduce it to a 4 way staggered intersection.
- c) Moffatt Road and Blue Gums Road form a straight alignment over the intersection and from a distance, appear to be a continuous road. There is a risk of motorists

Figure 3 – Blue Gums Road appears to continue straight onto Moffatt Road.

failing to give way and continuing over the intersection at speed. It is recommended that the intersection is re-aligned to alter the line of sight and make the primary road more conspicuous. Duplication of “GIVE WAY”, “STOP” signs

- d) in conjunction with advanced warning signs could also be considered.

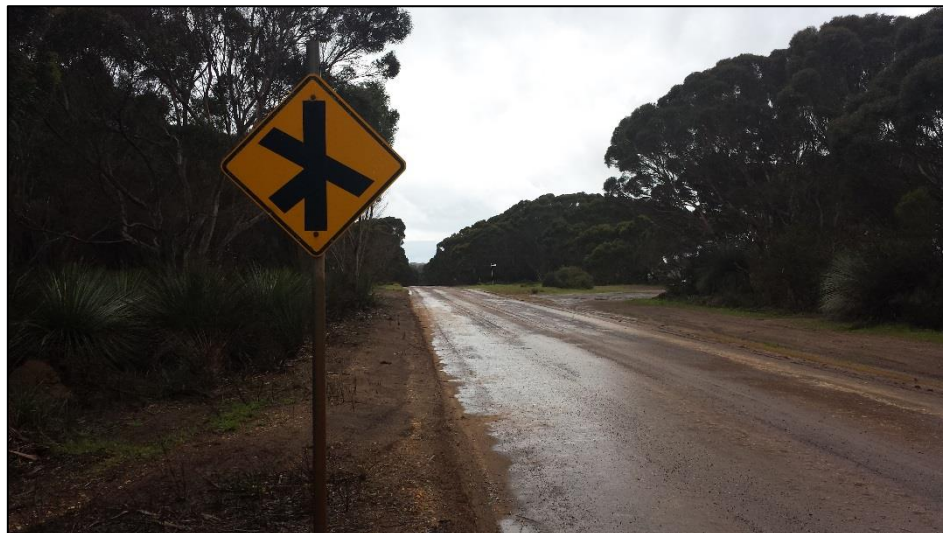
- a) The intersection warning sign on Willson River Road is non-compliant and could be confusing to motorists. The sign is also situated too close to the intersection, especially given the default 100km/h limit. It is recommended that the existing sign is removed and a W2-1 sign is installed at the distance prescribed in Table D1 of AS1742.2.

Figure 4 – Intersection warning sign is non-standard and in close proximity to the intersection.

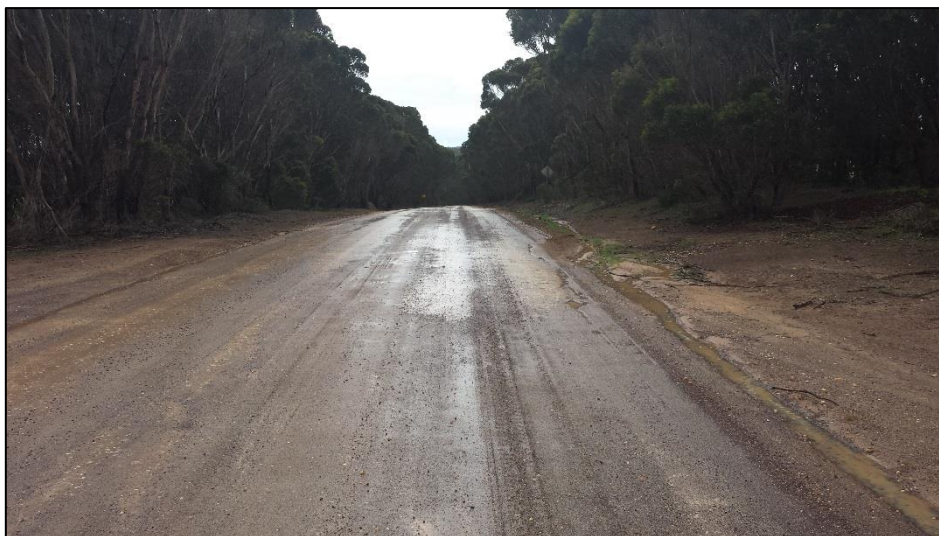
- b) Sight distance to the right along Willson River Road is between 50 and 60m; well below the recommended Safe Intersection Sight Distance (SISD) detailed in AustRoads Guide to Road Design (AGRD). “Give Way” signs are installed at the intersection but there is an increased crash risk due to the restricted sight distance. Because of this, it is recommended that “STOP” signs are installed in accordance with AS1742.2 Figure 2.2.

Figure 5 – Sight distance (northbound) from Moffatt Road is restricted by a crest on Willson River Road.

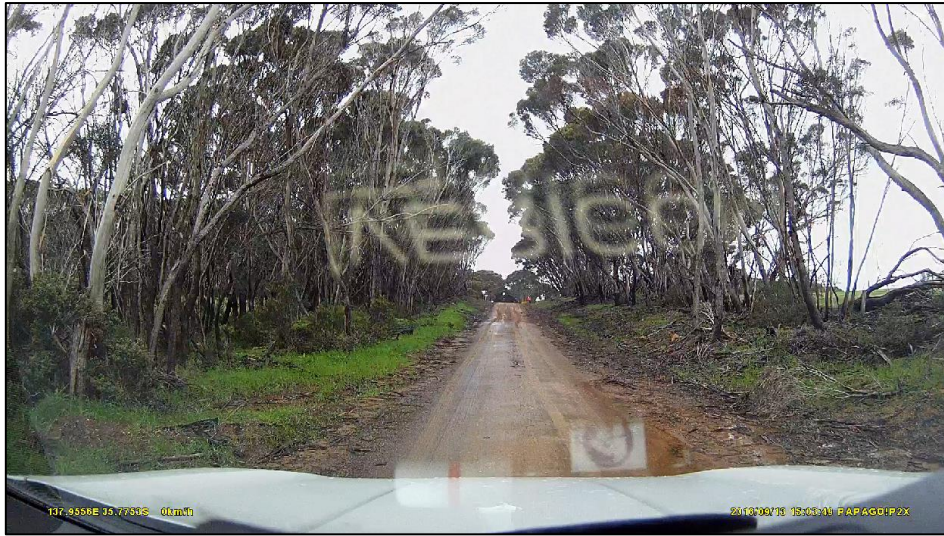
- a) The Approach Sight Distance (ASD) to the intersection is restricted on Blue Gums Road by a crest and falls below the requirements in the AGRD for a road with a speed limit of 100km/h. Despite the “GIVE WAY” sign provided, motorists may not be aware on approach to the intersection that they must give way. It is

Figure 6 – Poor Approach Sight Distance to the intersection caused by a crest on Blue Gums Road.

recommended that the crest is reduced as far as possible and advance warning signs are provided.
