# Tinsmith Corner

Road Safety Audit

March 2017

# Tinsmith Corner Road Safety Audit

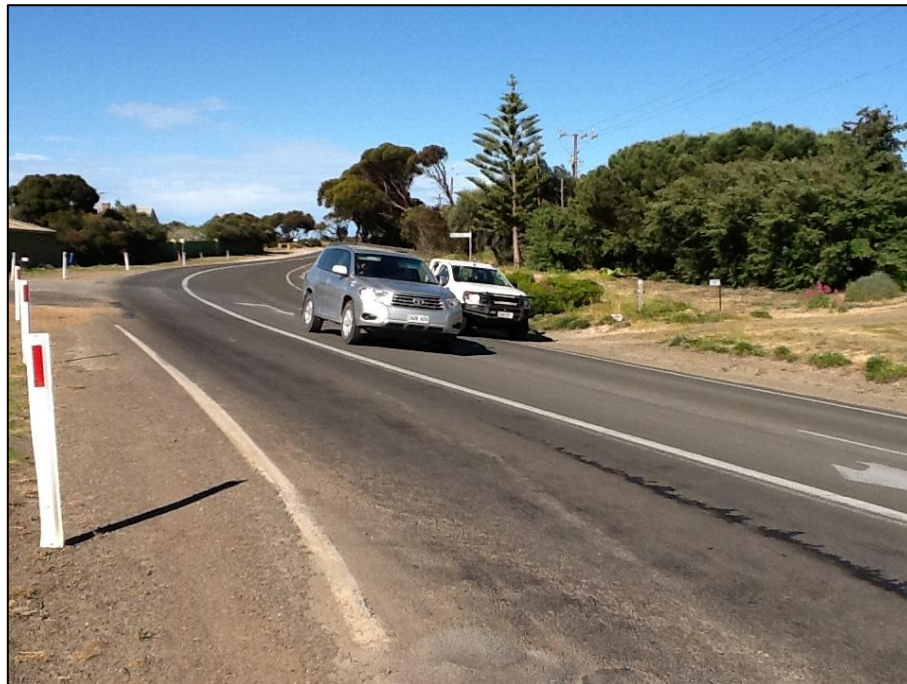
- a) The super-elevation created by adding a by-pass lane on the inside of the curve placed vehicles lower than the other two lanes- adding to driver inability to see a reasonable distance when entering the Playford Highway from Tinsmith Road. This could increase the risk of crashes occurring. It is recommended that the lane width is increased to provide a basic right treatment (BAR). Raising the level of the junction should also be investigated.
- b) The intersection is located within an existing 100 km/h speed zone, this increases the crash risk given the poor sight distance. It is recommended that the Kingscote 80km/h speed limit is extended to include Tinsmith Corner.

**Figure 2 –Steep geometry over extended lane width created sight difficulty for entering traffic. (Note excavation depth into the opposite embankment)**

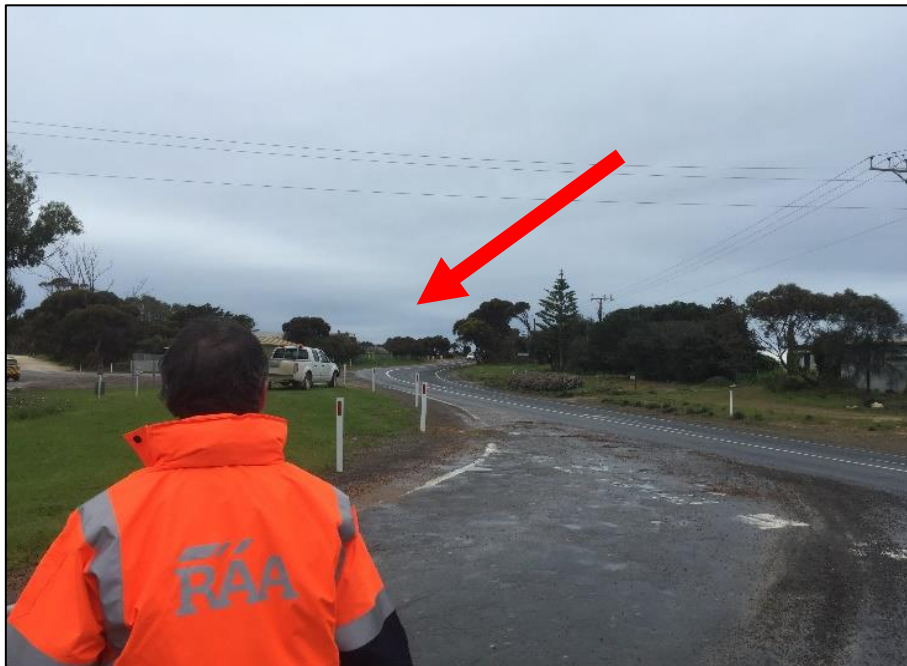
- a) Sight distance was measured at 132 metres to the east and 205 metres to the west of the intersection and provides limited time for heavy vehicles to slow if a vehicle commences a turn. It is recommended that the speed limit is reduced along the Playford Highway at this section to allow additional reaction time commensurate with the sight distance.
- b) Vegetation restricts right distance to the east, increasing the risk of a crash. It is recommended that vegetation trimming and removal is undertaken in accordance with both DPTI and Kangaroo Island Council vegetation management plans.

**Figure 3 – Sight Distance- the vegetation indicated obstructs long range sight distance. On observation, drivers tend to hold further back from the Give Way line in order to optimise their view of oncoming traffic from Kingscote.**

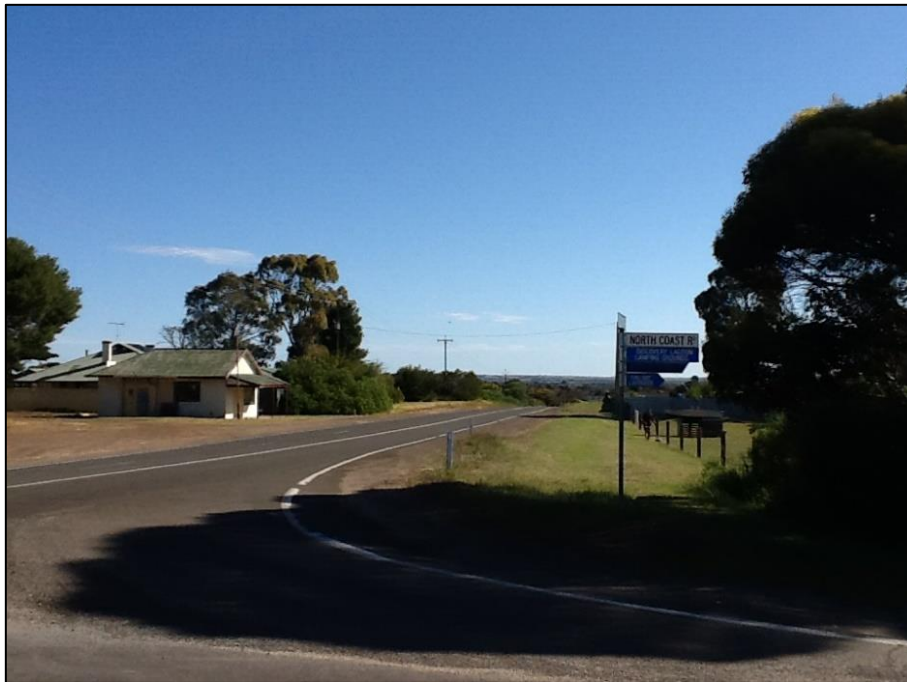
Figure 4 - Holding further back from the Give Way line actually appears to reduce the line of sight to the west as seen from the photo above.

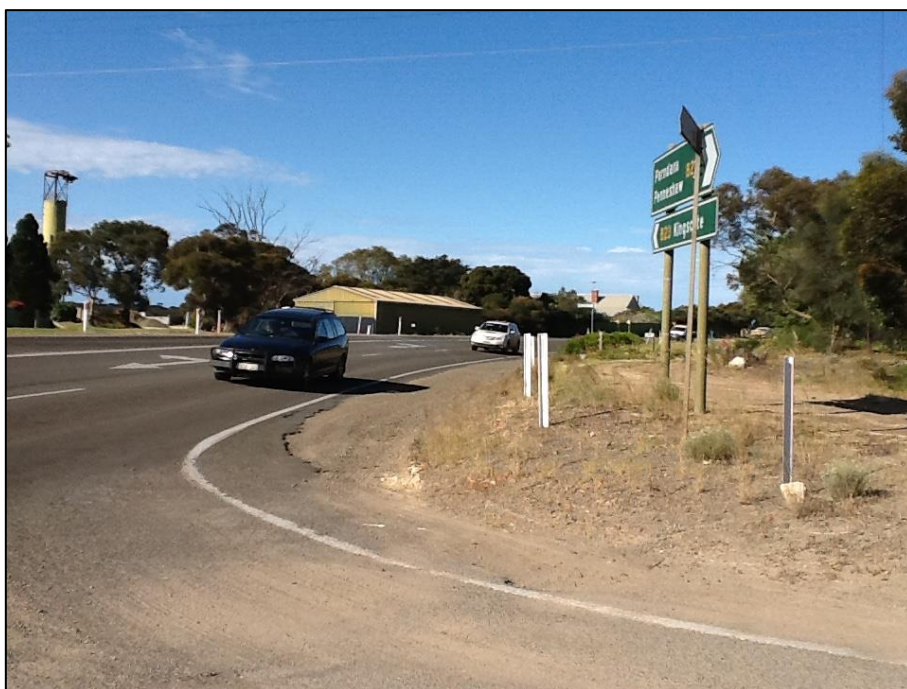
Figure 5 -The resultant embankment and relocation of signage associated with the works to increase the lane width on Playford Highway restricts sight distance to the east from Tinsmith Road.

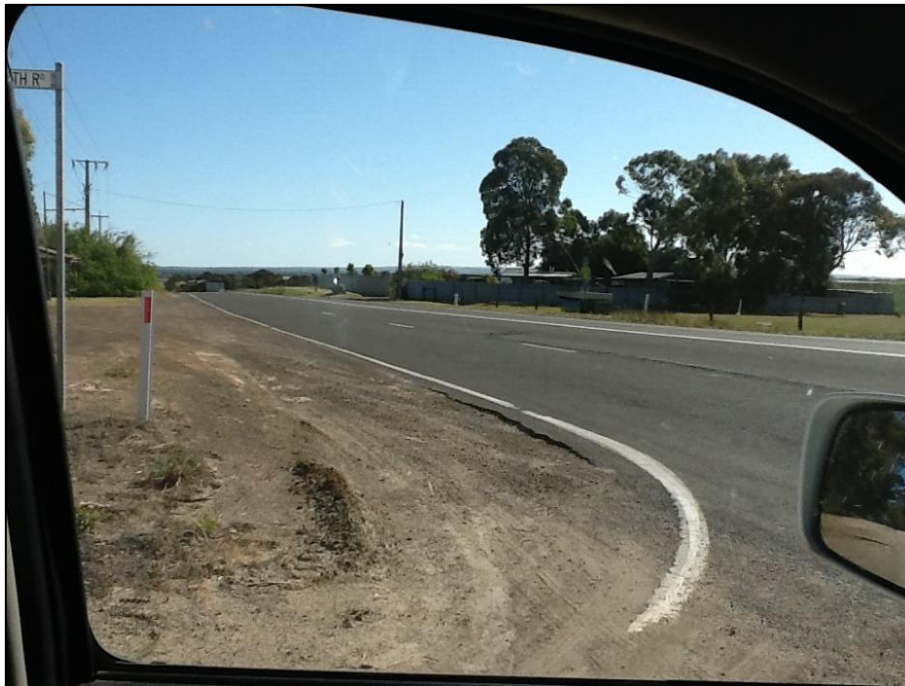
**Figure 6 - Sight distance to the west on the Tinsmith Road approach.**

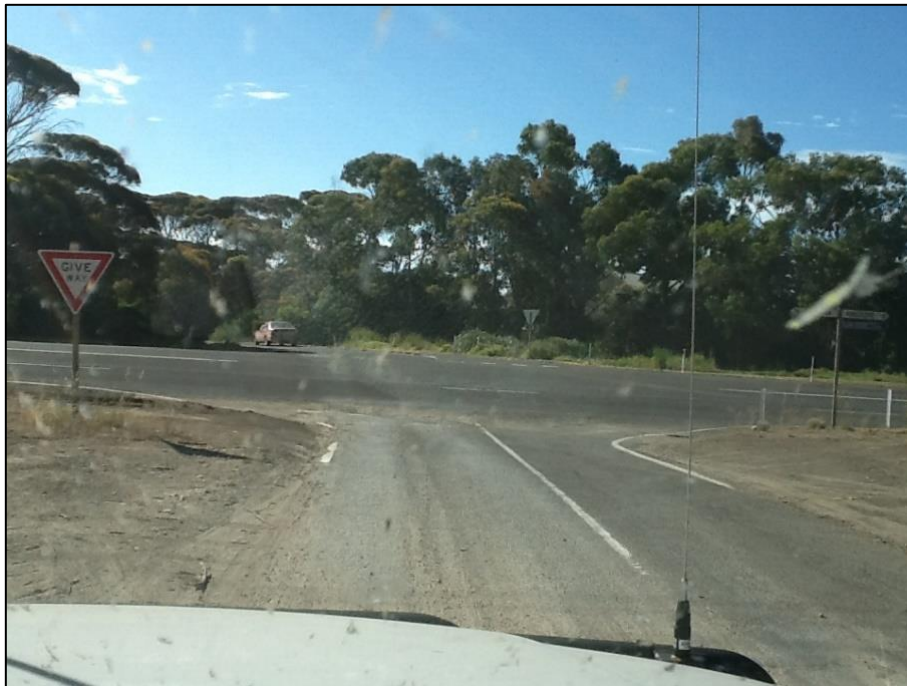
Figure 7 - Signage and general vision on Tinsmith Rd approach.

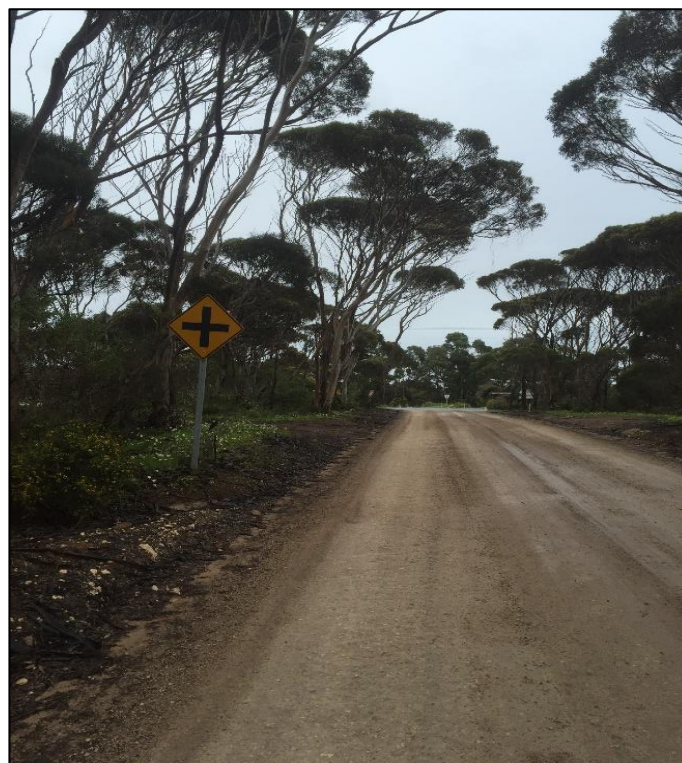
- a) Advanced warning and give way signs are obstructed by vegetation on approach to the intersection. This increases the risk that motorists do not become aware of the intersection and may fail to give way, increasing the likelihood of a crash. It is recommended that vegetation trimming or removal is undertaken in accordance with both DPTI and Kangaroo Island Council vegetation management plans to make the signs conspicuous.

Figure 8 - Tinsmith Road approach- Cross road sign obscured by vegetation from further back.
