Barossa Valley Way – Hermann Thumm Drive, Lyndoch

Road **Safety** Audit

August 2017

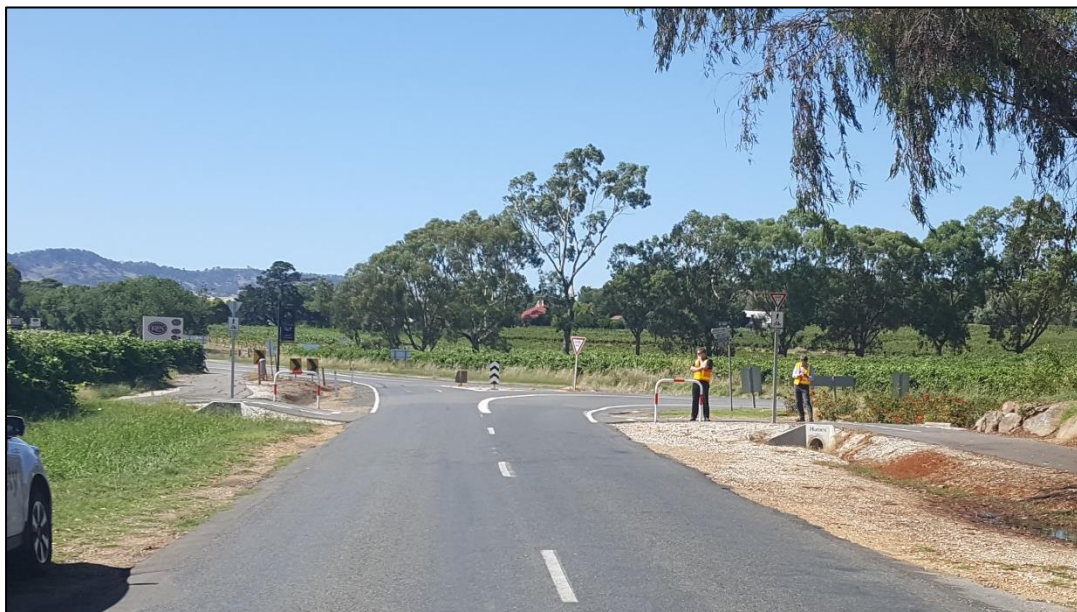
- a) Lack of perception of the intersection – On approach to the intersection, the road appears to continue to the left. Give Way signs and line marking have not been provided for motorists turning left, to head south on Barossa Valley Way. While a T intersection warning sign has been provided, the Give Way sign for motorists turning right is barely visible on approach. As a result there is a high risk that motorists will fail to Give Way to traffic on Barossa Valley Way, particularly when turning left, significantly increasing the crash risk.

Figure 2 – Hermann Thumm Drive approach to the intersection.

It is recommended that a Give Way sign is provided for left turn vehicles and the size of the signs increased to R2-1B.

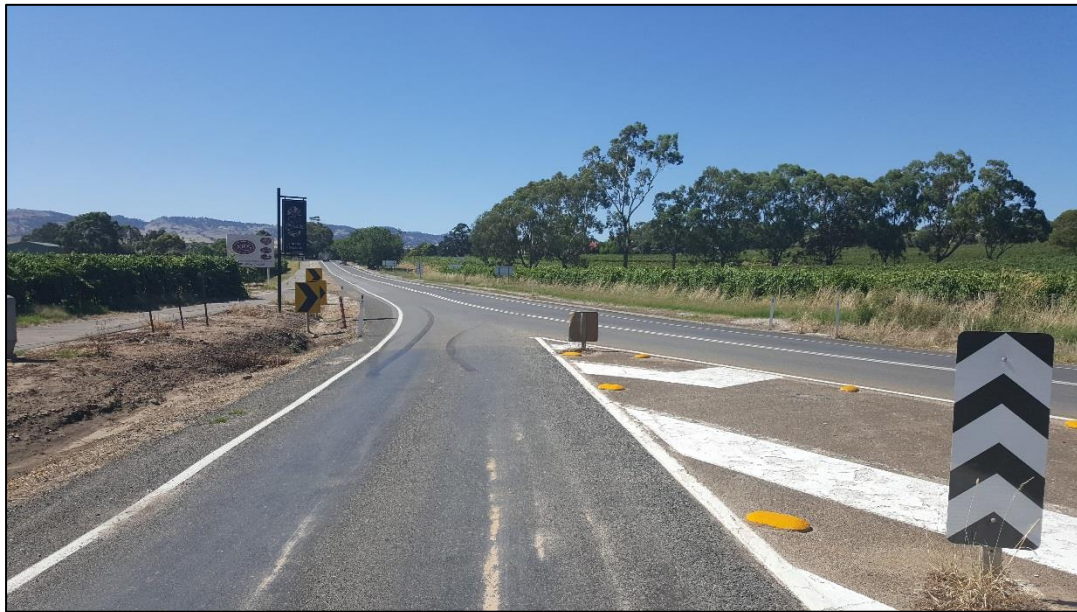
Figure 3 – Absence of Give Way signs and line marking for vehicles turning left.

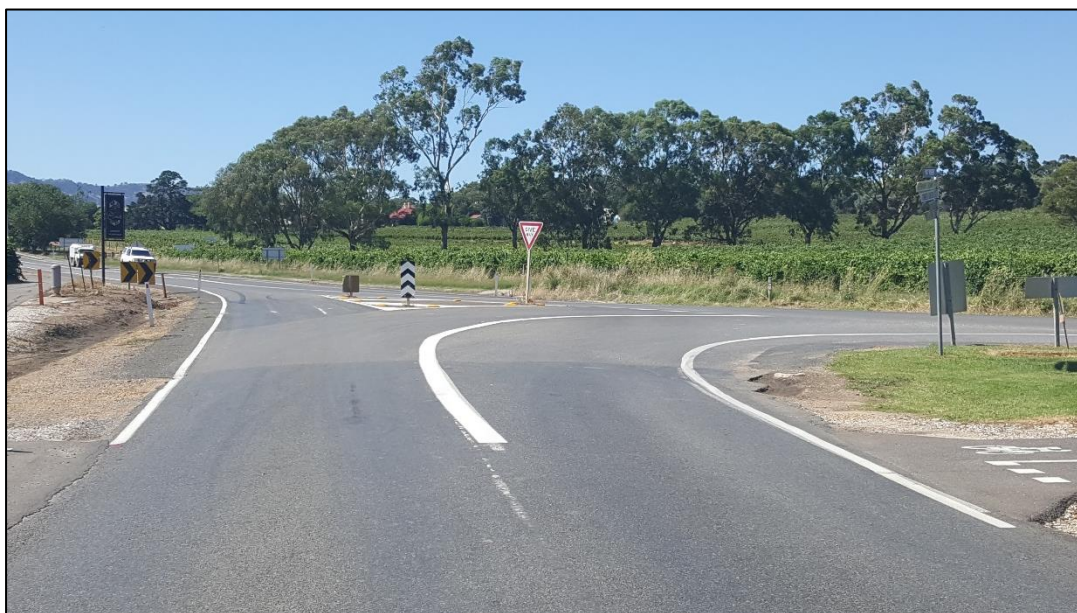
- b) Confusing visual cues – the Chevron Alignment Markers (CAMs) on the east side of Hermann Thumm drive are visible to those approaching the intersection and may cause confusion when interpreted in conjunction with the visual bend to the right, approaching the Give Way line.

Figure 4 – CAMs appear to direct traffic right when vehicles are required to Give Way.

It is recommended that the sign placement is reviewed to assess the angle of view to the motorist. If necessary, apply louvres so that the signs are only visible to motorists travelling on Barossa Valley Way.

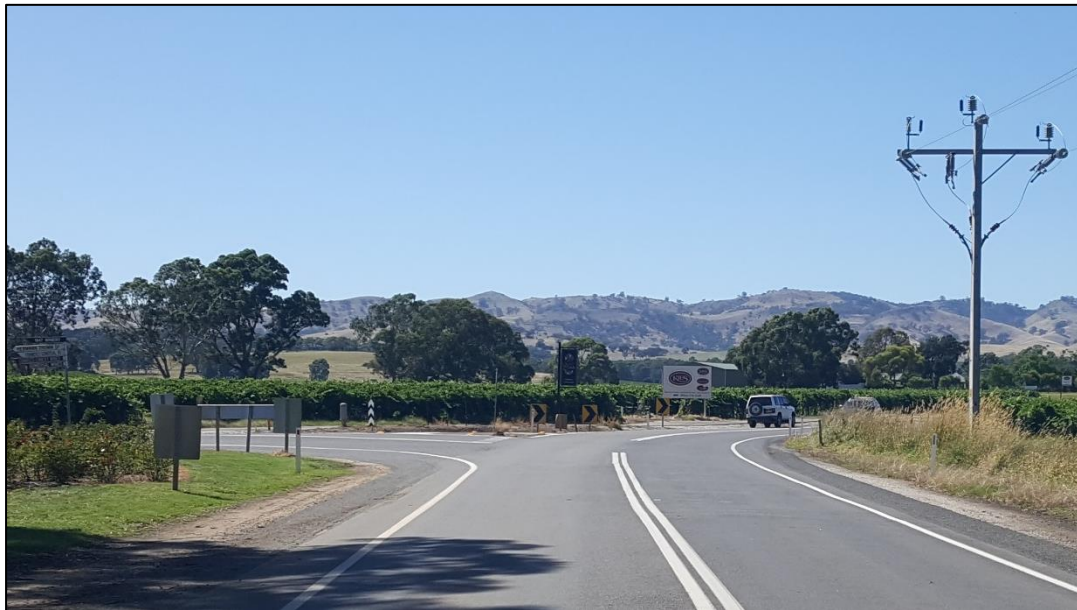
- a) Missing Chevron Alignment Markers Southbound – On approach to the curve, there appears to be Chevron Alignment Markers (CAMs) missing from the curve. This may reduce the conspicuity of the curve and warning that the curve is substandard. It is recommended that the position and number of CAMs is reviewed against the requirements in AS1742.2.

Figure 5 – Chevron alignment markers appear to be missing, particularly to the right, at the position of the 4WD vehicle.

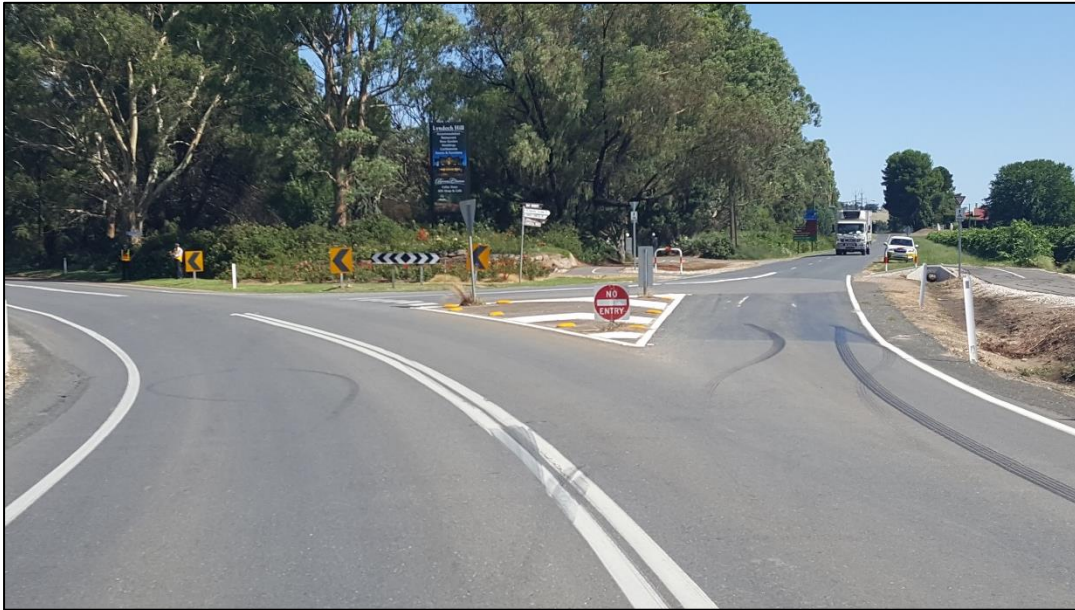
- b) Conflicting signage – Approaching the intersection northbound, there is a conflicting message between the CAMs and the sight board. The predominant risk on approach is the substandard curve, so the CAMs should take precedent. The sight board is prescribed in AS 1742.2 for use opposite T intersections on high speed roads. It is therefore recommended that the sight board is removed.

Figure 6 – Conflicting messages created by the combination of CAMS and sight board. Note sign clutter, removing unnecessary signs where possible will enhance core warning signs.

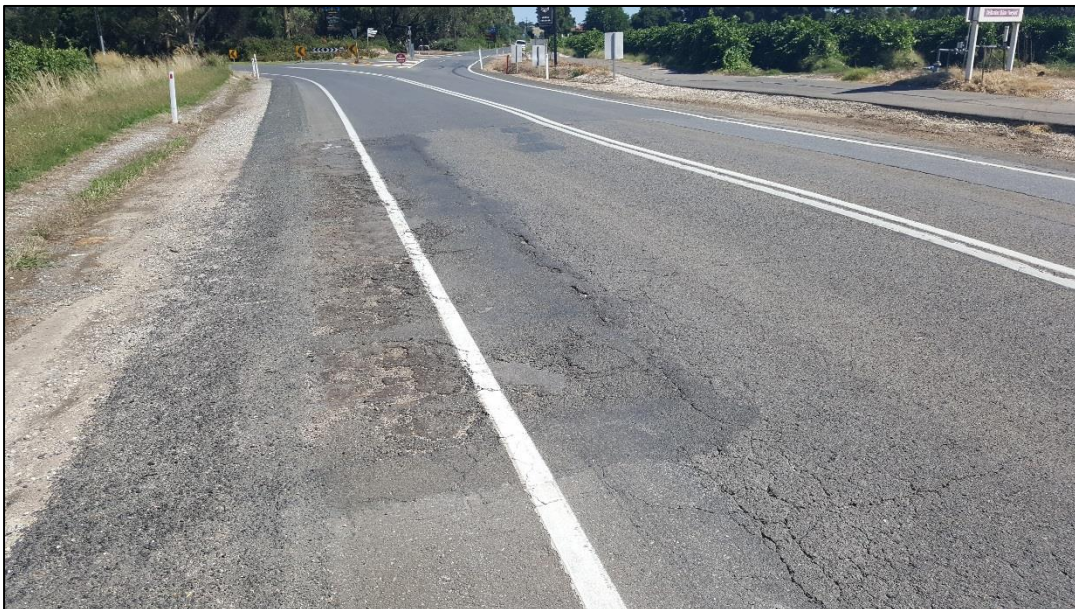
- c) Pavement surface deterioration – on the northbound approach to the intersection, pavement is showing signs of deterioration. Broken pavement and loose material may reduce skid resistance. It is recommended that pavement remediation is undertaken to improve the surface.

Figure 7 – Pavement deterioration.
