Road Safety Audit

Intersection Sturt Highway & Airport Road, Renmark

May 2018

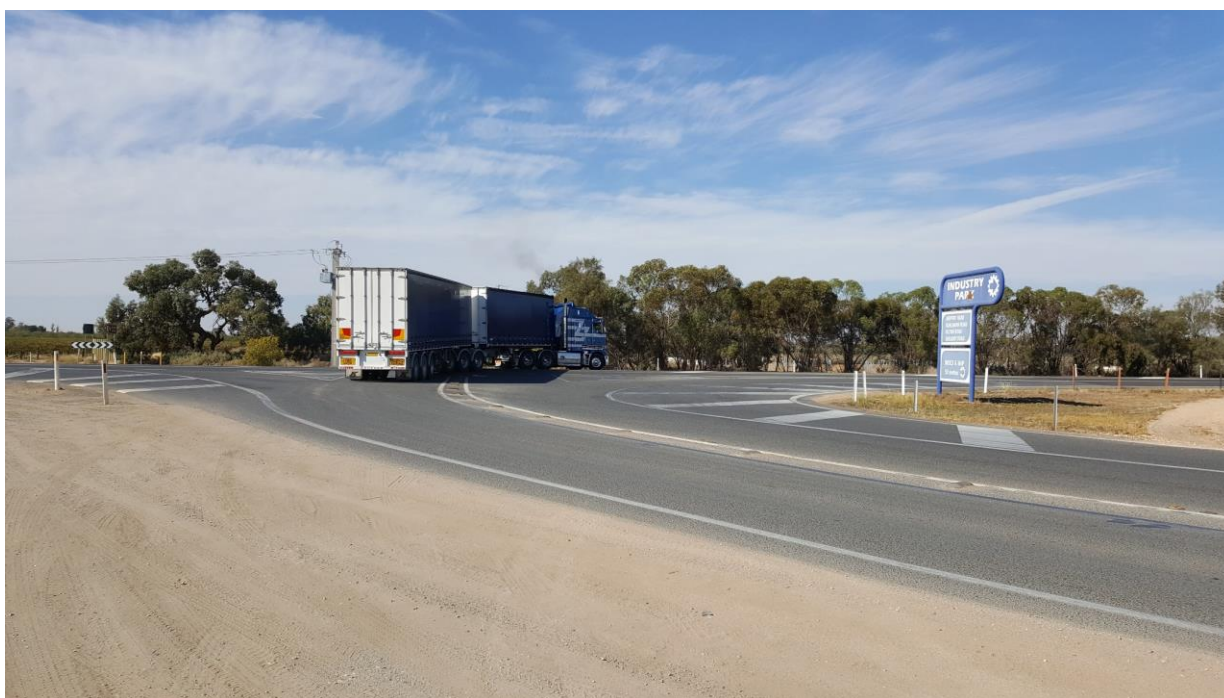
Heavy freight including B-Doubles regularly use this intersection to access the Renmark industrial precinct. All turn movements are supported by the current layout and regularly used however right turn movements are of particular concern due to the time it takes for a heavy vehicle to complete the turn and fully clear the carriageway.

Figure 3: B Doubles regularly turn right from Airport Road

2014 DPTI traffic volume estimates on this section of Sturt Highway are 8300 vehicles per day inclusive of 13.5% (1100) commercial vehicles. B Doubles (Class 10) make up over one third of all commercial vehicles on Sturt Highway in this location, with an estimated 420 vehicles per day. These figures refer to the section between Old Sturt Highway and Twentyseventh Street.

Given these traffic volume figures, and based on observations on site and feedback provided to the audit team by RAA Members, heavy vehicles to turning right from Airport Road can regularly experience delays. This in turn causes drivers to make potentially dangerous turning manoeuvres due to the very limited opportunities where there is sufficient gap in both directions to commence a right turn.

After turning right from Airport Road, the majority of heavy vehicles immediately begin driving on the wide westbound shoulder in order to allow other westbound vehicles to pass whilst they accelerate to speed. This manoeuvre can be risky as the wide shoulder does not extend far enough for heavy vehicles to reach the speed limit and they are then required to merge back onto the busy highway at high speed.

It is recommended that a significant upgrade of this intersection is considered that will reduce speeds in the immediate vicinity, and provide timely opportunities for heavy vehicle operators to safely undertake a right turn from Airport Road on to Sturt Highway.

- Installation of a large roundabout suitable for all vehicle types using this intersection
- Installation of formal acceleration lane for right turning vehicles
- Grade Separation, in the long term, dependant on future development

Of these three options, a large roundabout is the preferred option due to the cost restraints of grade separation and the potential introduction of additional safety issues by introducing an acceleration lane prior to the overtaking lane west of the intersection.

Item	Deficiency	Suggested Action	Risk Rating
1.	Freight movements	Construct a roundabout or consider other treatments suitable for a high volume of freight. Consideration needs to be given of future freight demand and designing for B-Triple combinations to prevent this intersection from becoming a future bottleneck.	A

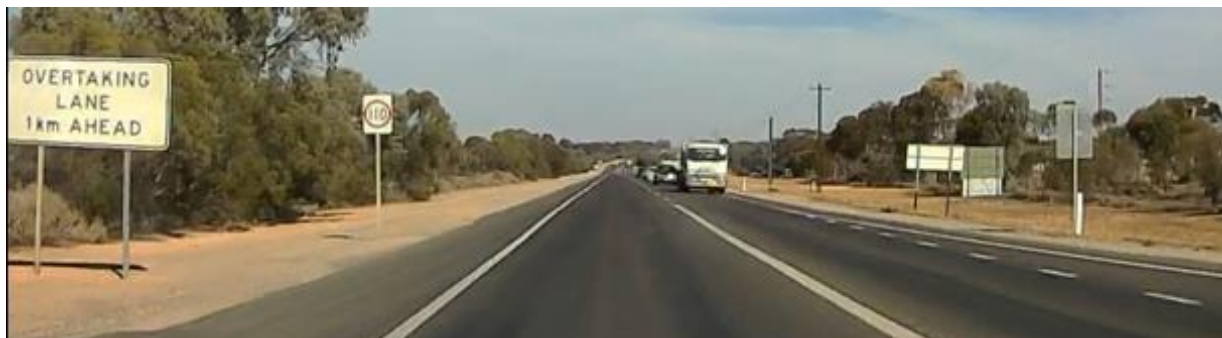
The speed limit changes from 90km/h to 110km/h approximately 200m west of the intersection, at the beginning of the left turn lane taper.

Figure 4: (Looking west) the speed limit changes from 90km/h to 110km/h just beyond the intersection

At the time of our visit, although speeds were not formally recorded, there appeared to be a lack of compliance with this speed zone. Westbound vehicles were noted to be accelerating to the 110km/h speed limit at the intersection, before the 110km/h signage, however, signage was visible from the intersection. Similarly, westbound vehicles were slow to reduce speed from 110km/h to 90km/h and were noted to 'coast' to the lower speed limit after passing the 90km/h signage, which is fairly common practice.

This causes vehicle speeds on Sturt Highway to be in excess of the 90km/h on occasion, which in turn increases the length of the minimum gap sight distance (MGSD) required to safely turn from Airport Road and can lead to an increase of the severity of a potential crash. Referring to table 3.4 and 3.5 in Austroads Guide to Road Design – Part4A, the MGSD for approach speeds of 90km/h is 125m, and for approach speeds of 110km/h is 153m.

It is recommended that vehicle speeds on Sturt Highway are surveyed, and that consideration is given to extending the 90km/h zone by 300m to the west so that vehicle speeds on Sturt Highway are more consistent through the intersection.

2.	Location of speed limit change	Extend 90km/h zone by 300m to the west	A
3.	Right turn Airport Road to Sturt Highway	Construct Roundabout suitable for high volume of freight traffic.	A

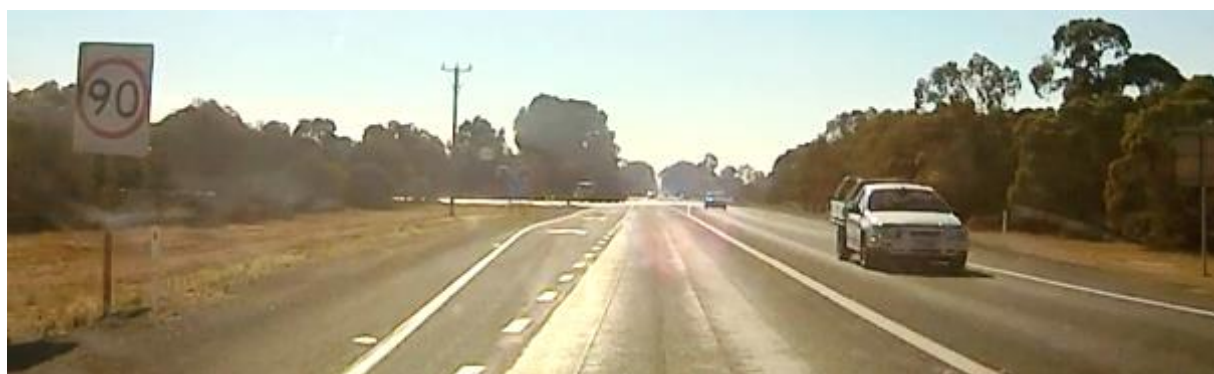
Figure 5: (Looking east) the speed limit changes to 90km/h from 110km/h whilst approaching the intersection

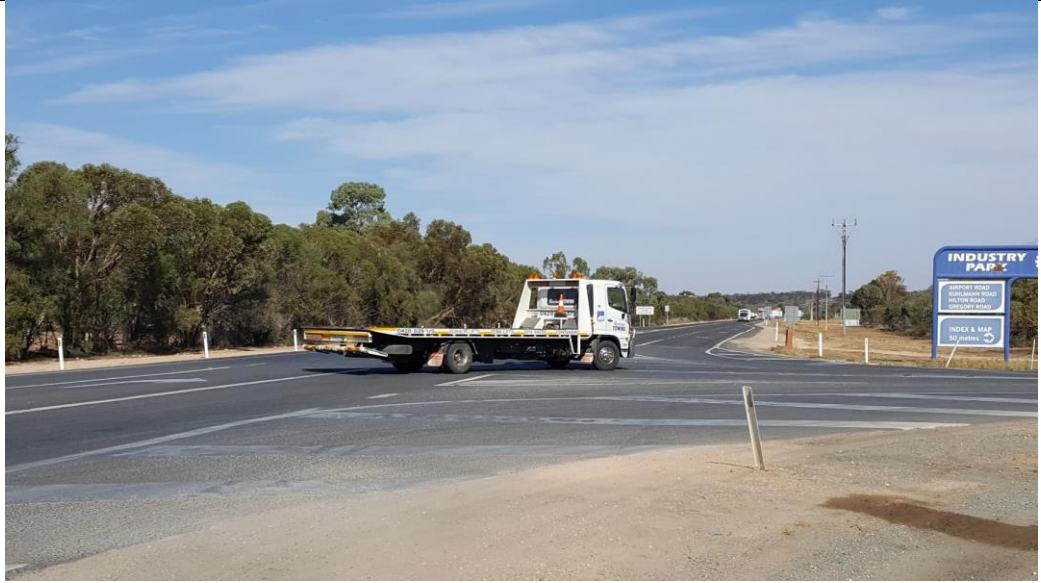
</div> <p data-bbox="568 848 1209 880">Figure 7: Heavy vehicles cut the corner when turning right</p> <p data-bbox="347 927 1428 1187">Heavy vehicles turning right from Sturt Highway onto Airport Road regularly cut the corner, posing a risk to vehicles turning right out of Airport Road. For smaller rigid vehicles this is more down to driver error however the swept path of larger articulated combinations requires this space. It was noted that some vehicles utilised the painted traffic island on the western corner of the intersection to generate additional turning space.</p> <p data-bbox="347 1240 1428 1406">As previously stated in the report, a roundabout is the recommended option and will address this issue. If a roundabout is not supported, in the short term, widening of Airport Road at the apron to create additional space for turning vehicles is recommended.</p>

4.	Right turn from Sturt Highway to Airport Road	Roundabout suitable for high volume of freight traffic. If roundabout not adopted, widening of Airport Road at the apron to cater for swept path of heavy vehicles.	B

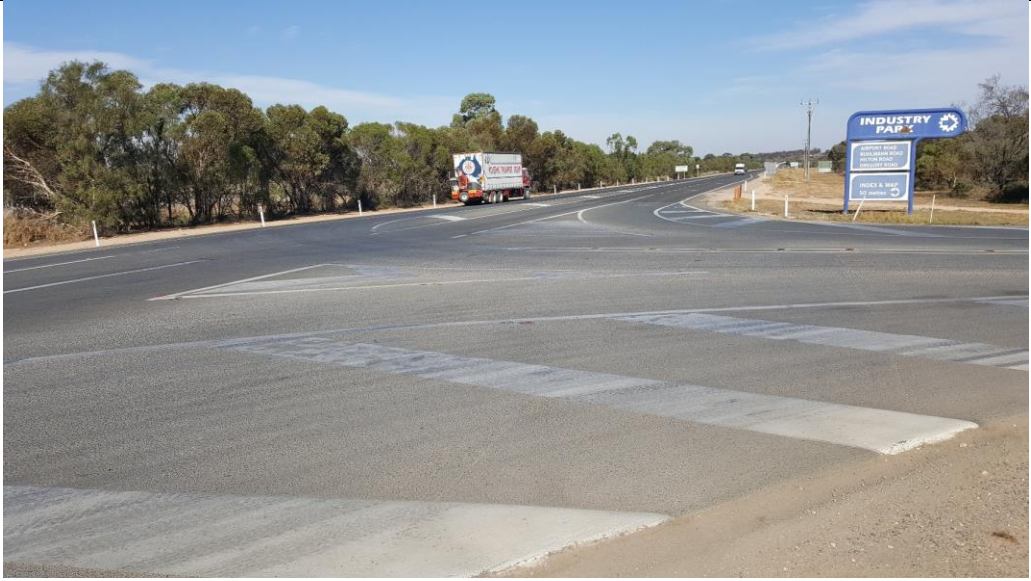
</div> <p>Figure 8: Line marking at the intersection is in poor condition</p> <p>Line marking was noted to be in poor condition due to the constant heavy vehicle traffic. It is recommended that line marking is refreshed, and scheduled for refreshing on a more regular basis than it is currently.</p>

5.	Faded/deteriorated line markings	Refresh line marking and schedule refreshing on a more regular basis.	B
6.	Skid resistance	Undertake skit testing on Sturt Highway and consider remediation should this show poor skid resistance in the wet.	A

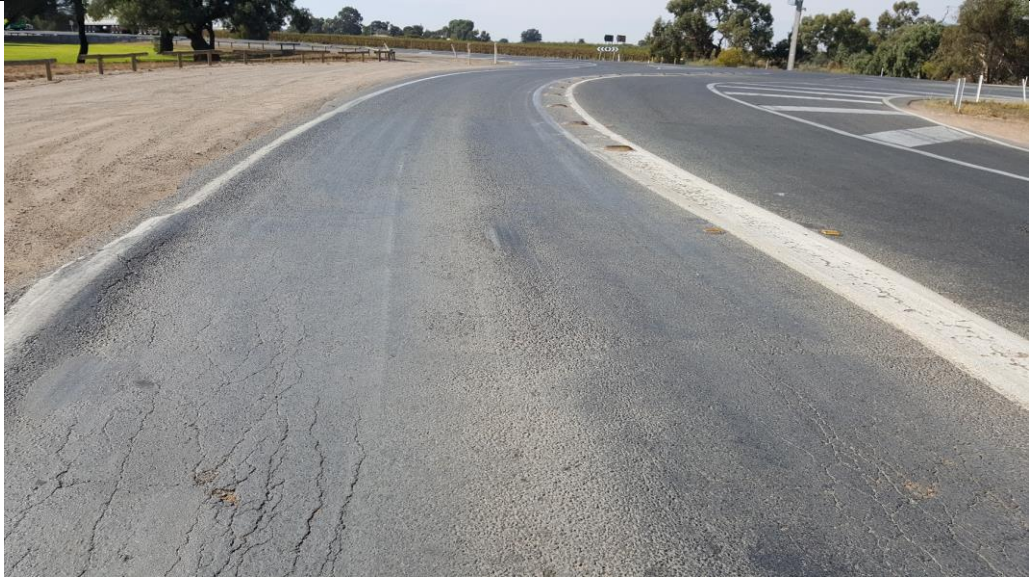
</div> <div data-bbox="539 844 1238 875"><p>Figure 11: The surface of Airport Road is in very poor condition</p></div> <div data-bbox="370 911 1404 1487">

7.	Failing pavement on Airport Road	Comment: Pavement was noted to be in very poor condition and it is suggested that a reseal is considered in the vicinity of the intersection.	Comment

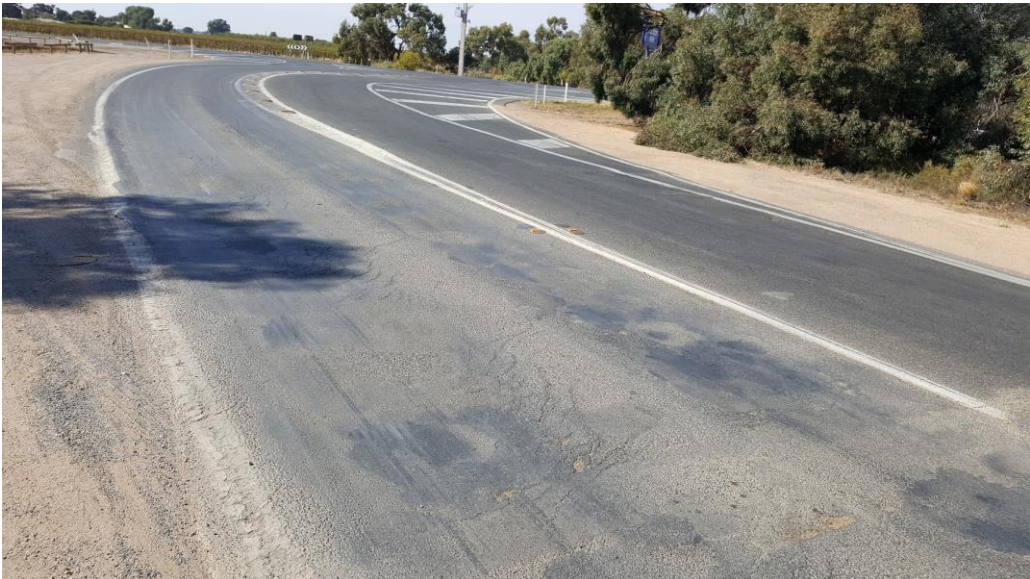
</div> <div data-bbox="580 1496 1197 1527"><p>Figure 12: Potholes and cracks forming on Airport Road</p></div> <p>The surface on Airport Road is in very poor condition and large lumps are visible between the wheel paths and on the edges due to the turning motion of vehicles on approach to the intersection.</p> <p>Although not an immediate safety concern due to the low speed environment, there is potential to cause vehicle damage, which will increase as the road deteriorates further.</p> <p>It is recommended that Airport Road is resealed in the vicinity of this intersection.</p>
