Road Safety Audit

Sturt Highway – Waikerie

May 2018

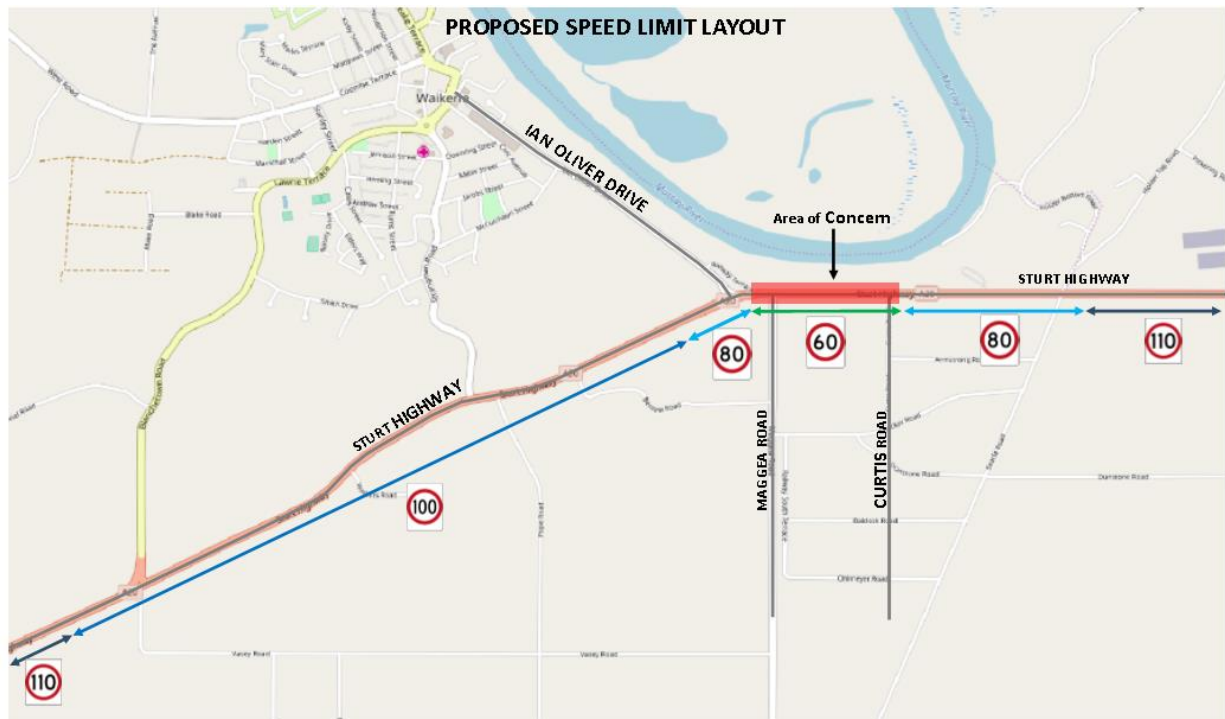
Figure 2: Recommended speed limit layout for Sturt Highway in Waikerie

After assessing this area against each speed limit guideline, it is recommended that a 60km/h speed limit is applied for approximately 800m of Sturt Highway replacing 800m of the existing 80km/h speed limit zone. An electronic variable speed limit should be considered which could allow vehicles to travel 80km/h overnight where there are considerably less vehicles and pedestrians in the area. It is recommended that traffic counts and movements including pedestrian activity is reviewed in order to determine suitable times to implement a potential variable speed limit zone.

This option utilizes an 80km/h buffer zone for approximately 400m on the western approach, a 60km/h zone of approximately 800m and a 1.7km 80km/h zone on the eastern approach. It should also be noted that the 60km/h zone in this option is contained entirely within the current 80km/h zone and changes to the total length of the speed zone are not required. By replacing 800m of 80km/h road with a 60km/h speed limit, the total increase in travel time is 12 seconds.

An 80km/h buffer zone is preferred to '60 ahead' advisory signage due to the risks associated with a potential increase in Sturt Highway speeds at the intersections with Ian Oliver Drive and Holder Top Road and these should be maintained at 80km/h in their own right.

| Item | Deficiency | Suggested Action | Risk Rating |
|---|---|---|---|
| 3. | Speed Limit | Reduce speed limit to 60km/h for approximately 800m through the site. | A |

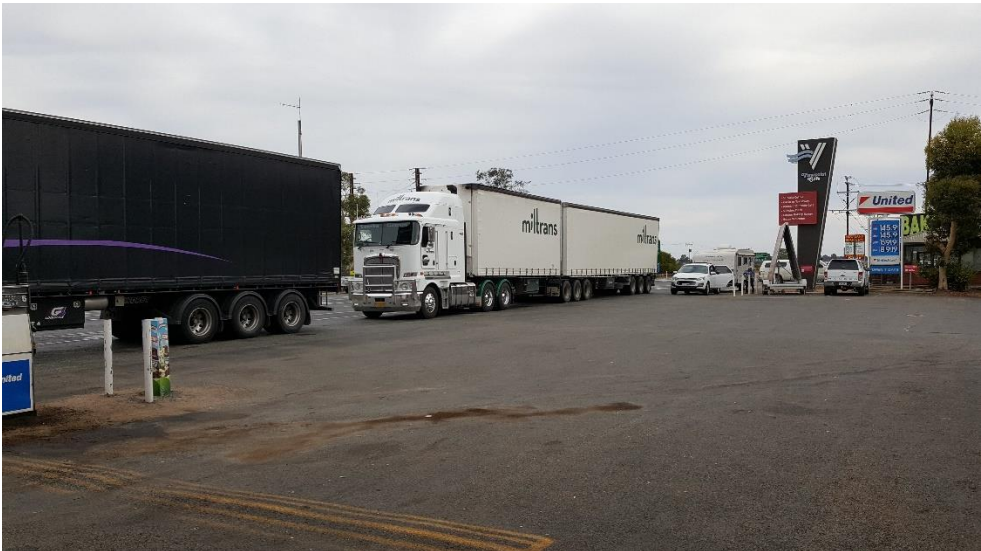
| 5 | Long vehicles parking on northern service road |
| | <div data-bbox="395 280 1380 828"> </div> <p data-bbox="359 840 1420 907">Figure 5: Caravans parking in the service road. In this case caravans blocked designated parking spaces in front of New Land Bakery as well as the exit to the drive-through.</p> <div data-bbox="395 952 1380 1500"></div> <p data-bbox="359 1512 1420 1657">Figure 6: B-Doubles and caravans parking on the service road. In this case B-Doubles blocked off the service road and a caravan blocked off a possible route around the B-Doubles. The only option for vehicles to pass was to drive across the painted island and onto the highway around the parked vehicles.</p> <p data-bbox="351 1713 1428 1780">Long vehicles such as freight and tourists towing caravans regularly stop on the service road to access businesses. This creates numerous issues including:</p> <ul data-bbox="399 1848 1428 2016" style="list-style-type: none">• Driver confusion about where to safely park• Reducing sight distance to other vehicles on the service road and pedestrians• Restricting access to businesses and blocking parking locations. |

| | <p>It is recommended that parking facilities are provided on the north side of Sturt Highway that are convenient and accommodate road trains and caravan drivers that regularly stop in Waikerie. The parking facility on Maggea Road is recognised however this is seldom utilised nor is it desirable for eastbound freight to perform three right turns in order to use this parking facility then continue east.</p> <p>This area could be used effectively for caravans, but needs improved signage to alert approaching drivers of this parking facility.</p> <p>Two locations that may be feasible to provide long vehicle parking include the currently vacant land east of Illalangi Gourmet Foods and the open paved area west of New Land Bakery. Both of these options should be explored for potential parking provisions.</p> |

| Item | Deficiency | Suggested Action | Risk Rating |
|---|---|---|---|
| 5. | Long vehicles parking on northern service road | Provide parking on the northern side of Sturt Highway for caravans and heavy vehicle combinations | A |

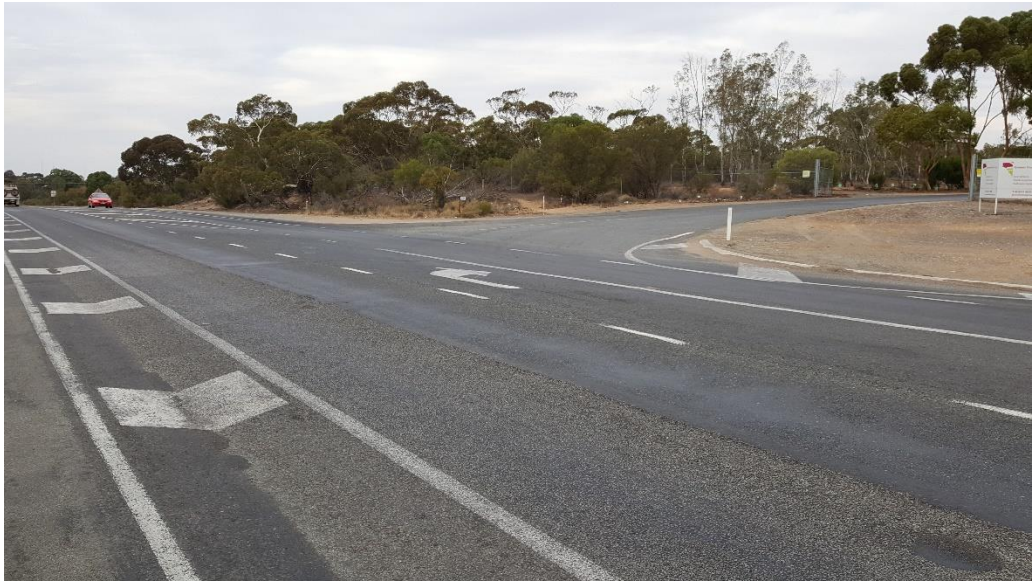
| 7 | Heavy vehicles driving over painted median when turning right into Growers Wine Group |
| | <div data-bbox="368 324 1406 902"></div> <p data-bbox="368 907 1406 974">Figure 7: The channelised right turn lane into Growers Wine Group was barely long enough, causing heavy vehicles to drive on the painted median prior to entering the turn lane.</p> <p data-bbox="347 1025 1433 1198">Heavy vehicles turning right into Growers Wine Group drive over the painted median island at high speed prior to entering the channelised right turn lane. This poses a high risk to pedestrians who regularly stand on this painted median when crossing Sturt highway.</p> <p data-bbox="347 1249 1433 1422">It is recommended that the channelised right turn lane is extended to safely accommodate deceleration and right turn movements, and a raised concrete median is installed to restrict vehicles from driving on the islands and increase the level of safety for pedestrians.</p> |

| Item | Deficiency | Suggested Action | Risk Rating |
|---|---|---|---|
| 7. | Heavy vehicles driving over painted median when turning right into Growers Wine Group | Extend channelized right turn lane | B |

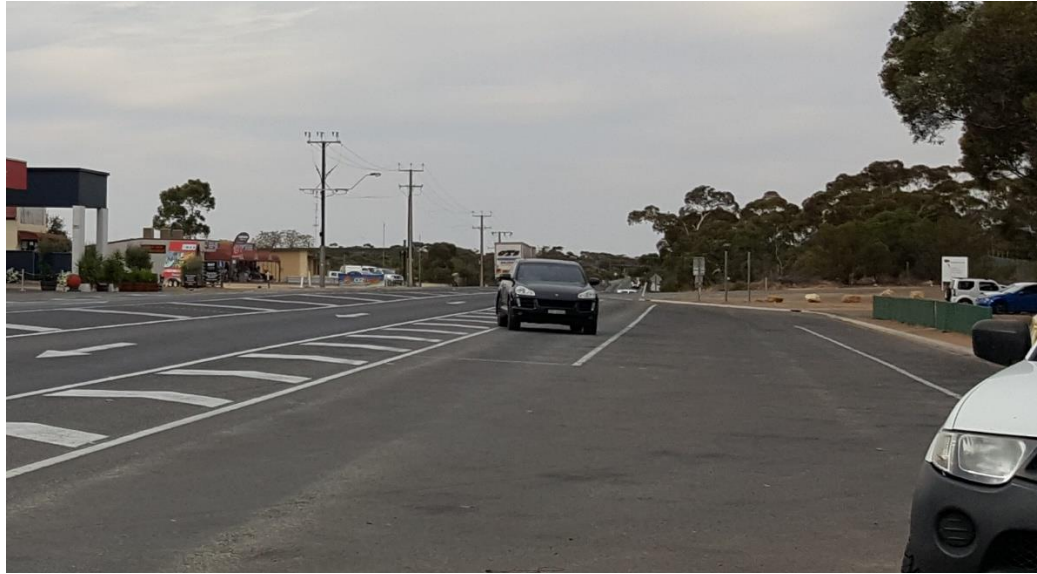
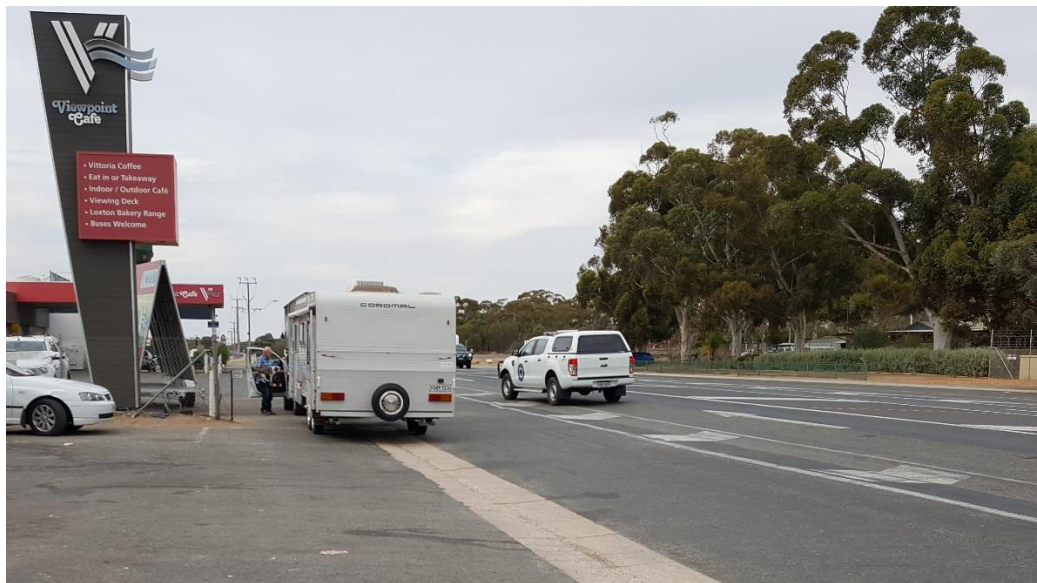
Painted Traffic Islands

Figure 8: Vehicles regularly enter and exit the highway sporadically over painted islands.

Figure 9: Vehicles regularly enter and exit the highway sporadically over painted islands.

Painted traffic islands and medians on site are functioning poorly. The intention of these devices is generally to direct and restrict traffic however painted traffic islands are regularly being utilised for U-turns, right turns and entering and exiting the highway.

It is recommended that raised concrete islands and medians are utilised as an alternative to painted traffic islands between Ian Oliver Drive and Growers Wine Group. Sections of painted island may still be used on the noses of these island to

| | <p>accommodate the wider swept paths of caravans and heavy vehicle where required.</p> <p>It is noted that if raised concrete traffic islands are installed that upgrades to street lighting will be required as discussed below in item 11.</p> |

| Item | Deficiency | Suggested Action | Risk Rating |
|---|---|---|---|
| 8. | Painted Traffic Islands | Utilise raised concrete islands and medians as an alternative to painted islands between Ian Oliver Drive and Growers Wine Group | A |

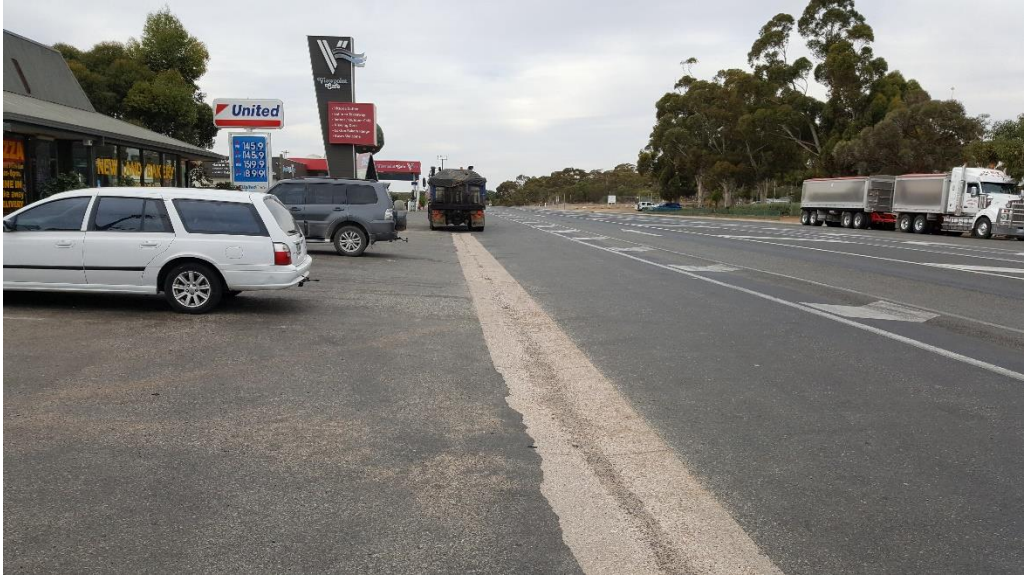
| 9 | <p>90 degree parking in front of New Land Bakery</p> <p>Figure 10: 90 degree parking in front of New Land Bakery causes some vehicles to back out onto Sturt Highway.</p> <p>Current 90 degree parking in front of New Land Bakery requires traffic to back out into the service road but in some cases vehicles are backing straight out onto Sturt Highway. Due to poorly parked vehicles, sight distance to the west is regularly restricted for these vehicles and they are backing out blind.</p> <p>It is recommended that 60 degree angle parking is installed to encourage drivers to back out into the service road rather than backing out onto the major highway. When parking in the area is formalised, sight distance issues for reversing vehicles should be far less common.</p> |

| Item | Deficiency | Suggested Action | Risk Rating |
|---|---|---|---|
| 9. | 90 degree parking in front of New Land Bakery | Convert to 60 degree parking to reduce the number of vehicles reversing onto Sturt Highway | C |

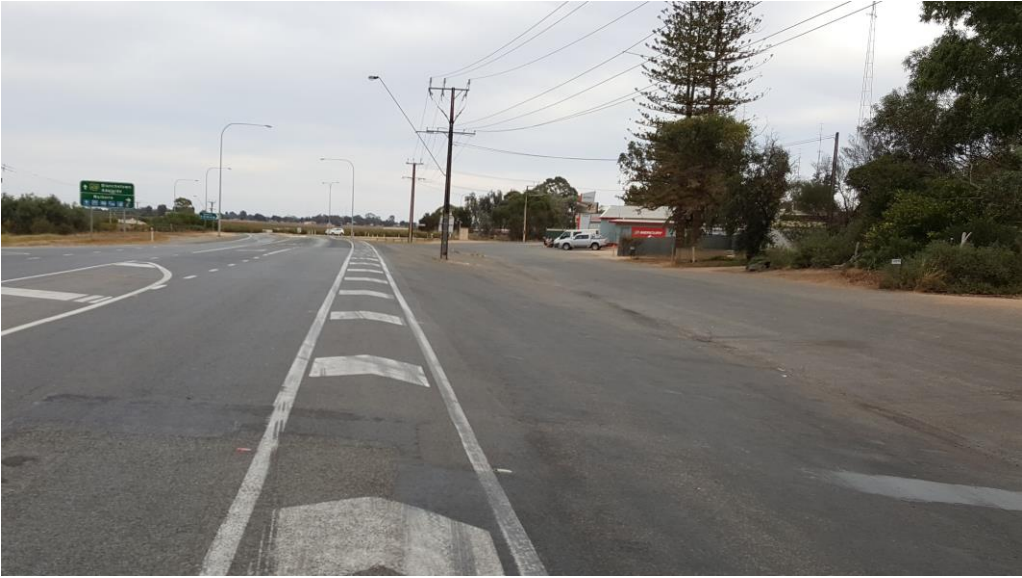
| 10 | Stobie Poles |
| | <p>Figure 11: Stobie poles present a hazard and also restrict potential parking locations</p> <p>Stobie poles on site are a crash risk however are generally set back from Sturt Highway. Two stobie poles in particular raise concern, namely the stobie pole opposite Maggea Road and the stobie pole opposite the Growers Wine Group driveway.</p> <p>It is recommended that these two stobie poles are removed and power is undergrounded, with hazard signs installed on stobie poles in the short time. This will provide safety benefits by removing hazardous fixed objects within the clear zone but also provide clear space to consider for additional long vehicle parking spaces.</p> |

| Item | Deficiency | Suggested Action | Risk Rating |
|---|---|---|---|
| 10. | Stobie Poles | Underground power in certain locations to remove stobie poles and create space for caravan and heavy vehicle parking. | C |

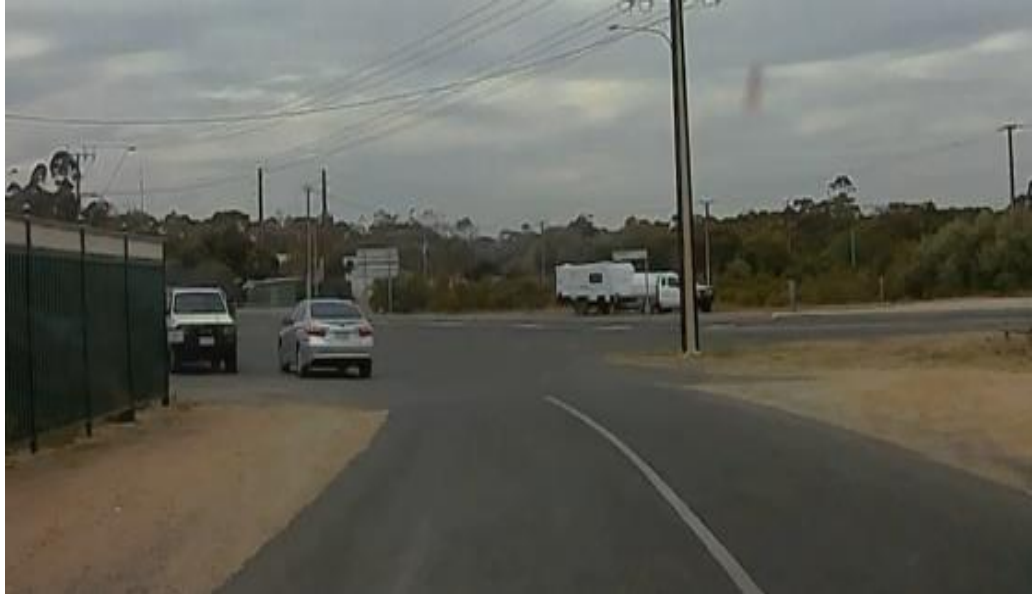
| 13 | <p>Poor layout at Railway Terrace intersection</p> |
| | <div data-bbox="368 506 1404 1097" data-label="Image"></div> <p>Figure 12: The end of Railway Terrace is very poorly delineated and priorities are not clear with the beginning of the Sturt Highway service road.</p> <p>The Railway Terrace intersection was causing a number of safety issues, including:</p> <ul style="list-style-type: none">• Vehicles turning right from Railway Terrace onto Sturt Highway,• Vehicles travelling west along the service lane to access Railway Terrace• Near misses between vehicles entering the service road from railway terrace and vehicles entering the service road from Sturt Highway. <p>It is recommended that this intersection is formalised with line marking and pavement bar treatments to restrict vehicle access directly onto Sturt Highway from Railway Terrace.</p> <p>Railway Terrace could be extended in front of residential properties to provide safe access to these properties and connect to the service road near the New Land Bakery.</p> <p>This would leave space between the Sturt Highway service road and the extension of Railway Terrace to consider for long vehicle parking, especially if the stobie pole is removed as recommended in item 10.</p> |

| Item | Deficiency | Suggested Action | Risk Rating |
|---|---|---|---|
| 13. | Poor layout at Railway Terrace intersection | Improve delineation with line marking and pavement bar treatments to restrict direct access onto Sturt Highway from Railway Terrace | B |
