Road Safety Audit

Intersection Southern Ports Highway & Southend Access Road, Southend

May 2019

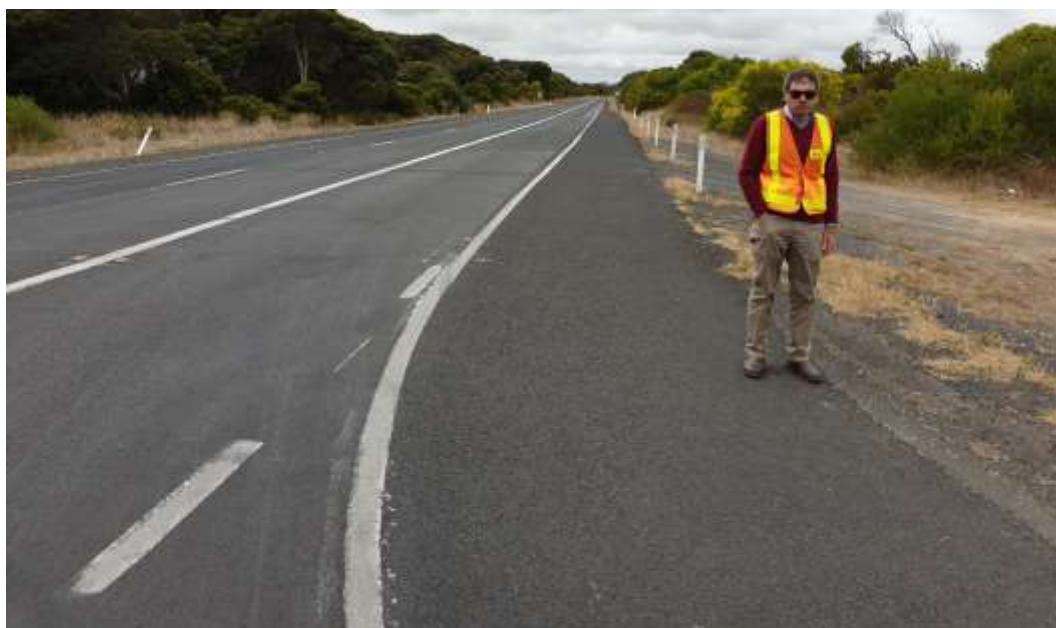
A left turn lane does not protect vehicles from trailing traffic when turning left from Southern Ports Highway with vehicles required to turn left from the through lane. The shoulder has been widened on the approach, which allows drivers to partially leave the through lane to make a left turn, however, this is of insufficient width to allow vehicles to fully leave the through lane.

Observations on site indicated that some drivers would utilise the wide shoulder to make a left turn whilst straddling the edge line and that other drivers would not cross the edge line to make a left turn. Trailing vehicles would often cross the solid dividing centre line to pass a left turning vehicle, placing them at risk of a head on collision with southeast bound traffic.

Another observed aspect of poor driver behaviour was an absence of safe following distances. With high volumes of slower vehicles (i.e. Caravans, tourists) travelling to Southend, tailgating was prevalent, giving less reaction time to the trailing driver should a vehicle slow down to make a left turn.

The widened shoulder sometimes utilised by vehicles turning left onto Southend Access Road

Construction of a sheltered left turn lane is recommended as the best option to address these issues, providing sufficient space for left turning vehicles to safely leave the main carriageway prior to turning.

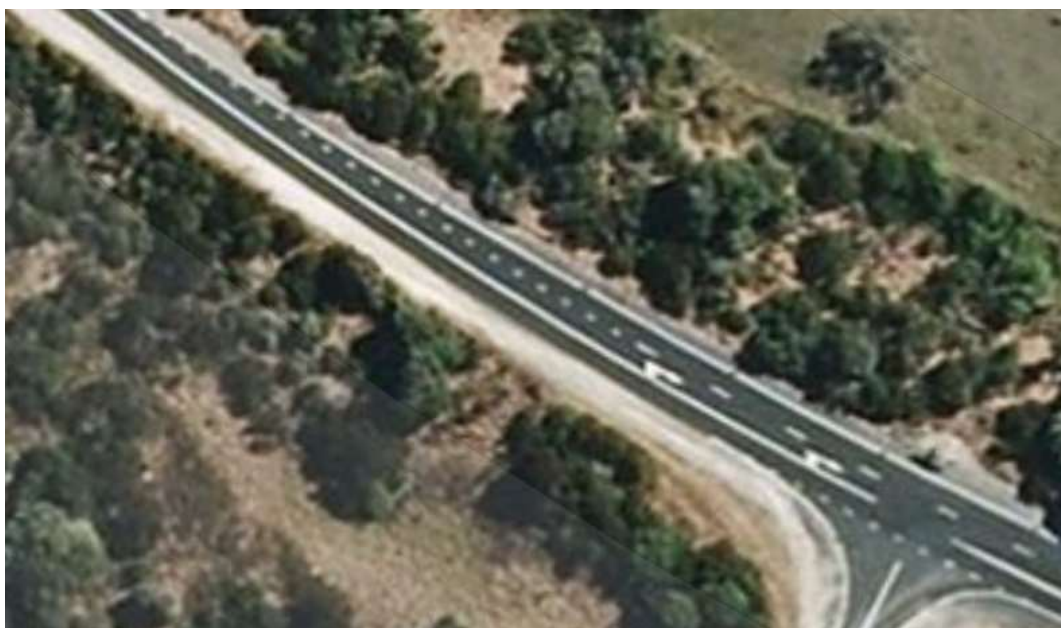
A dedicated right turn lane does not shelter vehicles turning right from Southern Ports Highway onto Southend Access Road. There are two southeast bound lanes through the intersection, with one being a through lane and the other a shared right/through lane. Line marking directs southeast bound vehicles into the shared right/through lane, regardless of whether they are intending to turn right or continue southeast, increasing the risk of a rear end collision occurring in this lane.

Line marking directs all southeast bound traffic into the right-through lane.

It is recommended that line marking on Southern Ports Highway be modified to create a dedicated right turn lane and dedicated through lane, with remaining road space to the southeast of the intersection converted to a painted traffic island. The painted island will provide clearance between northwest bound and southeast bound traffic streams to the southeast of the intersection. This additional clearance is particularly important when taking into account the poor driver behaviour observed and raised in item 1 and will provide extra protection when northwest bound vehicles cross the solid dividing line.

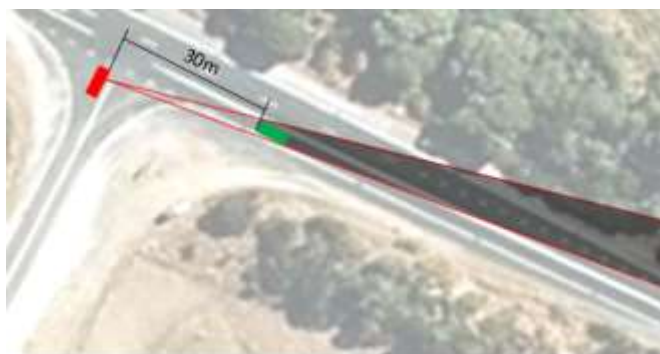
A vehicle turning from the main carriageway has minimal impact on sight distance to the southeast

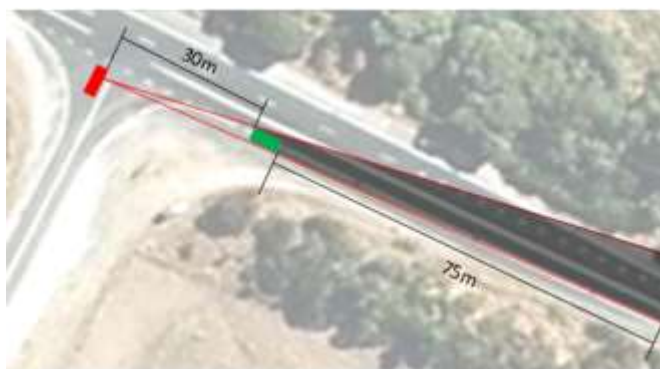
There are no obstructions to sight lines to the southeast from the holding position on Southend Access Road, and sight distance is substantial. It is possible for a vehicle turning left from Southern Ports Highway onto Southend Access Road to conceal the presence of through vehicles to a vehicle turning out of Southend Access Road as shown in the below diagrams.

A vehicle straddling the edge line to turn left obscures the entire northwest bound lane behind the vehicle.

It is of the auditor's opinion that installing a left turn lane as discussed in item 1 will provide greater awareness of the two northwest bound traffic movements through the intersection. It is reasonable to expect that all left turning vehicles will utilise the left turn lane, creating consistency with northwest bound movements through the intersection.

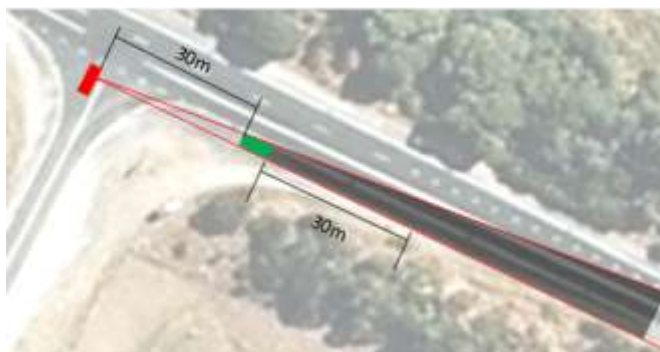
A vehicle turning left from the shoulder provides 30m of visibility behind the vehicle before completely obscuring the northwest bound lane.

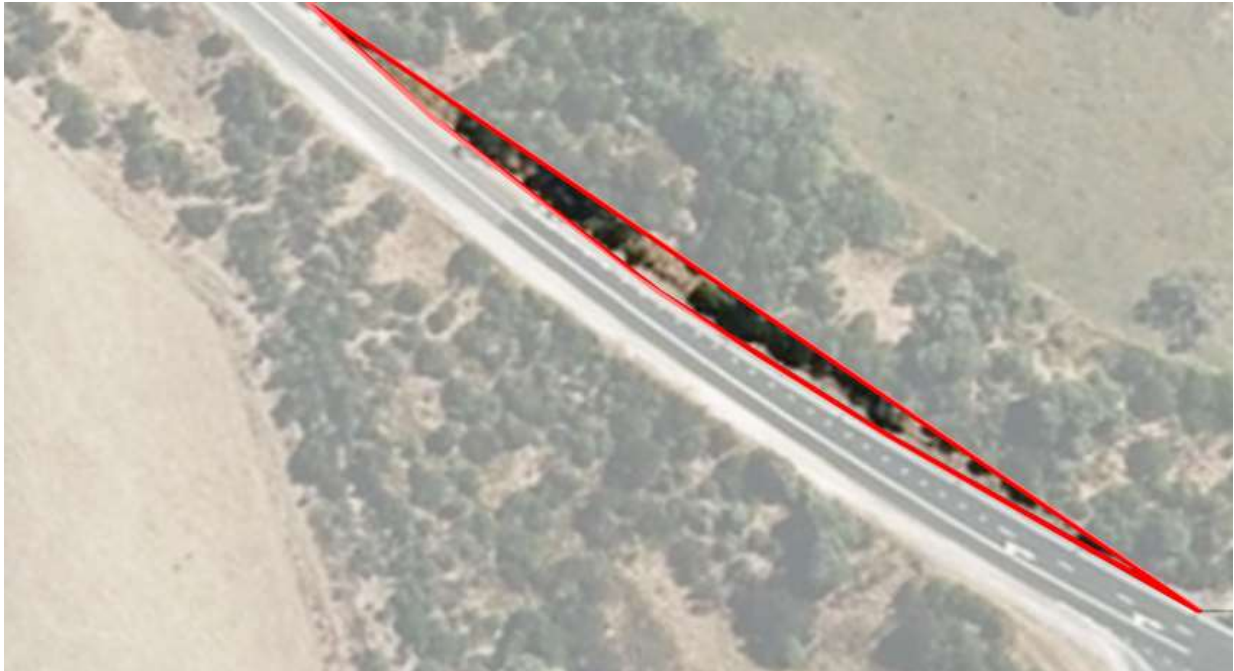
Vegetation highlighted in the below images is at risk of restricting sight distance of;

- Vehicles turning right onto Southend Access Road to southeast bound vehicles; and
- Southeast bound vehicles to vehicles turning right from Southend Access Road.

Satellite image highlighting location of vegetation

At the time of assessment, sight distance was sufficient and no immediate action is required. This should be monitored on a regular basis with consideration being given to removing some vegetation on the inside of the curve to prevent future overgrowth.

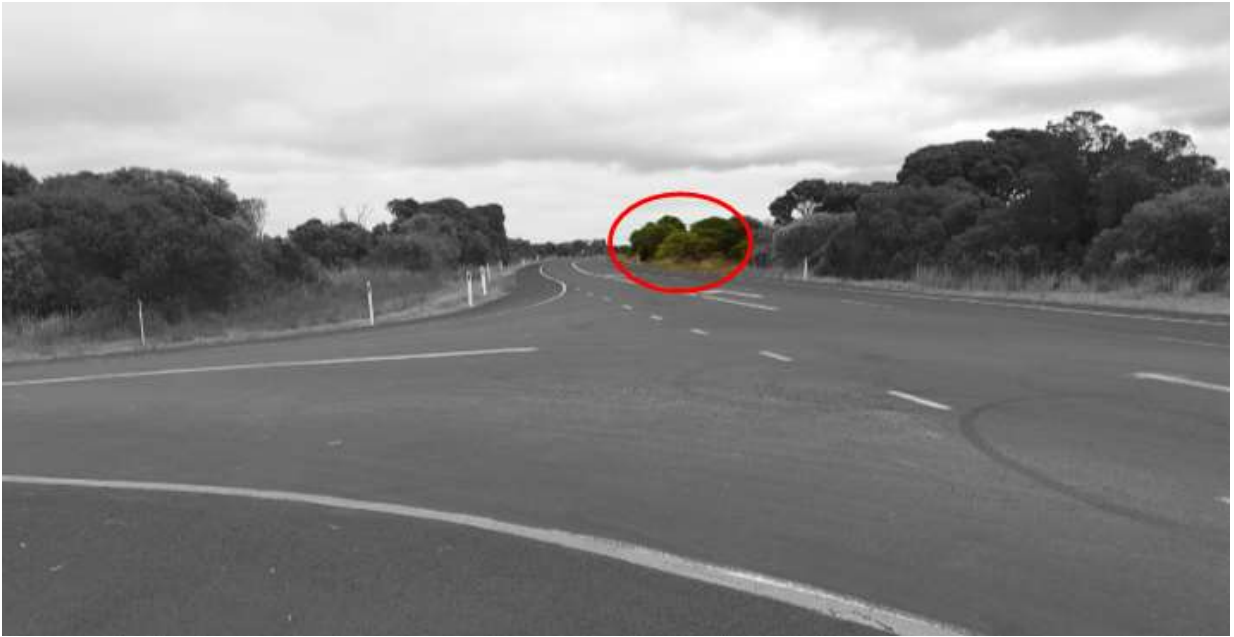
Vegetation on the inside of the curve
