# RAA Sinking Pit Cover Assessment

Road being assessed: Brighton Road

Date of assessment: 19/5/2017 & 29/6/2017

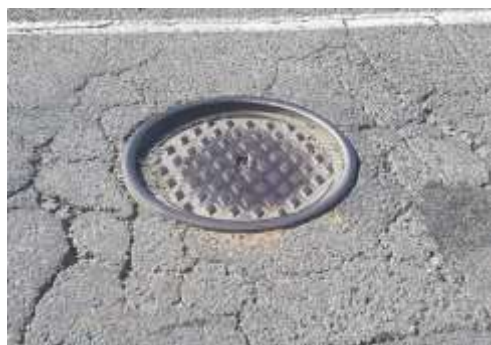
*Pit cover opposite Stephenson Ave*
