Risky Roads

Survey Results 2017

June 2017

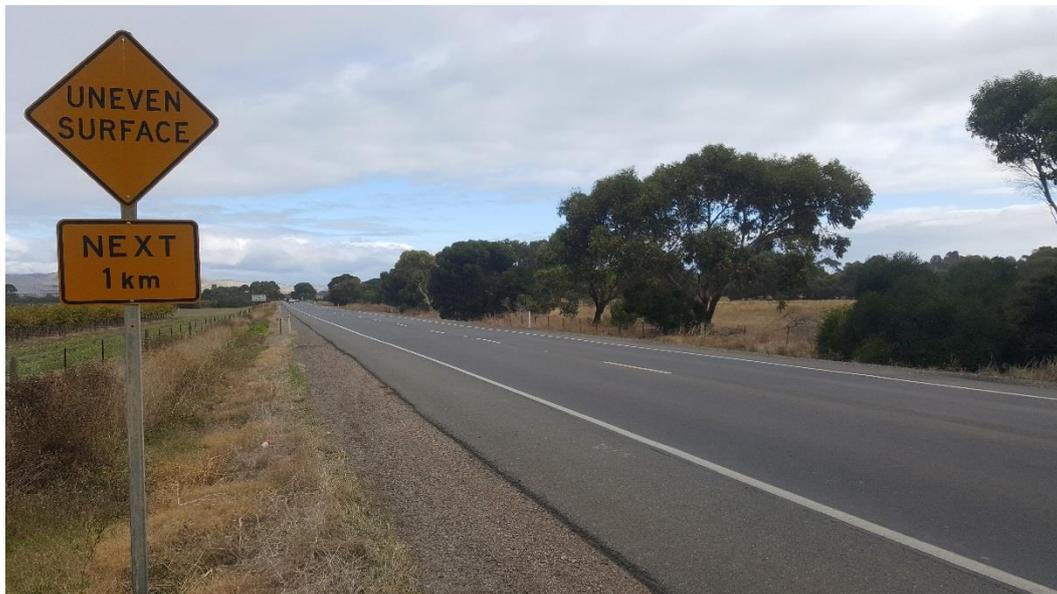
Respondents to the Risky Roads survey nominated Main South Road for its uneven or undulating surface, a lack of overtaking opportunities, as well as being too narrow. Respondents also nominated it for its inadequate crossing or turning opportunities, which is borne out by the number of intersections along Main South Road that also made the top 10 list. The number of pot holes was also highlighted.

The most common comment made by respondents regarding Main South Road was that it was inadequate for the sheer volume of traffic that uses it. Respondents cited the poor condition of the existing surface, stating that when localised repairs are made, they do not last very long before they break down and pot holes re-emerge. The undulating surface was another factor that led to respondents nominating this road. Several respondents also highlighted the damage that had been caused to their vehicles as a result of hitting potholes on Main South Road.

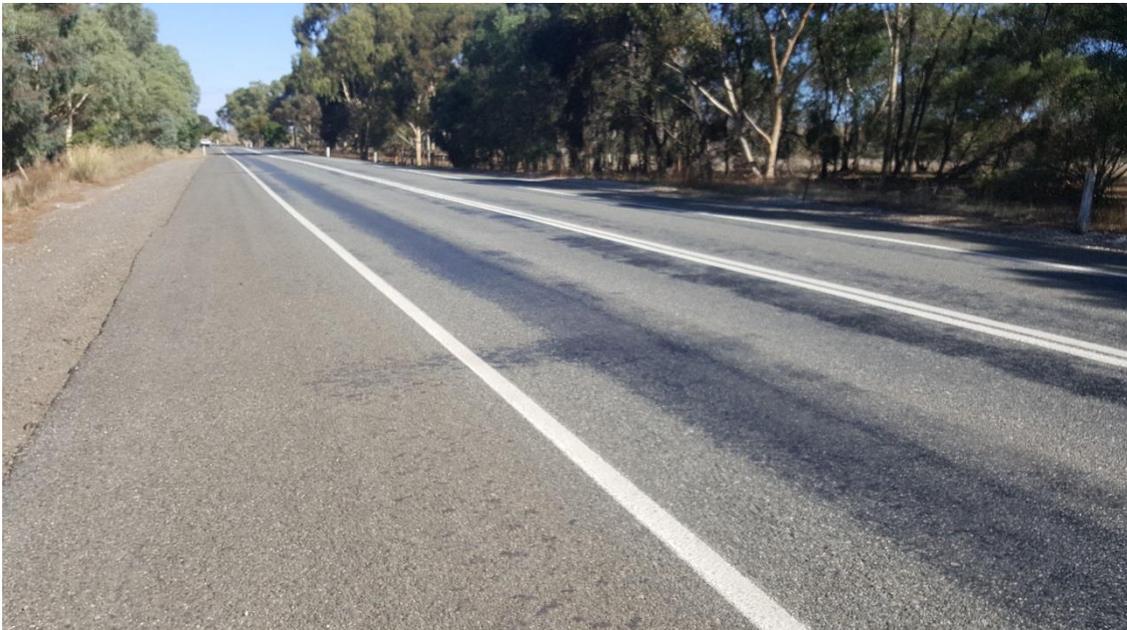
Respondents mainly nominated the Horrocks Highway for its uneven or undulating surface. They also had issue with pot holes, crumbling road edges and for the roads rough and loose surface. The primary focus of the comments that respondents left highlighted the often large undulations in the road surface which makes for a bumpy and unpleasant journey. Respondents noted the advisory 'Uneven Surface' and recommended reduced speed limit signs that had been installed, but highlighted that this should only be an interim measure. The undulations in the road surface are not only a problem for regular users of this road but pose increased risks for tourists, especially those who may be towing caravans or trailers.

As this road carries a mix of vehicle types, in their comments respondents also highlighted a lack of overtaking opportunities. Respondents said that this was particularly an issue at harvest times and during peak tourist seasons.

Based on the aforementioned issues, it will come as no surprise that respondents wanted the undulations to be fixed. A number of respondents also suggested that the road needed to be

Advisory signs highlight the uneven surface along the road, along with a recommended speed limit, but this is a reactive measure and infrastructure improvements need to be planned in order to address these issues. In addition to this, several overtaking lanes should also be installed.

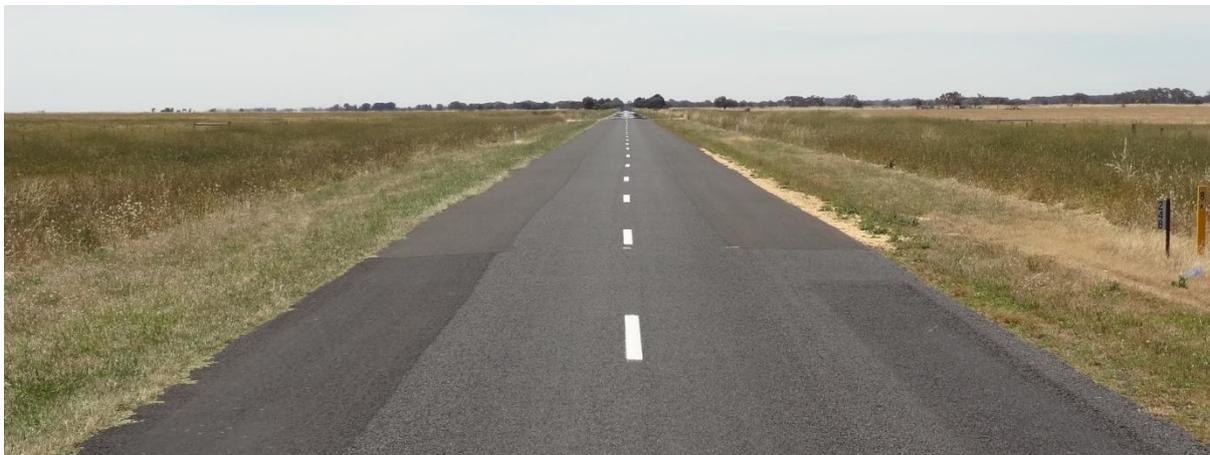
The narrowness of the road was an issue that was highlighted in the comments that respondents made. It was suggested that the road is too narrow for vehicles, especially the heavy vehicles that use it. This in turn adds pressure to the road edges and as such leads to crumbling. Respondents commented that when facing a heavy vehicle that is approaching them, it often feels too close when they pass.

Similar to the Horrocks Highway, respondents that nominated the Princes Highway called for it to be rebuilt in order to smooth the road surface. This would need to include road and shoulder widening as well as the installation of edge line markings.

The margin of error that heavy vehicles have to operate with on this road is way too small. Therefore RAA recommends the highest priority for this road, in particular between Kingston SE and Millicent should be to widen it to ensure adequate room for large vehicles to pass one another in sections that are currently narrow. Some work to improve road safety has been done on the Princes Highway, but there are still a number of things that need further improvement such as installing audio tactile line marking.

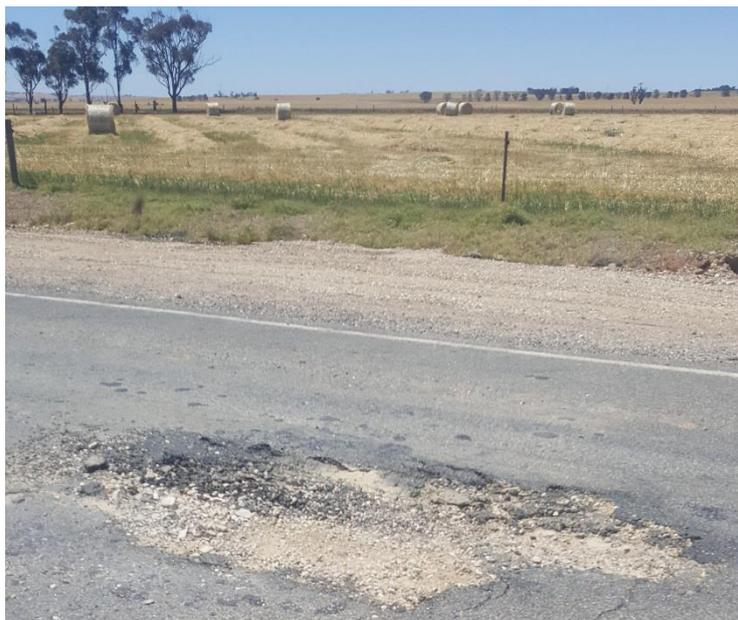
The majority of respondents who nominated Owen Road did so for its entire length. Those who nominated a section of Owen Road tended to make reference to the sections between Owen and Hamley Bridge as well as between Hamley Bridge and Templers. The road was nominated due to having crumbling road edges in the main. It was also nominated for having pot holes, an uneven or undulating surface and one that is rough, slippery or loose. Respondents highlighted the many patchwork jobs that have been done on Owen Road to fill potholes, which then quickly deteriorate.

For ways in which the road can be improved, respondents were unanimous in highlighting that the road itself is beyond the point where local patching can be done. They have called for the entire road to be resurfaced from scratch. Respondents claim that the road has been left in a state of disrepair for too long.

RAA Comment: The condition of Owen Road is reminiscent of the Bute to Kulpara Road that was featured in the 2013 Risky Roads report. In February 2017 it was announced that \$1.7m would be spent on a five kilometre section of Owen Road, between Alma South Road and Emu Road which is north of Hamley Bridge. RAA welcomes this investment but is concerned that it falls well short of what is required to bring the road up to an acceptable standard.

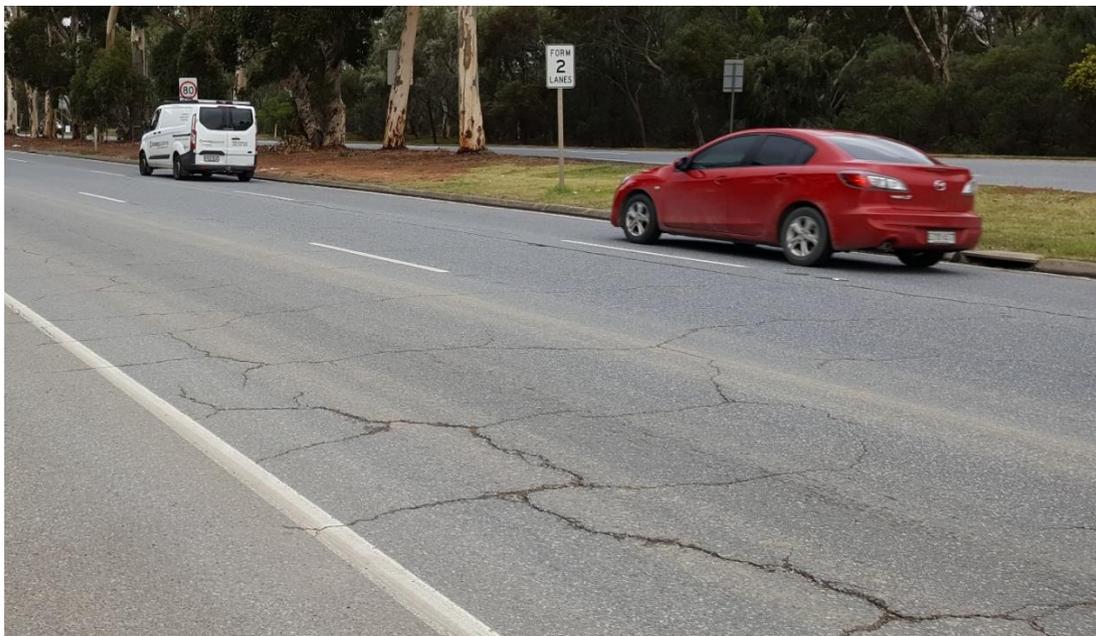
The main reason respondents nominated Main North Road was for its confusing layout. It was also nominated for having an uneven or undulating surface, crumbling road edges and potholes. Most people were inclined to nominate a section of Main North Road rather than its entire length. For those who nominated a section of Main North Road, their main area of concern was between Grand Junction Road at Gepps Cross and The Grove Way at Salisbury Heights.

For those who nominated Main North Road for its confusing layout they mainly made reference to the number of intersections along it where additional lanes are added, only for them to disappear soon after passing through. Respondents claimed that the constant requirements to merge causes frustration and congestion.

In response to this particular complaint, respondents suggested that an additional lane should not just be added at intersections, but installed along this particular stretch of Main North Road.

RAA Comment: The additional lanes that respondents refer to in their nominations have been installed in an attempt to try and increase the amount of traffic that can pass through these intersections. However, respondents in their comments tend to find them frustrating, claiming that they interrupt the flow of traffic and cause frustration amongst road users. RAA is unaware of any research that has been conducted that demonstrates their effectiveness.

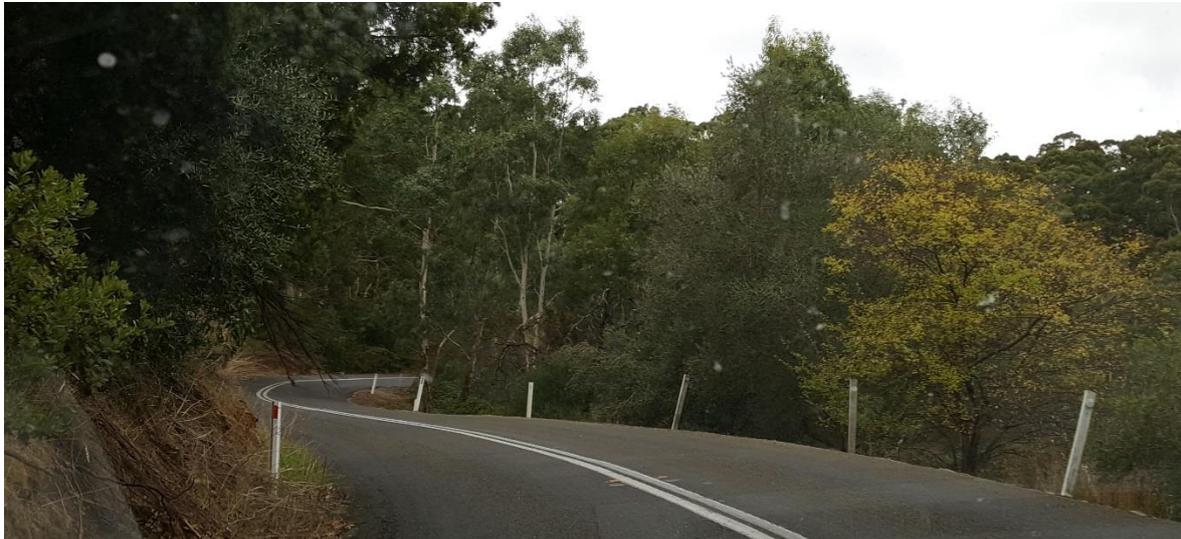
Respondents nominated Main Road because of how narrow it is. They also flagged that it has crumbling road edges, pot holes, a rough surface and that there are hazardous roadside objects that exist. Whilst a handful of nominations were for locations north of Blackwood Roundabout, many of them were actually for a section further south, particularly near Black Road.

For this particular section, respondents felt that the road has a dangerous drop off for most of its distance between Black Road and Oakridge Road without guard barrier protection. It was also highlighted that the road surface along this particular section was breaking down. The lack of cycling infrastructure was also mentioned, with respondents highlighting the risks that poor sight lines and badly worn edges when passing through corners poses.

Respondents have called for the road to be realigned, widened and resurfaced. They also called for the installation of guard barriers and some also called for a speed limit reduction.

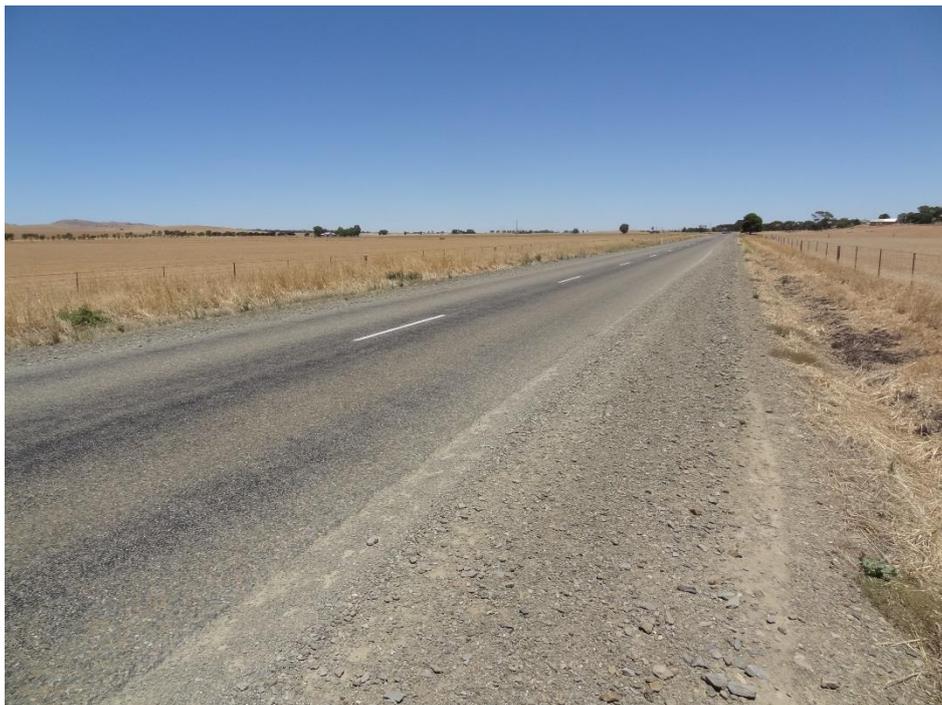
Nominations regarding the quality of the road surface were prominent for the Barrier Highway. Respondents nominated it due to its crumbling road edges, as well as for having an uneven or undulating surface. Issues with pot holes were also raised as well as the road width being too narrow.

In their comments, respondents stated that there can be sharp drop offs at the edge of the road where heavy vehicles wear the gravel shoulders away. Perhaps one of the reasons why this occurs is because of the undulating surface of the road, which makes it more difficult for heavy vehicles to stay in their lane. Respondents also stated that there are potholes, of which some have been repaired, although once filled, it doesn't take too long for the holes to form again.

Respondents that nominated the Barrier Highway have called for the road surface to be improved as well as for the road to be widened.

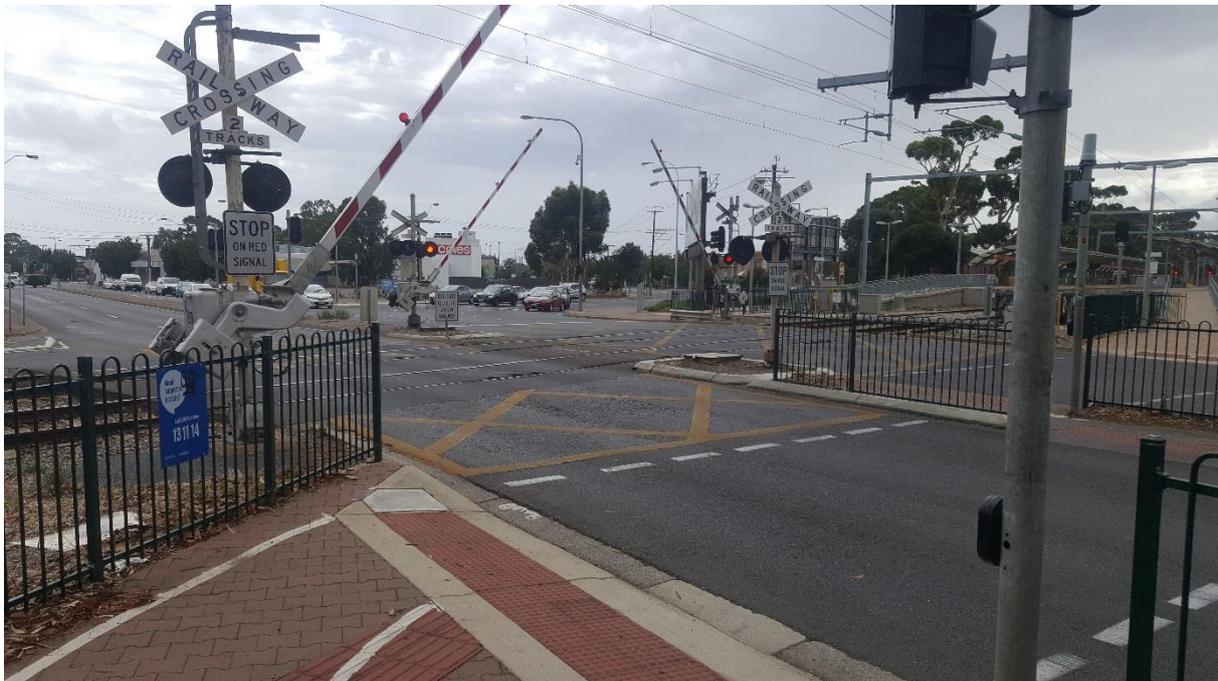
For respondents who nominated the Oaklands Rail Crossing, they highlighted that it had a confusing layout, that there were inadequate crossing or turning opportunities and that the traffic signals were also inadequate. Comments not only reflected the poor travel times at this intersection throughout the day but also flagged the confusing layout and the high number of traffic signals which can be interpreted incorrectly.

Perhaps unsurprisingly, the overwhelming call from respondents as to how this intersection could be improved was to have some form of grade separation. There seemed to be little preference of whether it should be an overpass or an underpass or of which mode of transport should be subject to the grade change.

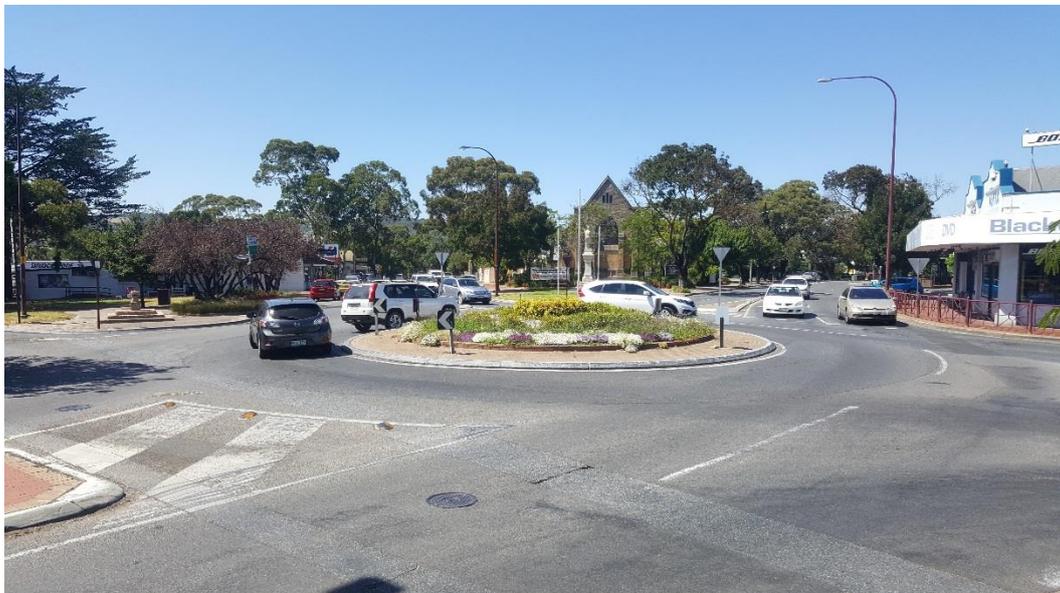
In the Risky Roads survey, respondents flagged issues with its confusing layout as well as how there were inadequate turning opportunities. They also highlighted how there was a need for traffic signals at the roundabout and that pedestrian crossing facilities needed to be improved.

Generally, respondents highlighted how dangerous it is to navigate Blackwood Roundabout because it is too small for the volume of vehicles it is expected to handle. It was suggested that road users take many risks when navigating it and that it can be confusing to know which lane to get in prior to entering; in particular flagging the left turn lane from Shepherds Hill Road onto Main Road as an issue. Similar to Britannia Roundabout before it was upgraded, respondents claimed that motorists try and avoid it, thus putting more pressure on side streets. Another frustration that respondents flagged was with the height of vegetation within the roundabout, which can restrict visibility.

In terms of improvements, there were a range of suggestions which included installing traffic signals, either full time or part time. Others stated that the roundabout needed to be redesigned and that one of the arms such as Station Avenue needed to be blocked off. As a short term measure respondents welcomed having vegetation within the roundabout but commented that it needed to be smaller, which would help visibility.

This location represents a long-standing issue for the communities of Blackwood, Coromandel Valley and beyond, and based on the number of nominations it received it replaces Britannia Roundabout as the 'worst roundabout in the state'. It is vital that it does not take as many decades to fix as its predecessor.

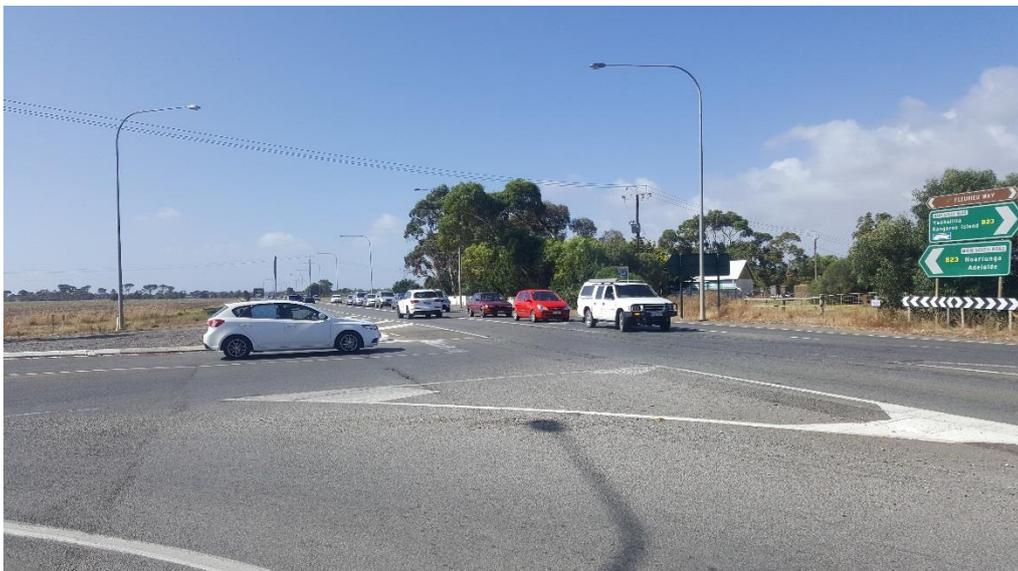
This particular location is the worst intersection on Main South Road for casualty crashes in the past five years. The crashes that occurred mainly involved vehicles making right turns either into or out from Aldinga Beach Road and were caused by failure to stand or by disobeying a stop sign.

In responses to the Risky Roads survey, respondents highlighted that there were inadequate crossing or turning opportunities at this intersection and that it had a confusing layout. An inappropriate speed limit was also flagged as well as the presence of pot holes. In mirroring the crashes that have occurred at this intersection, respondents to the survey highlight the risks of turning out from Aldinga Beach Road onto Main South Road. They pointed out that it can often take a lot of time exiting Aldinga Beach Road because of high traffic volumes on Main South Road, which in turn means that road users are more likely to undertake more risky manoeuvres in order to progress.

The most common suggestion for improvement at this intersection was to install traffic lights. However, respondents also stated that the road needed to be duplicated to cope with the increase in traffic volumes that has occurred due to the expansion of residential development in the area. The installation of a roundabout was also suggested as was the lowering of the

speed limit on Main South Road, although with the latter it is unclear whether this referred to the reduction in speed that already occurred in 2016.

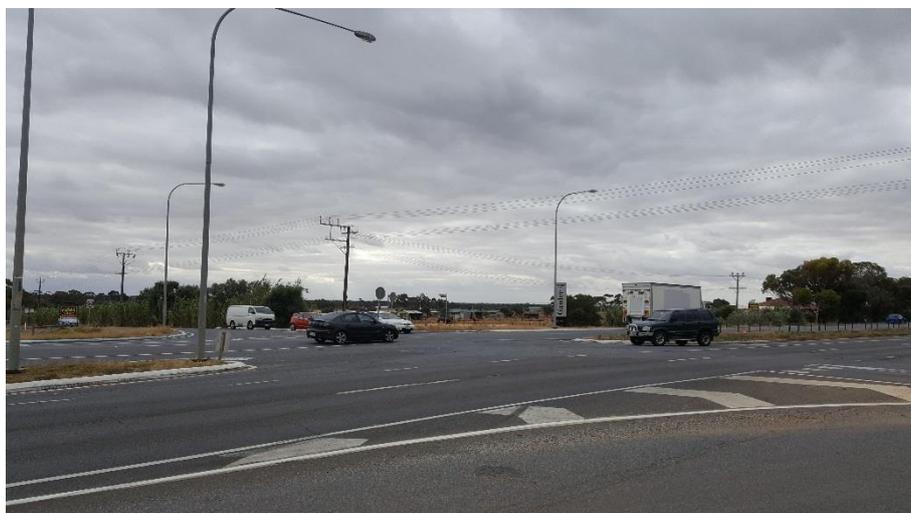
A scroll through the archives from The Bunyip brings up many articles regarding resident frustration regarding this intersection and how there have been several unsuccessful attempts to secure Black Spot funding to make it safer. The majority of crashes that occur at this intersection are right angle crashes, most often as a result of vehicles on Dalkeith Road disobeying the stop sign, by virtue of either not bringing their vehicle to a complete halt or by not giving way to vehicles on Main North Road.

The main focus of the nominations for this intersection were that there was inadequate crossing or turning opportunities and that there was a lack of traffic signals. Respondents also highlighted the confusing layout of the intersection as well as the lack of road lighting. In their comments, respondents highlighted that there had been many crashes at this intersection. They suggested that traffic can often be banked up on Dalkeith Road, which leads to frustration. This may lead to road users taking unnecessary risks when they arrive at the intersection. They also highlighted the risks of trying to navigate across a highway where the designated speed is 90km/h. It was also suggested that there is inadequate provision for cyclists at this intersection as it is the only practical route between Blakeview and Evanston South.

There was a general consensus amongst respondents that vehicles needed to be controlled better through this intersection, by way of traffic signals or a roundabout. It was also suggested that installing a similar seagull treatment that is used at the intersection of Main North Road and Karri Street at Munno Para West would improve safety.

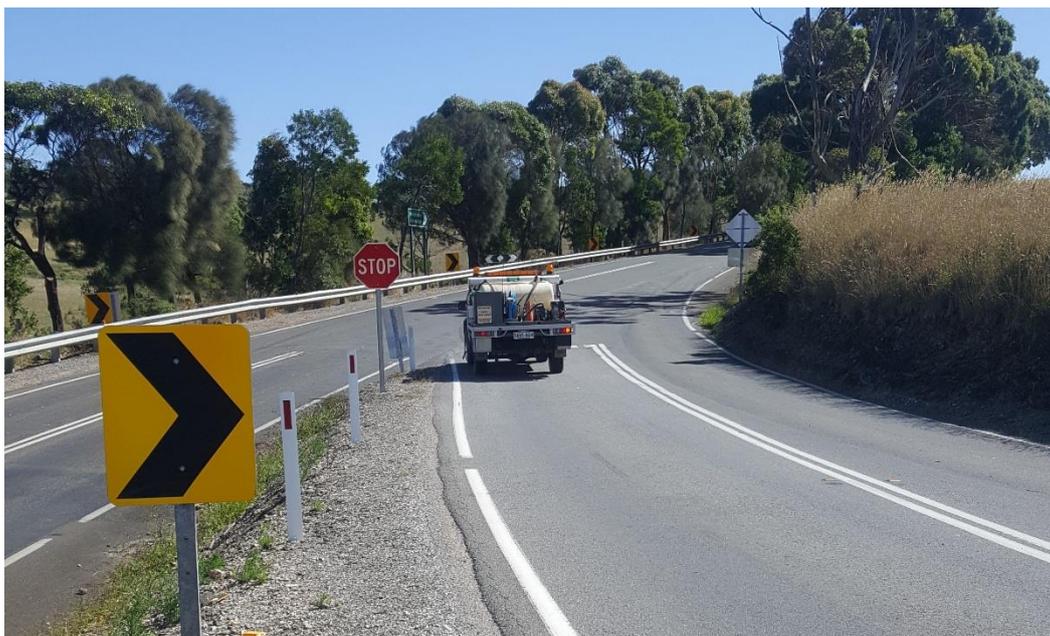
Survey responses for this intersection highlighted the poor sight distance, as well as the tight curves that are present on both roads. Respondents flagged that there were inadequate turning opportunities at the intersection and that it has a confusing layout.

In respondent comments, they flagged that in particular, when turning north from Paris Creek Road onto Bull Creek Road towards Meadows it is very difficult to see approaching traffic. It is a blind intersection and some respondents claimed that when negotiating it they just have to drive out and hope for the best. This is compounded by the fact that when turning onto Bull Creek Road, as well as having visibility issues, road users are then faced with an incline which means that it takes them longer to get up to speed.

Comments on how to improve this intersection varied. Short term measures included installing a mirror to try and improve visibility at the intersection, changing the speed limit as well as changing the priorities for who is required to give way. More long term suggestions included installing a separation lane on Bull Creek Road with an entry lane from Paris Creek Road.

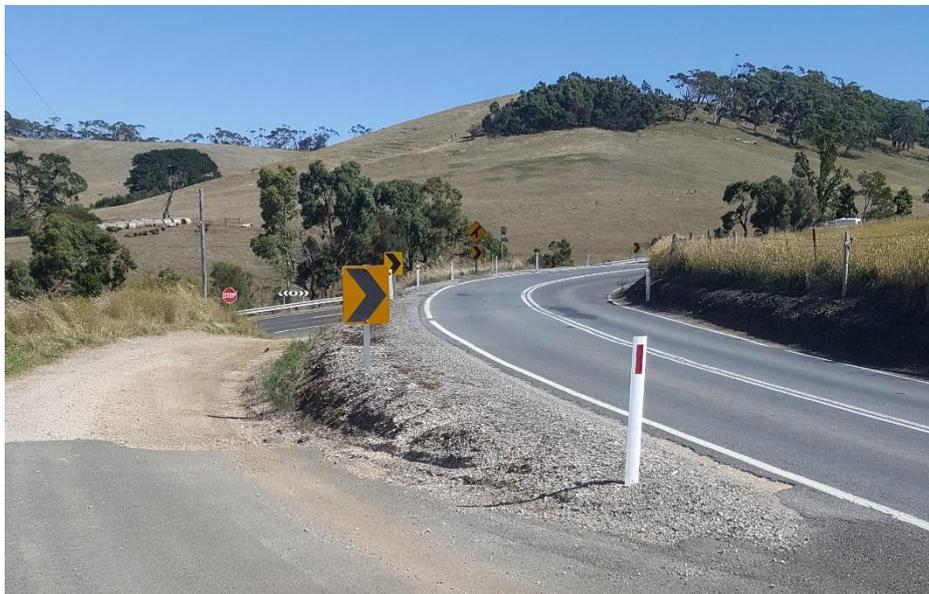
RAA Comment: This is an extremely dangerous intersection. The crash statistics may not support the need to upgrade the intersection but it poses significant risks to road users and is not conducive towards a safe systems approach. The condition of the alternative dirt road section of Paris Creek Road down to Bull Creek Road is not in an acceptable condition.

The best solution at this intersection is to undertake significant earthworks removal and road realignment to provide a single access point with increased sight distance onto Bull Creek Road. However, this would clearly be the most expensive treatment.

As a minimum, the unsealed filter lane down to Bull Creek Road should be sealed and the curve on Paris Creek Road, as shown in the above image, needs to have guard rail protection.

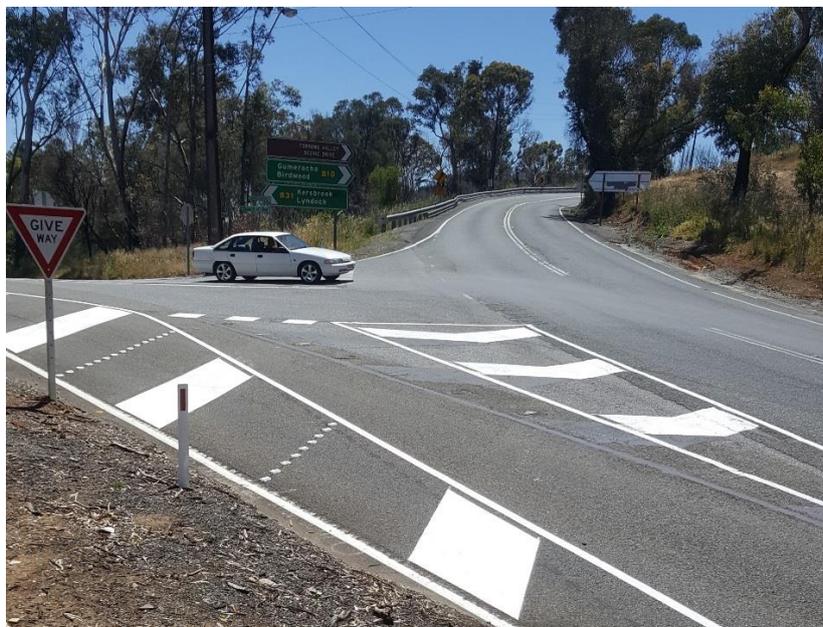
The main reasons respondents nominated this intersection is because of its poor sight distance as a result of the many curves and blind crests on North East Road. They also nominated it due to inadequate crossing or turning opportunities and for its confusing layout. Poor signage was also flagged as being an issue. These issues were also raised in the Risky Roads survey of 2013, although it received more nominations this year.

The comments that respondents left were mainly in relation to the aforementioned line marking upgrades that were made at the intersection in 2016. Respondents complained about the need to give way when turning left onto South Para Road and also about the way that the modified slip lane places vehicles in the path of oncoming vehicles on South Para Road.

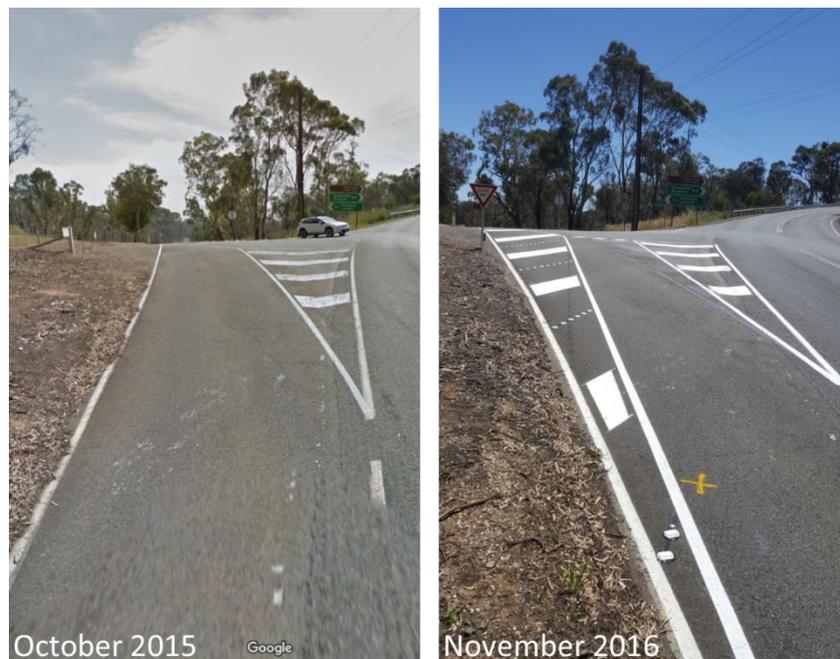
RAA Comment: Since the line markings were refreshed at this intersection in October 2016 RAA has received a number of complaints from the local residents' association regarding the work that had been carried out. In refreshing the line markings the left slip lane on North East Road was enhanced and a give way sign was installed. The problem that has been raised is that road users believe that these line markings represent a change in the requirement to give way, yet this has always been the case. This in itself highlights a concern as well as the risk that is posed by this intersection. It is possible that the previous line markings combined with the crest of the hill made it difficult for road users to interpret.

These upgraded line markings have made no difference to the fact that the requirement to give way is placed upon those vehicles turning left onto South Para Road. However, road users do not understand why this is the case. Respondents highlighted that the left turn follows a blind bend but this is equally the case for those vehicles turning right and arguably the risk of a crash occurring is higher for those vehicles that are stationary on North East Road whilst waiting to make this manoeuvre.

These line marking upgrades can only be a short term measure. What is recommended is that lane widening is conducted prior to this intersection to enable the left hand slip lane to be lengthened.

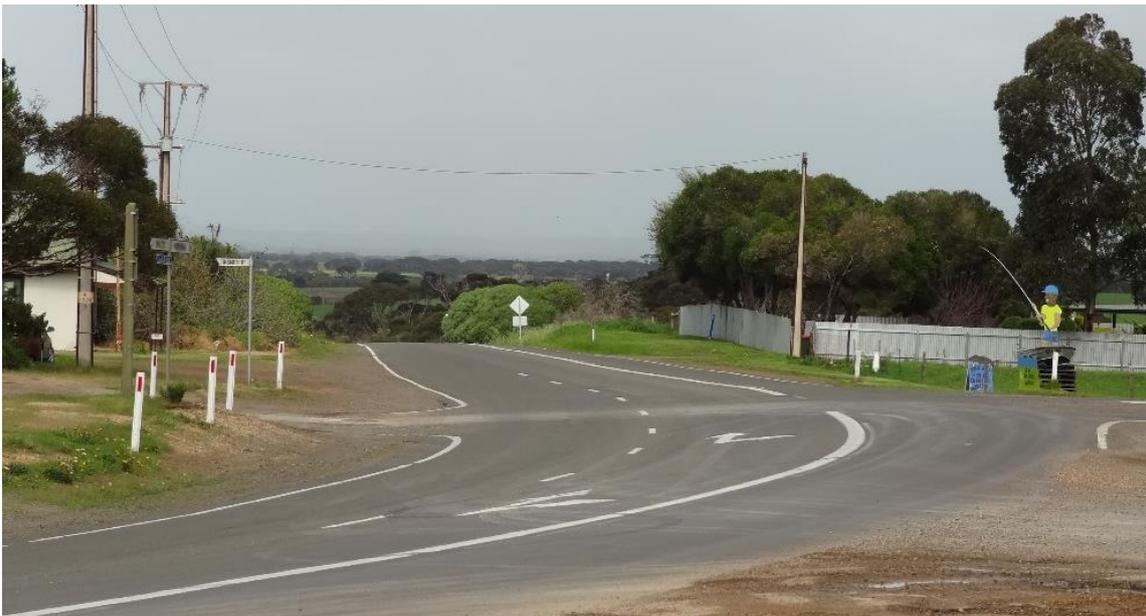
The main reason respondents nominated this particular intersection was due to its inappropriate speed limit. They also highlighted that it had inadequate crossing or turning opportunities and has a confusing layout. Comments that were left for this intersection were that the speed limit is too fast for the bend and that vegetation is encroaching onto the road space. Respondents highlighted that turning onto Playford Highway was a problem due to the high speed limit and that visibility was an issue due to the bend in the road.

Most people who nominated this intersection agreed that the speed limit needed to be dropped on Playford Highway, although there were also some suggestions that vegetation needed to be better managed and the road needed to be widened to improve sight distance.
