RAA Sinking Pit Cover Assessment

Road being assessed: **Marion Road in full**

Date of assessment: 18-06-2018 and 26-06-2018

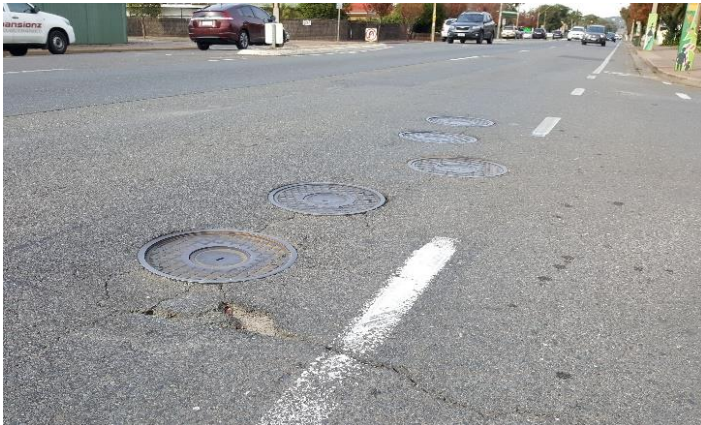
Series of 5 covers at the intersection with Andrew Avenue
