# **Clare and Goyder**

**Regional Road Assessment February 2018**

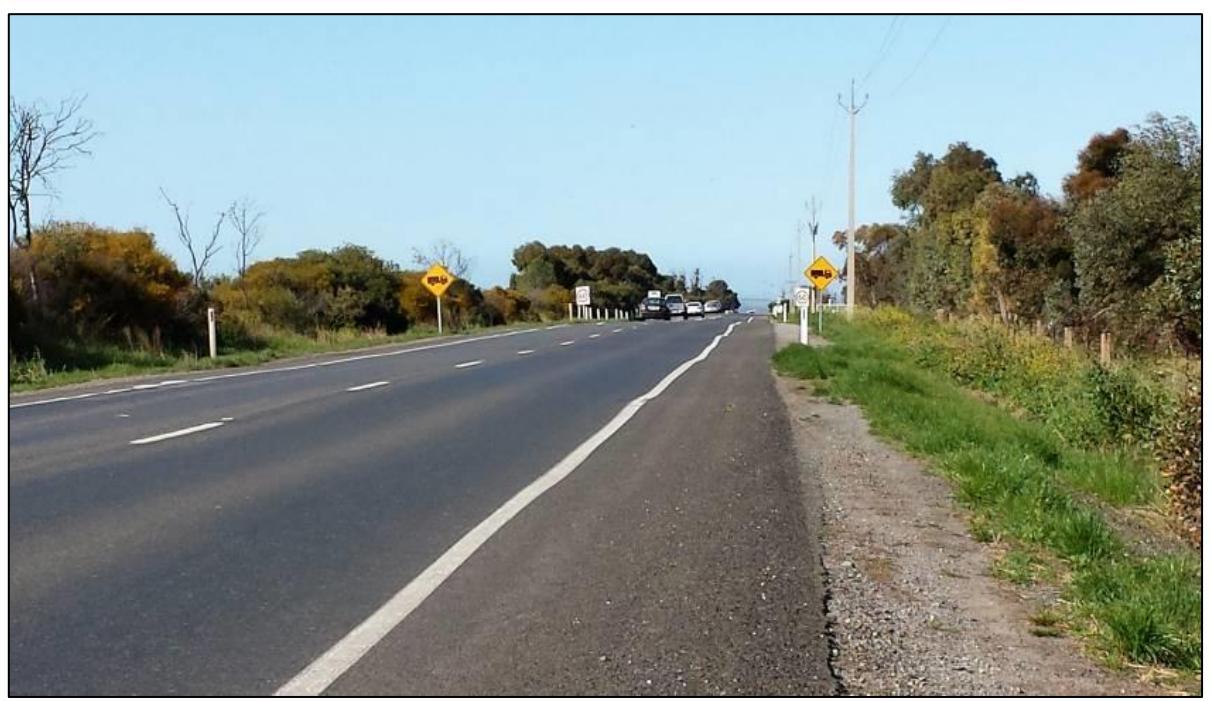
Road reconstruction is required south of Tarlee to address major failures, which was a major issue identified in RAA's Barossa and Light Tourism Region Assessment

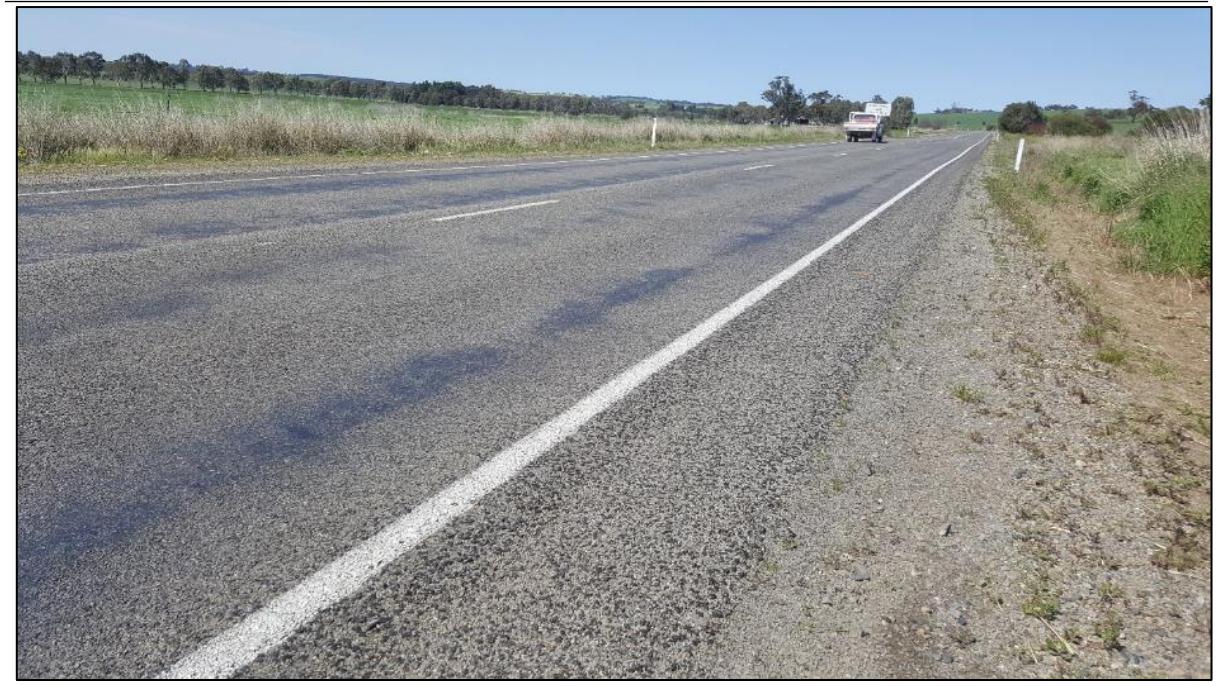
Rutting and surface polishing is prevalent between Tarlee and Rhynie

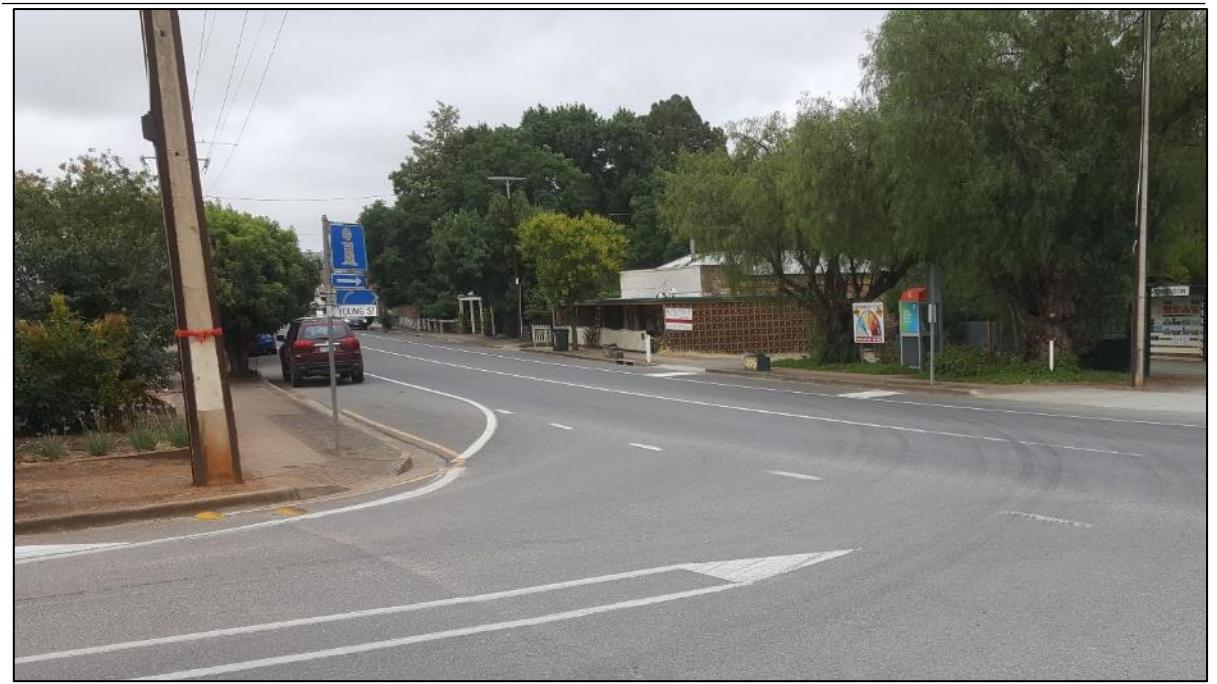
A continuity line such as this one pictured at the Port Road intersection helps maximise sight distance past parked vehicles

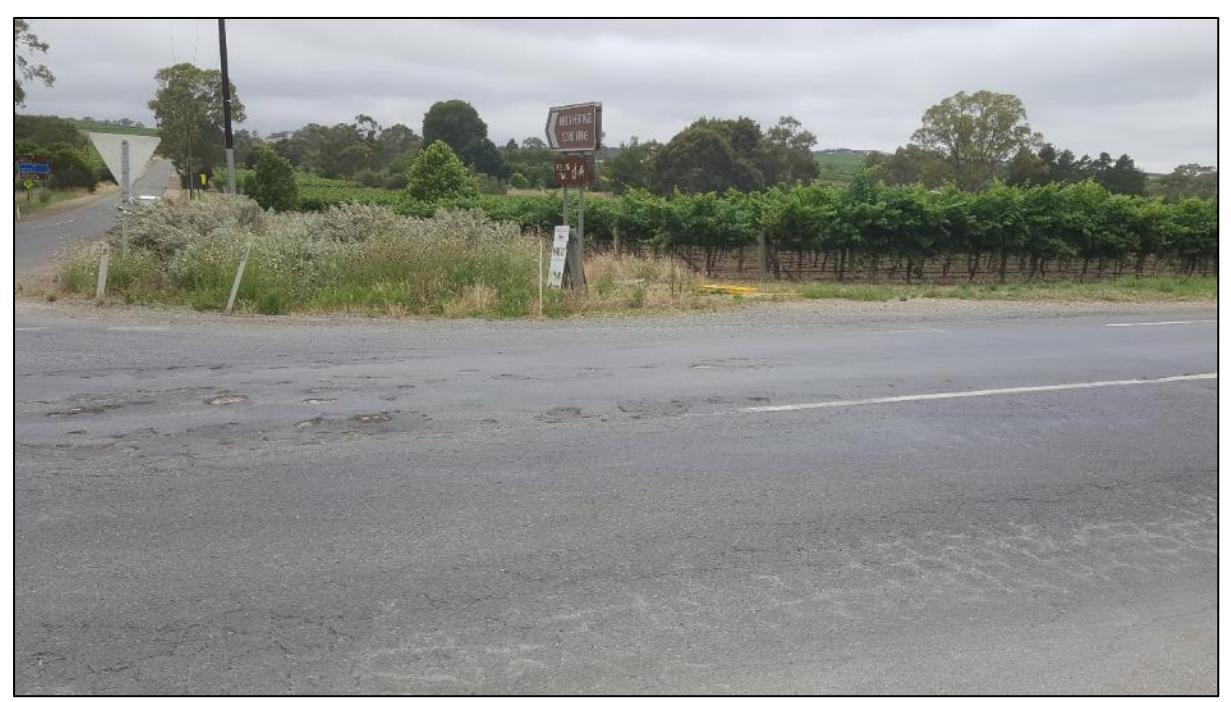
There were also a significant number of small potholes forming at the intersection as well as cracking and rutting, with the whole intersection overdue for a reseal.

The surface of Horrocks Highway at the Mintaro Road intersection is very poor

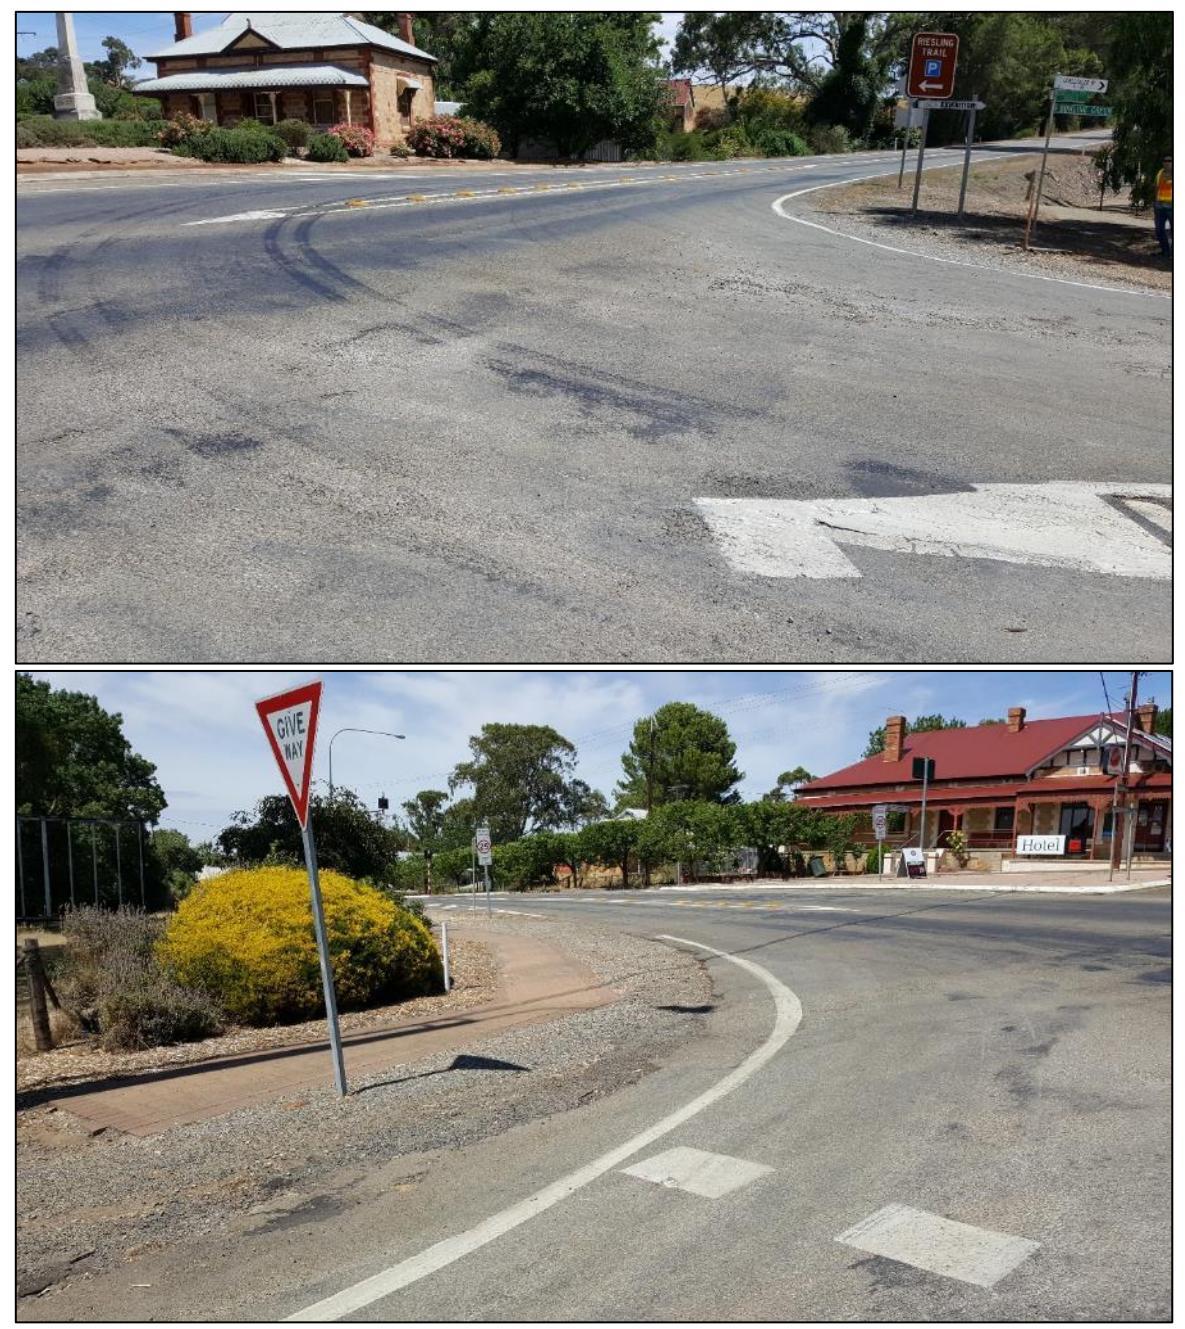
Top: Poor sight distance to the north Bottom: Poor sight distance to the south

An R1-1 'Stop' sign treatment may be more appropriate than the current give way signage and it is recommended that this is considered. A continuity line installed along the edge of Horrocks Highway is also highly recommended to delineate the edges and to assist motorists in determining a suitable position to maximise sight distance.

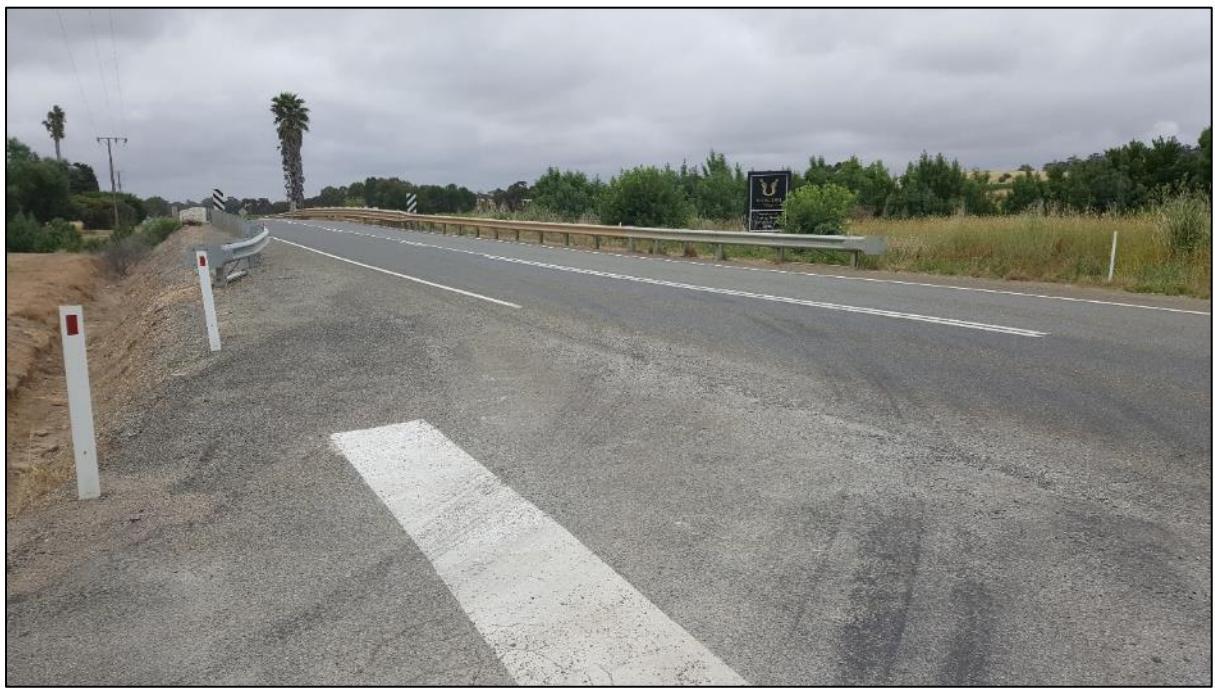
Stradbrooke Road runs alongside the Clare Valley Racing Club and the intersection with Horrocks Highway is controlled with a stop sign. Sight distance to the north when turning right from Stradbrooke Road was severely compromised due to the close proximity of the Hutt River Bridge. This bridge is raised, and corresponding barrier protection also impedes sight distance.

Sight distance to the north is very poor

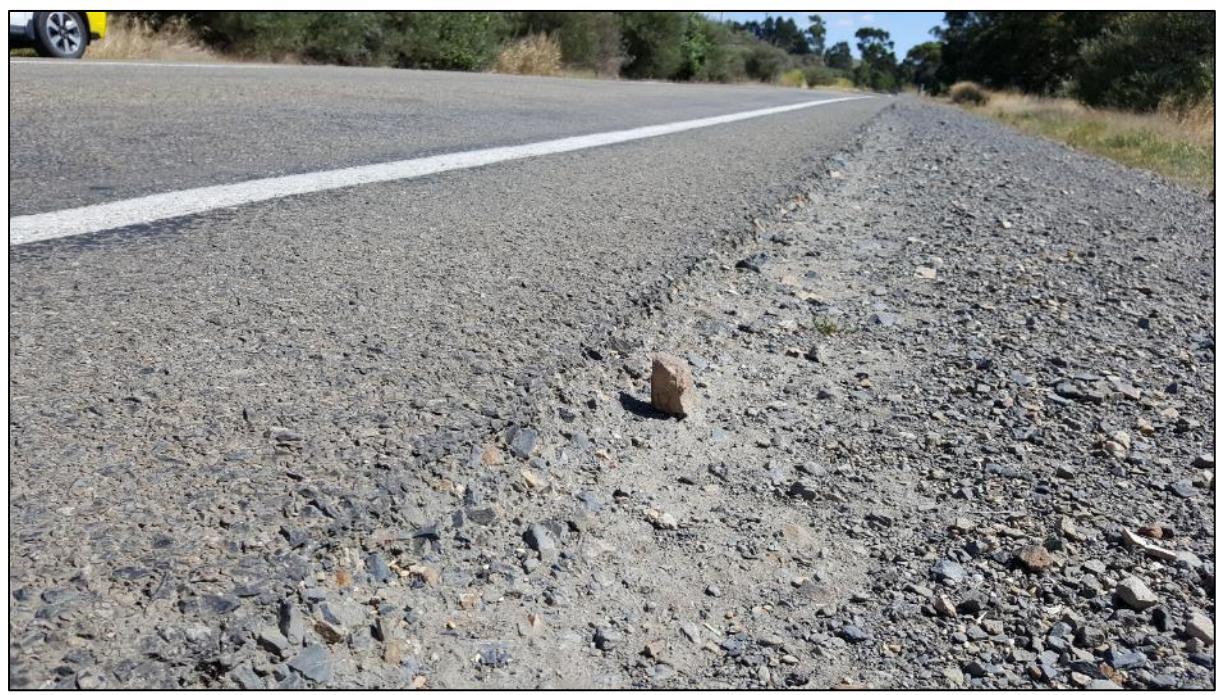
There are sections of the highway where the pavement is failing and cracks and potholes are present, indicating that there are areas that may be nearing the end of their serviceable life. There are also sections where the drop off from sealed to gravel shoulder is in the order of 50-100mm.

Severe edge drop-off south of Riverton

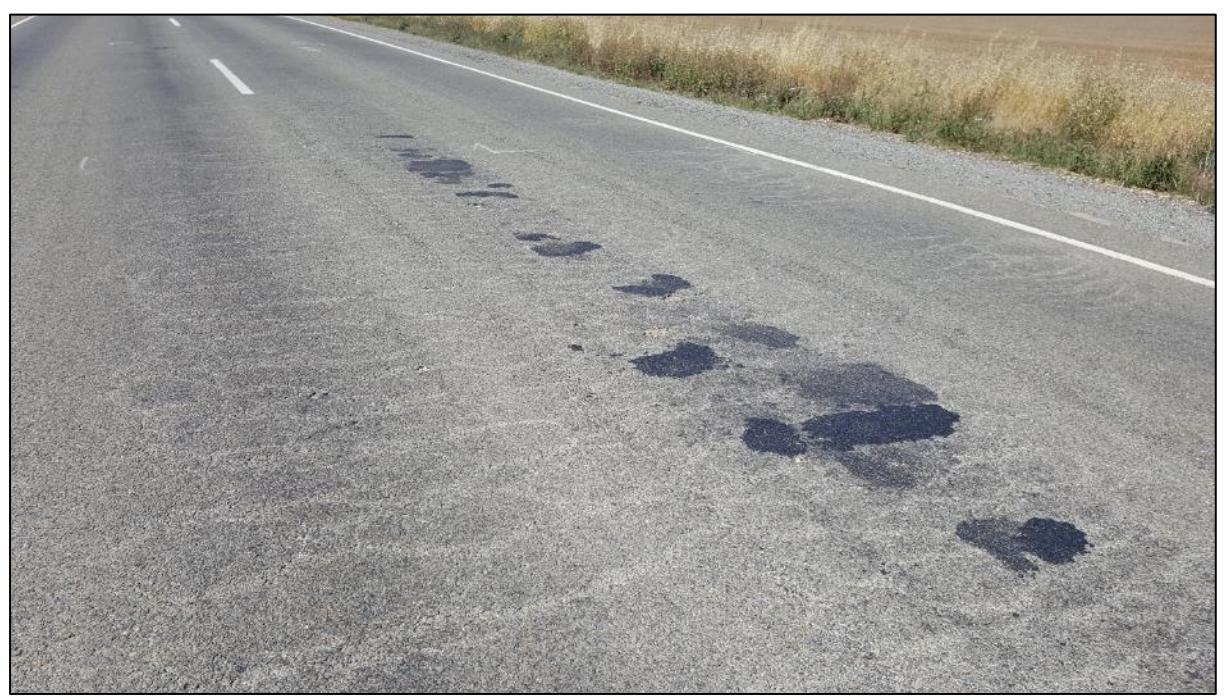
Localised cracks and potholes indicate that the pavement is failing and near the end of its serviceable life

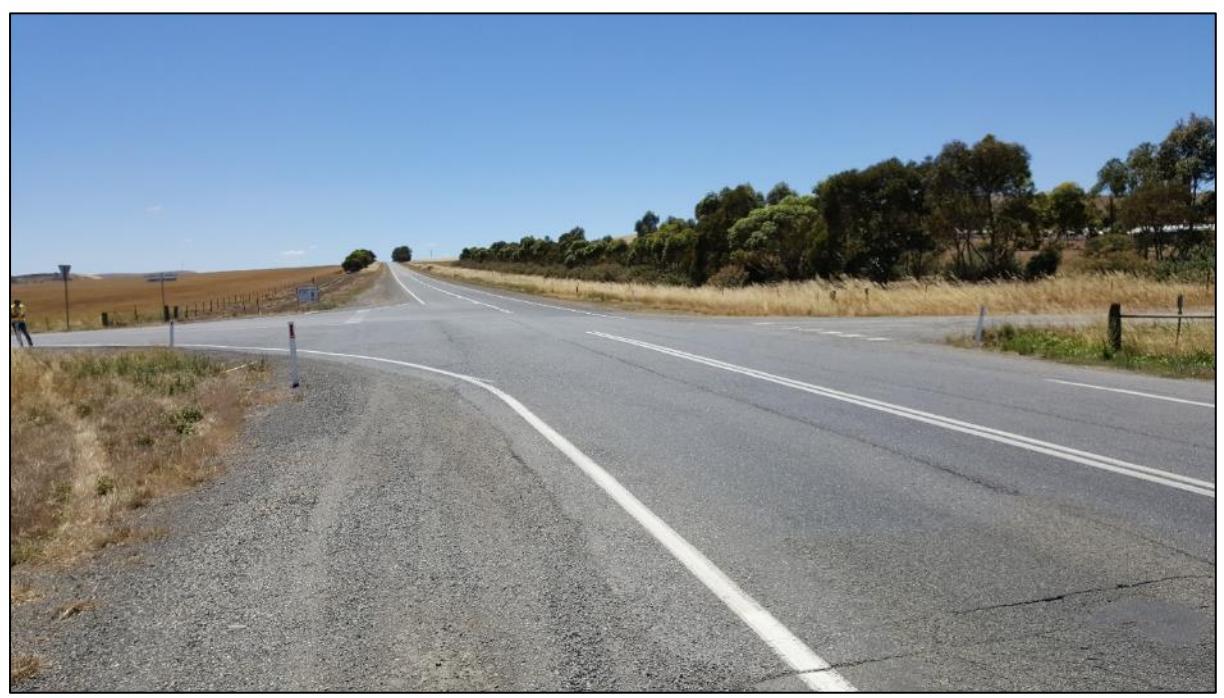
In its current state the intersection is not fit for the level of use or its designated purpose of diverting heavy vehicles around Burra. RAA identified a number of safety issues including a lack of turning lanes, a lack of visibility of Barrier Highway and the intersection for southbound vehicles on Copperhouse Road and poor signage.

The intersection of Barrier Highway and Copperhouse Road is not fit for its intended purpose

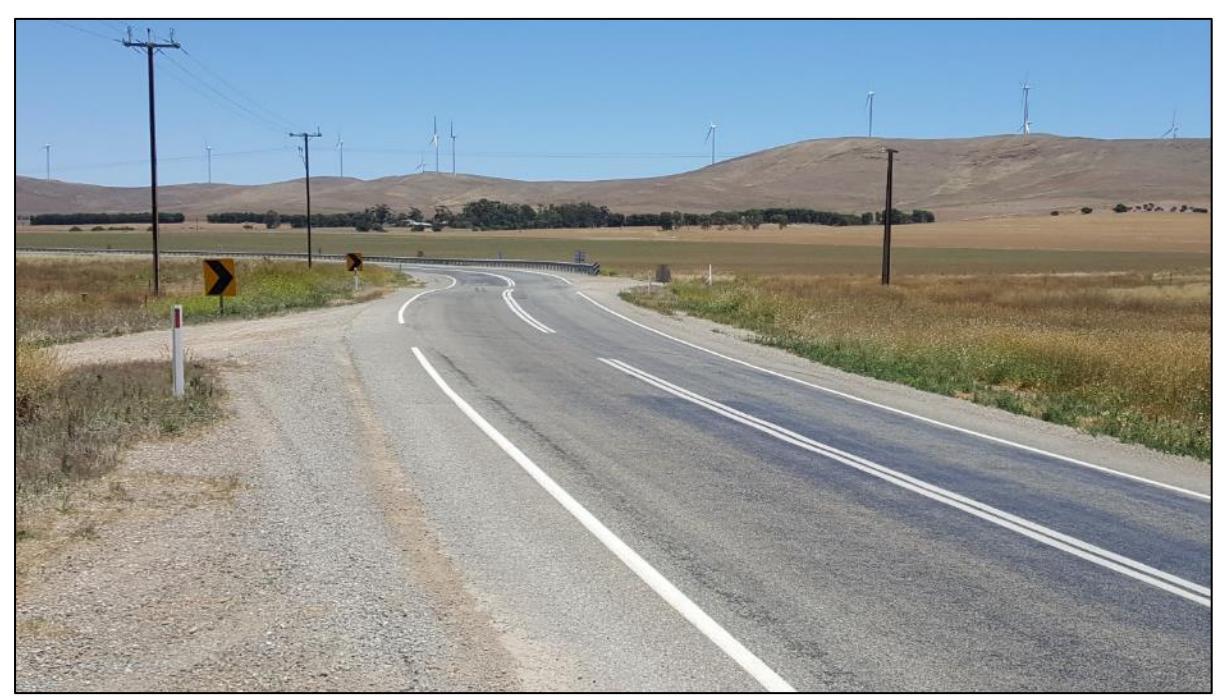
Following an assessment of crash history, we have identified that three semi-trailer rollovers have occurred here since 2007. Each of these rollover crashes resulted in injuries and were vehicles heading south towards Mount Bryan. The advisory speed limit through this 'S bend' is 85km/h which is suitable for cars and perhaps small trucks however on observing B-doubles through this intersection, 85km/h is far too fast and the observed speed of these vehicles was much lower. For truck drivers that are unfamiliar with this section of road there is a serious risk of a rollover if they travel at high speed due to the sudden change in camber and curvature of the road.

The sudden change in camber and curvature presents a high risk of rollover to semi-trailers

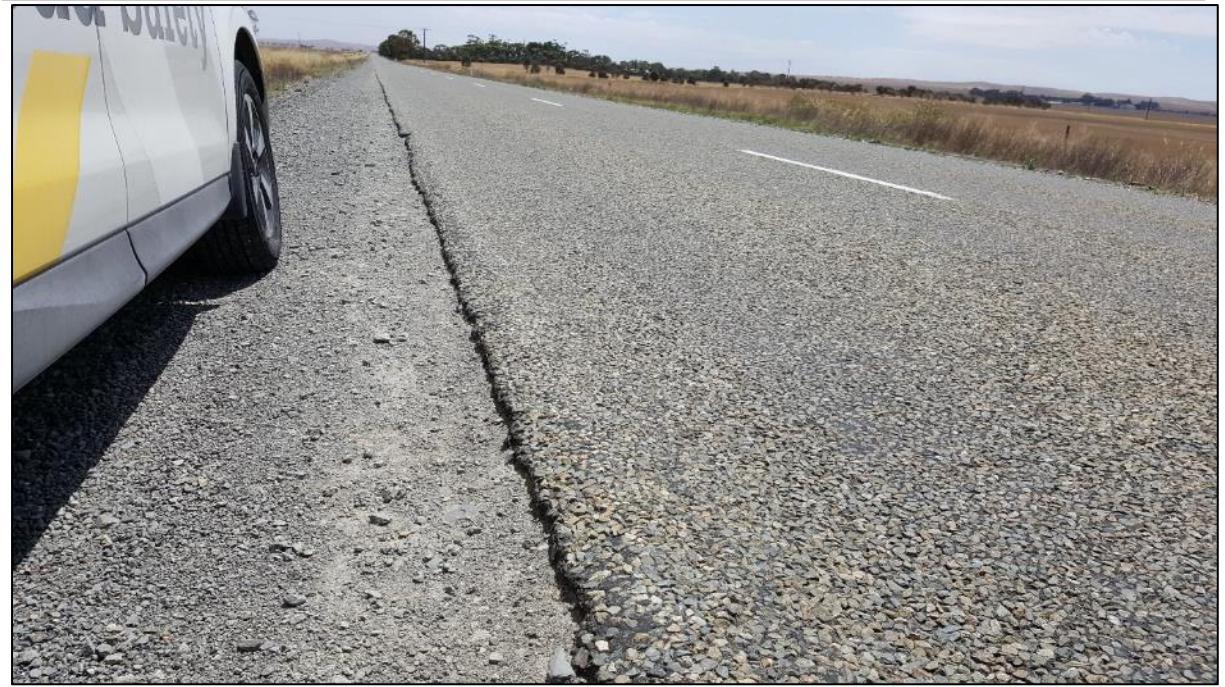
Narrow lanes and significant edge drop-off are the primary hazards east of Farrell Flat

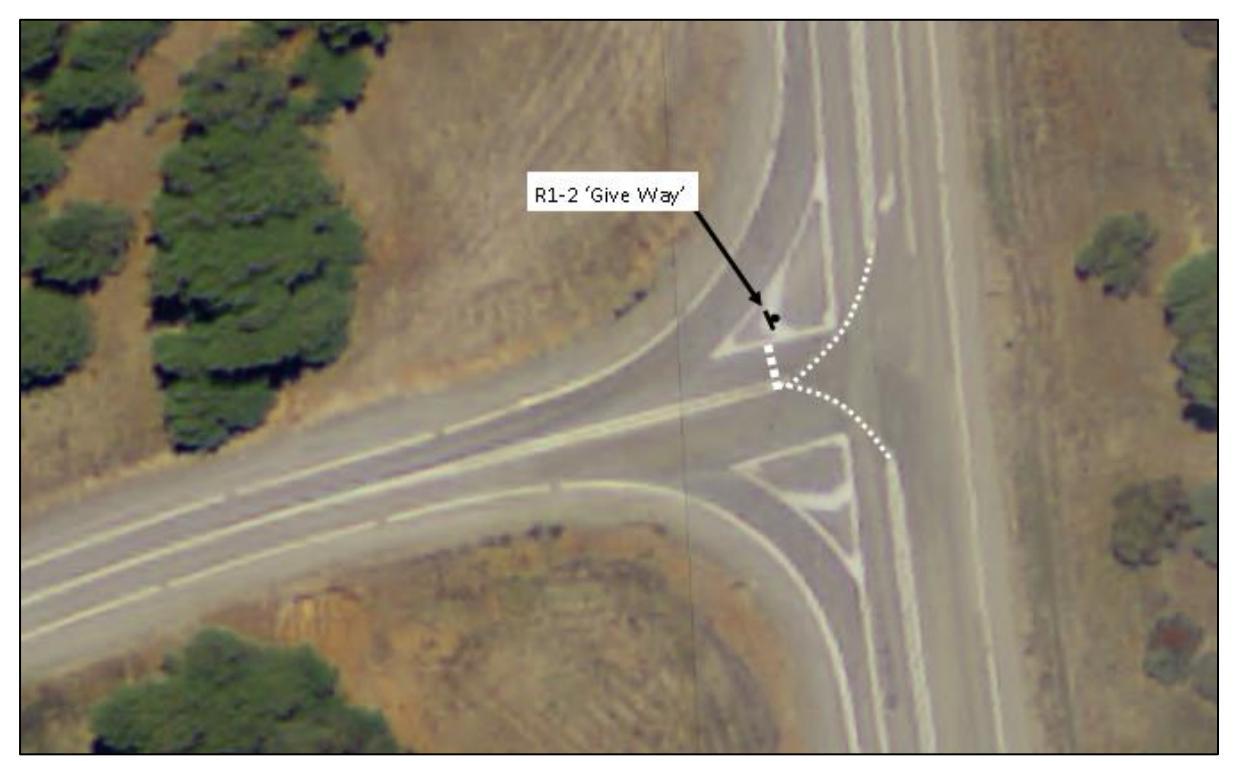
A give way holding line set back from the intersection will clarify a safe location to stop when giving way to turning vehicles

It is also advised that a give way holding line (and corresponding R1-2 'give way' sign) set back from the intersection of Barrier Highway is installed so vehicles turning right out of Farrell Flat Road do not impede the turn path of vehicles turning right into Farrell Flat Road from Barrier Highway. As a minimum, a continuity line should be painted along the edge of Barrier Highway through the intersection.

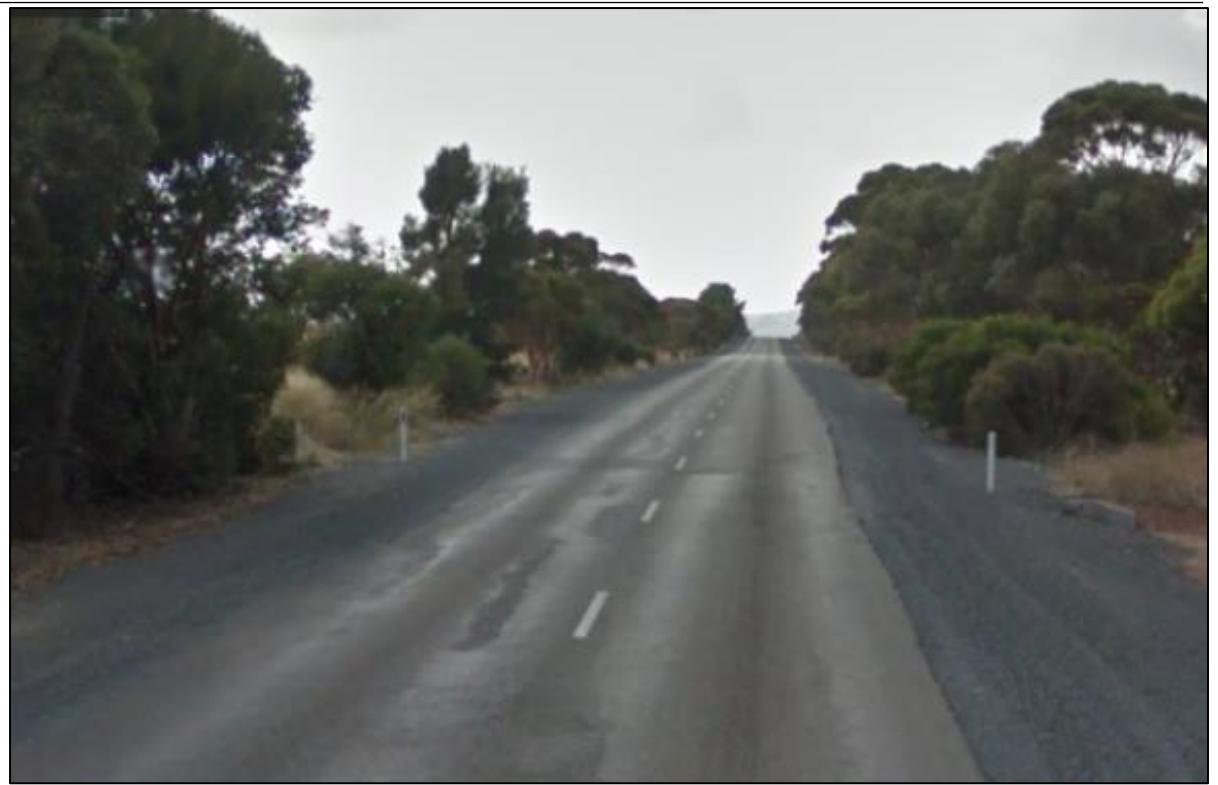
Blyth Road is very narrow east of Blyth (2015 Google imagery used)

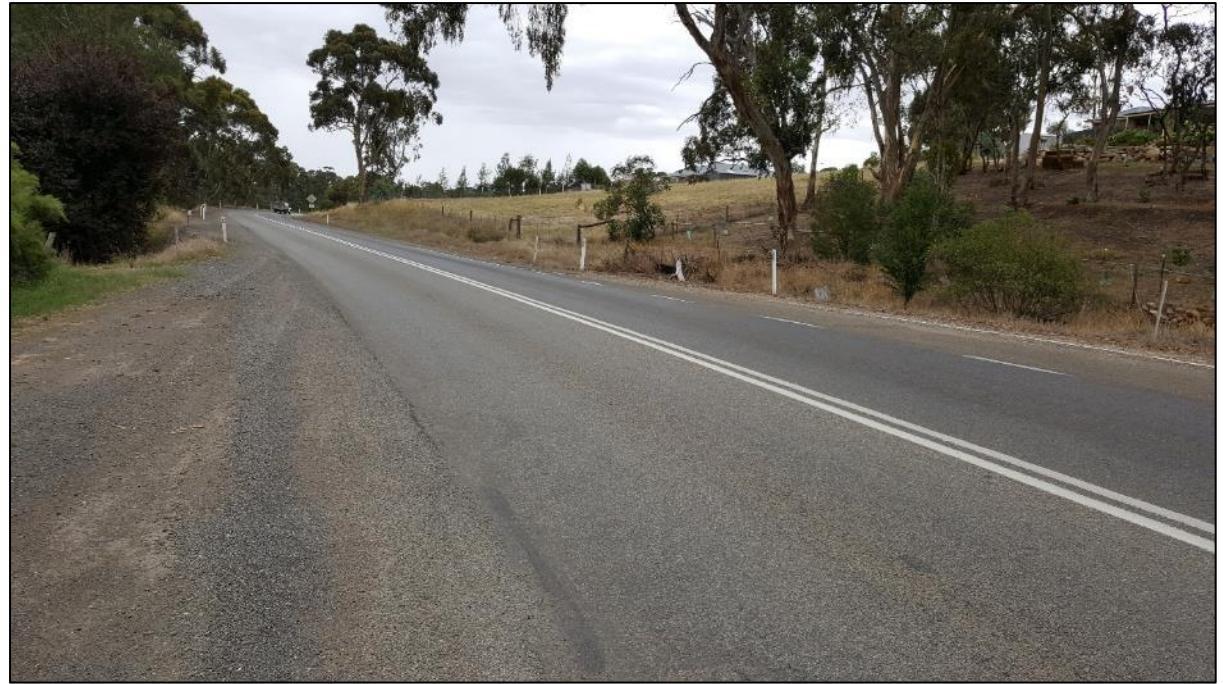
Narrow lanes, curves, and steep terrain are the primary issues on the eastern section of Blyth Road

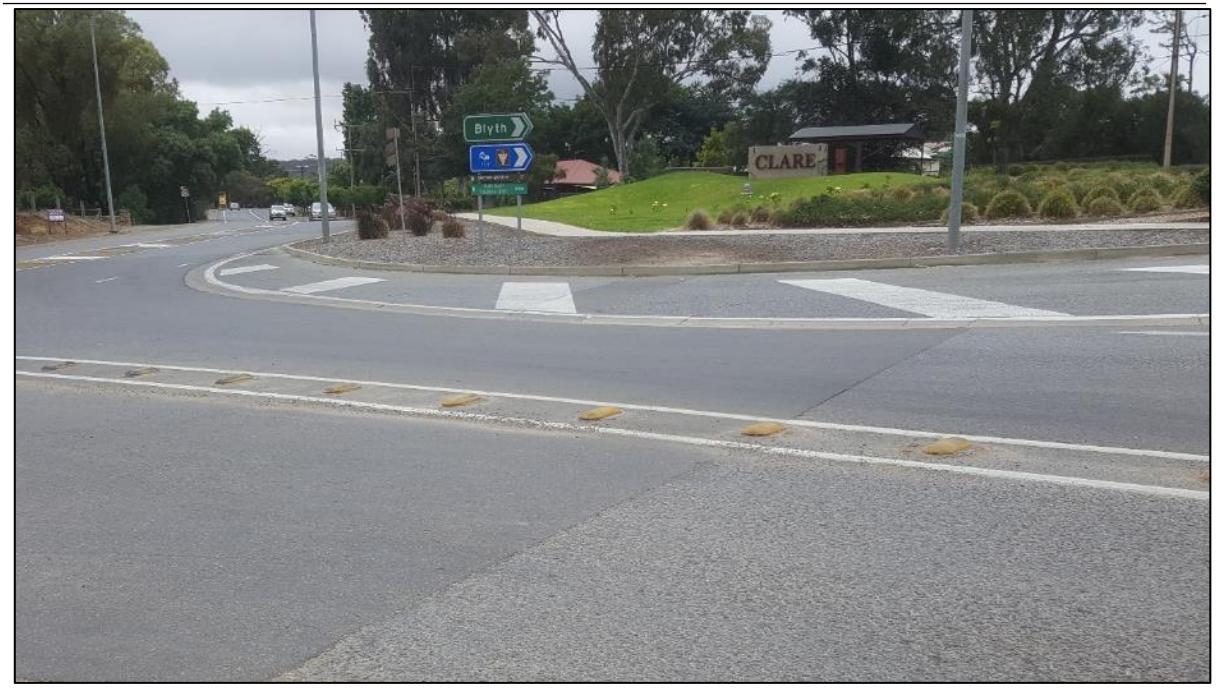
It is obvious that pedestrians regularly use this unsafe location to cross Blyth Road

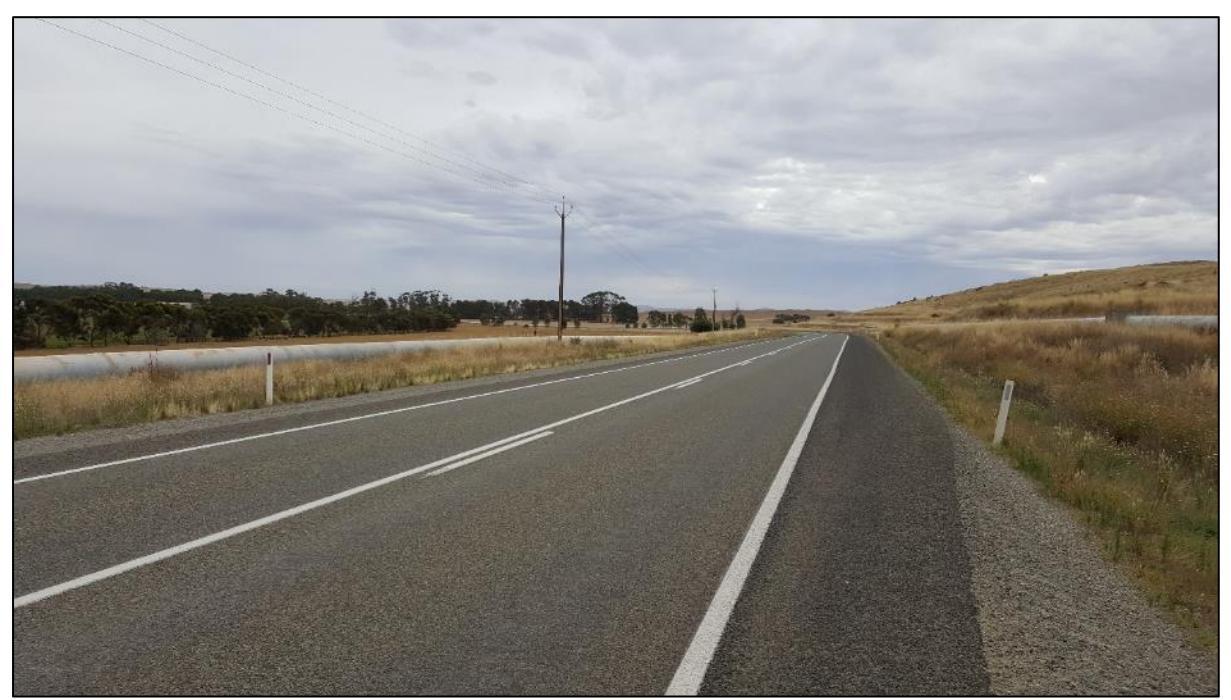
Shoulder seal is wide around the curves and appears recent and barrier protection is generally sufficient however there are some localised surface failures that need to be repaired.

Shoulders have been recently widened, especially around curves

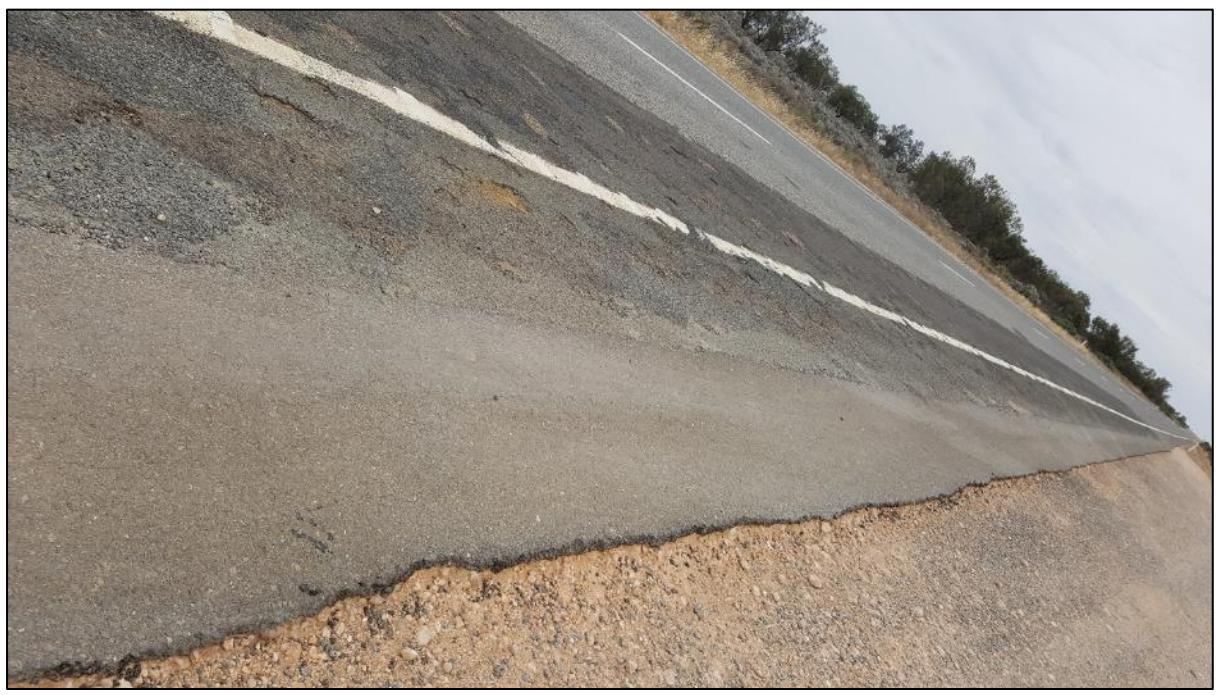
The vast majority of the Highway between Kooringa Road and Morgan was treated with audio tactile edge lines with approximately 60km of ATLM in each direction. Significant signs of deterioration were shown on the raised thermoplastic bumps however they were still very effective at achieving their purpose of creating noise when traversed. In the eastbound lane, there is a significant localised failure of previous repair works at the quarantine bin site 30km northwest of Morgan and it is recommended that this is repaired as a priority. There was a similar failure in the pavement just to the east in the westbound lane. Segments of edge drop off were also identified and additional material may need to be added to the gravel shoulder to reduce this edge drop off.

Pavement failure and 50mm+ edge drop off at the Quarantine bin site

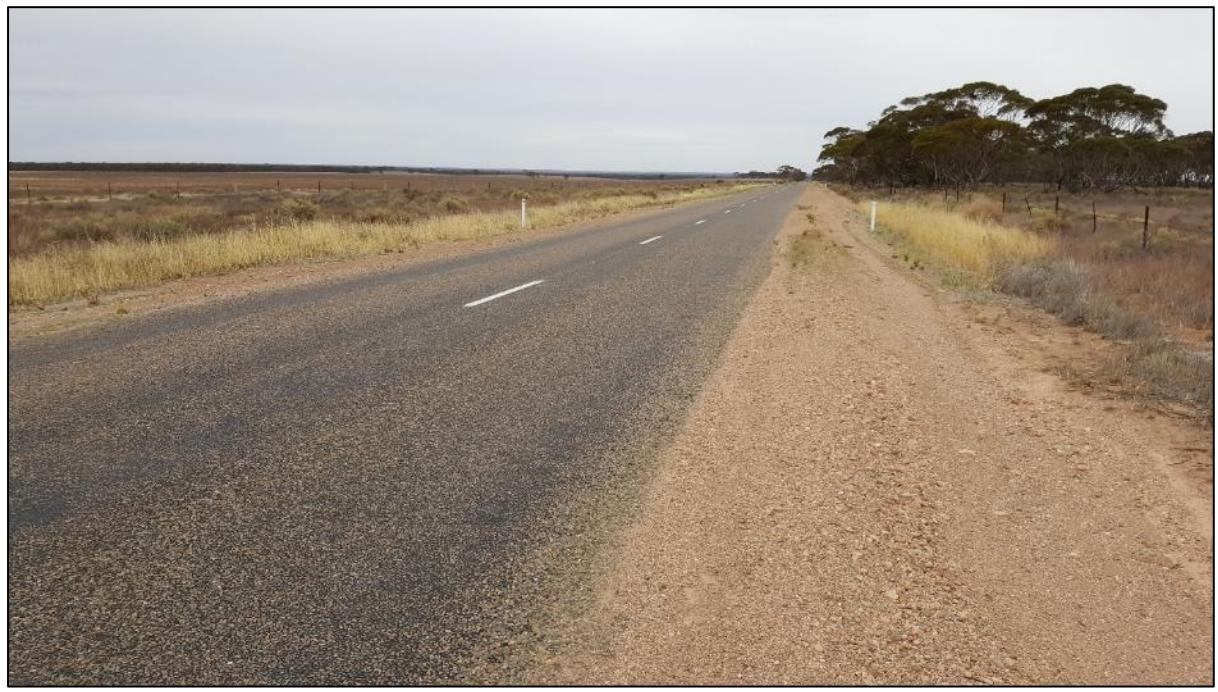
The surface was generally reasonable with some uneven sections close to Morgan requiring repair works however our primary safety concern is the narrow sealed carriageway for the majority of the length of the road and a minimum 0.5m shoulder seal is recommended to improve safety and reduce the risk of single vehicle crashes on Thiele Highway.

The narrow carriageway and lack of sealed shoulders are a safety concern on Thiele Highway

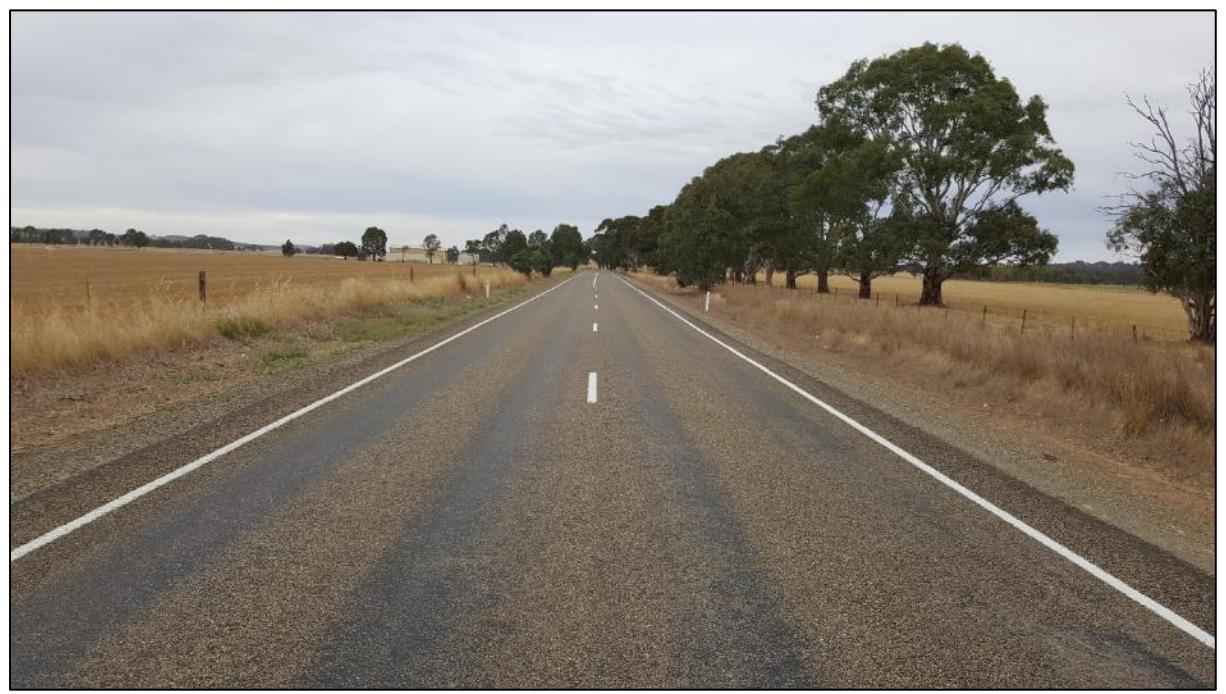
Generally the road was in good condition between Bungaree and Spalding, particularly the northern section where recent works had been targeted. In the southern sections, the surface was highly polished in places creating potential traction issues in wet weather. There were also sections where the road surface was uneven and rutting was forming. Localised surface failures were noticed, primarily over bridges and culverts and some local undulations were experienced.

Surface polishing is evident on the southern section of RM Williams Way

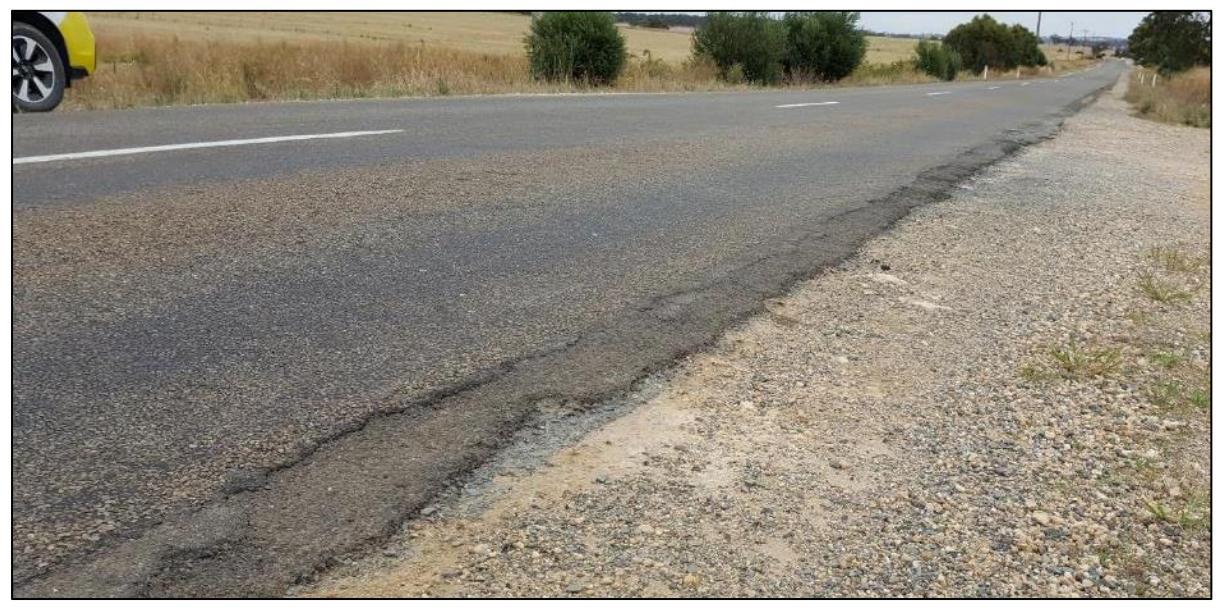
Narrow lanes and edge drop-off posed a serious risk between Saddleworth and Auburn

These factors all contribute to a greater risk of a vehicle losing control or rolling over in the event that a vehicle leaves the sealed surface and it is recommended that the width of this road is brought up to the standard of the eastern segment and 3.2m lane widths and 1.0m sealed shoulders are provided.

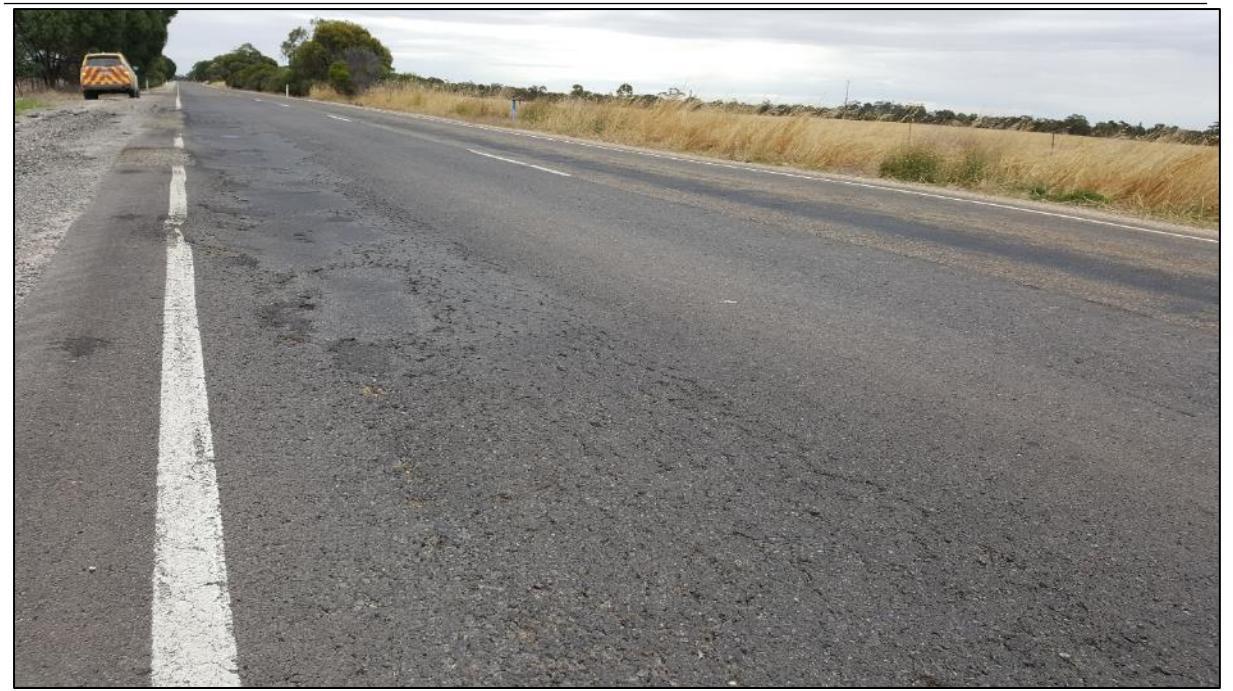
Pavement rehabilitation is required to address rutting west of Halbury

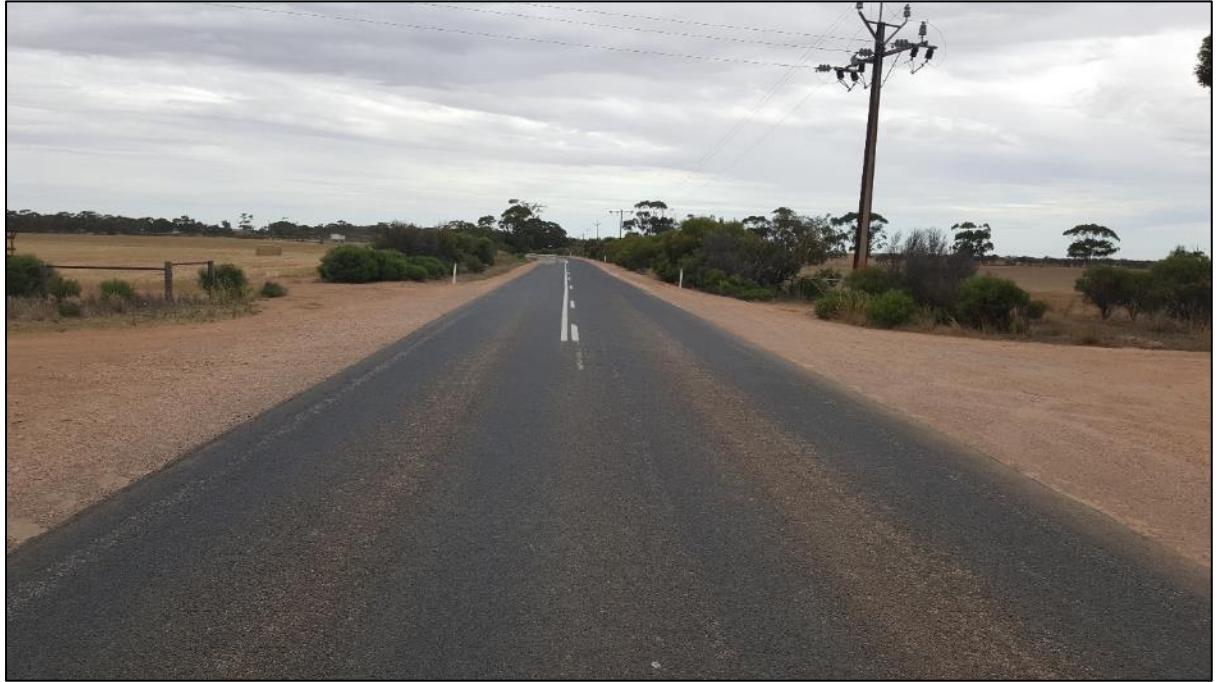
Blyth Plains Road is very narrow and would significantly benefit from shoulder sealing

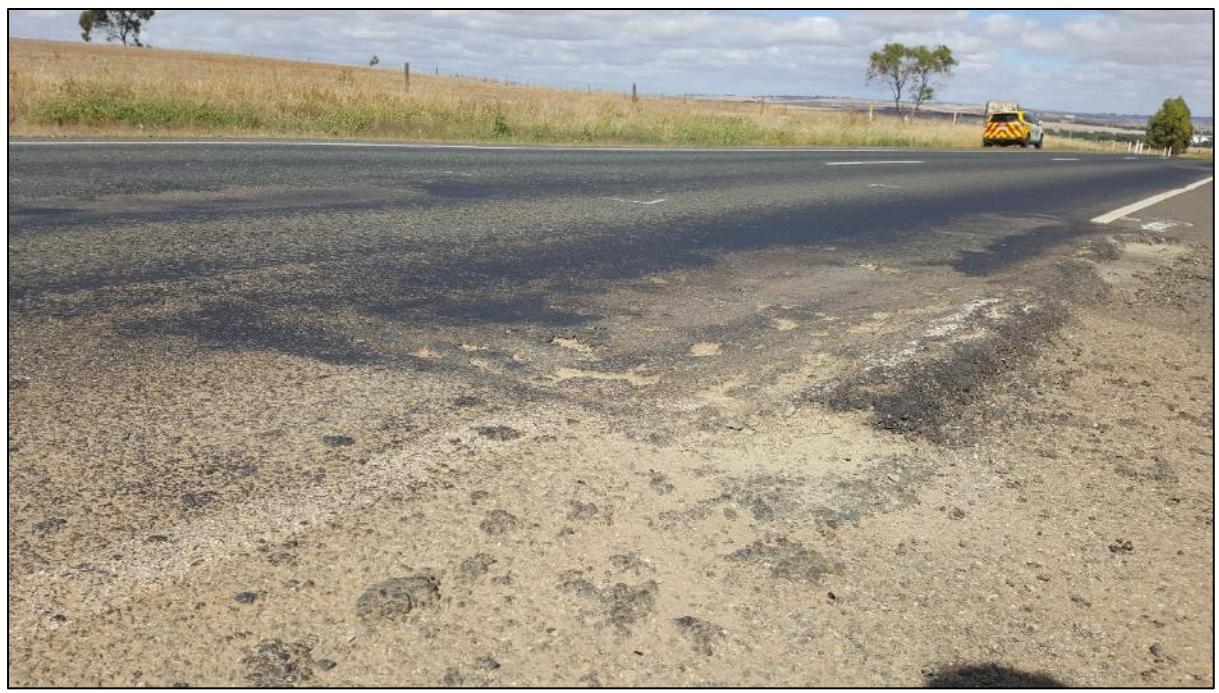
One of many local pavement failures on the north western end of Tarlee Road

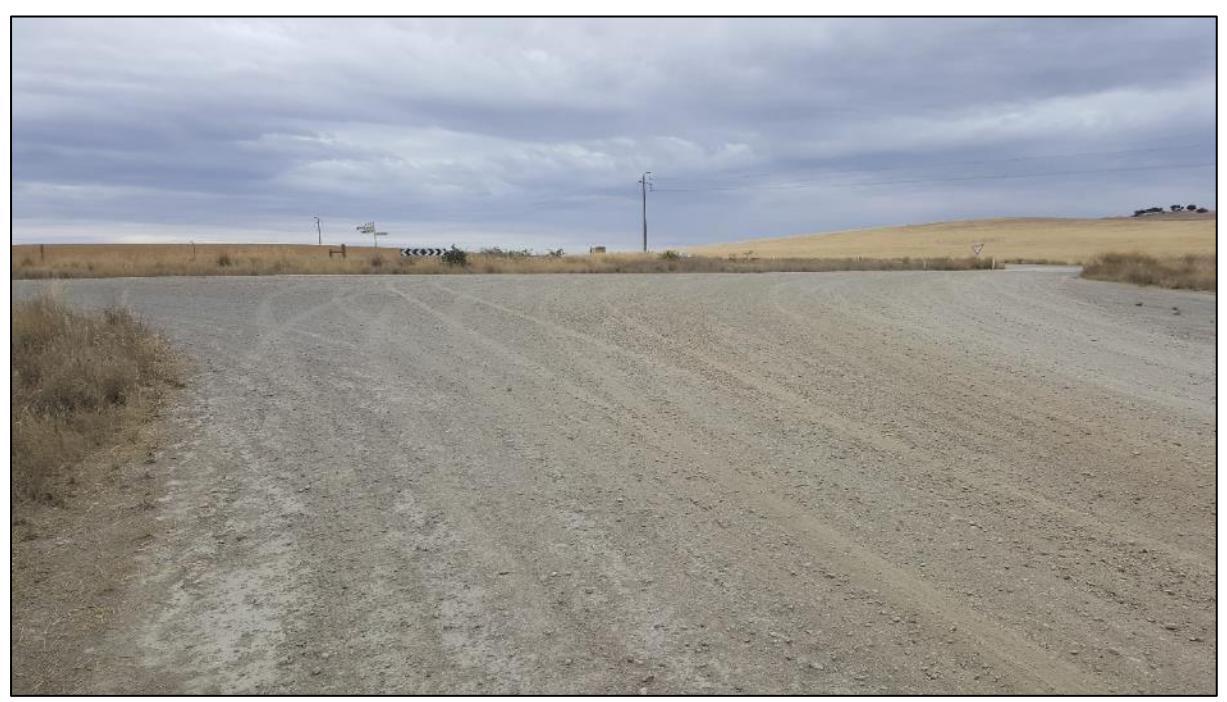
The intersection of Black Springs Road/Barton Hill Road/Barrier Highway was troublesome
