# **Clare and Goyder**

**Regional Road Assessment February 2018**

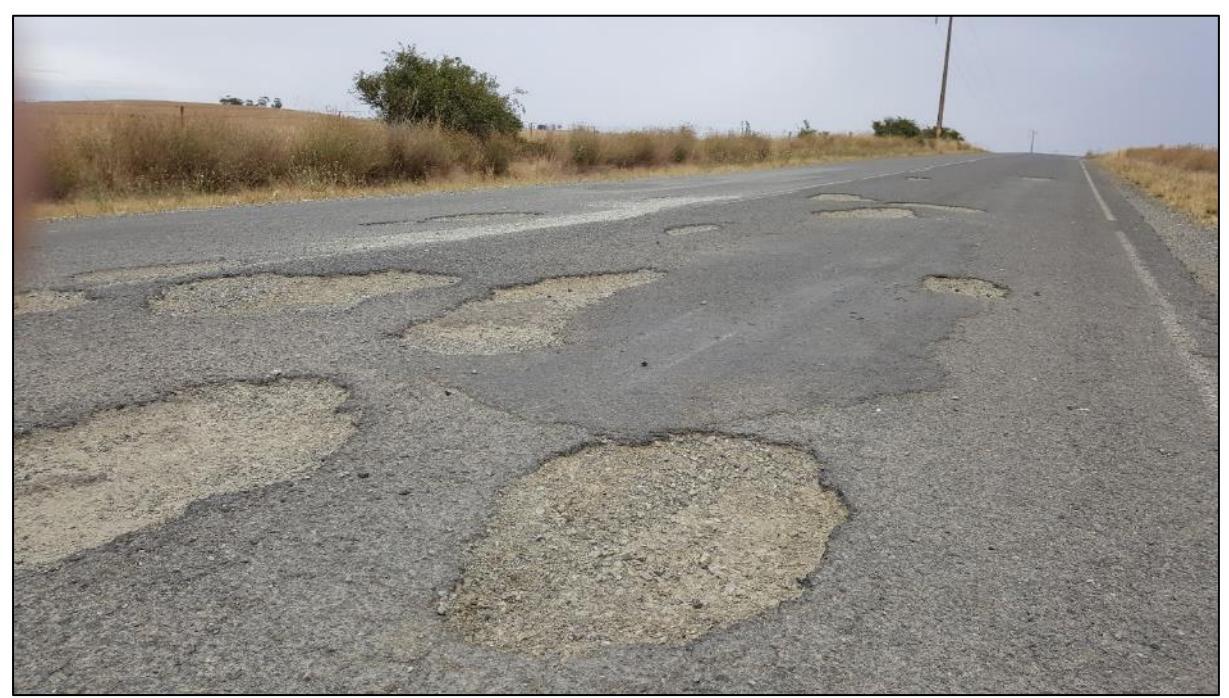
Potholes on the southern end of Main Road 45 were the worst seen on this assessment
