Heatherbank Terrace, Stonyfell

Road Safety Audit

May 2017

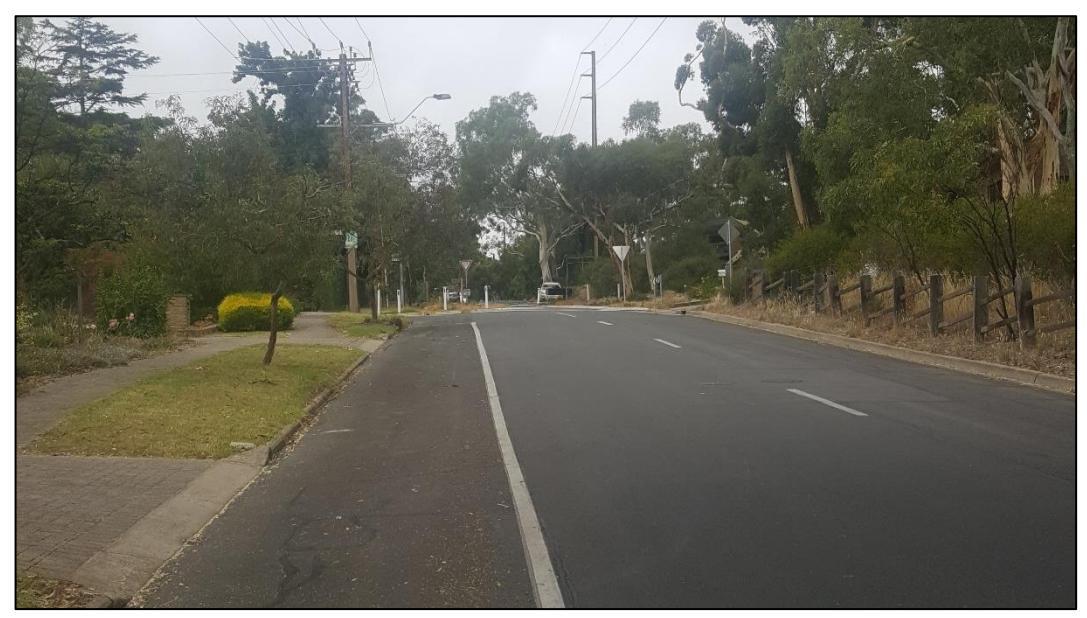
a) Steep Grade – Heatherbank Terrace is characterised by a steep grade, which peaks at 16%. RAA undertook grade measurements immediately prior to, on and after the driveway link using a Vericom VC4000 which suggested an approximate grade of 14.1% at that locality. The installation of driveway links on grades exceeding 10% is not desirable since it necessitates an increased level of braking while negotiating the geometry. There is an increased risk of loss of control on steeper grades. Additionally, the change of grade at either end of the driveway link can cause vehicles to scrape at the crest and may inflict damage to vehicles. There is evidence of this occurring (Figure 3)

Figure 2 – Steep grade on approach to the driveway link.

It is recommended that other forms of traffic calming devices should be considered which would reduce the driver's workload on a steep grade. Should a driveway link be maintained, it is recommended that the changes of grade are assessed and managed in accordance with the requirements outlined in DPTI's "Manual of Legal Responsibilities and Technical Requirements for Traffic Control Devices" document. Reference also should also be made to AS2890.1 which stipulates change of grade requirements for accesses, to reduce the risk of vehicle damage.

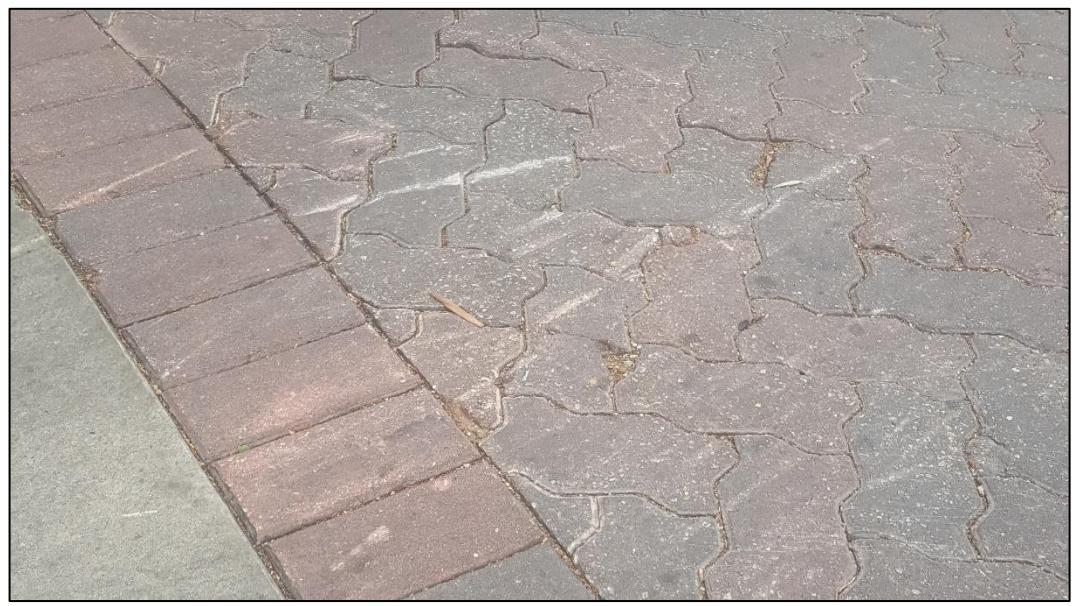
Figure 3 – Evidence of vehicles scraping the pavement at the eastern side of the driveway link.

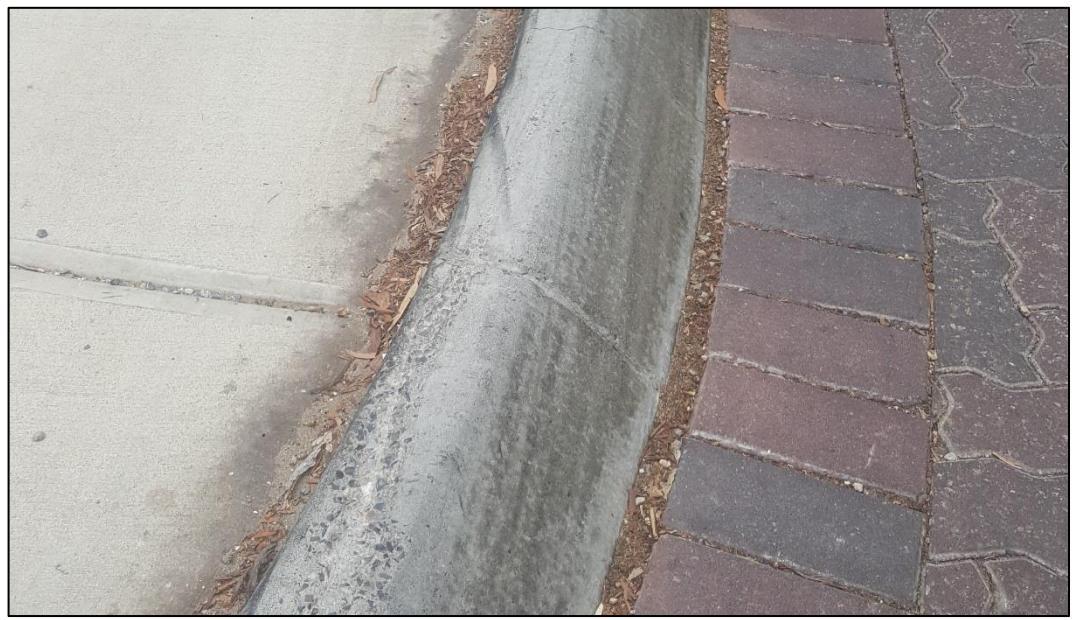
c) Challenging geometry – The audit team observed a number of light vehicles encountering difficulty in negotiating the driveway link. The kerbs may not be visible to drivers in some vehicles as a result of the combination of the narrow lane, tight curve radii and the grade of the driveway. The result was some light vehicles partially mounting the kerb. Heavy vehicles also appear to have difficulty negotiating the curves and aprons have been retrofitted on the inner radii. The challenging radius may increase the risk of vehicles departing the driveway midsection as a result of the motorists' inability to see the proximity of the kerb to the side of the vehicle, or for less skilled motorists.

Figure 4 – Numerous scrape and scuff marks along the kerb indicate vehicles are encountering difficulty negotiating the geometry.

If the driveway link is to remain, it is recommended the radii of the curves are increased, or the lane width increased, to assist traffic to negotiate the link.

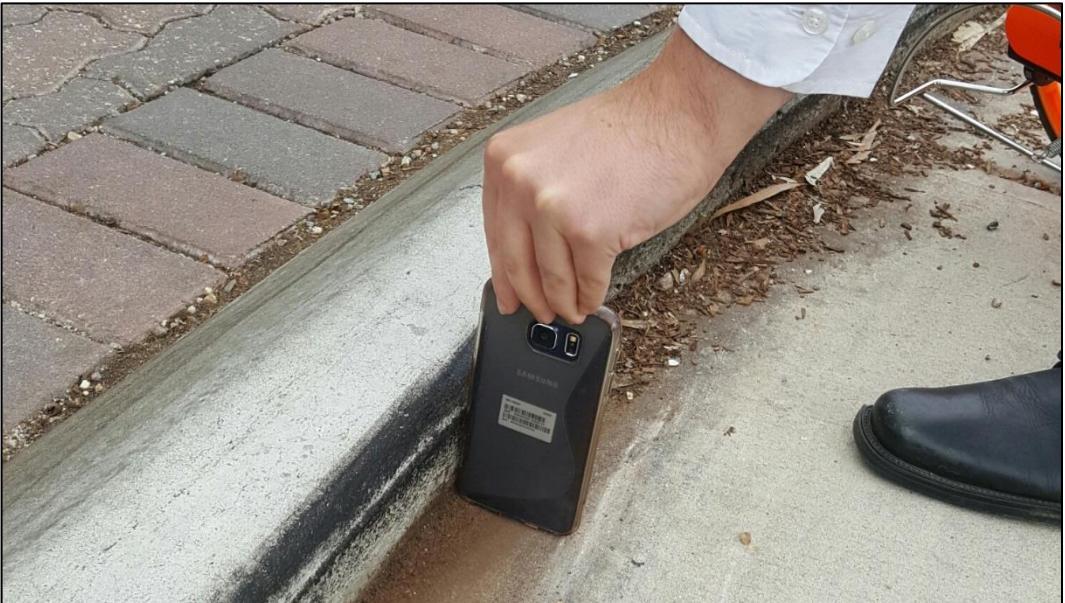
d) Kerb drop on aprons – Aprons have been constructed on the inner radius of the curves to accommodate heavy vehicle swept paths. The aprons have been constructed lower than the kerb height. Any light vehicle which unintentionally mounts the kerb may incur rim damage and once over, the kerb may act as a guide rail for the wheels, resulting in some loss of control.

Figure 5 – Vertical drop of approximately 100mm onto the apron on the inner curve, long scuff marks indicates kerb is acting as a guide rail for errant vehicles and light vehicles may experience difficulty returning to the lane.

It is recommended that the aprons are reconstructed to be level with the top of the kerb.

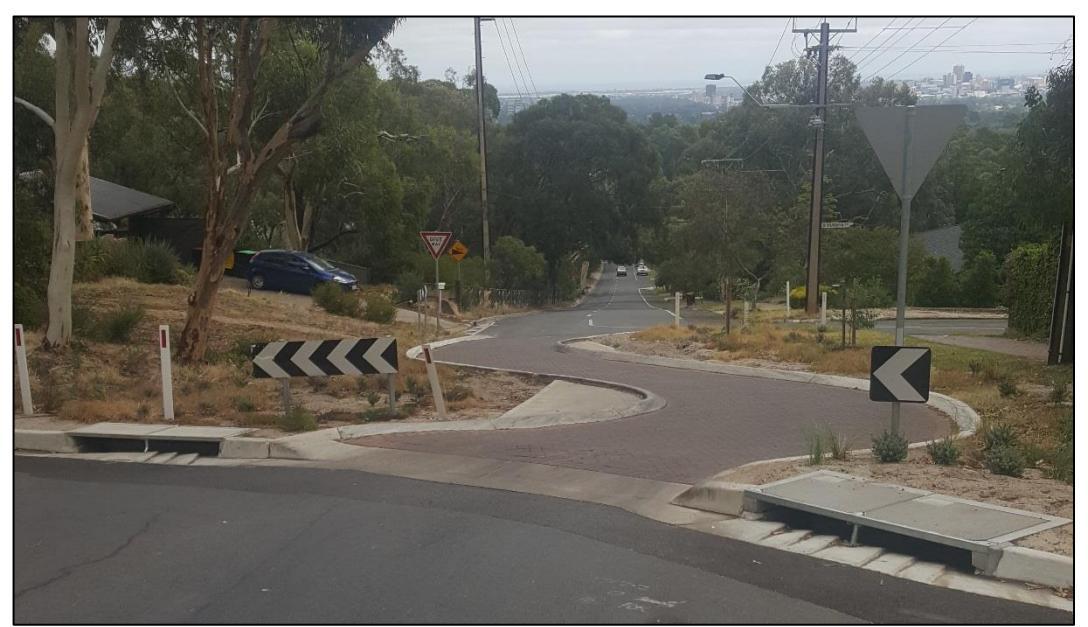
e) Driveway link access radii and kerb height – In the eastbound direction, the driveway link positions vehicles towards the centre of the road. In order to continue east on Heatherbank Terrace, the vehicle must turn left to stay within the eastbound traffic lane. The curve radii are sharp for this left turn manoeuvre and the kerb height is high. There is a risk of vehicles cutting the kerb and sustaining damage. Additionally, there is a side entry pit which may also sustain damage from this movement and the collapse of the cover from such a manoeuvre is a risk.

Figure 6 – Entry radii into the driveway link are sharp and side entry pits are located immediately adjacent, increasing the risk of damage to vehicles and pits covers.

It is recommended that the curve radii at the access onto the driveway link is increased and the side entry pit relocated, or an alternative drainage solution is developed.

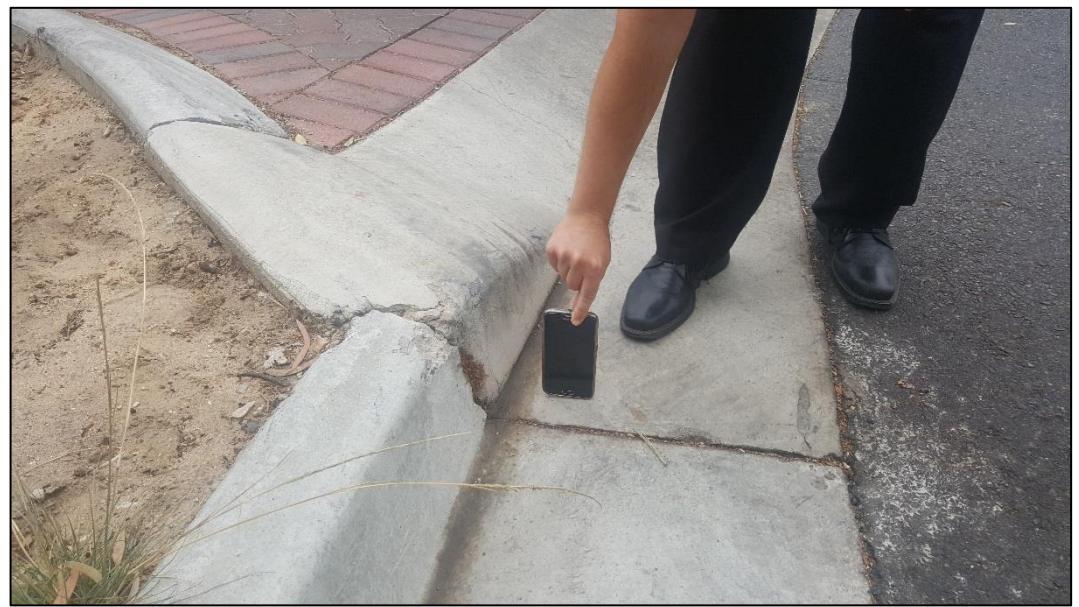
Figure 7 – Kerb height at driveway link entry radius is at least 150mm. Vehicles turning sharply in our out of the driveway link are at risk of sustaining damage.

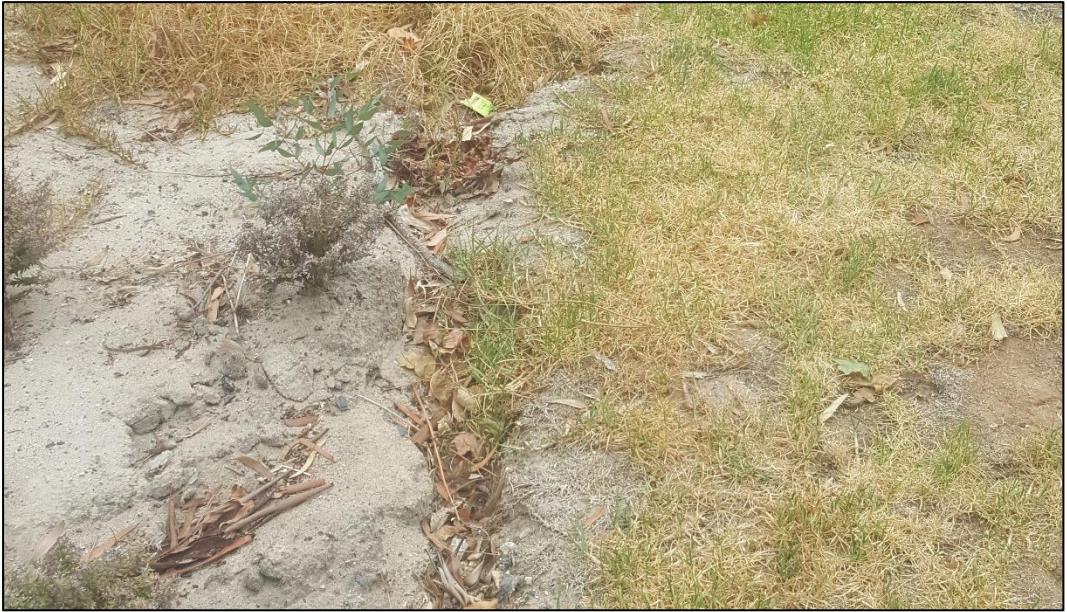
f) Erosion – Exposed areas of the landscape area are prone to erosion, particularly since the driveway link occurs on a steep grade. Wash out of material will reduce the skid resistance on sections of Heatherbank Terrace that are critical for braking and cornering.

Figure 8 – Evidence of erosion within main landscaping.

It is recommended that jute matting is installed on any remaining exposed sections of the nature strip and appropriate ground cover plants are introduced to stabilise the topsoil. Additionally, the concrete apron should be extended to reduce topsoil exposure to heavy vehicle over-run.

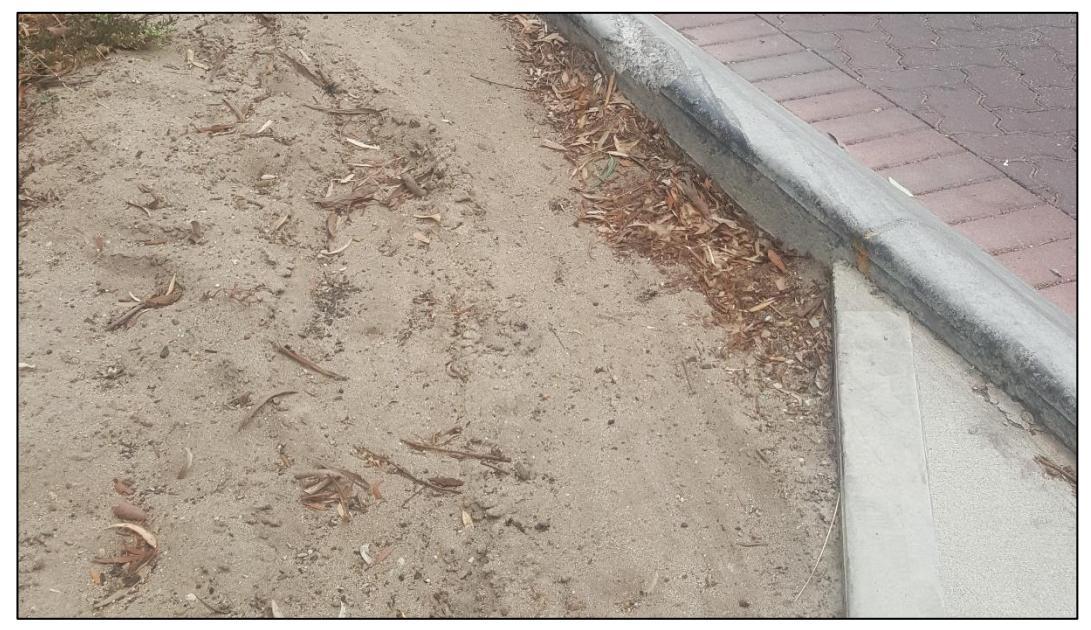
Figure 9 – Evidence of erosion adjacent to apron.

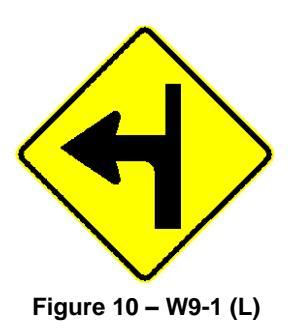
h) Warning signs – Warning signs corresponding to the change of priority are absent on all approaches to the site. The addition of modified intersection warning sign (W9-1) in accordance with AS1742.2 would clarify the change of priorities and reduce the likelihood of confusion.

It is recommended that warning signs W9-1 (L) be installed on Heatherbank Terrace in either direction.

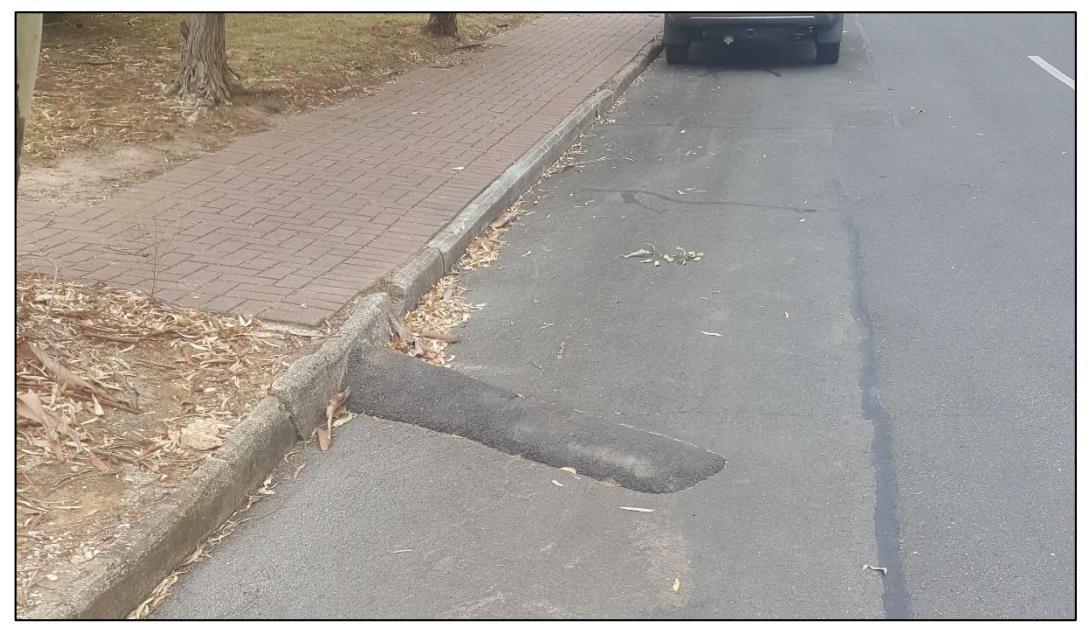
Asphalt hump on road – An asphalt hump has been constructed on the east side of the driveway link in the eastbound lane. It is unlikely that this will be visible at night and may present a hazard for cyclists and vehicles travelling in the eastbound direction. The hump also serves to divert stormwater from the kerbside which is

not desirable since water sheeting may occur in high rainfall events, which could present a hydroplaning hazard.

Figure 11 – Asphalt hump constructed within traffic lane to deflect stormwater.

It is recommended that the hump is removed and stormwater redesigned to avoid the need for physical deflections within a trafficable area.

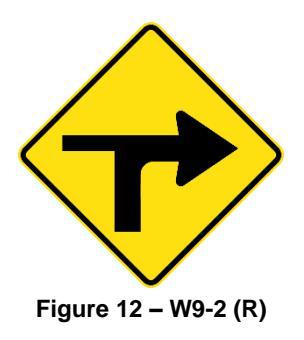
a) Warning signs – Warning signs corresponding to the change of priority are absent on all approaches to the site. The addition of modified intersection warning sign (W9-1) in accordance with AS1742.2 would clarify the change of priorities and reduce the likelihood of confusion.

It is recommended that warning sign W9-2 (R) be installed on Wurinya Avenue.
