RAA Sinking Pit Cover Assessment

Road being assessed: Hampstead Road

Date of assessment: 20-12-2017

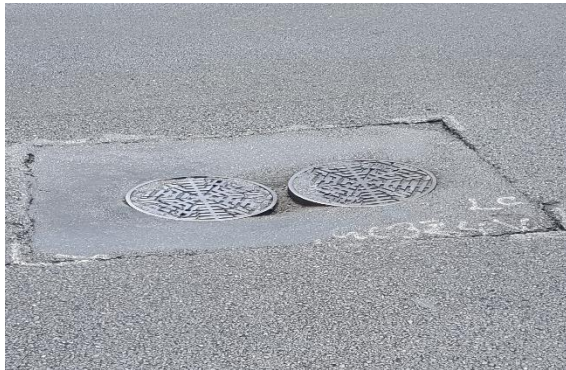
Pit covers at the intersection of Lorraine Ave

| Location Description | Possible SAW ID | W/WW | Latitude | Longitude | Direction/Lane |
|---|---|---|---|---|---|
| Intersection w/ Lorraine Ave x2 | 3351881/3351897 | W | -34.879074 | 138.619710 | SB LH |
