RAA Regional Road Assessment

# Eyre Peninsula

February 2015

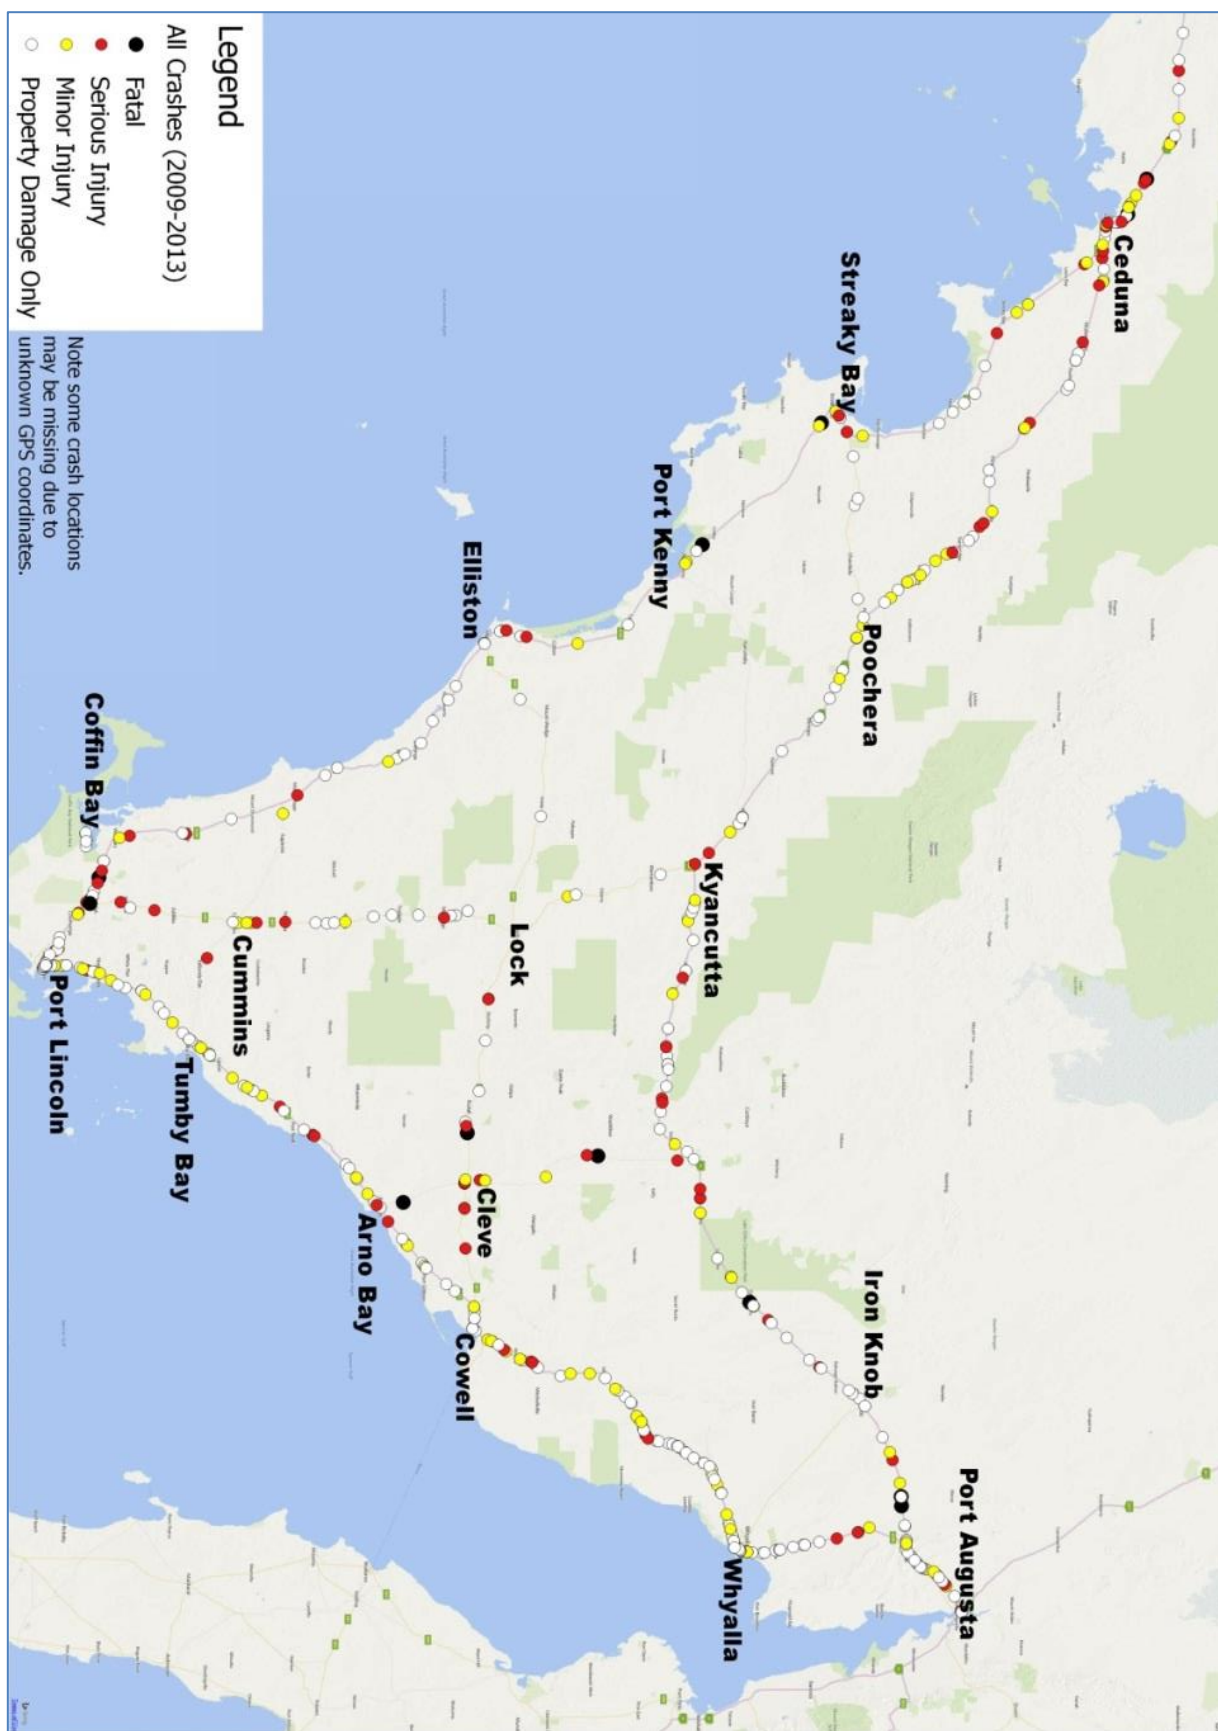
Figure 1 - Eyre Peninsula Crash Summary Map

The map shown in Figure 1 summarises the type of crashes and their locations across the Peninsula. The highest number of crashes occurs along the Lincoln and Eyre Highway which reflects the high traffic volumes typical of these roads. The map also shows that with few exceptions on the Eyre Highway, the majority of the fatal crashes occur on the B-class or minor road network which may reflect on the standard of infrastructure and nature of roadside hazards along these roads. The Flinders Highway between Port Lincoln and Coffin Bay also shows a high number of crashes together with fatality crash types. This is perhaps also a function of the traffic volume along this section of the Flinders Highway; however the relative number of fatal and serious injury crashes is a clear indication that infrastructure improvements are required there.

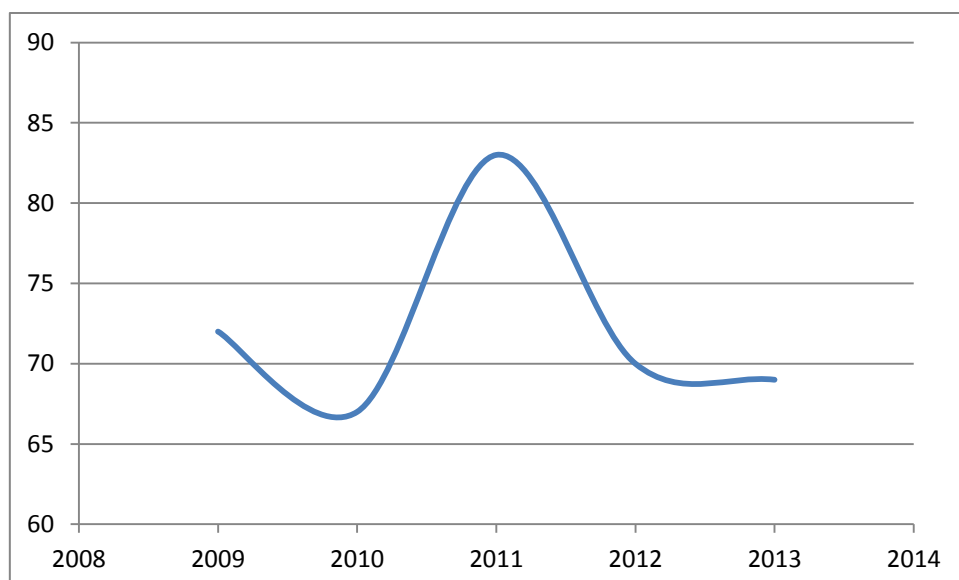
Figure 2 - Crashes on Lincoln Highway, 2009-2013

- Right angle (79 crashes)
- Hit fixed object (75 crashes)
- Rear end (51 crashes)

The crash history suggests that the priorities are upgrading key intersections, barrier protection from drops and significant roadside objects, and protected turn lanes at intersections with high volumes of turning movements.

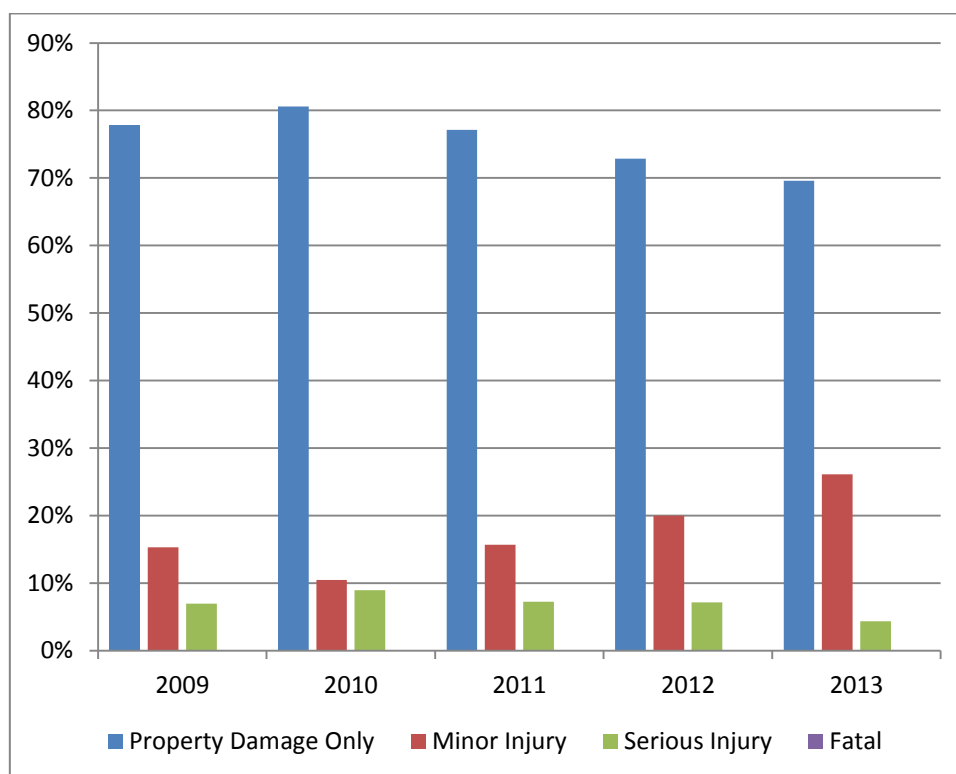
**Figure 3 – Crashes by Severity, 2009-2013**

The majority of crashes along the Lincoln Highway tend to involve property damage only. During the five year monitoring period there were 72 property damage only crashes, 67 minor injury crashes and 83 serious injury crashes. While there have been no fatal crashes recorded on the Lincoln Highway in the last five years, at the time of publishing this report, at least one fatal crash resulting in three fatalities occurred in 2015.

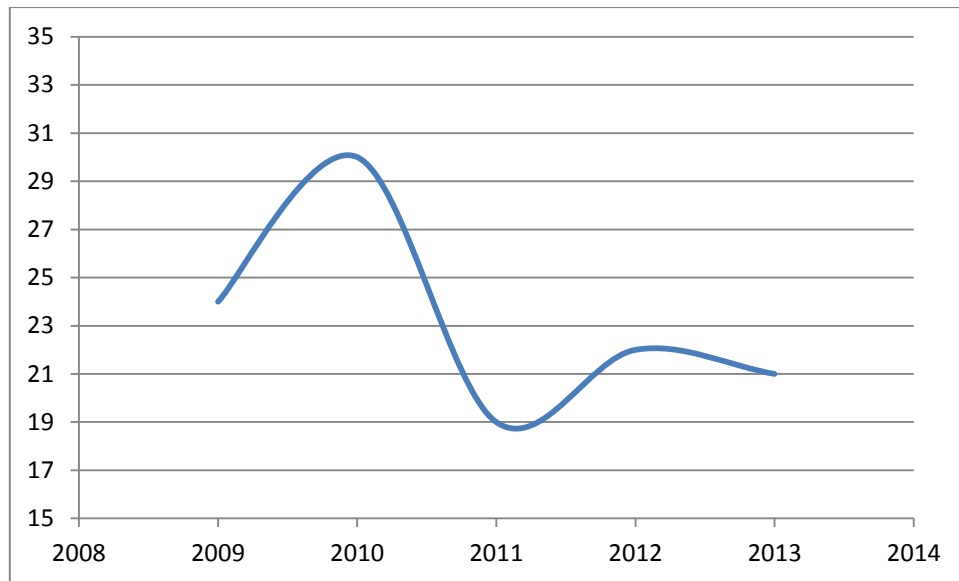
**Figure 6 - Crashes on Flinders Highway, 2009-2013**

Crash history for Elliston to Streaky Bay was made up almost entirely of run-off road crashes, and hit animal incidents. Fatigue may be a contributing factor to the high number of run-off road crashes along this section of road. As such, ATLM and additional rest stops should be considered.

Between Streaky Bay and Ceduna, 8 out of the 15 recorded crashes were rollover crashes. 3 were hit animal, 3 were hit fixed object and 1 head on. Such a high proportion of rollover crashes is an indication that significant drops are not being sufficiently protected. It is recommended that a W-beam barrier treatment program be implemented to protect vehicles from roadside drops of greater than 3m.

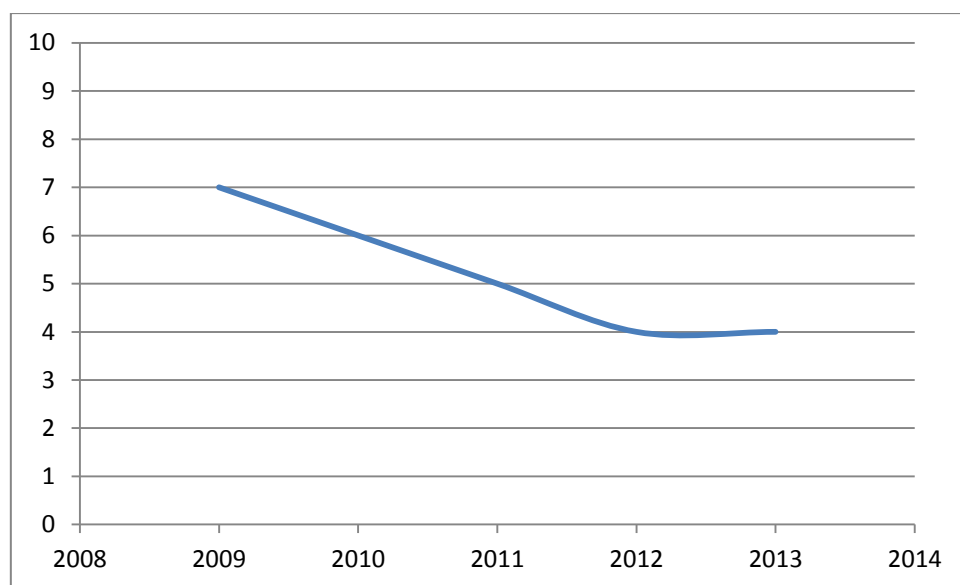
**Figure 10 - Crashes on Birdseye Highway, 2009-2013**

- 1) Animal collisions (8 crashes)
- 2) Vehicle rollovers (7 crashes)
- 3) Hit fixed objects (7 crashes)

Unfortunately, there are limited treatments to address animal collisions. Vegetation removal at the side of the road may assist but this is impractical over long distances. The best form of protection is to avoid driving at dawn or dusk. Where this is necessary, drivers should use headlights on high beam, when it is safe and legal to do so. Rollover and hit fixed object crash types are an indication that driver fatigue or inattention is prevalent and fatigue/inattention countermeasures such as audio tactile line marking or barrier protection to reduce the severity of a crash would be welcome improvements.

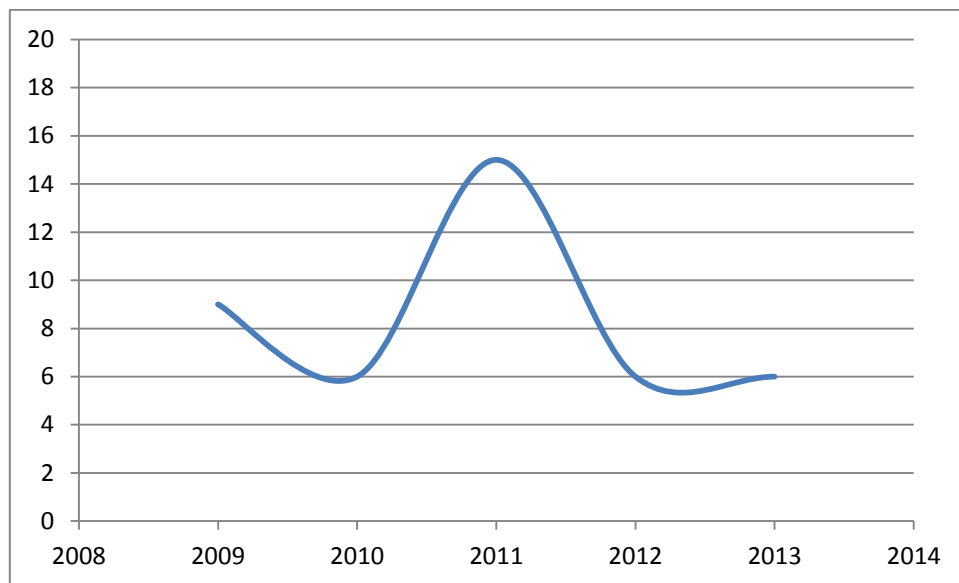
**Figure 14 - Crashes on Tod Highway, 2009-2013**

- 1) Hit fixed object (12 crashes)
- 2) Vehicle rollovers (11 crashes)
- 3) Animal collisions (5 crashes)

Hit fixed object and rollover crash types are an indication that driver fatigue or inattention is an issue along the highway and countermeasures such as audio tactile line marking or barrier protection, to reduce the severity of a crash, may be worthwhile improvements.

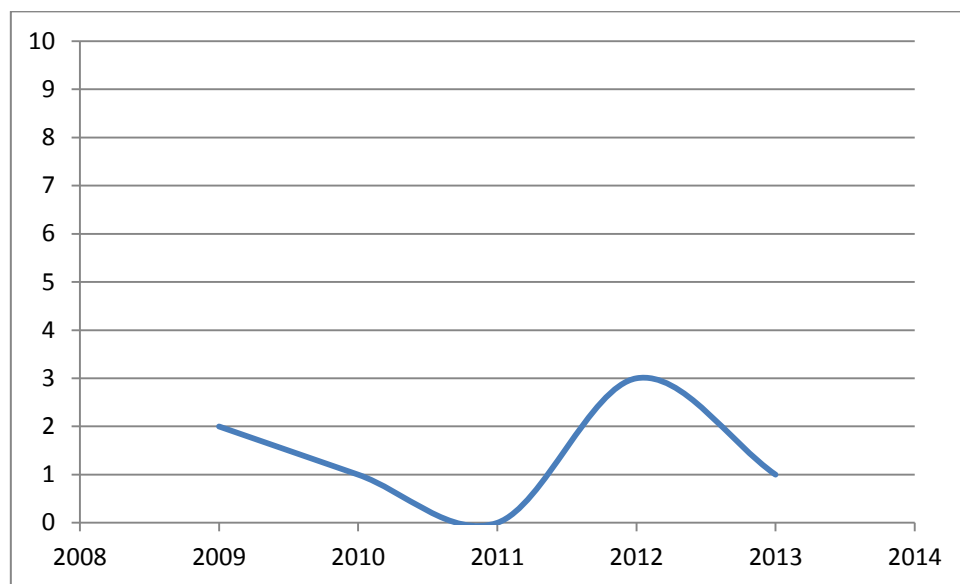
Figure 16 - Crashes on Bratten Way, 2009-2013

- 1) Hit fixed object (3 crashes)
- 2) Vehicle rollovers (2 crashes)
- 3) Right angle crash (1 crash)

Hit fixed object and rollover crash types are an indication that driver fatigue or inattention is an issue along the highway and countermeasures such as audio tactile line marking or barrier protection, to reduce the severity of a crash, may be worthwhile improvements.

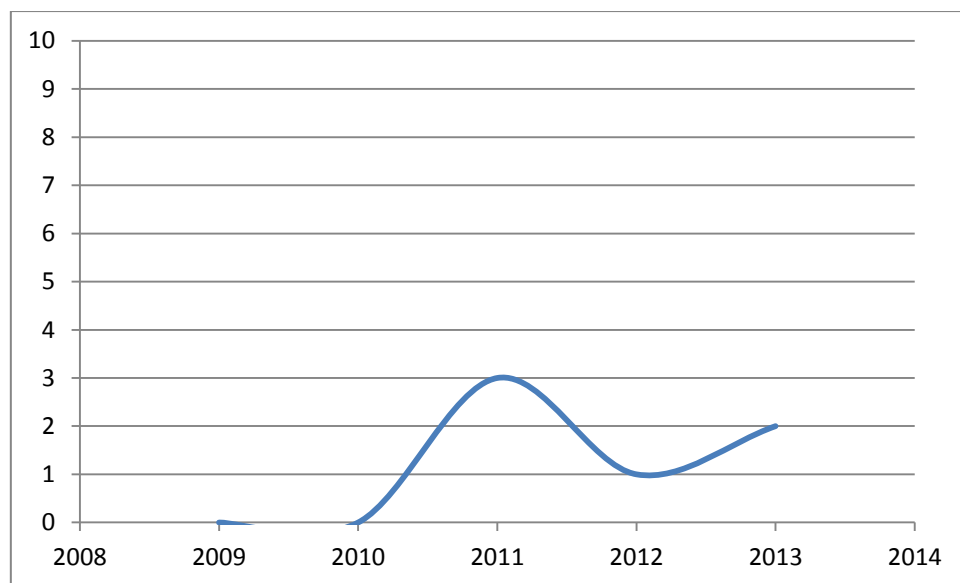
Figure 21 - Crashes on Streaky Bay Highway, 2009-2013

- 1) Hit fixed object/left road – out of control (2 crashes each)
- 2) Vehicle rollover/right angle (1 crash each)

Since the number of crashes along Streaky Bay Highway is low, it is difficult to identify a pattern in the type of crashes, but protection from significant hazards would be beneficial to minimise the severity of any crash that occurs.

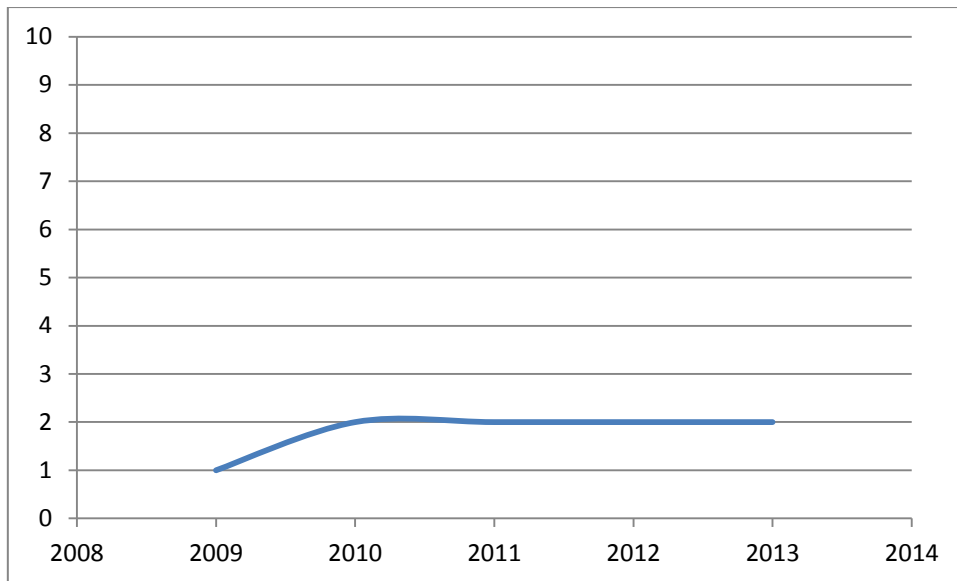
**Figure 23 - Crashes on Kimba to Cleve Road, 2009-2013**

- 1) Hit fixed object (6 crashes)
- 2) Head-on, animal collisions, vehicle rollovers (1 crash each)

The number of hit fixed object crashes is an indication that driver fatigue or inattention is an issue along the highway and countermeasures such as ATLM or barrier protection, to reduce the severity of a crash, may be worthwhile improvements.

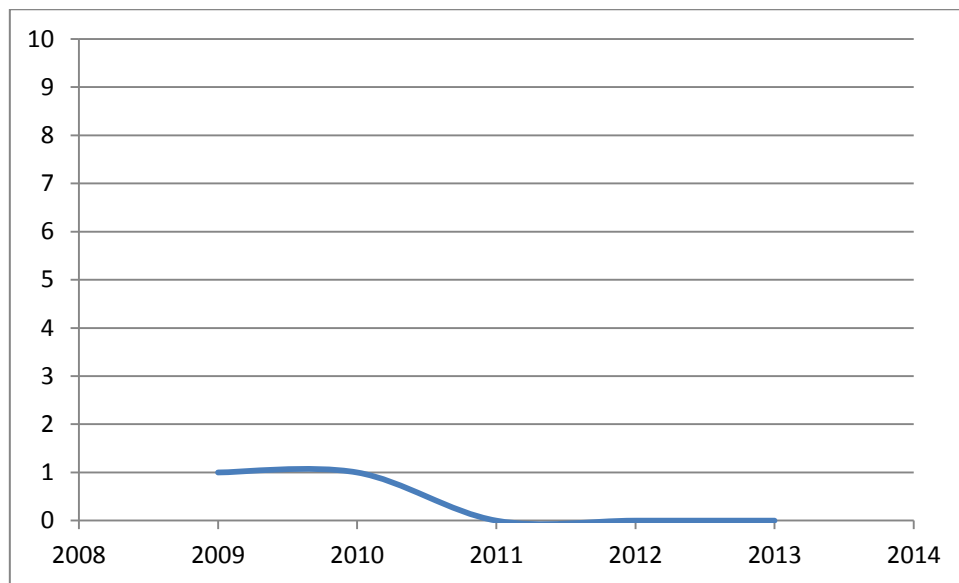
Figure 25 - Crashes on Arno Bay Road, 2009-2013

Very few crashes occur on Arno Bay Road, the last reported crash occurred in 2010 and was a serious injury crash involving a vehicle hitting a fixed object at the side of the road. Prior to this, one other crash occurred in 2009 which involved a vehicle rollover, resulting in a fatality.

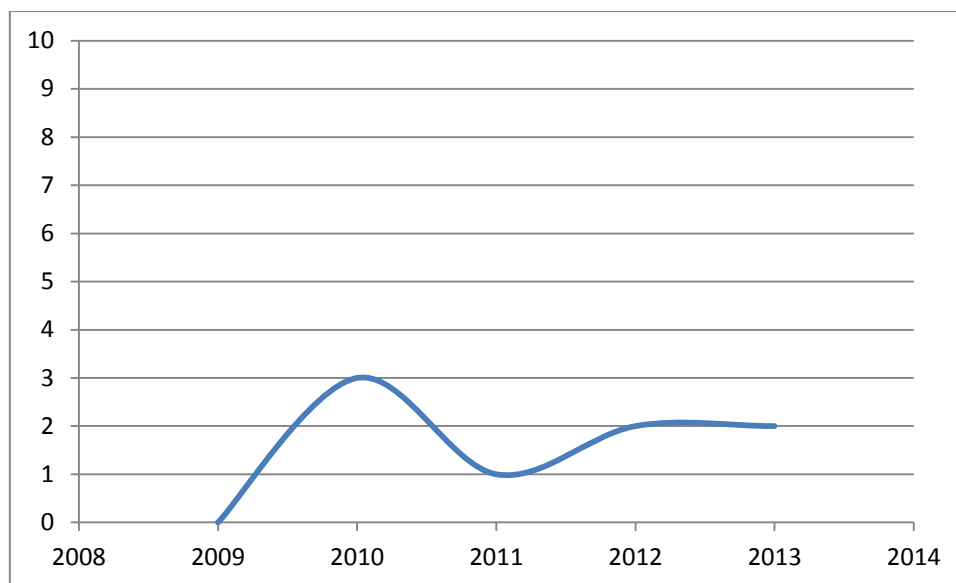
**Figure 26 - Crashes on Coffin Bay Road, 2009-2013**

The number of crashes has remained low over the past five years, with an average of between one and two crashes per year. All crashes that have occurred have involved property damage only. The most frequent crashes that occur along the road are:

- 1) Animal collisions (3 crashes)
- 2) Hit fixed object (2 crashes)
- 3) Hit parked vehicle, rear end and vehicle rollovers (1 crash each)
