Mid North

RAA Regional Road Assessment

October 2015

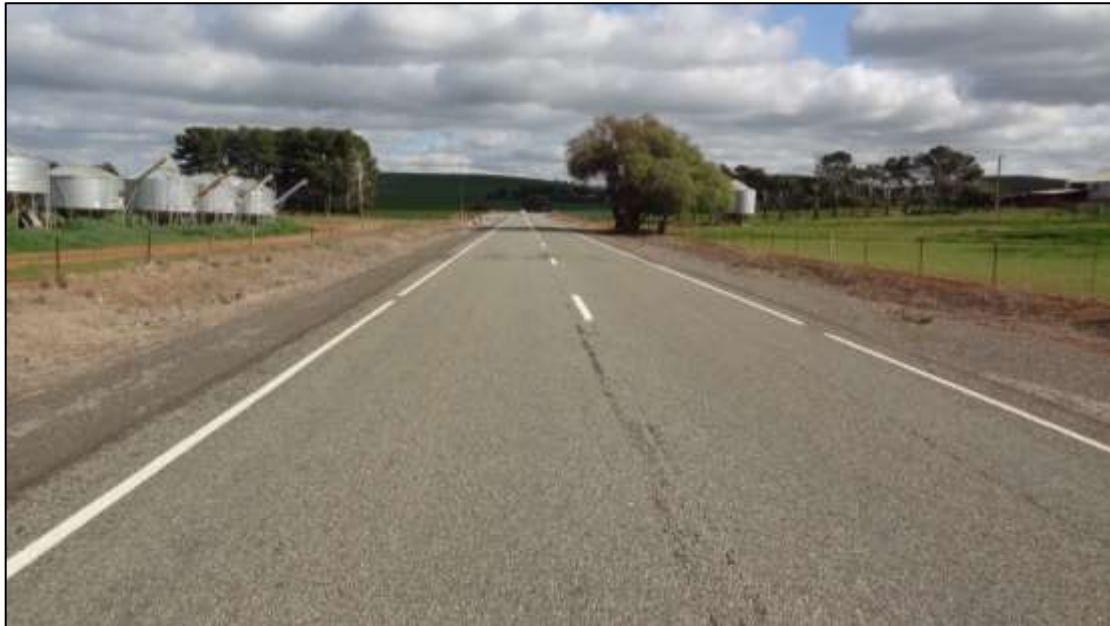
visibly narrower with widths of between 3m and 3.3m recorded. Sealed shoulders were barely present for up to 3km after Auburn with an average shoulder width of 100mm. The sealed shoulder then varied between 300mm and 1m to Halbury. Between Halbury and Port Wakefield lanes were measured between 3.2m and 3.3m with no sealed shoulder present, which is disappointing as some road sections were measured to be between 3.5m and 4m which could comfortably accommodate an edge of carriageway line providing some level of shoulder seal. On approach to Port Wakefield the sealed shoulder recommenced with a width of about 500mm which then increased to between 1m and 1.2m immediately south of Port Wakefield.

It is highly recommended that a sealed shoulder of at least 500mm is provided throughout the B84 to reduce the risk of run off road crashes and allow additional room to pass heavy vehicles, particularly where lane widths are restricted to just 3m. This is particularly important since the narrow lane widths also cause difficulty in keeping trailers or caravans wholly on the bitumen.

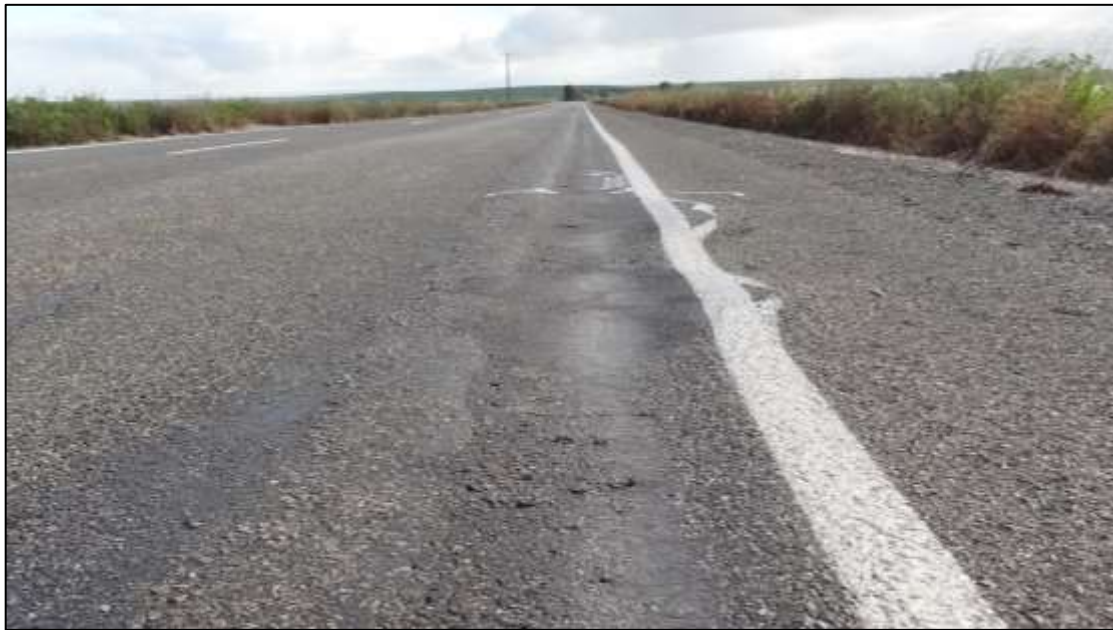
The assessment noted however that at about 12km north of Clare, there was very bad rutting in the road which were observed trapping water. The rutting was so bad in some areas, with estimated depths of around 100mm that the pavement could be seen visibly lifting at the edge of the seal and there was significant distortion of the edge of carriageway lines at some locations. It would be recommended that pavement rehabilitation is undertaken in areas that show extreme rutting and that rut filling is undertaken where ruts are shallower.

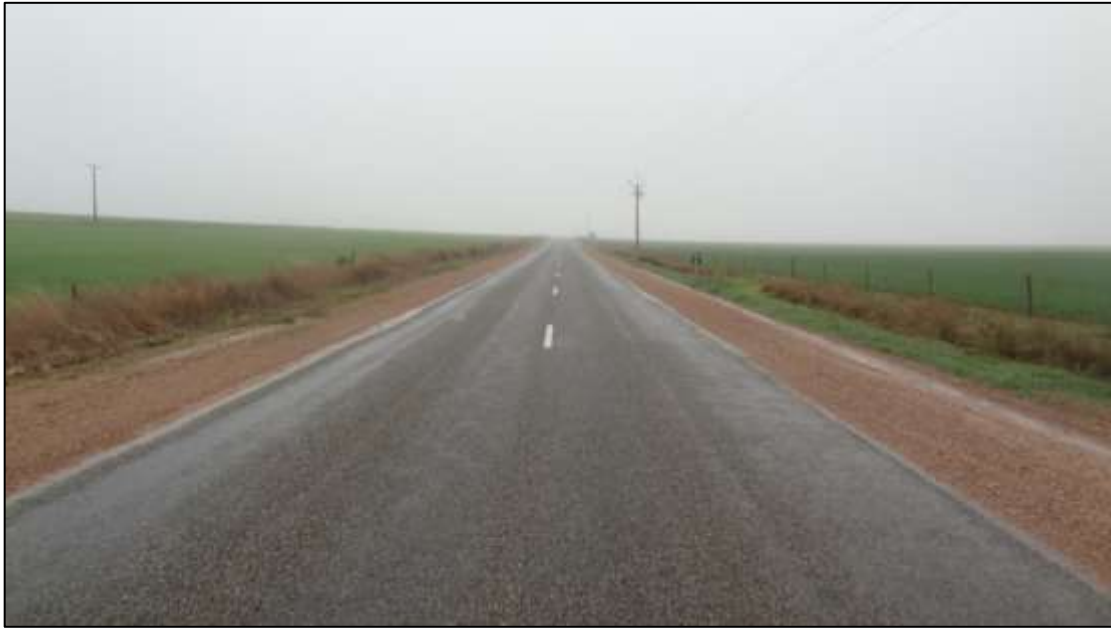
For the most part, between Georgetown and Murray Town, the B82 has lane widths of between 3.2 to 3.3m with a minimal sealed shoulder, usually 100 or 200mm at the most.

There was no sealed shoulder between Georgetown and Gladstone but from a point approximately 1km north of Gladstone, there were sealed shoulders of between 1 and 1.1m provided through to Laura. RAA welcomes the seal extension that has been undertaken on bends between Laura and Stone Hut. Along this section of the B82, RAA wish to see an increase in the lane widths to 3.5m with a minimum sealed shoulder of 300mm.

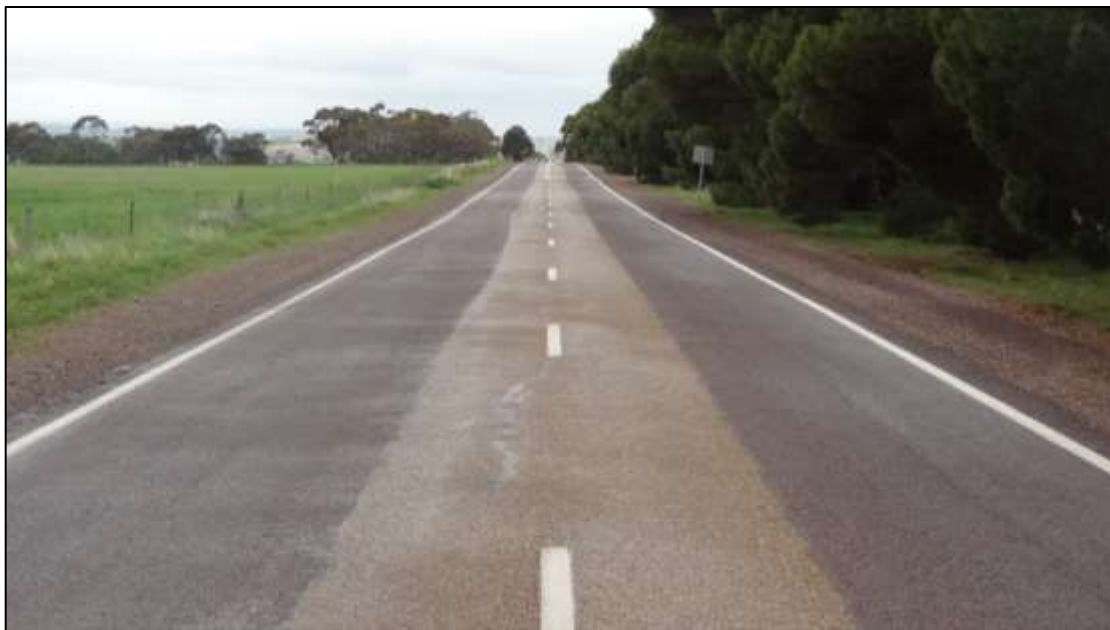
Along the 10km stretch of the B82 between Murraytown and Wilmington, there's a significant variation in the cross section of the highway. North of Murraytown, the lane widths were found to be 3.3m with a 1.0 to 1.2m sealed shoulder. About 9km north of Murraytown the lane widths continue between 3.3 and 3.4m but no sealed shoulder is provided until Bishop's Road where the lane width reduces to 3.2m but a sealed shoulder is provided of between 200 and 600mm. RAA would recommend that the geometry is rationalised to provide lanes of between 3.3 and 3.4m with a minimum 500mm sealed shoulder.

Between Melrose and Wilmington, lanes widths were between 3.2 and 3.3m with a 200 to 300mm sealed shoulder and a 1.4 to 1.5m unsealed shoulder. 11km north of Wilmington, there is a 5km section that has no sealed shoulder. A sealed shoulder of between 100 and 300mm is then provided to Wilmington. RAA would recommend an increase in the total seal to provide lane widths of 3.3 to 3.4m with a 500mm sealed shoulder.

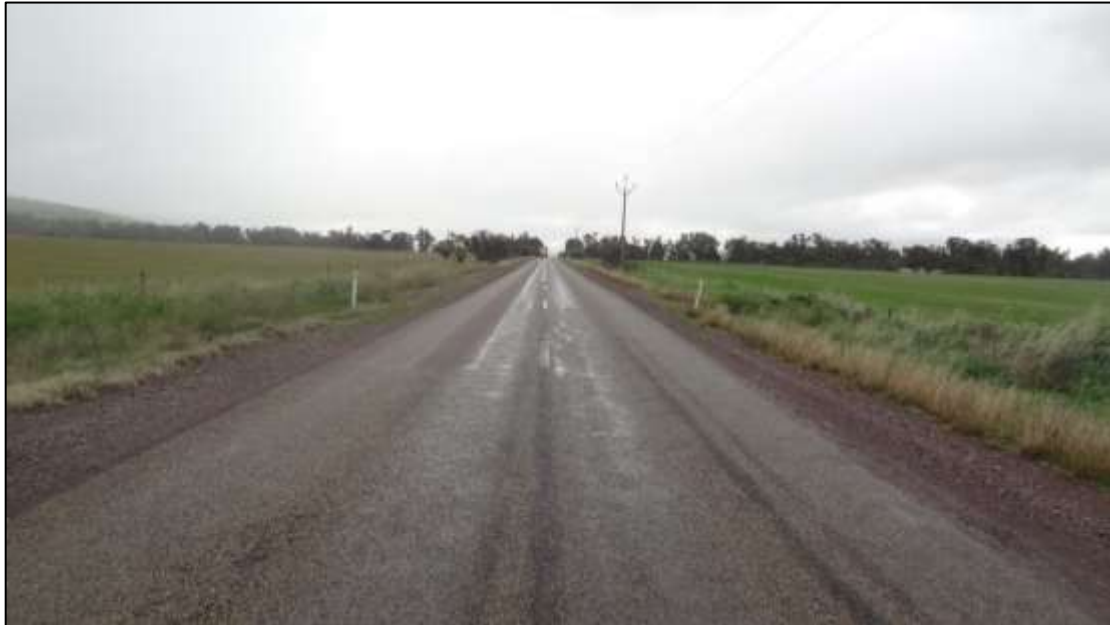
The quality of the texture along this section is very good, offering a coarse texture to provide good skid resistance and drainage. Bitumen bleeding and slight texture polishing was noted at two locations but was not considered to be significant.

The main areas of concern along this section was the extent of the asphalt edge break in some areas which was estimated to be between 40 and 50mm. Approximately 4km north of Melrose, pavement cracks were detected and it is recommended that crack sealing is undertaken as a priority. Further on from this at about 7km north of Melrose, rutting was recorded with some potholes starting to appear in the surface.

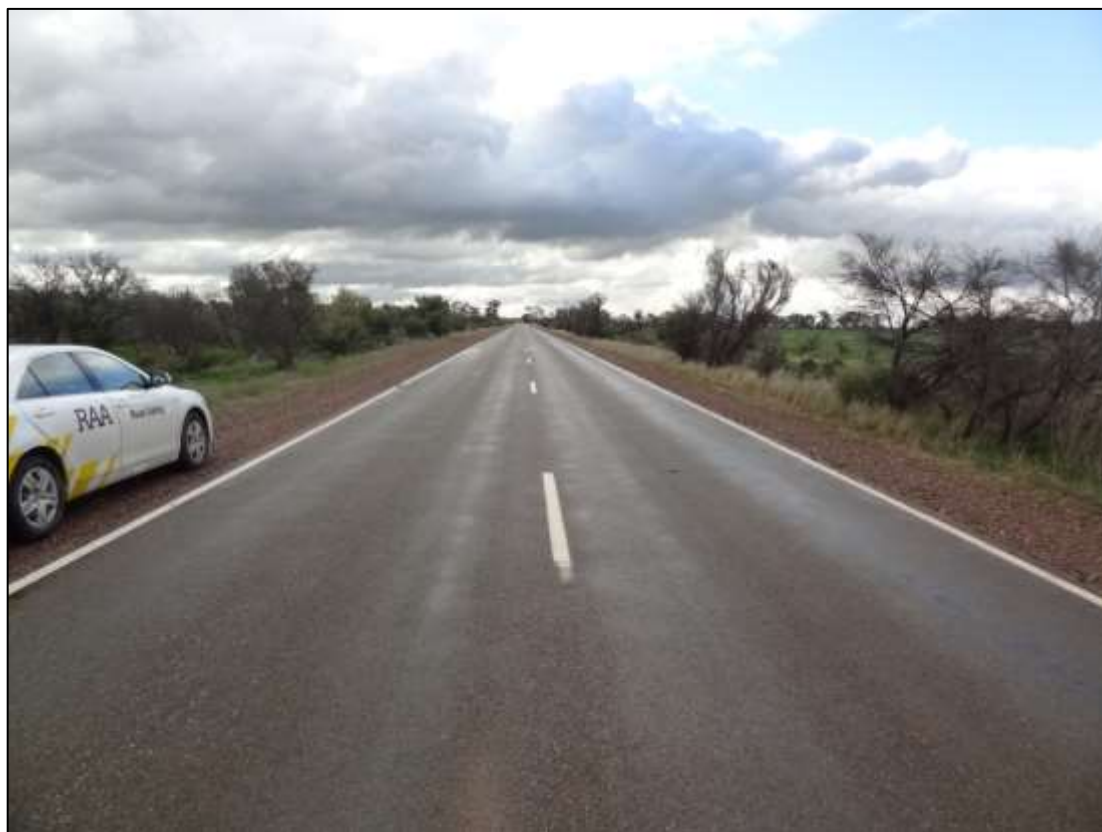
Centre lines, and edge lines provided a road lane width of 3.3-3.4m and also a sealed shoulder of approximately 0.3m. This gave the road a nice comfortable width and plenty of room to pass by larger vehicles travelling in the opposing direction. Unsealed shoulders were approximately 2.1m.

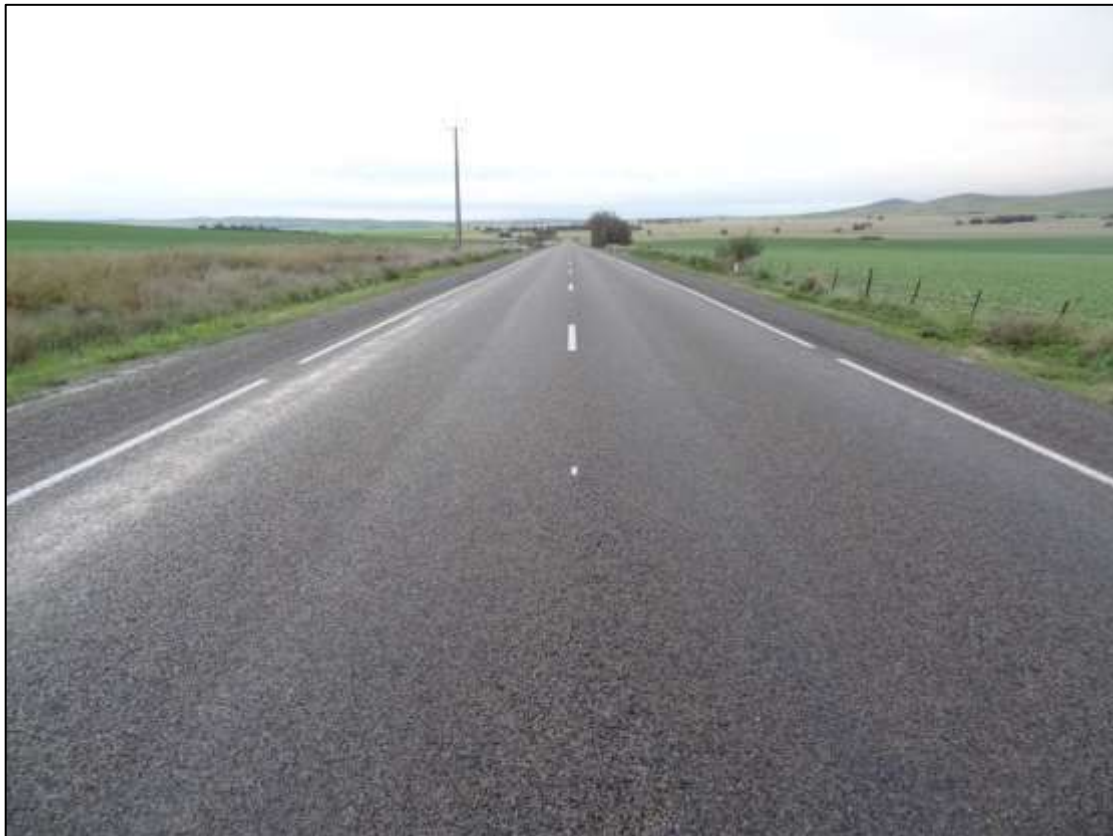
On the northern side of Yacka, the road surface was bumpier and additional cracking and rutting was observed, especially near to Georgetown.

The photo below was taken on one of the better sections of this part of the road, near to the intersection with the Goyder Highway.

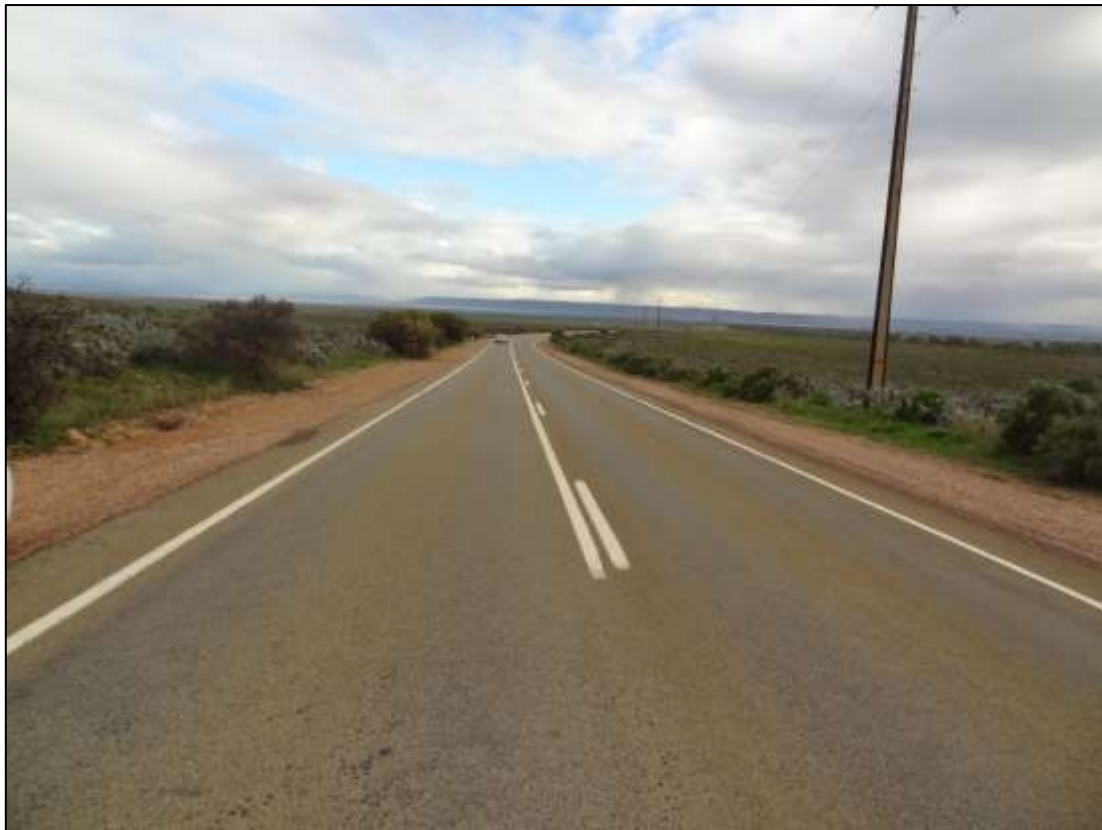
unsealed shoulder was between 2.2m and 2.5m. The photo below shows a typical road width and surface along this section of road.

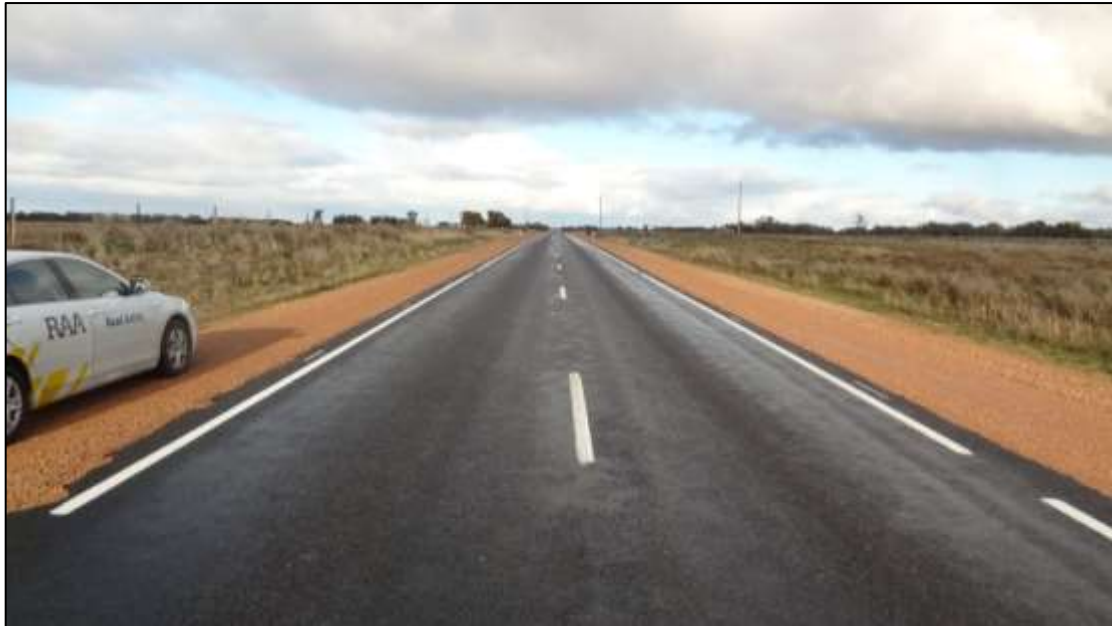
noted that towards Morgan, rut filling and patching has been undertaken to remedy the issue along some of the sections.

Unsealed shoulders were considered to be in good condition having been graded and appear to be well compacted. A few isolated areas were identified between Burra and Morgan where edge break was occurring but the extent of the problem wasn't significant and could perhaps be addressed with further grading to reduce any drop between the sealed and unsealed surfaces.

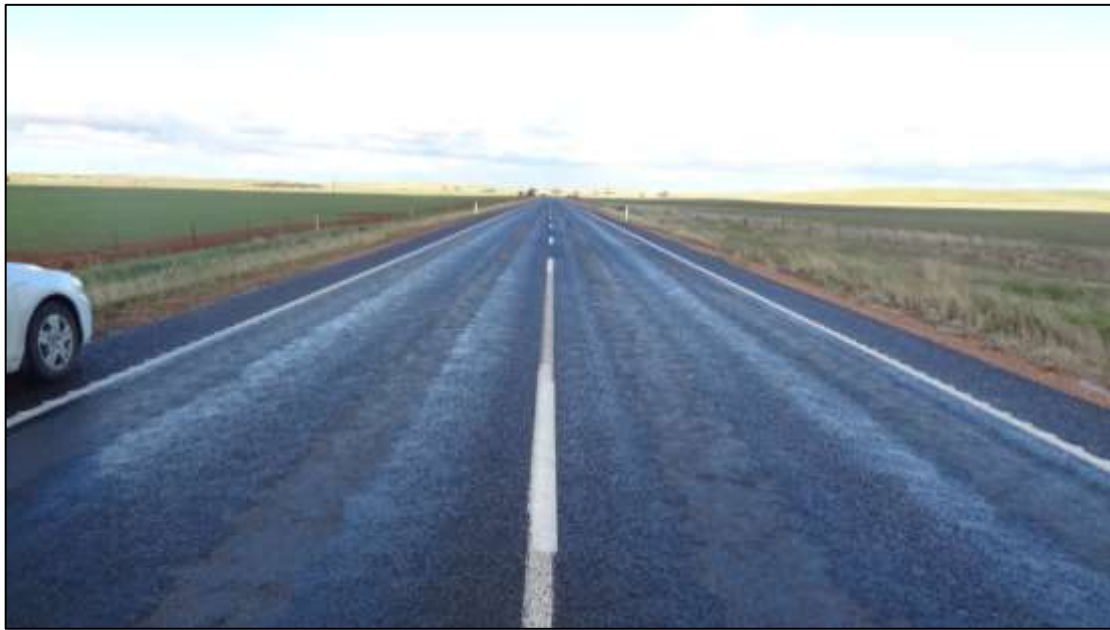
Generally there were few issues with the line marking between Spalding and Morgan. The marking provided offered clear delineation of the lanes. Between Burra and Morgan the assessment identified a section of road that had been remarked over the existing line marking. Along one section, RAA noted that a dashed line was marked over a previously solid line. This practice is not encouraged and where a decision has been made to alter the traffic management, the older lines should be blacked out to avoid confusion. Lack of reinstatement of line markings following pavement repairs was found to be a problem between Burra and Morgan.

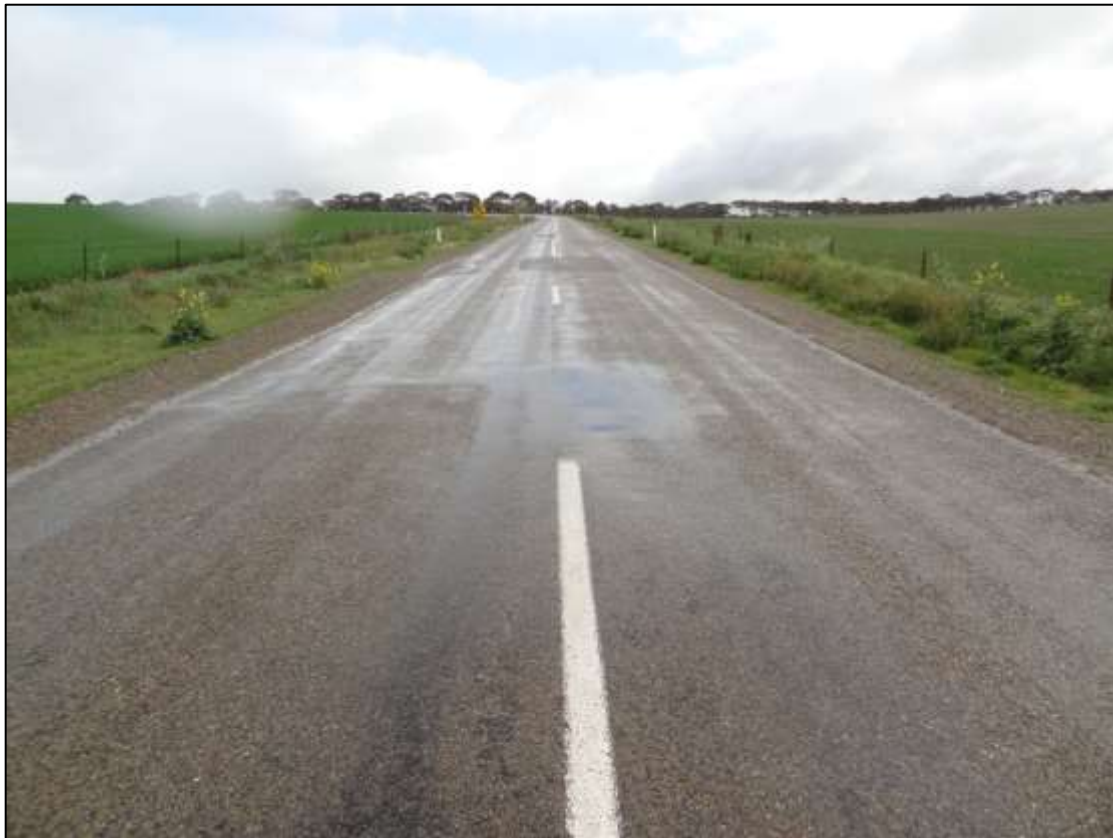
There were many small sections of repairs and patching to the road surface where it appeared that sections of severe rutting, cracking and bleeding had been repaired. In many of these locations the road was beginning to break up again. This was especially the case on the crest of a hill at 3.22km.

The ride quality produced by this road was average at best. The ruts on the surface, coupled with the old repair work patches and generally undulating surface provided a bumpy and uncomfortable ride. The only saving grace is the western end which appeared to have received a complete reseal in the more recent past. The photo below shows evidence of rutting bleeding and patches on the road surface which results in poor ride quality.

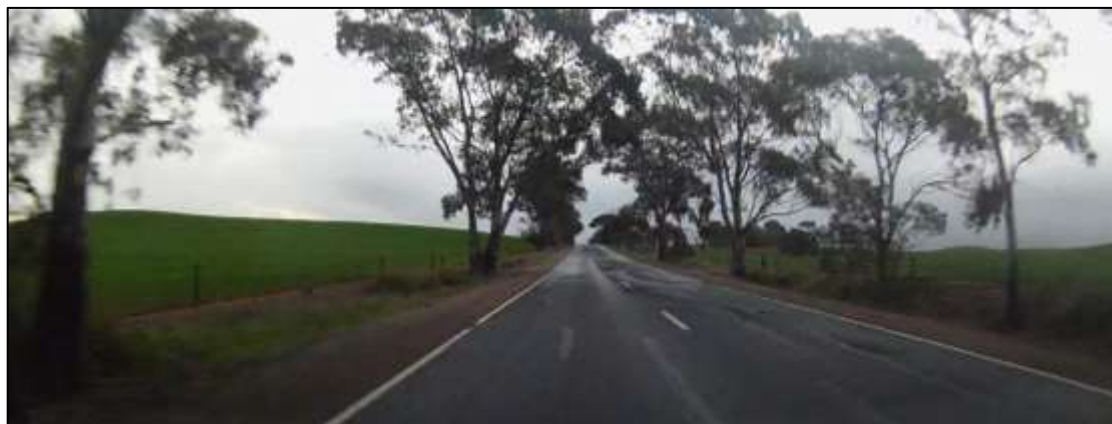
Road widths varied somewhat on the Goyder Highway. 3.6m lanes were recorded 7km from Gulnare. Edge lines were also provided although they were accompanied by a sealed shoulder that varied in width, sometimes as little as only 50mm wide. Being a 110km/h speed limit on this road, the sealed shoulders should be extended to provide a minimum of 0.5m and desirable 1m of sealed shoulder each side. Unsealed shoulder was between 1.3 and 1.7m. These sealed shoulders narrowed mostly on sections closer to Port Pirie. The image below shows the typical road environment found while driving this road.

- Shoulder widening to minimum 0.5m (desired 1.0m).
- Repair bleeding surface at most severe locations.
- Install RRPM's and ATLM.
- Protection for unprotected roadside drops.

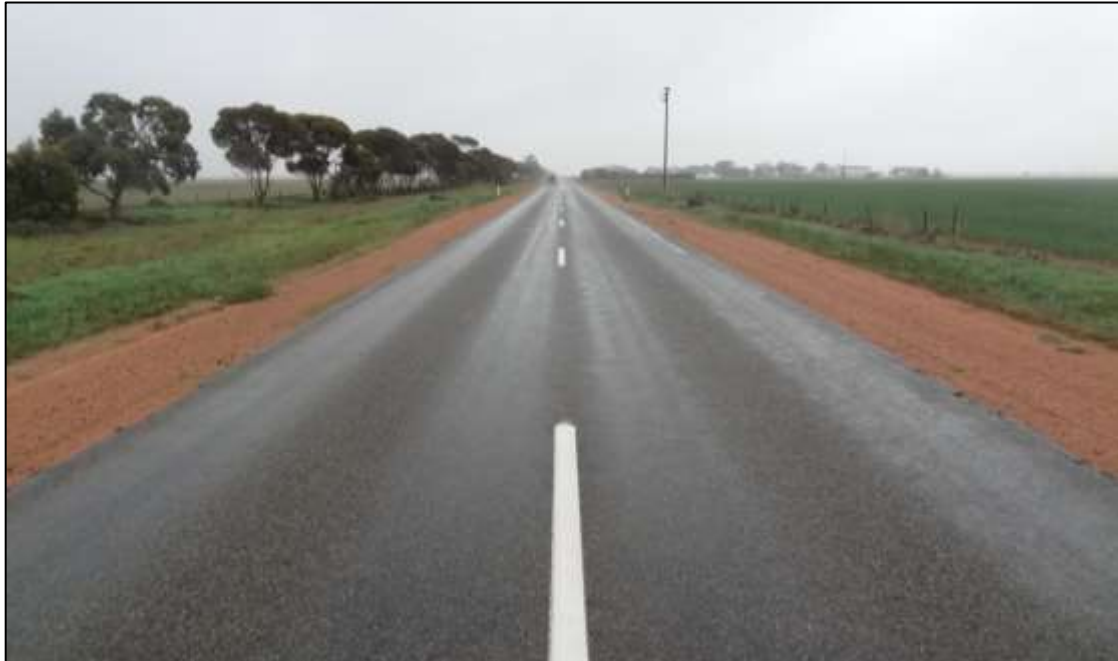
prominent, likely due to the fact that vehicles are not as often hitting the edge of the seal. It is highly recommended that the entire stretch of road is widened to be consistent with the southern area because of the huge safety benefits in preventing run off road crashes. Edge of seal repairs will be an ongoing expense until this is achieved.

- Repair of severe edge break and edge drop.
- Audio tactile line marking.
- Protection for unprotected roadside drops.

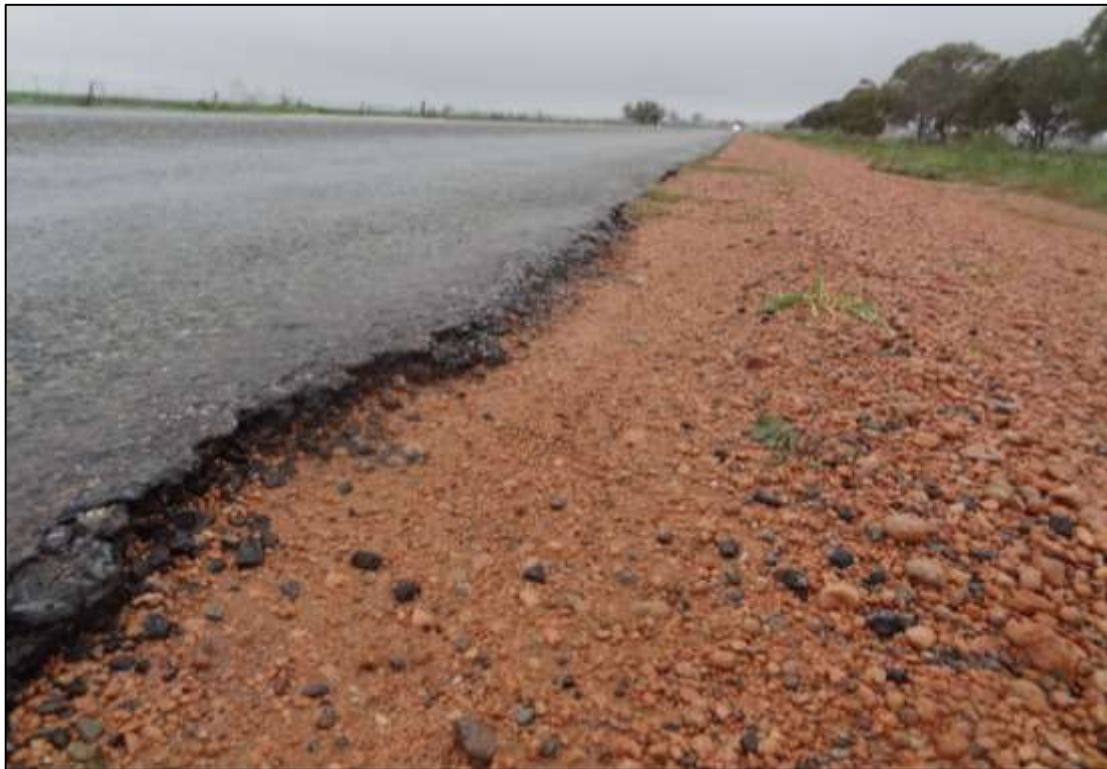
Between Port Pirie and Port Broughton the pavement varies significantly in terms of pavement width and surface conditions. The most significant issue again is edge break, which is common along the entire length of this road but especially the northern end. The edge break is commonly seen with drops to the unsealed surface of up to 100mm, which poses threats to run off road incidents and tyre side blowouts. On the northern end, sections of pavement rutting and bitumen bleeding were also encountered, but while not considered serious at this stage, should continue to be monitored. The road undergoes a number of changes in the pavement, each bringing slight changes to the ride quality and surface. Some sections are quite bumpy particularly between 40 and 47.5km before it improves following another change in surface at 47.5km.

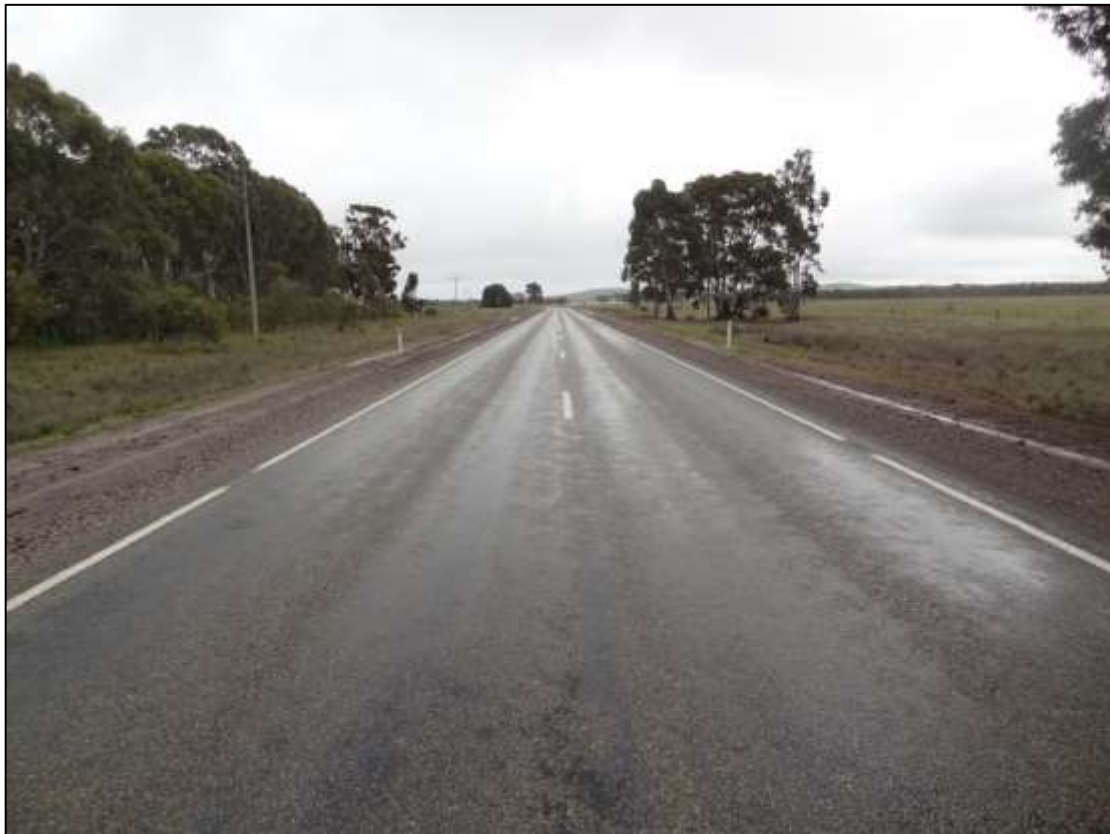
A road width recording took place at 19.35km and showed 3.2m lanes with sealed shoulders of 0.5m. The unsealed shoulder was between 2.6m and 2.9m. The entire road was not of this standard though, with many places having significantly less sealed shoulder width.

- Shoulder widening to minimum 0.5m.
- Repairs to sealed surface on worst affected areas.
- Protection for unprotected roadside drops.

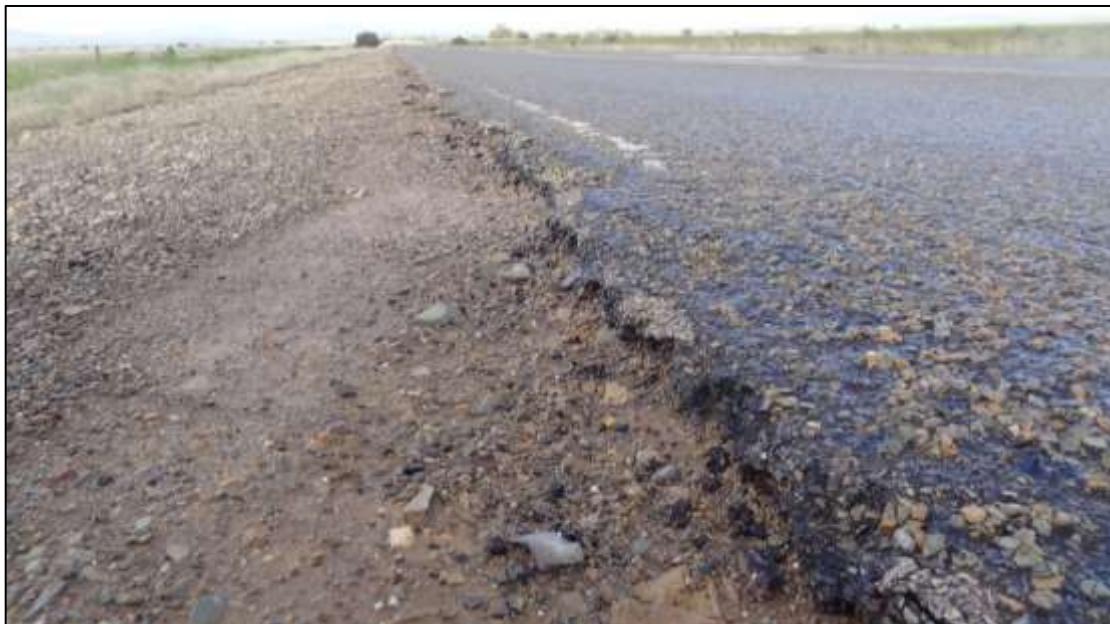
The presence of edge break was noted throughout RM Williams Way with attempts made to repair the damage. Between Carrieton and Orroroo, drops from the asphalt of between 50 and 60mm were estimated. It is recommended that the edge drop is repaired along that section either through seal extension or shoulder grading since drops of over 50mm can make vehicle recovery onto the pavement difficult.

- Extend seal to provide minimum 3.2m lanes
- Extend seal to provide minimum 500mm sealed shoulders.
- Repair edge break / edge drop
- Undertake rut filling program
- Remove abandoned line marking
- Refresh worn line marking
- Install ATLM on bends
- Install barrier protection for steep drops at the roadside

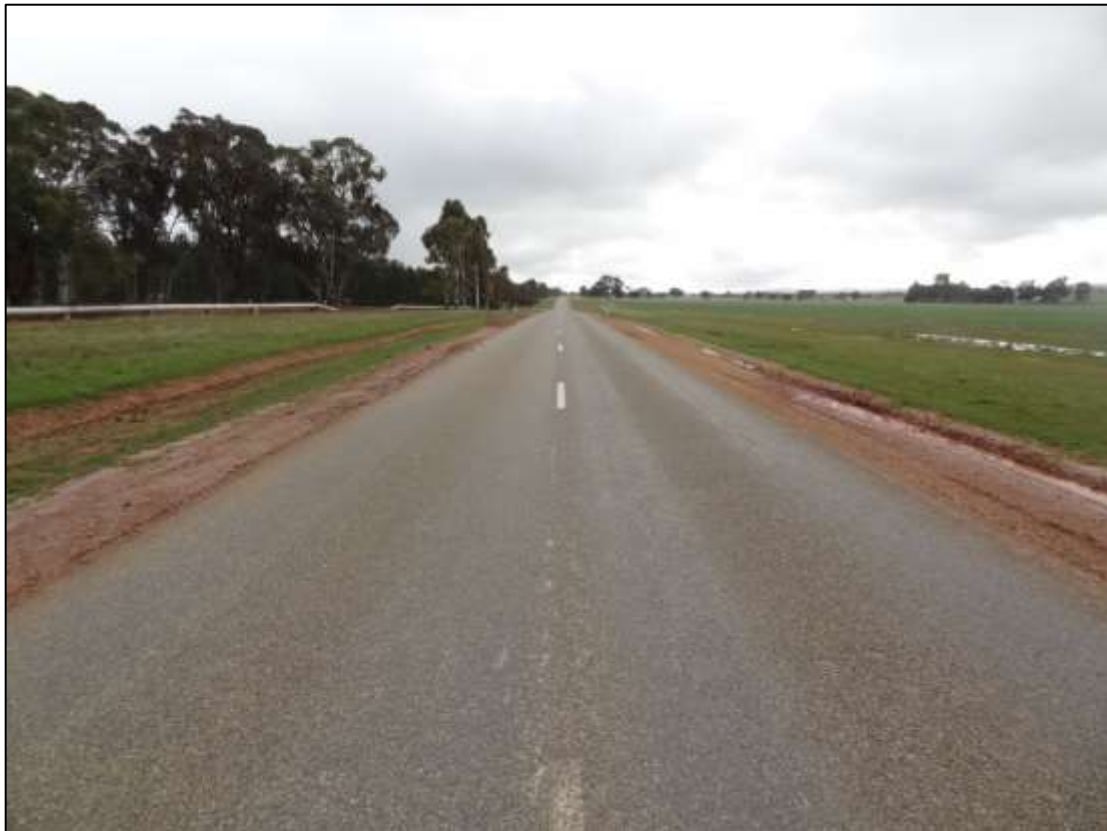
break was accompanied by significant drops to the unsealed surface of up to 100mm. These are dangerous for run off road incidents and can cause tyre side blow outs or loss of control of the vehicle.

Unsealed shoulders were poor and appeared to be very muddy, indicating potential drainage issues or poor quality material. At the time of assessment, it was raining which caused the shoulders to be very slippery and muddy. There are many sections where the shoulder has quite an adverse cross fall, and then falls back in towards the road which causes water to pool on the roadside. This issue coupled with the material that the shoulder consists of results in a soft muddy surface. These areas and particularly at 8.72km, should be modified with drainage channels created to ensure that water is taken away from the roadside. The shoulders should also be graded with a proper crushed rock material added. This issue was less significant on the southern end near Spalding, where the material was of a higher quality and appeared to be better and more recently graded. The photo below shows a particularly muddy area.

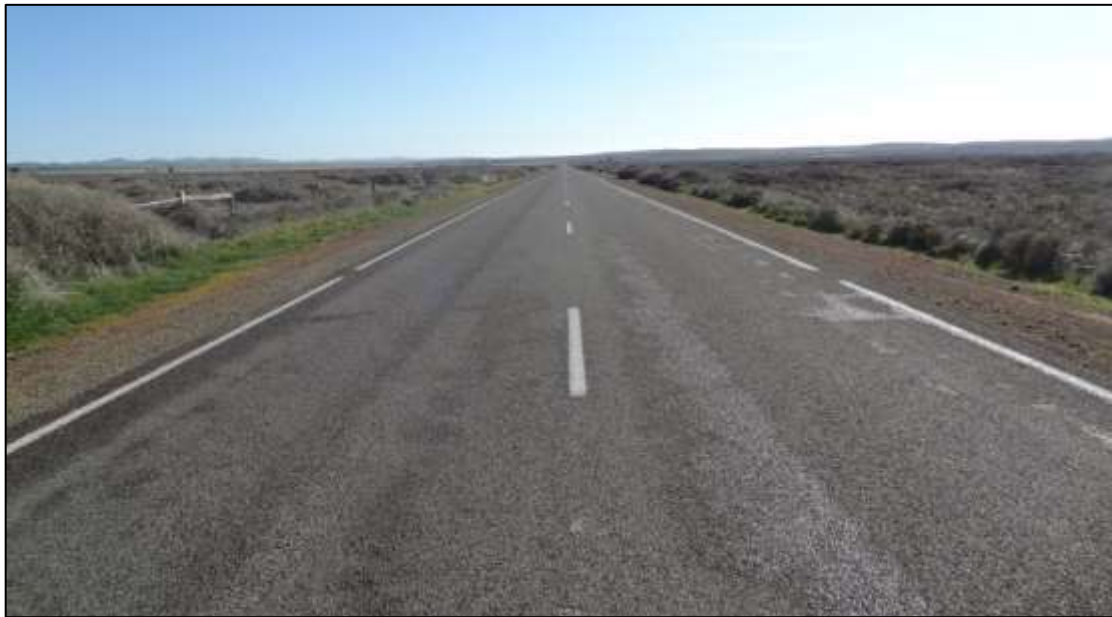
This road was a delight to drive on because of its smooth road surface and very few defects. Noted was the macro-texture which was coarse and provided a good friction for tyres as well as decent drainage properties. The surface in general was smooth with very little bumps or lumps, which caused the ride quality to be exceptionally good. The only defects that were recorded during the assessment were rutting and pot holing which was found in one of the floodway dips but had been repaired in the past. This was recorded at approximately 20.48km.

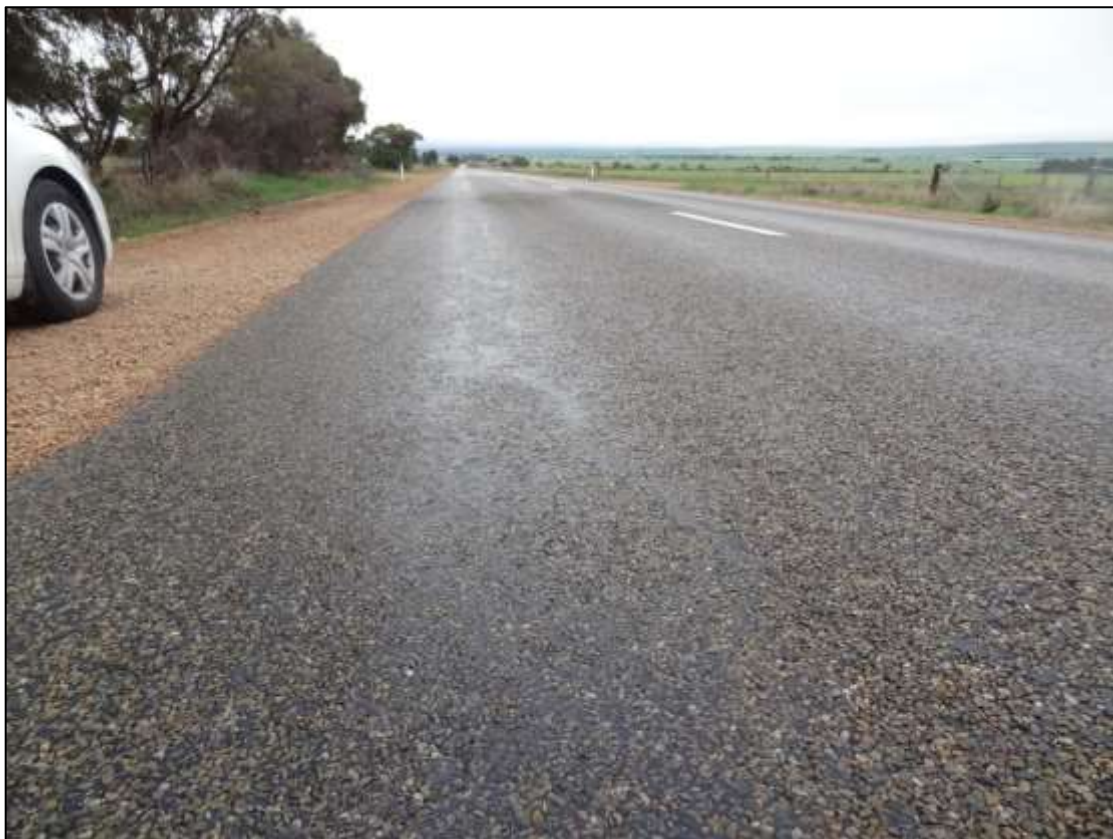
Small bumps and lumps in the pavement surface resulted in a poor ride quality on the outskirts of Port Broughton. The addition of ruts and some bleeding in the passenger and driver wheel paths along with short sections of road repairs did not improve the ride either. Occasional edge break was seen, although not as significant as the edge break on Port Pirie to Port Broughton Road. The texture was average to good, and generally provided a coarse surface with good drainage properties. On the short section of road between the Augusta Highway and Crystal Brook (Gadd Ave) the road surface was significantly better with very little signs of bleeding rutting or cracking in the pavement surface. The photo below was taken near Clements Gap.

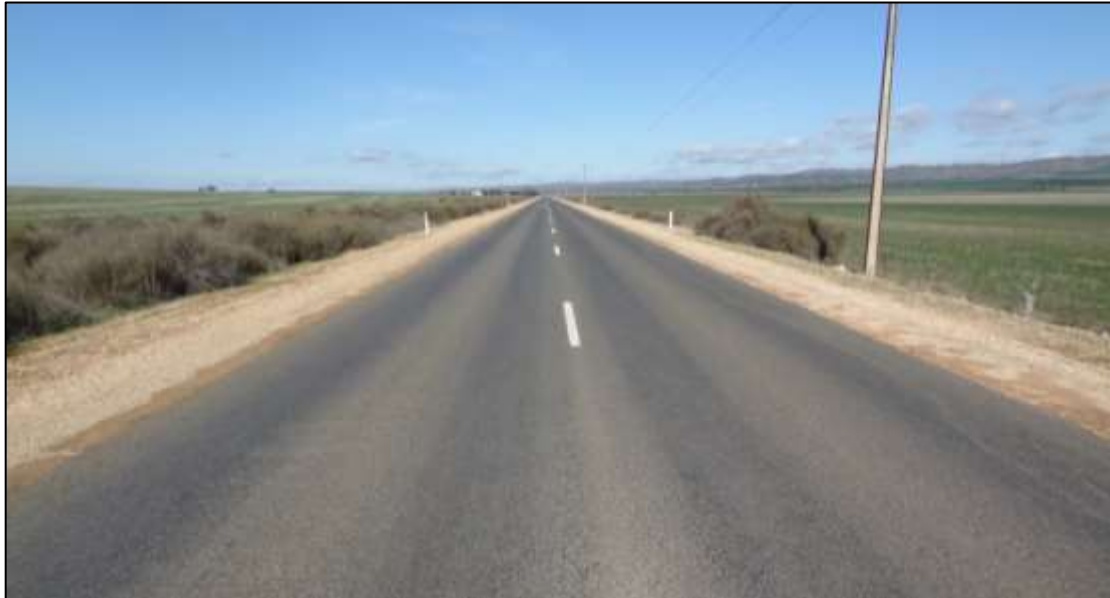
It was found that the lane widths were extremely narrow on the outskirts of Robertstown with a road width of only 3.0m lanes, no sealed shoulders and unsealed shoulders of approximately 2.3m. Further south, after travelling 3.1km the lane widths widened to 3.4m, still with no sealed shoulders. Notably the extra 0.4m on each side of the road felt

much more comfortable to drive on especially when passing other vehicles in the opposing direction. Unfortunately this seal extension persisted for approximately 2km before reducing back down to barely more than 3.0m per lane and then continued at a similar width for the remainder of the journey.

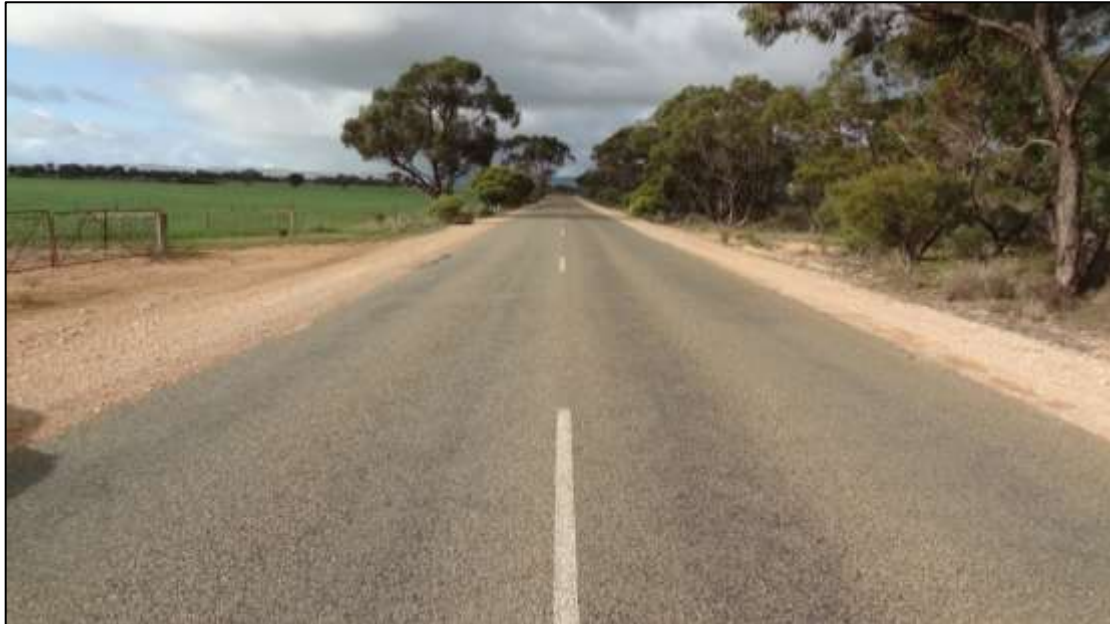
remaining section towards Blyth. To the east of Blyth, the lanes remain the same width and the assessment noted that the lanes were particularly narrow and made driving uncomfortable when passing heavy vehicles on bends. Seal widening is therefore recommended to provide a minimum of between 3.2m and 3.3m lanes with at least a 300mm sealed shoulder.

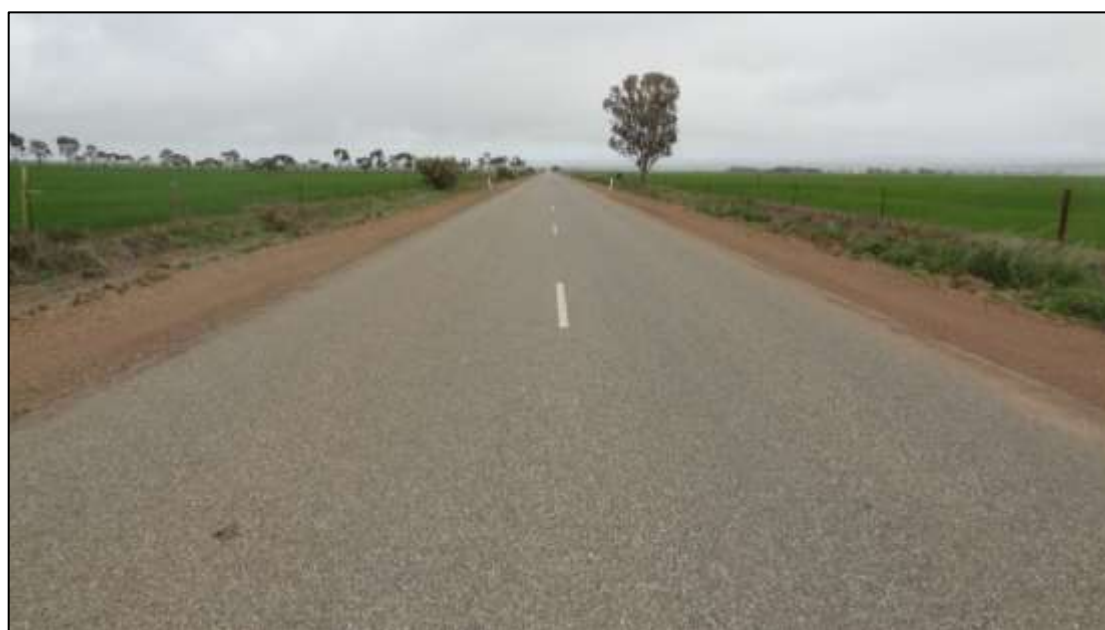
From Orroroo to Pekina, the lane widths were measured at 3.5m with a 300 to 400mm sealed shoulder. Between Pekina and Appila, the road width reduced and lanes were generally restricted to 3.3m with no sealed shoulder. The assessment found that for some short sections, a shoulder seal of 400mm was provided. On approach to Appila, the lane widths were measured at 3.6 to 3.8m with no sealed shoulder although the available seal width could permit an edge of carriageway line that would provide a shoulder. The wider seal continued on south to Laura with unsealed shoulders of between 1.2 and 1.5m provided.

The lane widths are reasonably wide along the Orroroo to Laura Road considering that it is unclassified road. RAA would however recommend an increase in the seal width that would allow provision of a sealed shoulder of between 300 and 500mm.

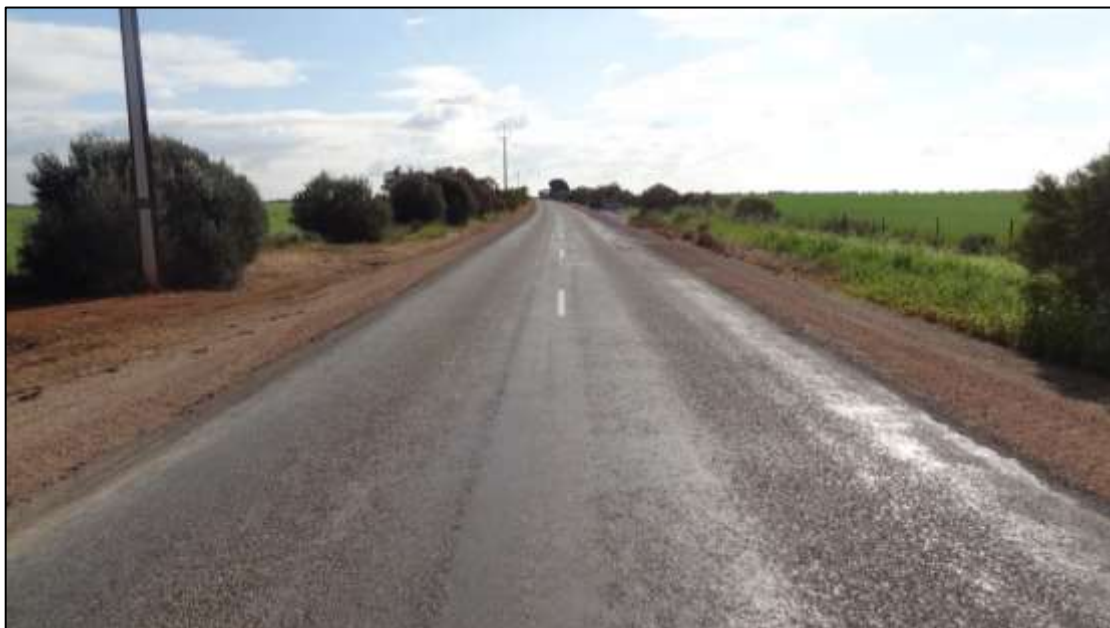
Edge break was a widespread issue along the B81 between Owen and Roseworthy. Bad edge break was noted on numerous occasions and the resulting edge drop was estimated to be between 30 and 60mm. About 32km south of Balaklava, a section of the highway demonstrated extreme edge break with an estimated drop of around 100mm. The edge break should be repaired as a priority to address safety issues and to prevent loss of the edge of carriageway lines.

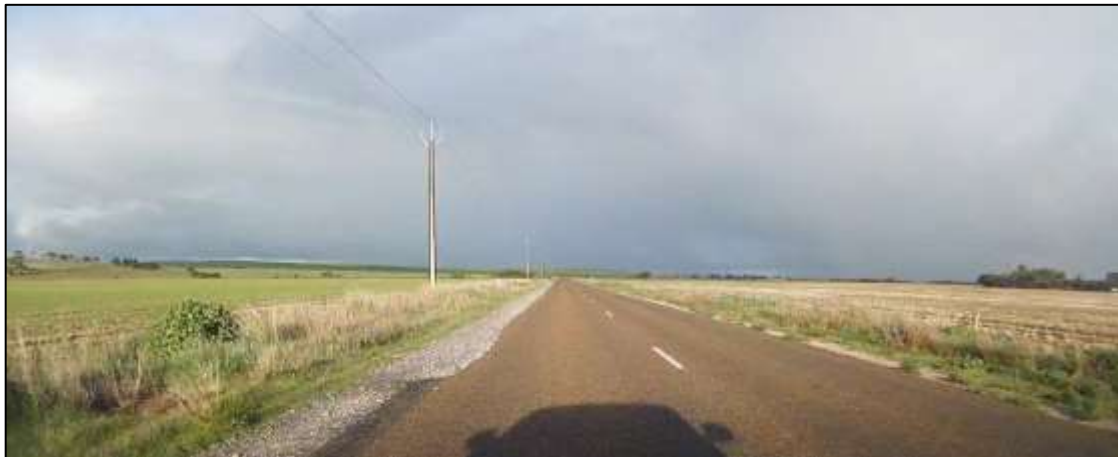
The most concerning factor on this road is the significant presence of edge break which occurs on almost the entire length of road between Redhill and Brinkworth. The narrow lanes and lack of edge lines have likely been a contributing factor in forming the edge break because of the common occurrence of vehicles hitting the edge of the sealed surface with their tyres. The worst edge break was found on bends. This is likely the result of more vehicles hitting the edge of the bitumen at these locations. The following image shows a typical section of road for this area.

- Repair to significant edge break and edge drop.
