Mid North

RAA Regional Road Assessment

October 2015

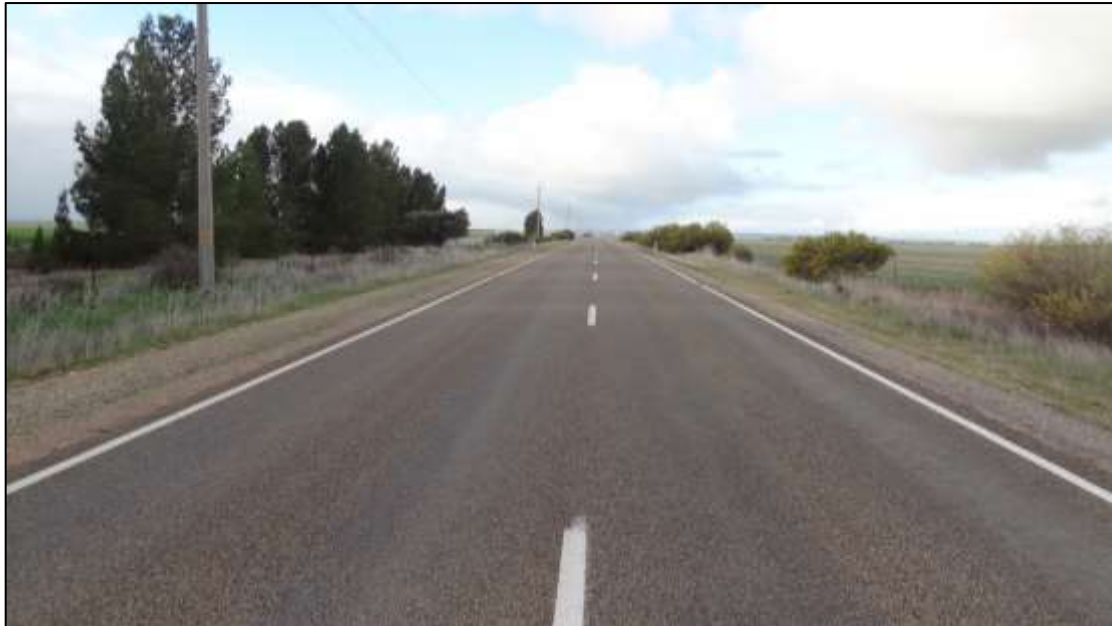
Measurements along the road between Brinkworth and Snowtown showed that lane widths varied between 3.3 and 3.4m with a 300mm to 500mm sealed shoulder and 1.3m to 1.7m unsealed shoulder. These dimensions are considered adequate for the class of road and the volume of traffic however seal extension is recommended on bends. For a section of about 5km east of Snowtown, the sealed shoulders were noted to fall to

around 200mm wide and it is highly recommended that seal extensions are undertaken to provide a sealed shoulder of between 300 and 500mm.

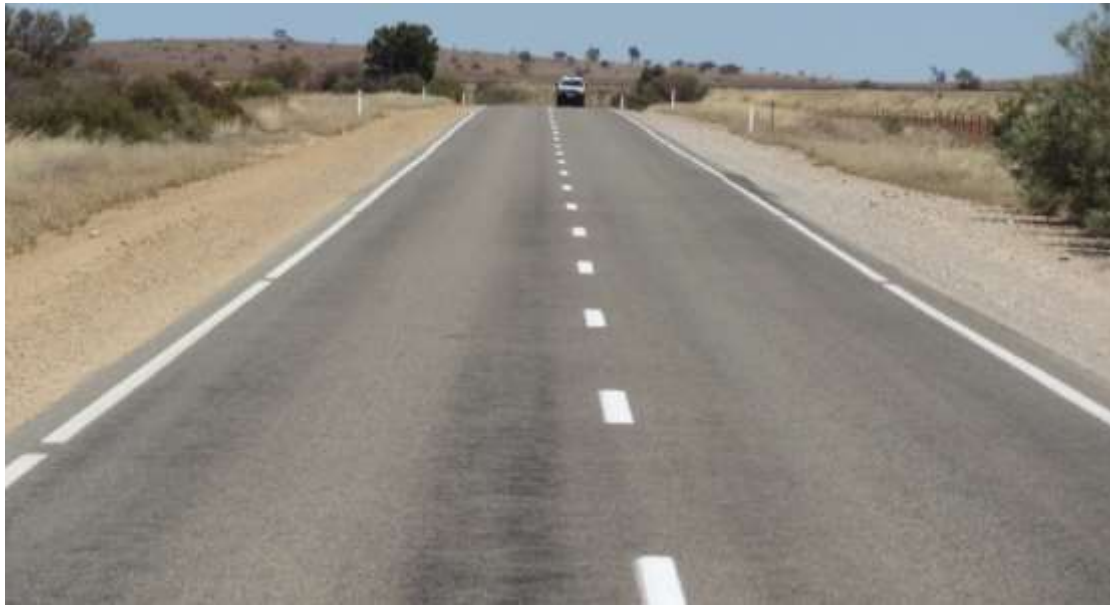
Figure 2: A section of road between the Barrier Highway and Peterborough. Surface conditions and line markings are good; however the lanes and shoulder seals are narrow.

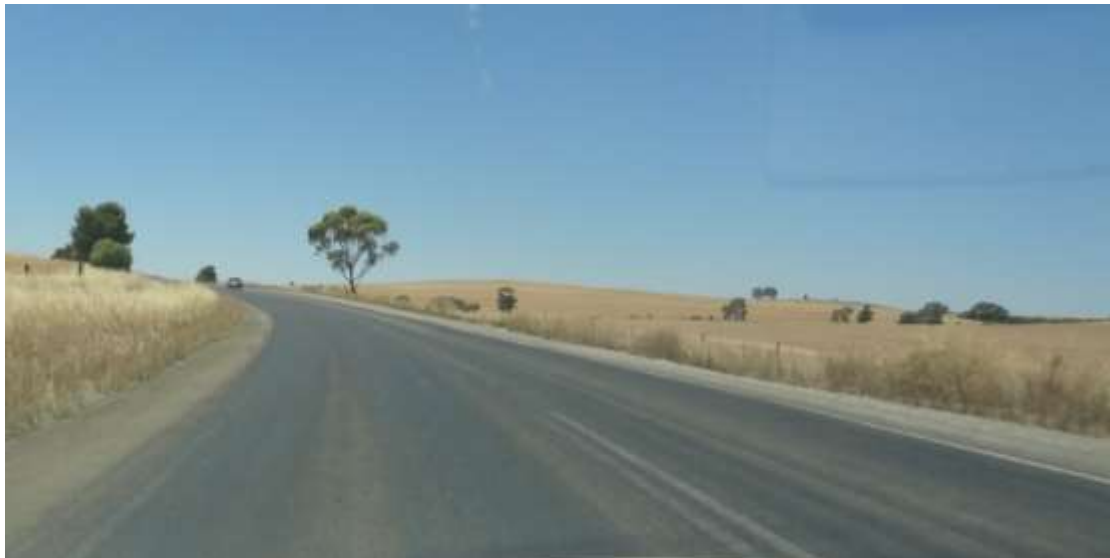
when cornering at speed. Aggregate loss in this section of the road was so bad that it often created a situation where the road line markings could no longer be seen, which causes a danger of vehicles accidentally moving out of their lane into oncoming traffic or onto the unsealed shoulder. Figure 3 below shows a section of road with severe stripping of aggregate and poor line marking quality.

Figure 3: Aggregate loss in the road surface resulting in line markings which cannot be seen.

Road surface aggregate loss was evident every 5-10km between Jamestown and Highway A1. In some cases it lasted for a kilometre or more.

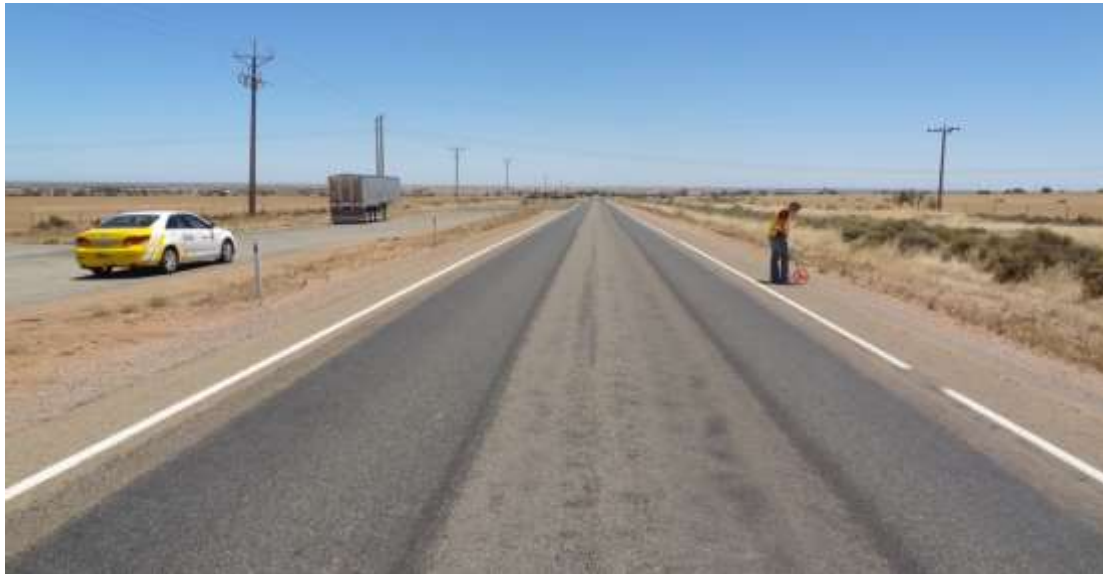
Road patching is another significant pavement surface issue for this section of road. The road is patched in many sections due to previous road failure which creates a bumpy and inconsistent ride for drivers. There are also many sections of the road where patching has occurred over the edge lines or centre lines of the road and the lines have not been repainted, mainly in the second half of this section of road after Gladstone. Missing centre lines are of particular concern and should be addressed as an issue of high priority. There are particularly long sections of missing centre lines after Gladstone close to the intersection with Highway A1, as can be seen below in figure 4.

Figure 4: A long section of road with no centre line, just prior to the intersection with Highway A1.

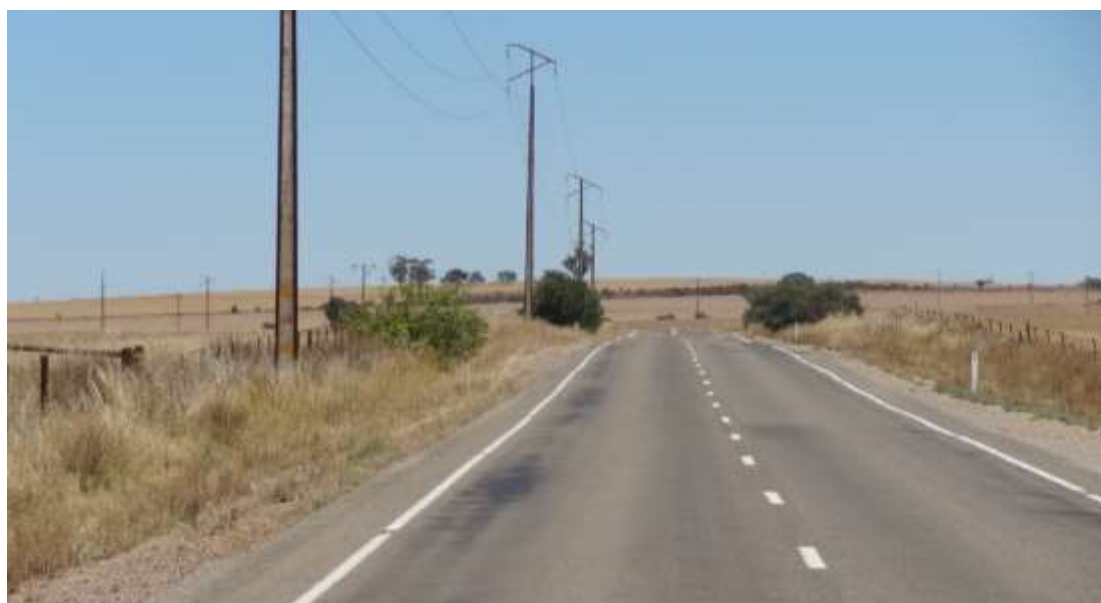
Of highest concern is the high number of unprotected stobie poles and trees which are situated close to the side of the road in this section of the Mid North Freight Routes. In places these approach as close as 3 metres from the edge of seal, and are common and evenly spaced along the entire 48km between Jamestown and Highway A1. This is hazardous as it increases the chance of a serious crash resulting from a vehicle running off the road. These significant roadside hazards should ideally be either relocated, or protected with W-Beam railing when within 5 metres of the seal. Figure 5 below shows the stobie poles in close proximity to the road.

Figure 5: Roadside hazards of stobie poles and trees.

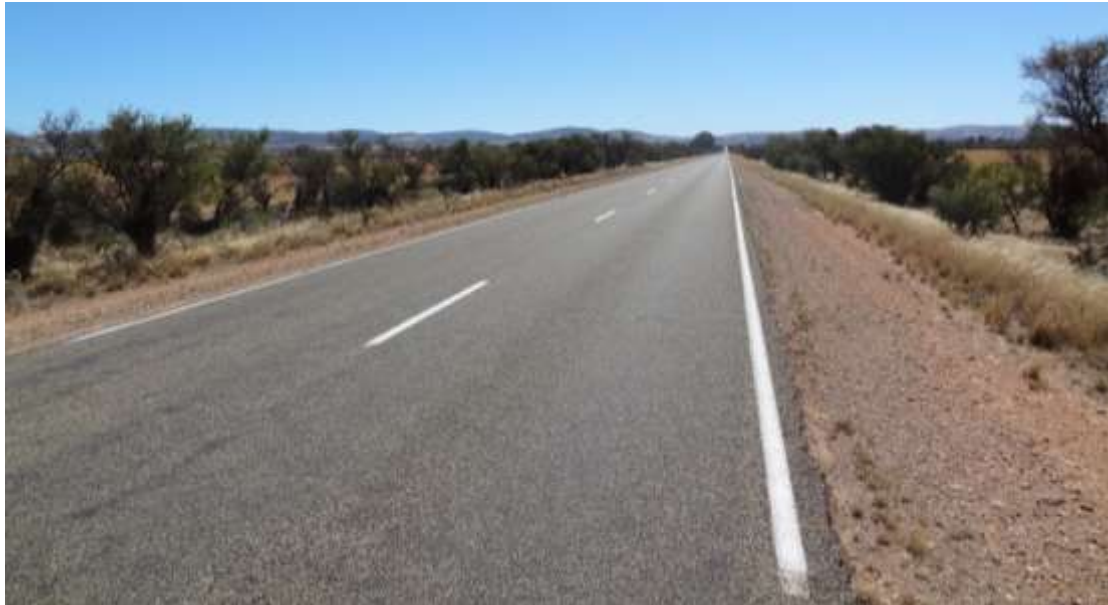
A few instances of significant unprotected trees were evident in the 10km north of Jamestown, and 5km prior to Black Rock. One such instance is displayed in figure 6 below.

Figure 6: *Small to medium sized shrubbery lining the sides of RM Williams Way.*

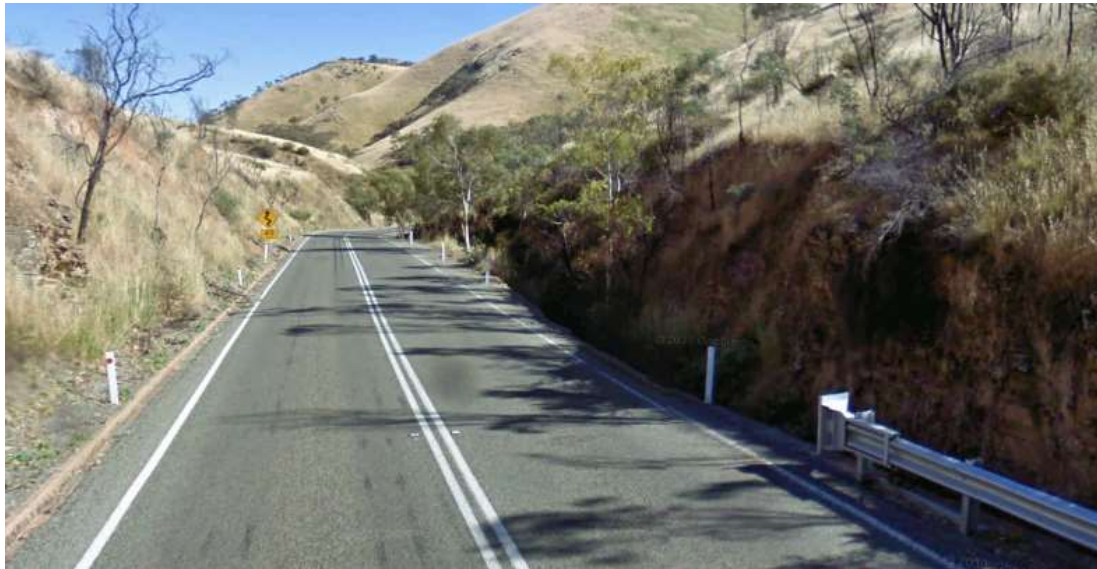
It is clear that much work has been done in an attempt to improve the safety of the Horrocks Pass. There are long sections of W-Beam railing protecting from drops and significant trees, and there is a lot of signage warning of narrow roads, tight bends, directional boards, and suggested speeds. To improve the safety of this dangerous section of road W-Beam barriers should be considered for the entire length of Horrocks Pass, protecting from all roadside drop offs and vegetation hazards. Another improvement to consider would be to reduce the speed limit in this area to 80km/h, rather than simply suggesting slower speeds. It is a short section of road, as such a slower speed limit will have minimal effects on motorists and would benefit tourists or anyone who isn't familiar with the layout of the road. Figure 7 below displays a section of Horrocks Pass with a large unprotected drop in close proximity to the road.

Figure 7: A section of Horrocks Pass with a large unprotected drop on the side of the road. Provided W-Beam railing does not fully protect this hazard. Suggested speed sign reads 45km/h (Google Street view 2009).
