OUTBACK

Regional Road Assessment

August 2015

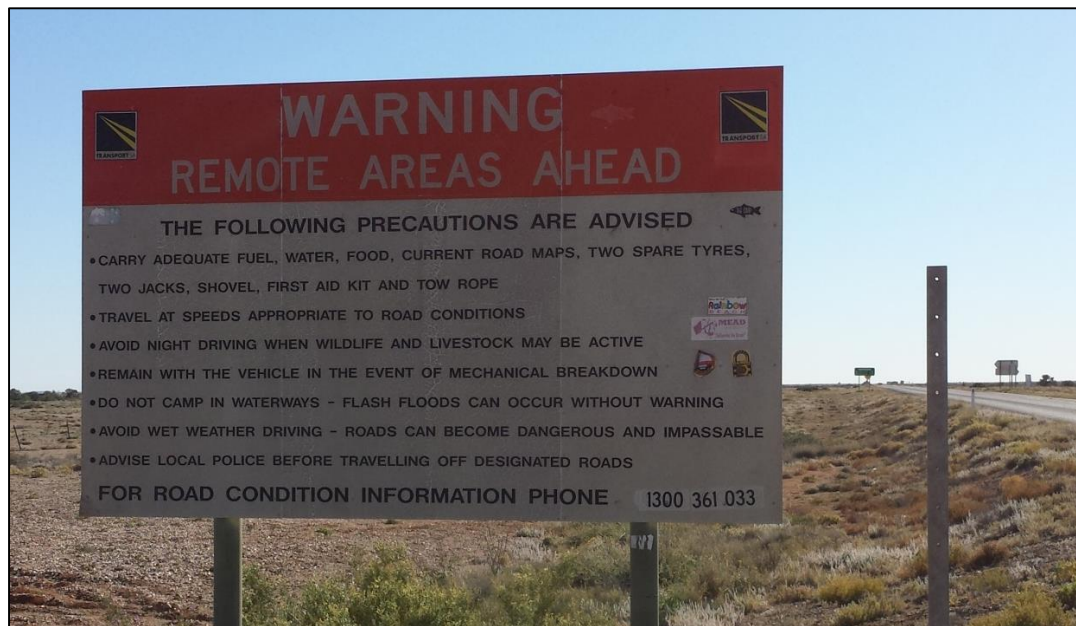
RAA welcome the installation of an advisory sign at the start of the track that outlined basic considerations and survival requirements such as ensuring a plentiful supply of fuel and water. The sign however had a significant amount of text and there was no incentive for the motorist to pull over at the side of the road, so whether motorists read the full sign is questionable. Additionally the sign was faded and dirty and could be difficult to read under some conditions. It is recommended that a rest area is considered within the locality of the sign. It may also be beneficial to provide multi-lingual information displays at the rest area to cater for a majority of the international tourists that may visit. Education should however start early on and not be limited to the start of the track. RAA strongly recommends the development of educational literature that could be made available through the tourist information office that advises tourists how to prepare and what to expect during their journey.

Figure 11 – At the start of the Birdsville Track a sign provides sound advice to those starting their journey.

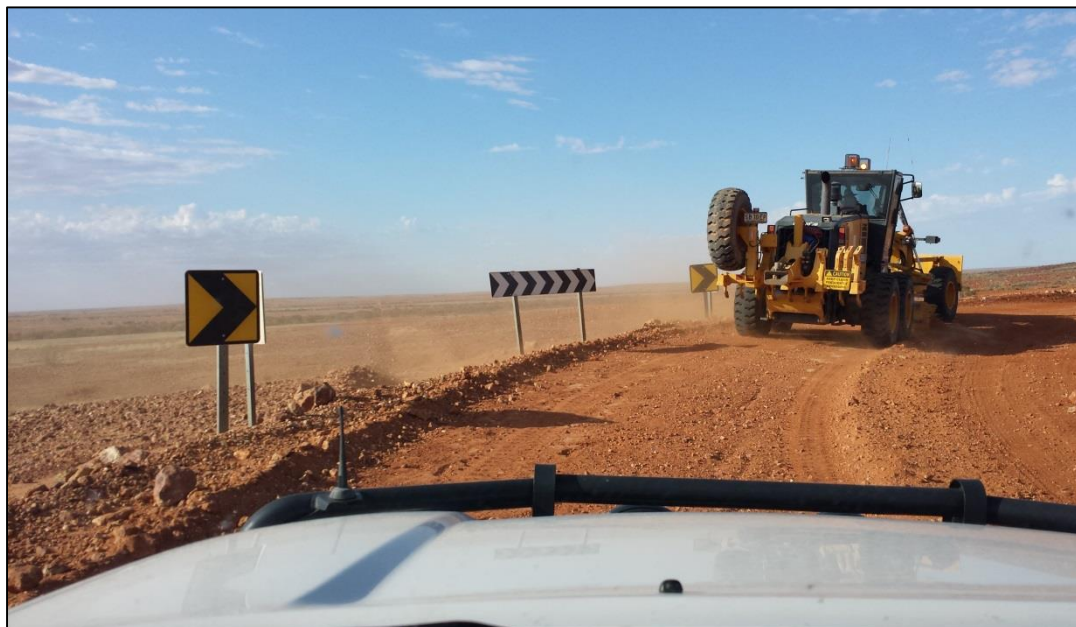
South of Moomba, the pavement was again in excellent condition, providing a relatively smooth ride that was comfortable to drive on at high speed. It was clear that there was an extensive and frequent grading program in place as the survey team passed a number of long distance road works where the track was being re-profiled and compacted. The increased maintenance south of Moomba may reflect the Oil and Gas industry traffic, since the higher volumes of heavy vehicles increase wear of the surface.

Figure 15 – The survey team encountered graders undertaking maintenance along the track at a number of locations.

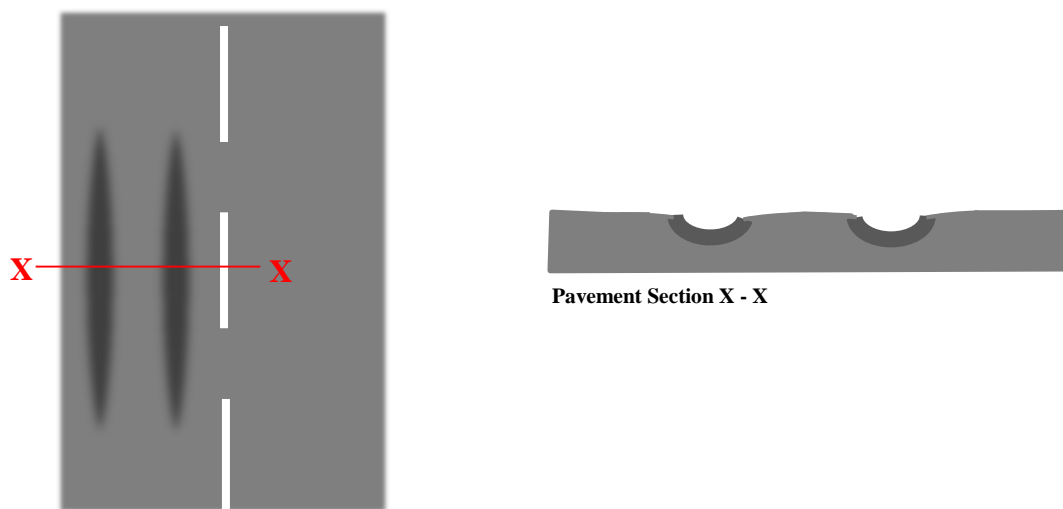
A rut is a defect in the form of a longitudinal depression in the pavement surface. It usually occurs in the wheel path of vehicles (Figure 2) and is caused by high volumes of heavy vehicles over time. Ruts can also form as a result of environmental influences such as extensive rainfall combined with a poorly sealed surface. This can permit moisture to enter the pavement foundations which can weaken the structure or cause movement in the soil beneath, both of which can lead to rutting.

Figure 2 – Pavement Rutting
