# Barossa and Light

## Regional Road Assessment

October 2017

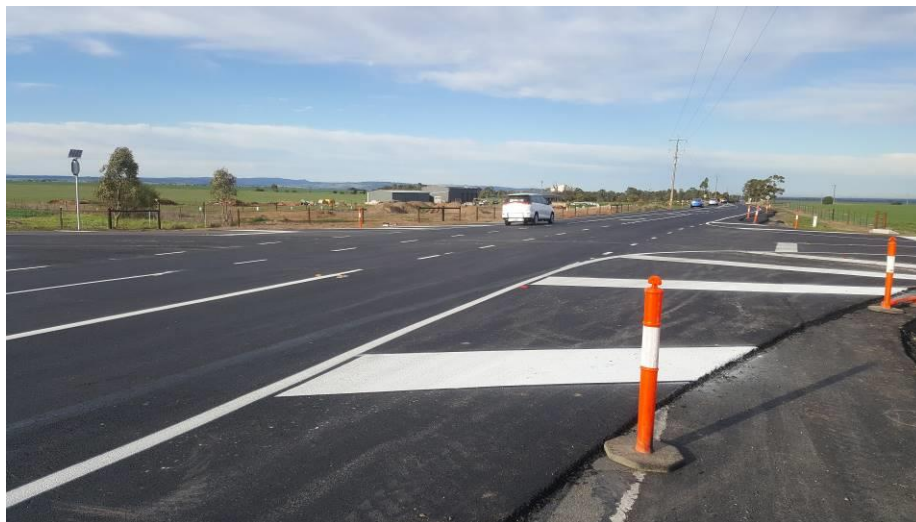
This current upgrade to this intersection was underway at the time of our assessment however the improvements made have been largely very positive in increasing safety.

Very large 'prepare to stop' signage has been duplicated on both Roseworthy Road approaches, and LED Stop signs that illuminate when a vehicle approaches have also been installed. The road has been significantly widened and right turn filter lanes have been installed on Thiele Highway. Exposed stobie poles are present on three of the four corners of the intersection however. It was also noted that there does not appear to be any street lighting at this stage.

*Figure 36: The Roseworthy Road junction was undergoing a major upgrade at the time of our site assessment.*

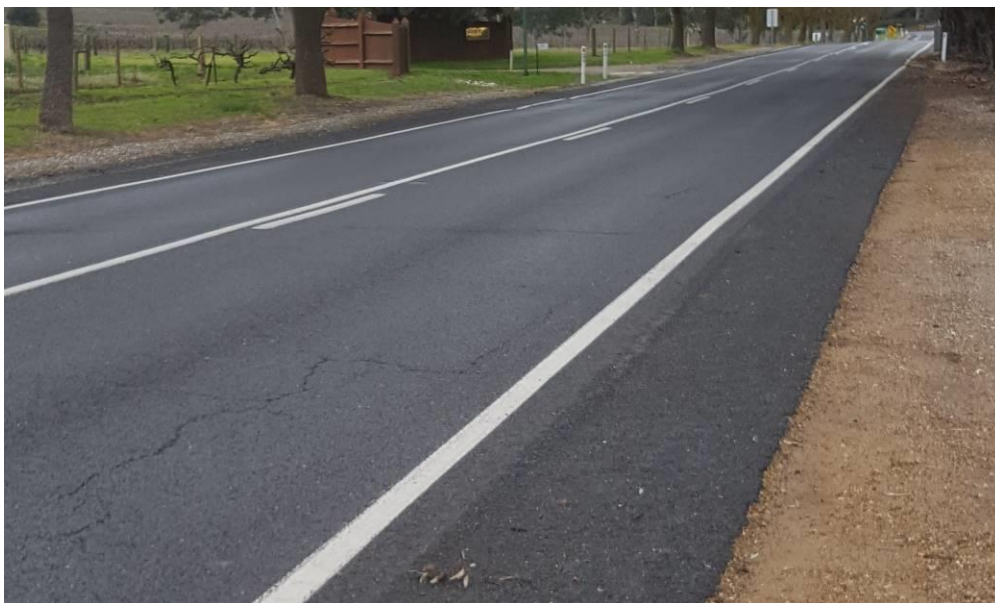
*Figure 40: Wide shoulders and lanes were good to see on this section of Barossa Valley Way*

There is no overtaking lane for westbound vehicles on this section of Barossa Valley Way, and it is recommended that investigation into the installation of an overtaking lane is undertaken.

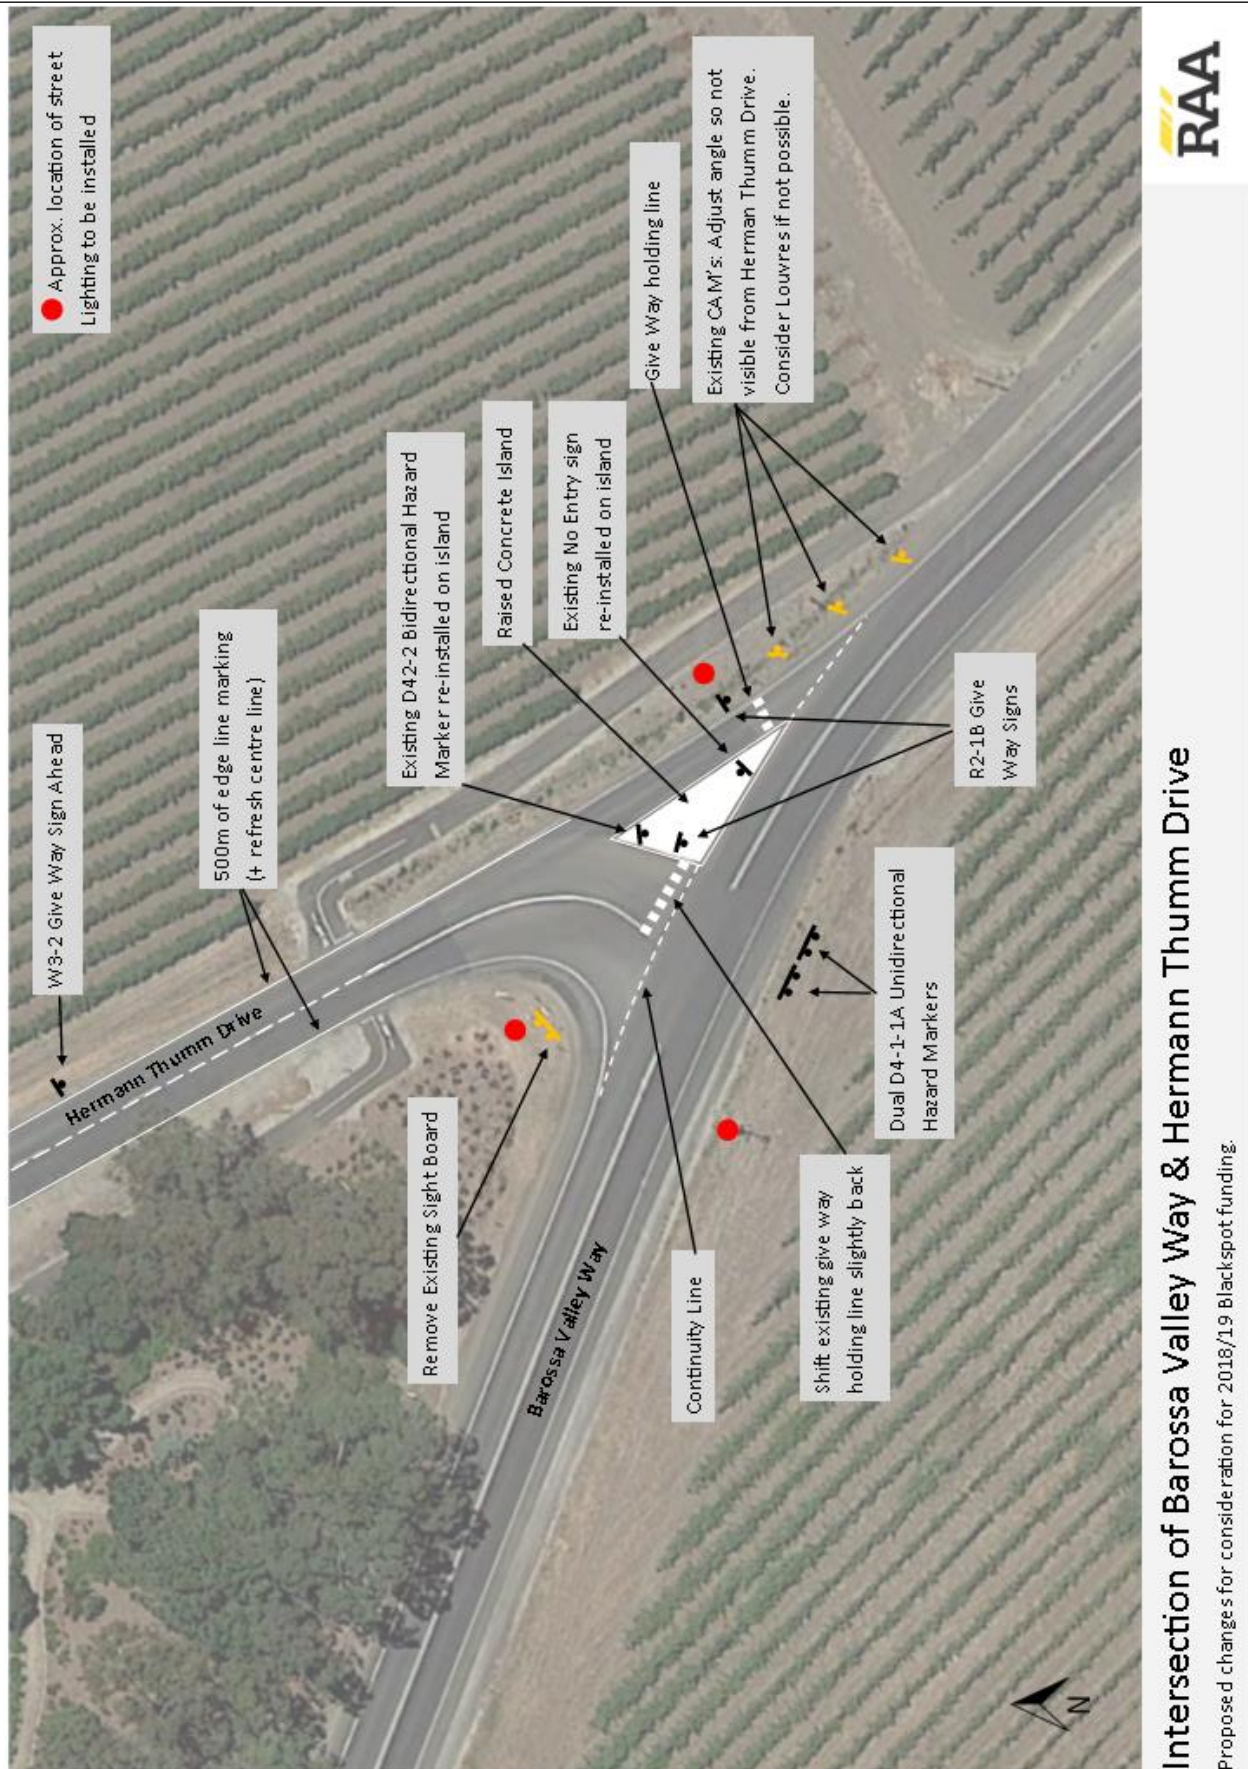
Figure 42: RAA Recommendation submitted for 2018-19 Black Spot funding

The audit recommends installing additional give way signs and holding lines and increasing their size, checking placement and rotation of CAMs whilst applying louvres if required, removing one sight board and rehabilitating the other sight board.

RAA have subsequently submitted a Black Spot nomination for this intersection seeking funding in the 2018-19 financial year. The Black Spot nomination included some additional improvements to street lighting, signage and line marking.

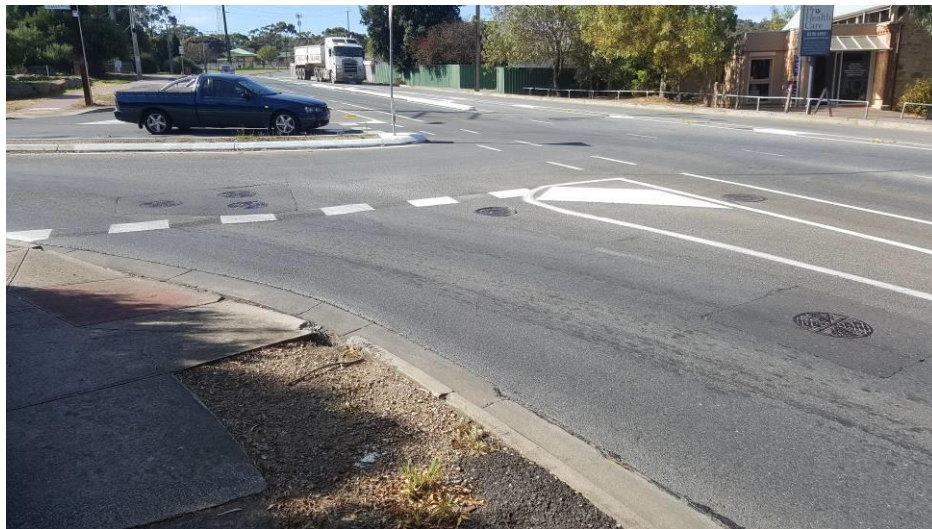
Upon observing traffic interactions when vehicles were using the left turn slip lane there was obvious confusion amongst motorists. Many motorists with priority turning right onto Gomersal Road gave way to vehicles using the slip lane, and at times vehicles using the slip lane pulled out in front of vehicles making a right turn. This inconsistency in driver behaviour greatly increases the risk of a right angle crash.

*Figure 44: A holding line used at a slip lane in Hope Valley improved compliance with the give way rule without a sign*

Installation of a Give Way sign at this slip lane may not be an effective solution as it could cause confusion to motorists continuing ahead on Barossa Valley Way however a painted give way holding line only could assist with enforcing the priority. This treatment is acceptable based on AS 1742.2 however the DPTI manual of legal responsibilities and technical requirements for traffic control devices states that this pavement marking must not be used to indicate the safe position for a vehicle to be held at a slip lane in South Australia. That being said, there are recent cases where this treatment has been used in South Australia and our observations at the time indicated that there was a potential increase in compliance compared to the intersection without the holding line.

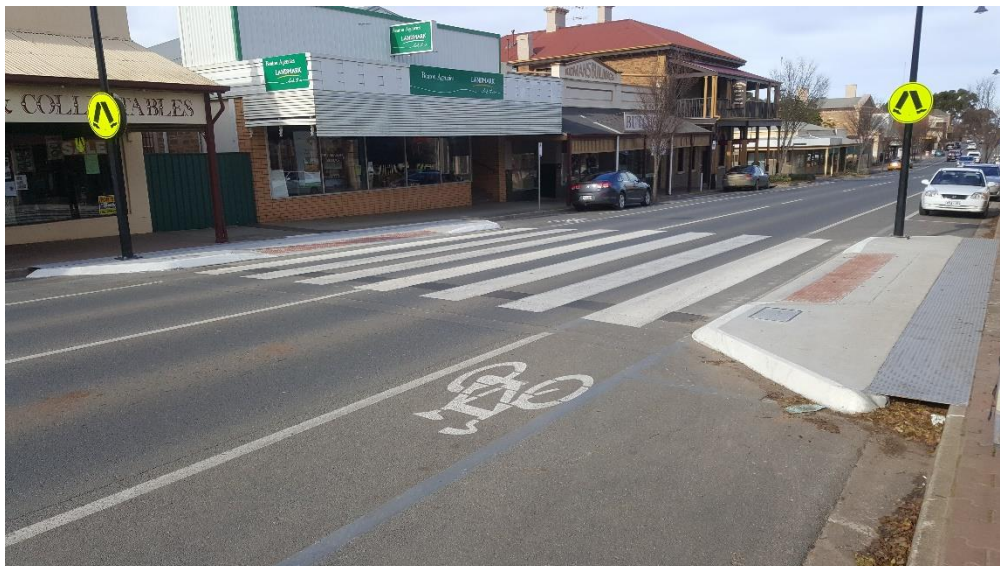
An excellent level of compliance was noted with drivers giving way to pedestrians, and approaching vehicle speeds were generally low and drivers appeared observant of pedestrians even if they were not about to cross.

There were a number of occasions where pedestrians were witnessed crossing the road in the vicinity of the Zebra Crossing (approx. 20m north) however vehicle traffic was quite low at the time of our visit and no risk was posed at the time.

Figure 60: The Zebra Crossing in Kapunda is a positive improvement along Main Street in Kapunda

In general, this treatment was seen as a significant improvement to Main Street in Kapunda and should be used as an example when considering Zebra Crossing treatments in regional towns in future.

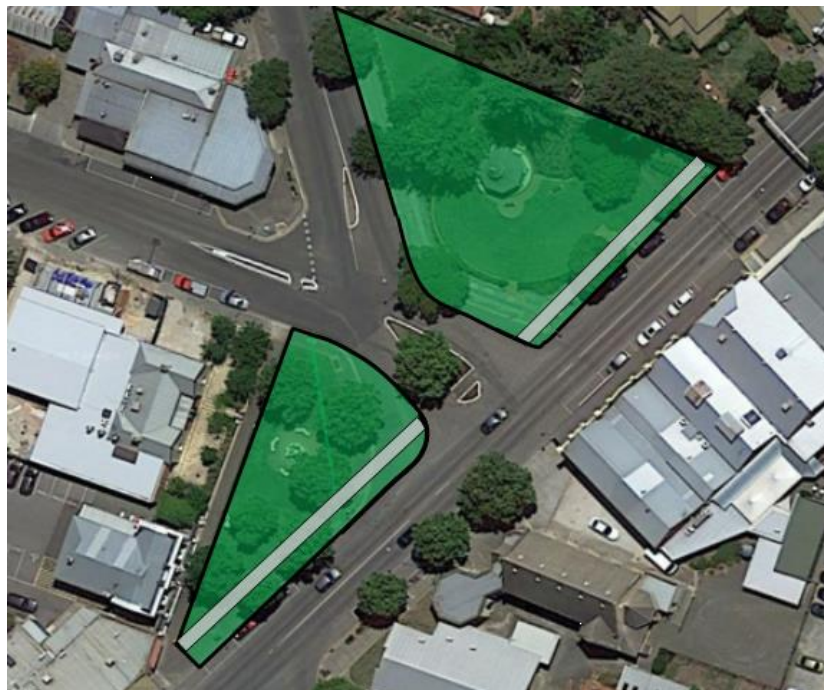
The intersection is well signed but can be somewhat confusing due to the wide entry on Barossa Valley Way. The most significant hazard was to pedestrians walking along the northern side of Murray Street crossing Bilyara Road. Due to the road geometry, vehicles were often witnessed turning left at high speed which allowed little time to stop for pedestrians who may be hidden due to parked vehicles just southwest of the intersection in front of the reserve.

Figure 62: Example treatment to narrow the road at the intersection of Murray Street and Bilyara Road

It is recommended that the roads are narrowed as shown in the figure below and any land gained is added to the reserves on each side of the road.

If this treatment is deemed too costly, painted islands with raised pavement bars should be installed to narrow the trafficable road surface and decrease the speeds at which motorists turn left from Murray Street onto Bilyara Road.

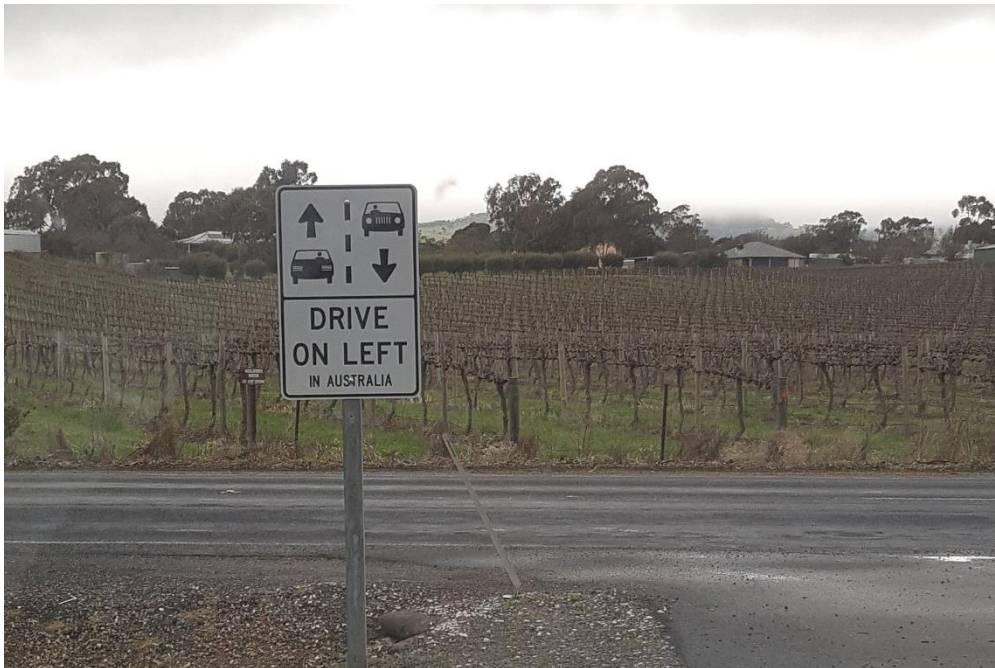
This sign was identified in a limited number of locations during this tourism region assessment. It was noticed when leaving a rest stop on Gomersal Road as well as when exiting the Maggie beer Farm Shop. This signage targets international tourists that may be accustomed to driving on the right hand side of the road and serves a useful reminder to drive on the left in Australia.

Figure 65: Drive on Left in Australia signage provides a timely reminder to international tourists

It is recommended that this signage is issued to wineries to install at the exits, as well in strategic locations in the region. Seppeltsfield Road is a good target area due to the high density of wineries along this road and hence increased tourist numbers.
