# **Clare and Goyder**

**Regional Road Assessment February 2018**

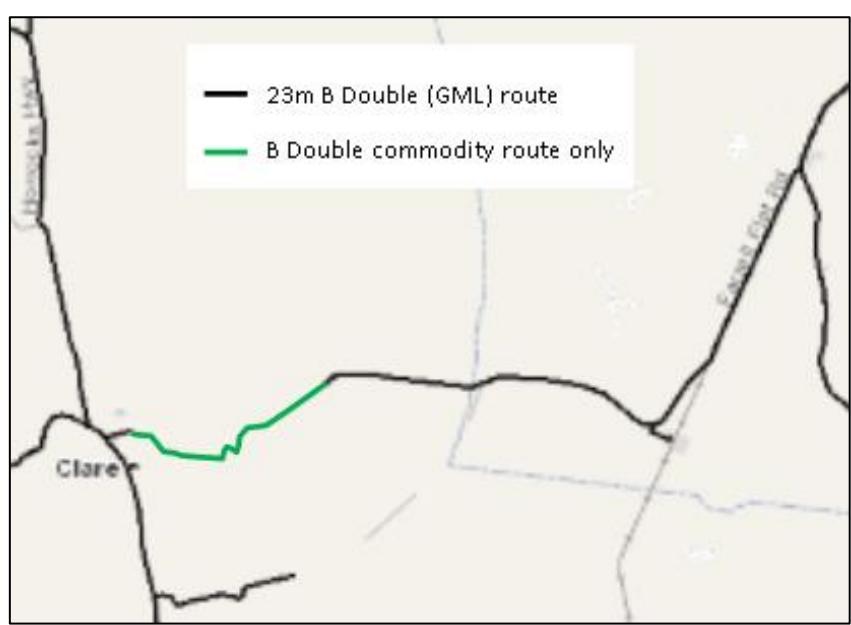
B double routes on Farrell Flat Route<sup>3</sup>

At the time of our assessment numerous hay trucks and wine tankers were witnessed using Farrell Flat Road through the section with tight corners and narrow bridges. These bulk commodity transport vehicles are permitted to use this road as shown in the RAVnet map below.

Widening the bridges just east of Clare and widening the inside shoulders around tight curves should be a priority to facilitate safer interactions with heavy vehicles using this important link. Road widening around the tight curves does face some major geographical hurdles requiring significant earth works.

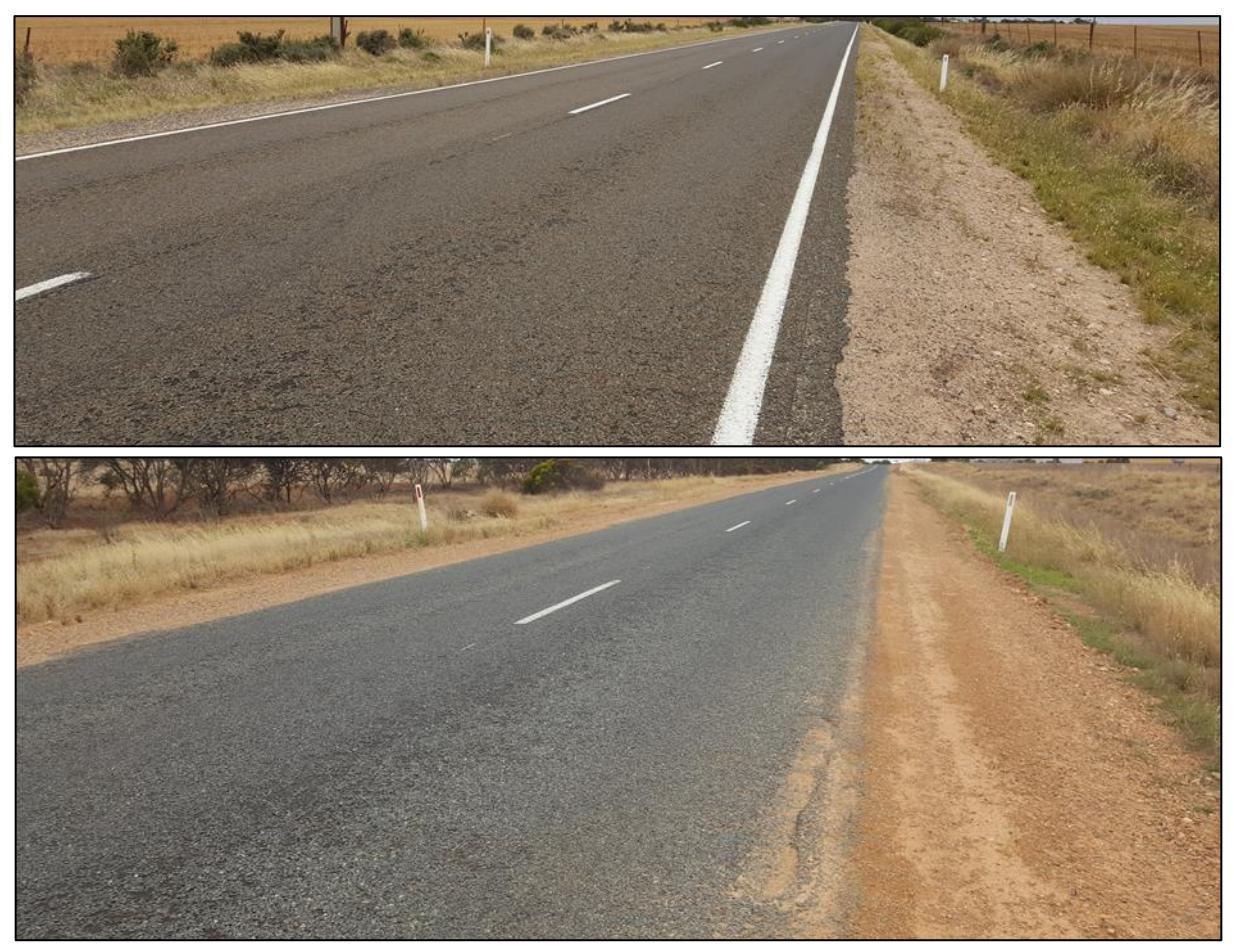
Top: Worlds End Highway north of Robertstown

Bottom: Worlds End Highway south of Robertstown

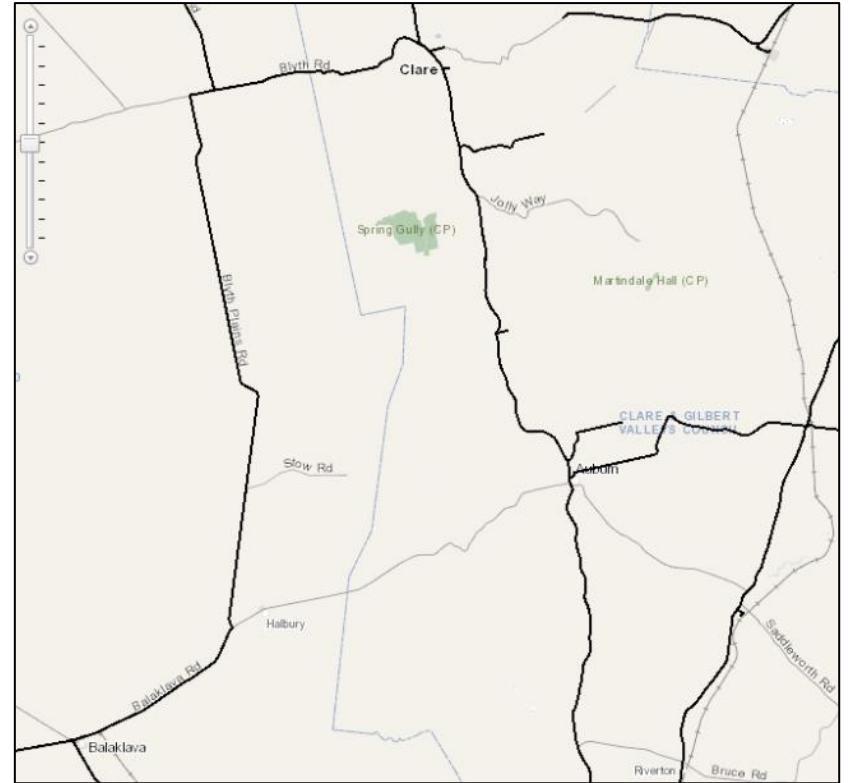
DPTIs RAVnet approved routes [23m B Double (GML)]<sup>4</sup>

The eastern end of Balaklava towards Auburn was generally in winding and undulating terrain making heavy vehicle movement along the road difficult. Assessing general heavy vehicle routes on RAVnet, the section between Blyth Plains Road and Auburn is a commodity route only and as such should experience low or seasonal heavy vehicle use. During our assessment, numerous long vehicles were witnessed to be using the route however it was not able to be determined if they were permitted to do so as part of a commodity freight route.

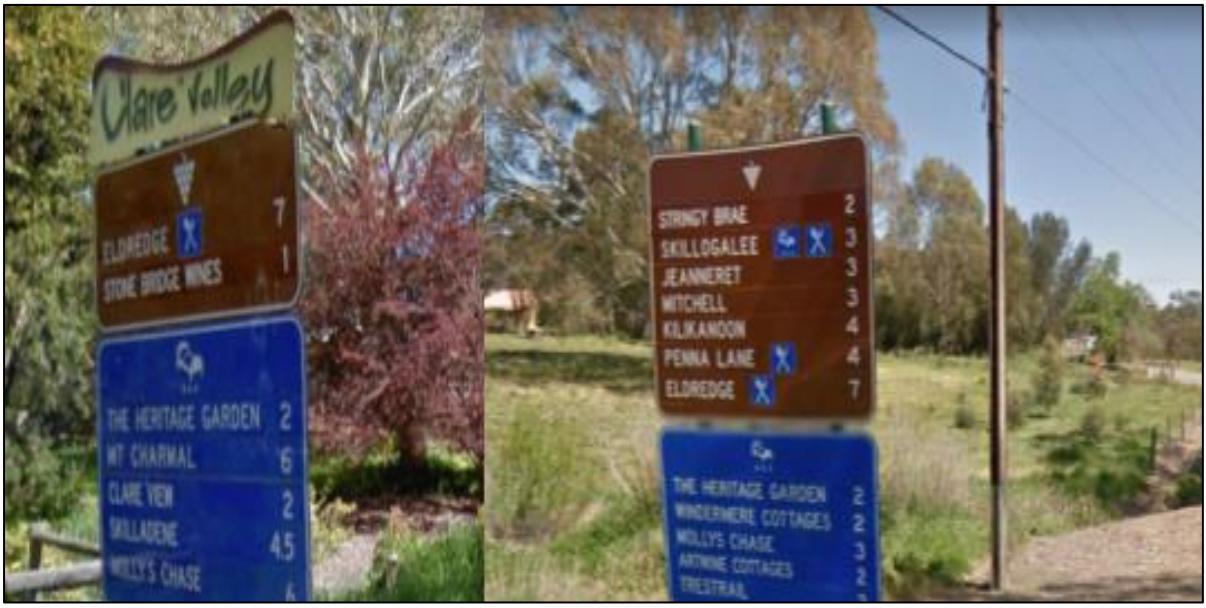
Left: Tourist signage on Spring Gully Road

Right: Tourist Signage on Bayes Road (2014 Google imagery used)

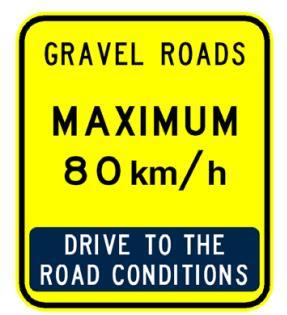
W1-SA101 'gravel roads – maximum 80km/h' advisory sign

To address previously mentioned issues as well potential speeding issues due to the steep downhill sections and a road environment that is not self-regulating in many places, a W1-SA101 'gravel roads – maximum 80km/h' advisory sign should be considered. This sign can be installed at each end of the unsealed section of Neagles Rock Road in accordance with DPTI operational instruction 4.10. This sign is not an enforceable speed limit however has previously had success reducing speeds in a trial within the Yankalilla District Council.
