Riverland

Regional Road Assessment June 2018

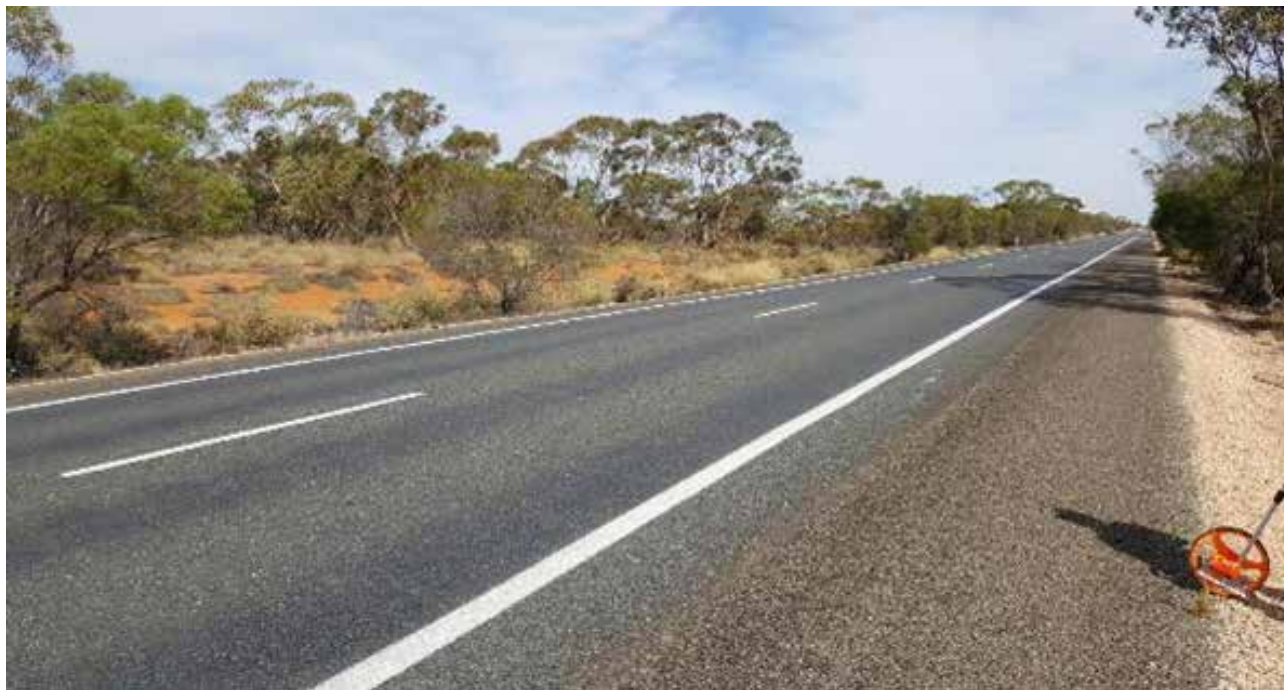
Road geometry is good between Blanchetown and Waikerie

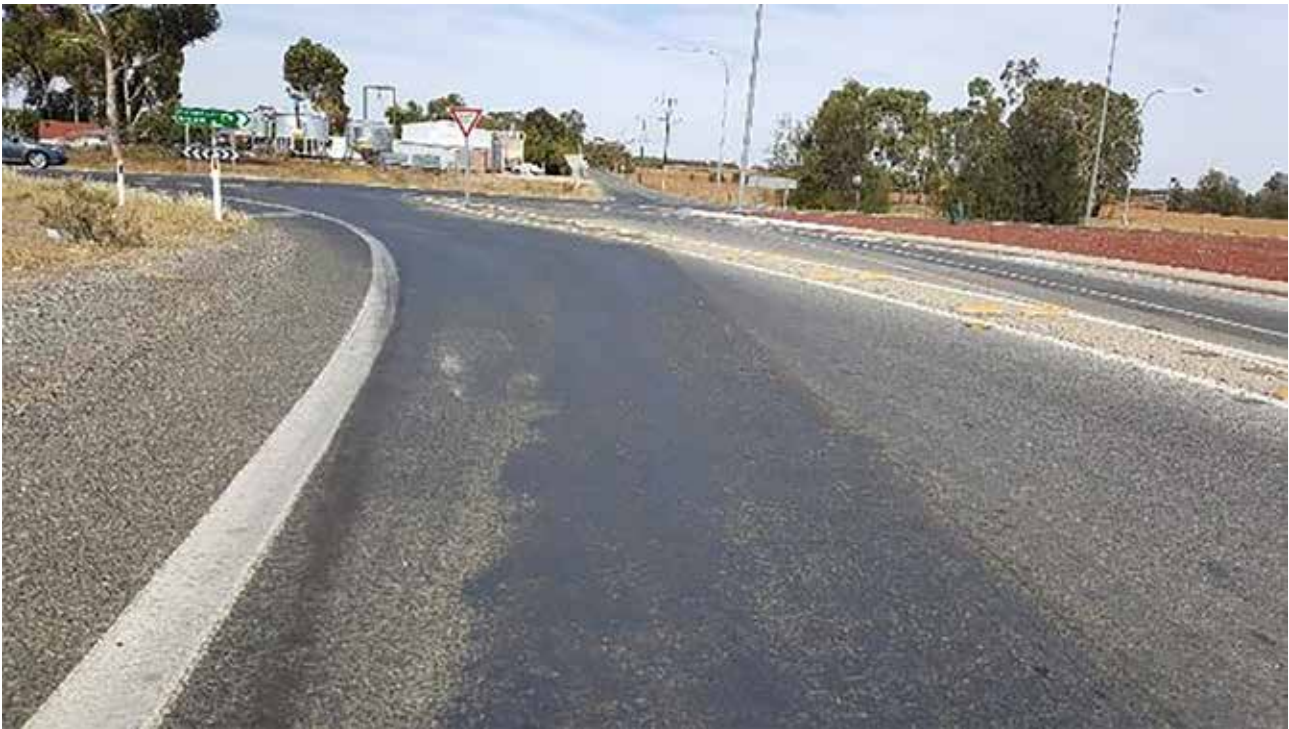
A give way sign is installed on the pavement bar treatment in the centre of the road, however, a give way sign was not installed on the verge. Give way and continuity lines at the intersection were faded and the surface on Old Blanchetown Road was highly polished and we would expect skid resistance during wet weather to be very poor because of this.

A highly polished surface and faded line marking increase the risk at this intersection

It is recommended that R1-2 'give way' signage is duplicated and line marking is refreshed. It is also recommended that wet weather skid resistance testing is undertaken to determine the pavement friction, and Old Blanchetown Road is resealed at the intersection if skid testing indicates that the pavement performs poorly in wet weather.

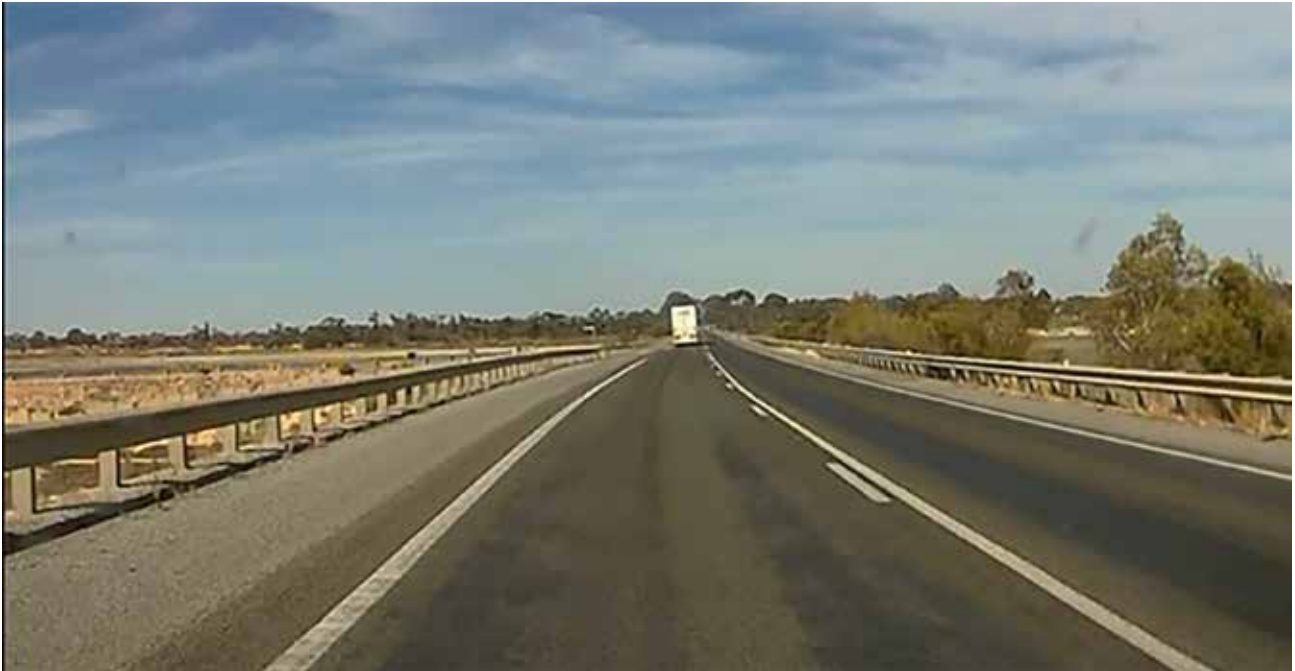
Eastbound, approximately 50m from Rogers Road on the left

Rogers Road is hardly visible from Sturt Highway in both directions due to the w-beam barrier used to protect the drop off where the highway has been built up.

No advance warning signage was noted prior to this intersection, and it is recommended that W2-4 'side road intersection' signage is installed in both directions to indicate the presence of this intersection as it is not clearly visible on approach.

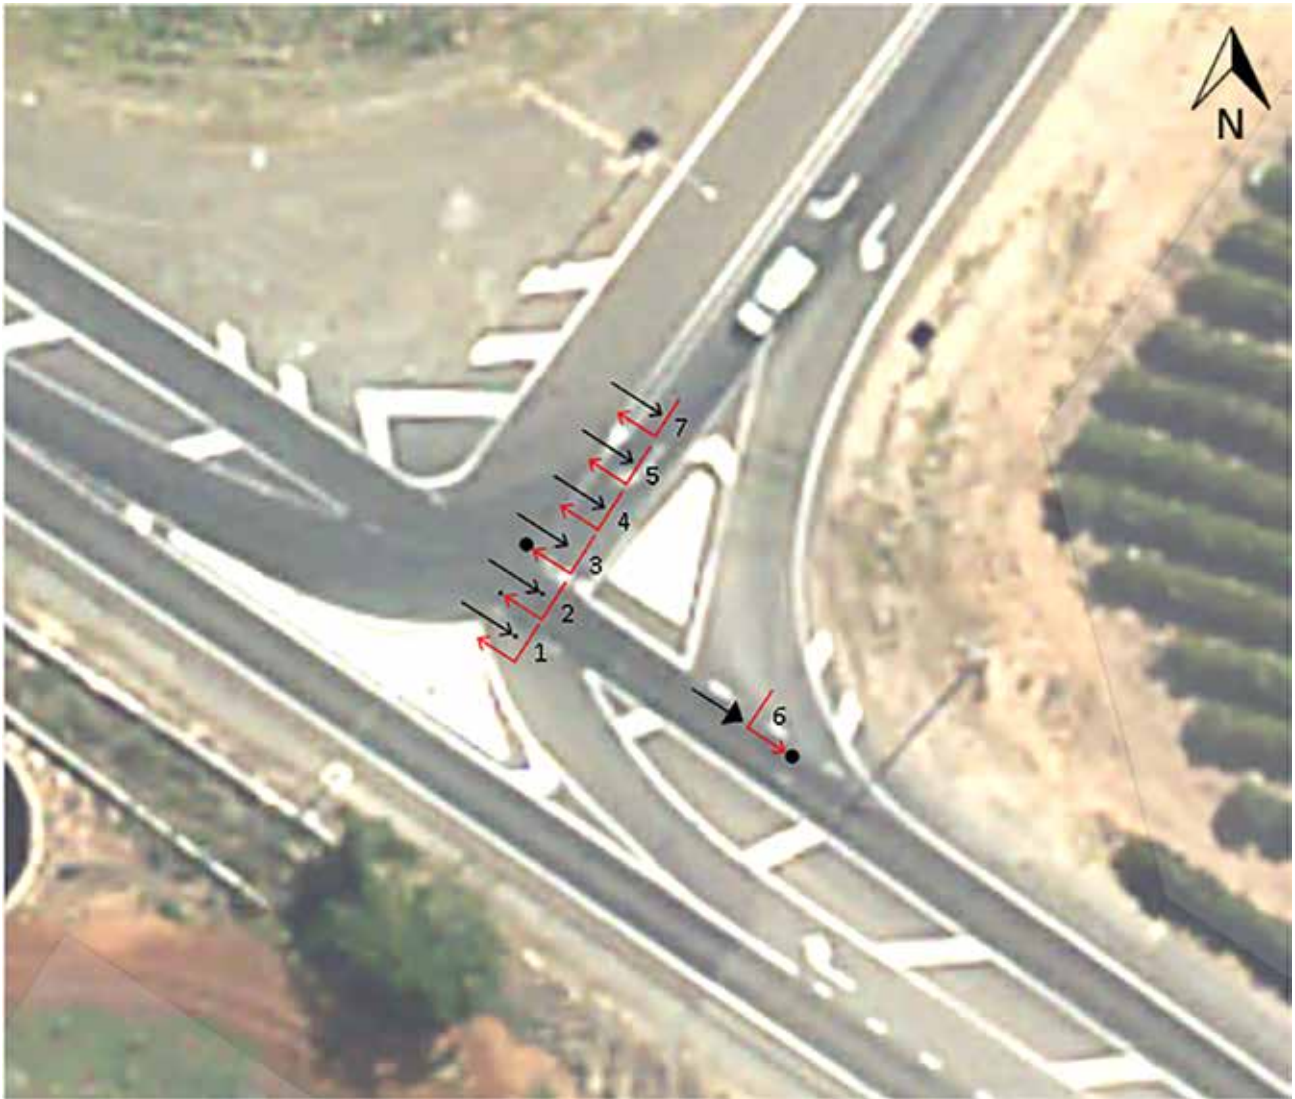
Seven crashes were reported at this intersection between 2012 and 2016. Six of these involved vehicles turning right from Sturt Highway and failing to give way to southeast bound vehicles continuing straight. One of these six crashes resulted in a fatality, two resulted in minor injuries, and the remaining three resulted in property damage only. There was another fatal crash involving a vehicle turning left from Sturt Highway onto Old Sturt Highway failing to give way to the southeast bound through traffic, which in this case was a semi-trailer. All crashes occurred during daylight in dry weather.

The common crash type is very clear on a crash diagram

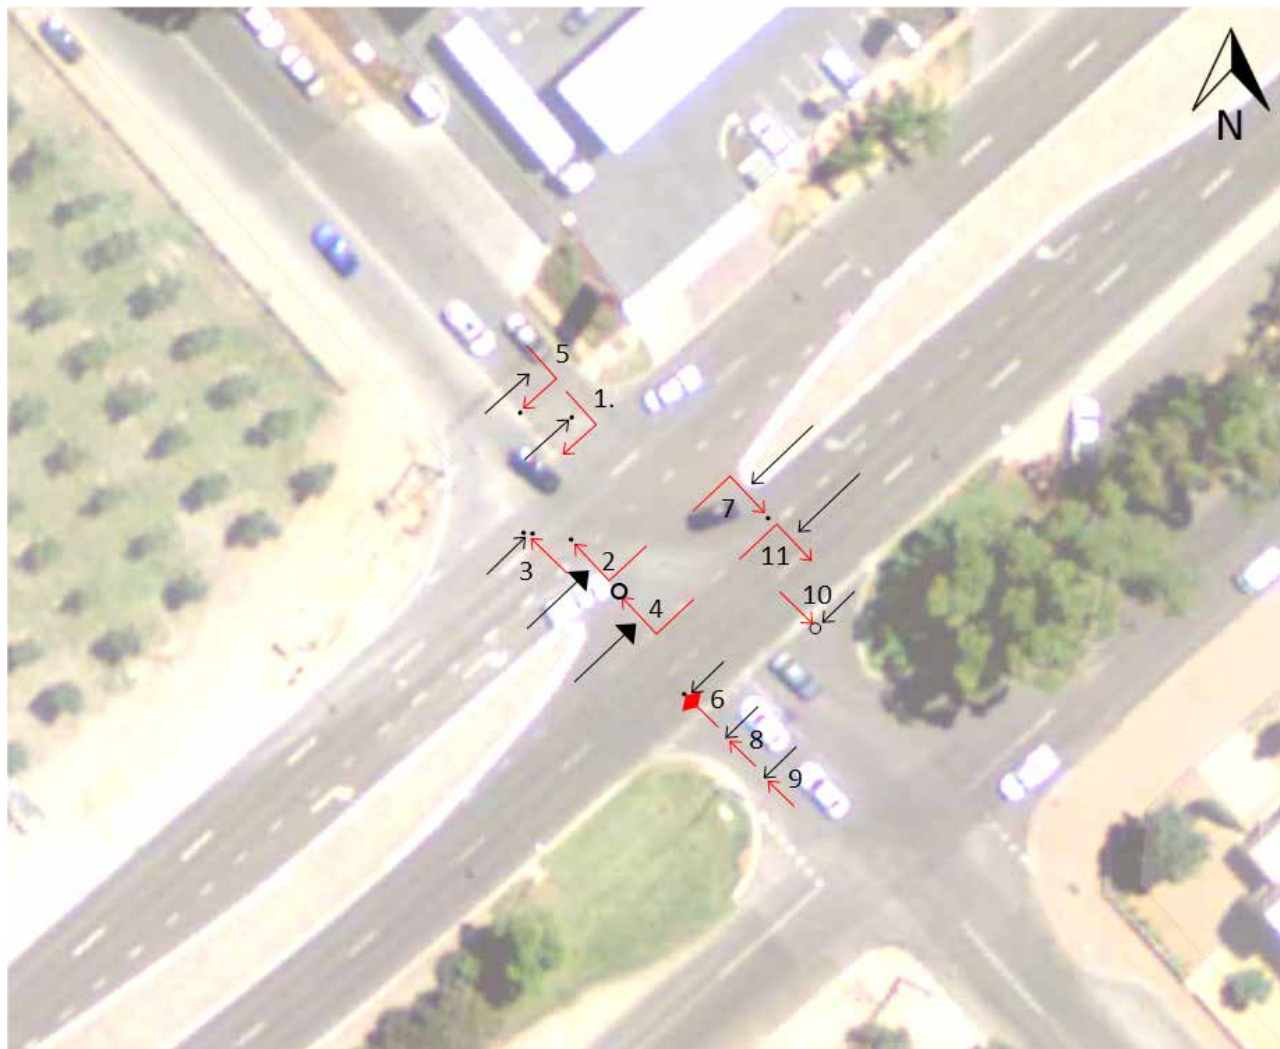
Crash diagram for the intersection of Twenty First Street and sturt highway (Renmark Avenue)

Four crashes involved right turns from Sturt Highway onto Twentyfirst Street with three of these causing injury. Five crashes involved vehicles continuing across Sturt Highway and failing to give way to traffic. Three of these resulted in injuries. Two crashes involved southeast bound vehicles turning right onto Sturt Highway failing to give way to northeast bound vehicles.

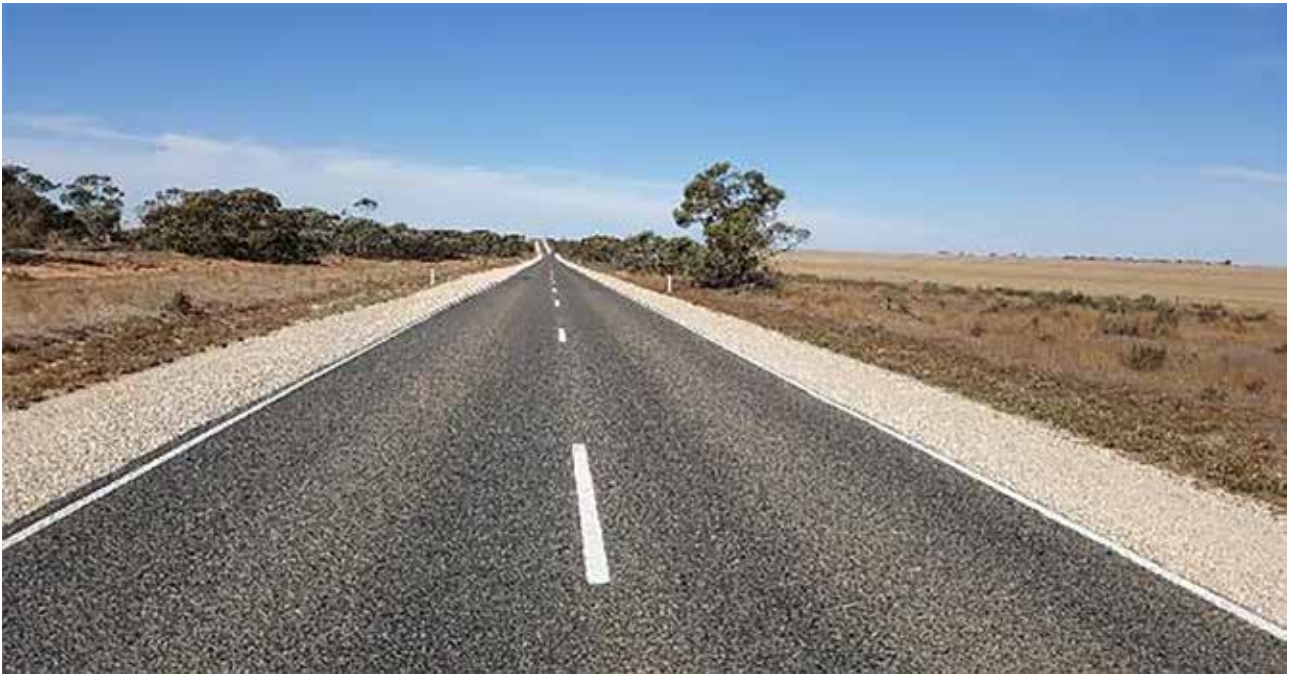
Lane widths were typically around 3.2 metres in each direction with no edge lines or sealed shoulders, however, there was a short section with narrower lane widths and edge lines. This section extended for approximately ten kilometres between Durdin Road and The Dog Fence Road, and the painted edge lines created a very narrow sealed shoulder, and narrower lanes with no actual change in the total width of the road seal.

Ten kilometres of edge lines narrowed the lanes however delineated the road edges

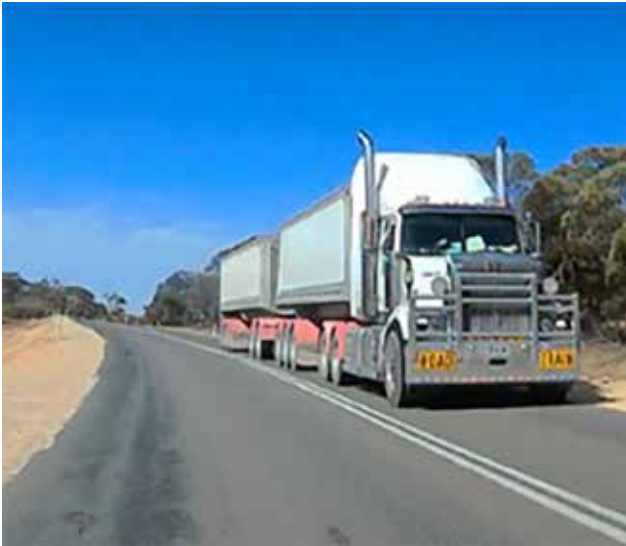
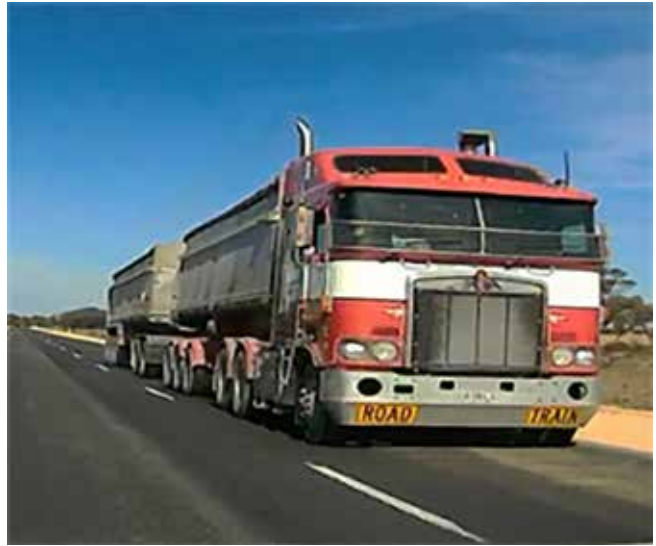
Browns Well Highway is relatively narrow, particularly considering it is approved for b-triple and road train use. The highway has been marginally widened around some curves, however, this treatment has not been applied to all curves, and we question whether the swept path of long vehicles would remain entirely within the lane around these curves. RAA recommend that as a minimum, lanes are widened to 3.3 metres in each direction, and widened additionally around curves. A minimum 0.5 metre shoulder seal should be provided as traffic volumes are low. Preferably, geometry would be improved to 3.5 metre wide lanes and 1 metre wide sealed shoulders, and if any increase in freight movements is expected, this should be the minimum road geometry.

Interactions with oncoming freight were close

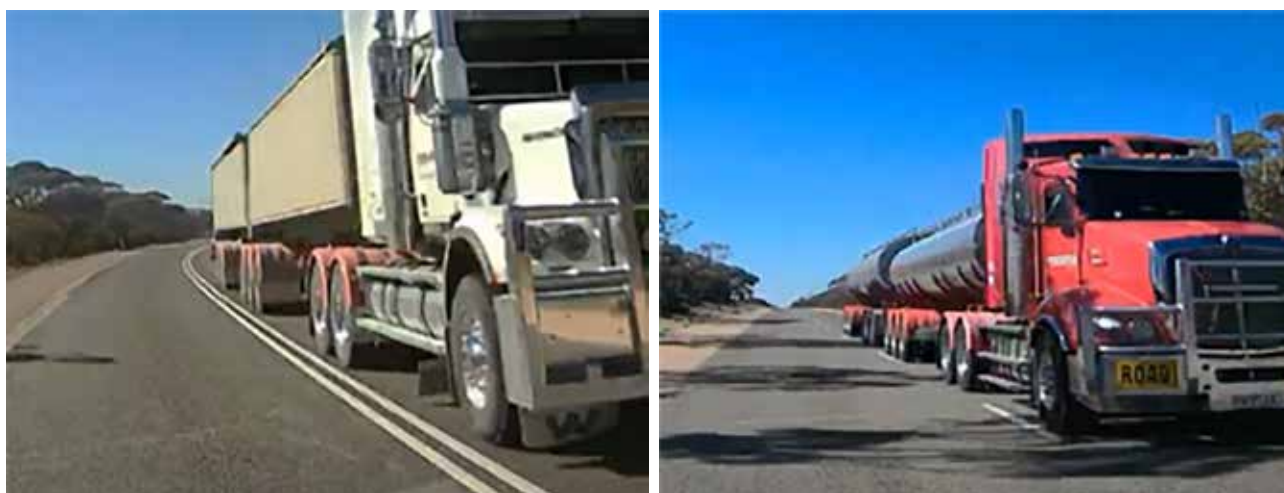
The surface condition on Stott Highway was generally good, with no significant issues identified, other than the narrow road width. At the time of our assessment, there had been a serious crash on Sturt Highway near Waikerie causing Sturt Highway to close in both directions. Due to this, road trains and caravans were diverting down Stott Highway from Loxton and presumably turning onto Hunter Road at Swan Reach to link back to Sturt Highway near Blanchetown. Although this was not a typical day, these interactions with Road trains were very uncomfortable due to the narrow carriageway width. Stott Highway is already b-double approved, however DPTI traffic volume estimates specify less than 10 b-double movements on average per day.

Interactions with heavy vehicles are uncomfortable on Stott Highway, however this is not a regular occurrence

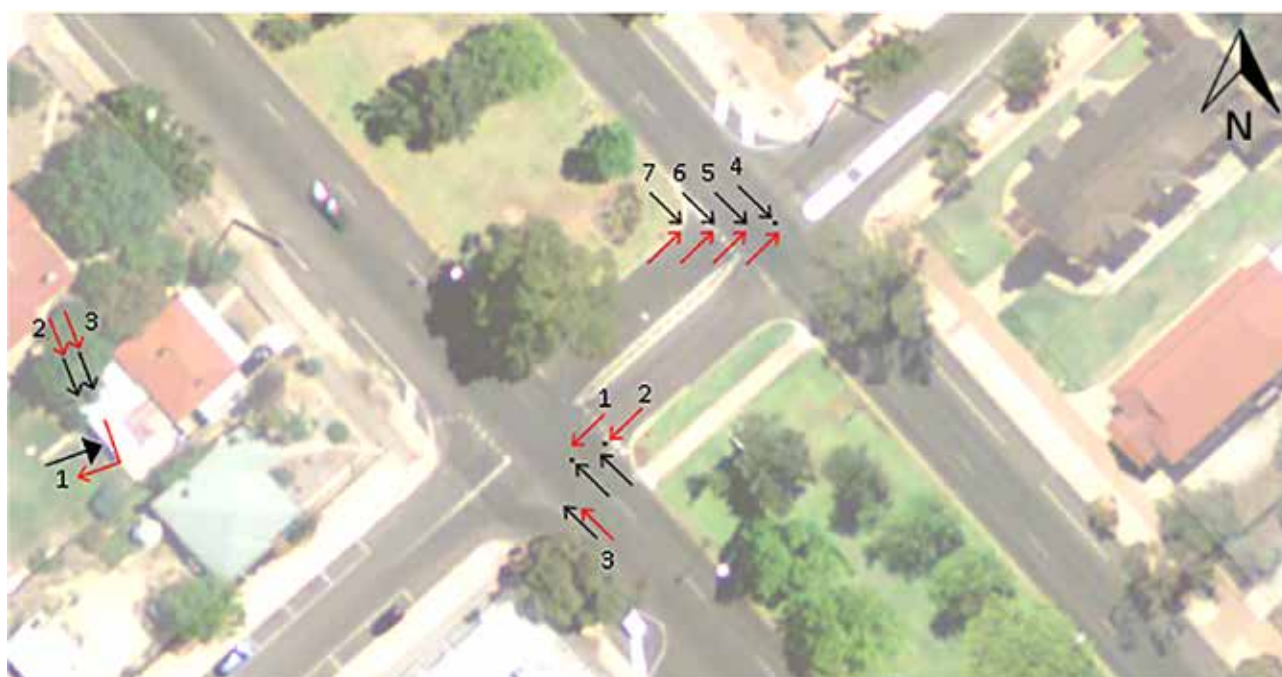
Crash diagram for the intersection of Ral Ral Avenue and Thurk Street

Of particular concern is the intersection with Ral Ral Avenue and Thurk Street, recording three minor injury crashes and a four property damage crashes as shown in the below crash diagram. Further information on crash diagram symbology is available in Appendix D. All of these crashes occurred in dry daylight conditions and six of the seven involved vehicles continuing straight on Thurk Street failing to give way after crossing through the median. The other crash was a side swipe causing property damage due to a vehicle making an incorrect turn, however, further information is not available.

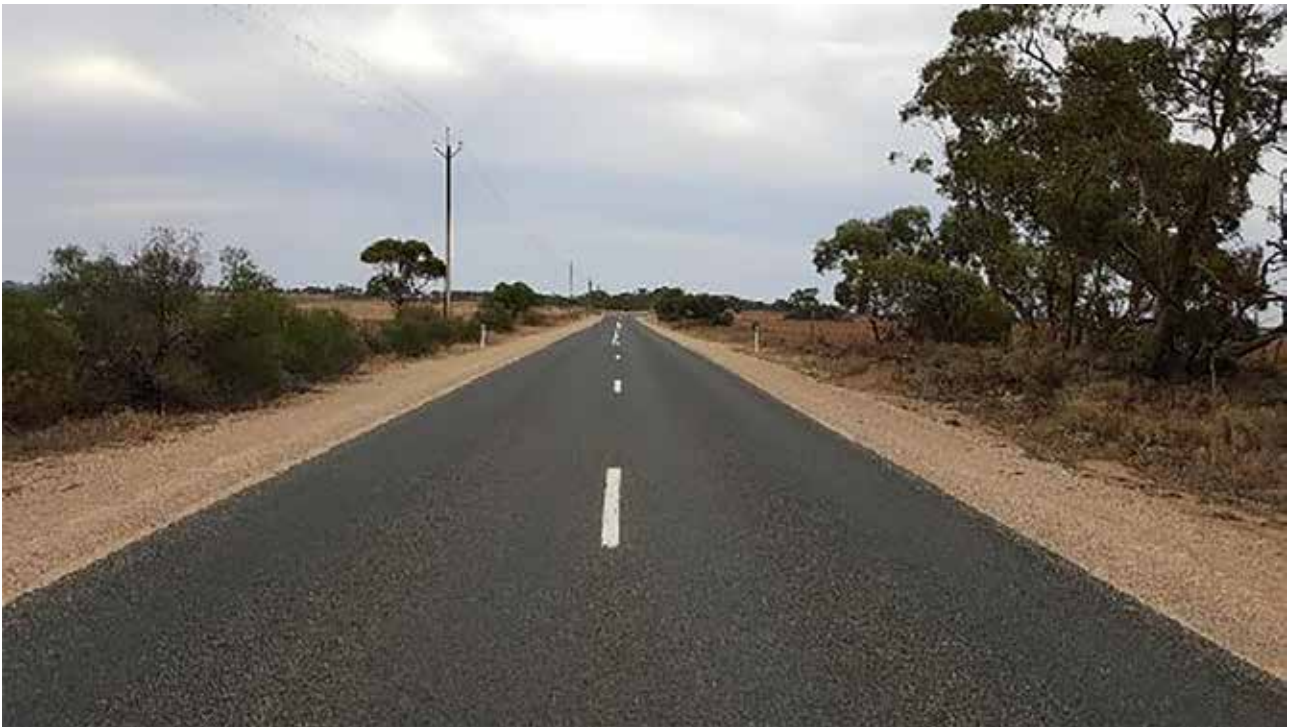
The clear zone was generally quite good but there were sections closer to the Murray River where vegetation was growing up to three metres from the edge. Stobie poles are prominent adjacent to sections of the road, and it is recommended that consideration is given to protecting stobie poles close to the carriageway.

Typical geometry of Taylorville Road

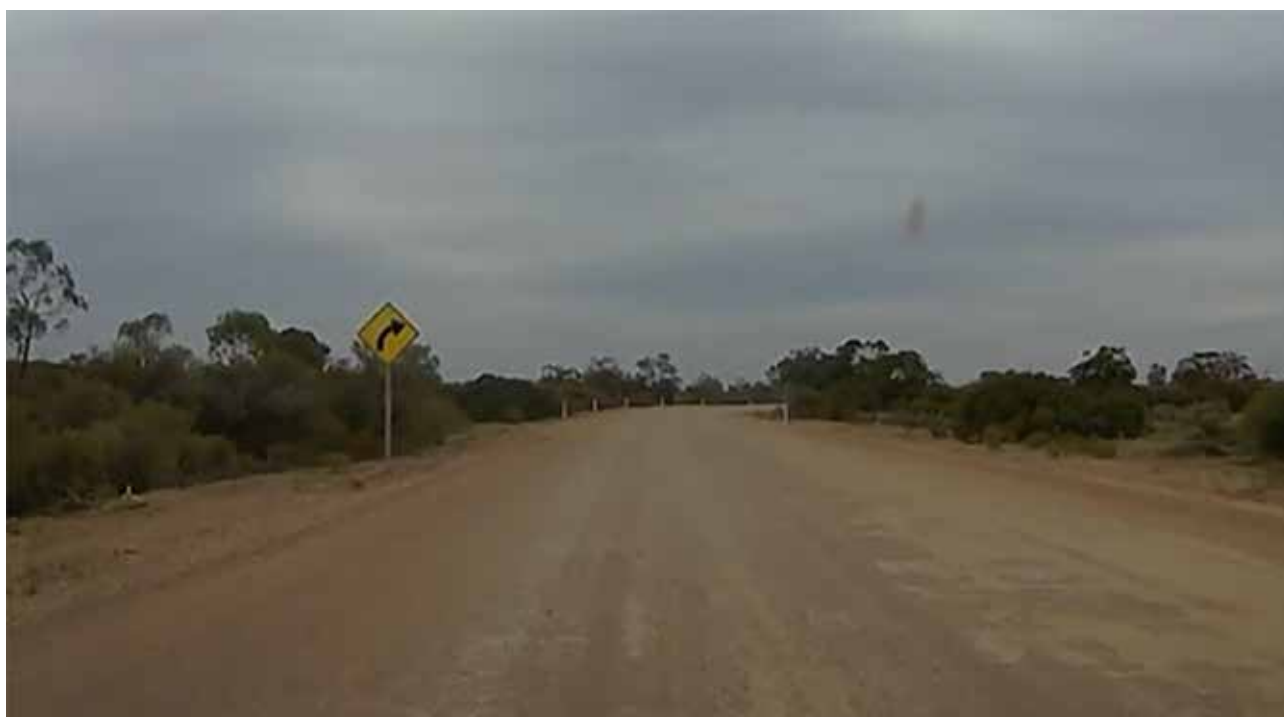
At the time of our assessment, Enduro Road had been recently graded and was in very good condition. The unsealed surface was smooth and comfortable to travel at 100km/h. Recent 'Roads to Recovery' funding may have addressed the primary issues on Enduro Road. Delineation around curves was generally very good with closely spaced guide posts or chevron alignment markers utilised.

Enduro Road was in very good condition at the time of our assessment

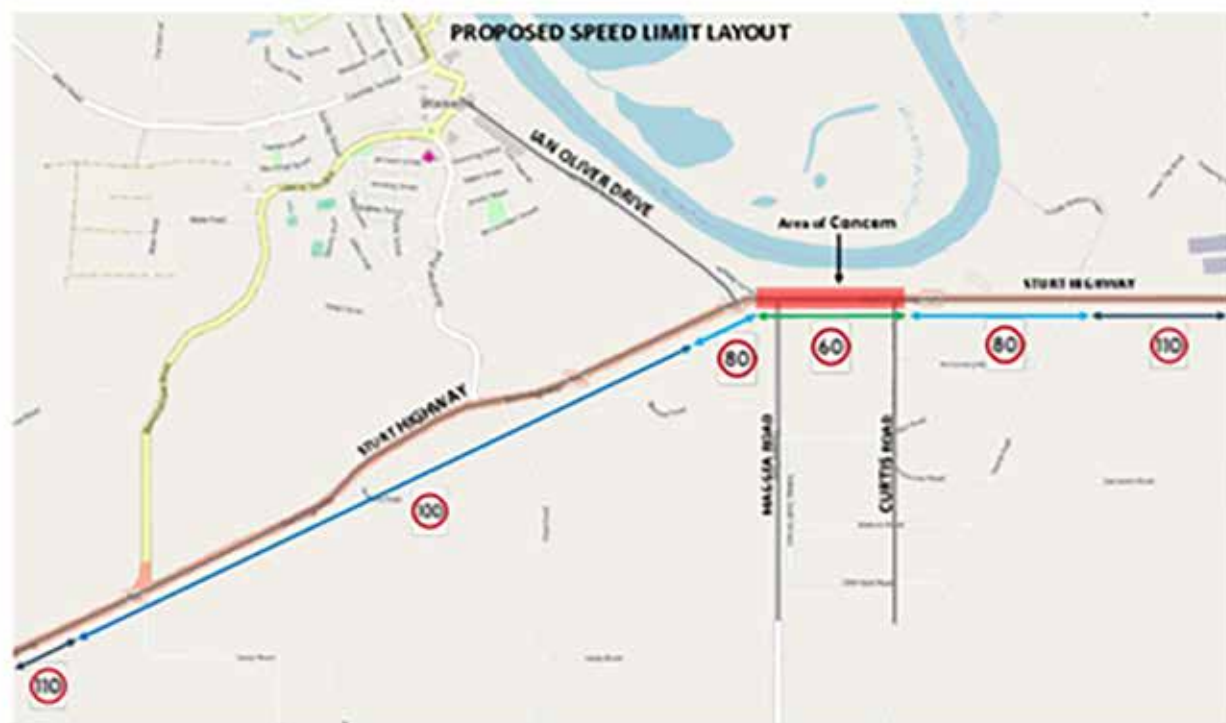
Figure 2: Recommended speed limit layout for Sturt Highway in Waikerie

This option utilizes an 80km/h buffer zone for approximately 400m on the western approach, a 60km/h zone of approximately 800m and a 1.7km 80km/h zone on the eastern approach. It should also be noted that the 60km/h zone in this option is contained entirely within the current 80km/h zone and changes to the total length of the speed zone are not required. By replacing 800m of 80km/h road with a 60km/h speed limit, the total increase in travel time is 12 seconds.

After assessing this area against each speed limit guideline, it is recommended that a 60km/h speed limit is applied for approximately 800m of Sturt Highway replacing 800m of the existing 80km/h speed limit zone. An electronic variable speed limit should be considered which could allow vehicles to travel 80km/h overnight where there are considerably less vehicles and pedestrians in the area. It is recommended that traffic counts and movements including pedestrian activity is reviewed in order to determine suitable times to implement a potential variable speed limit zone.

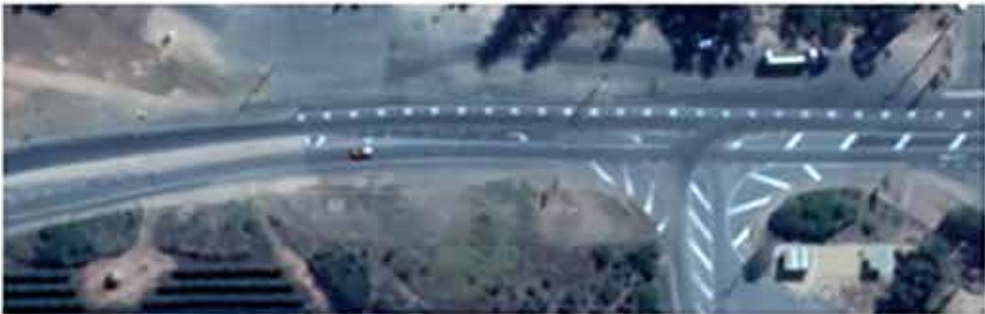
</div> <p data-bbox="443 846 1292 875">Figure 3: Satellite image of entry point to northern service road (Google, 2018)</p> <div data-bbox="373 922 1362 1346">

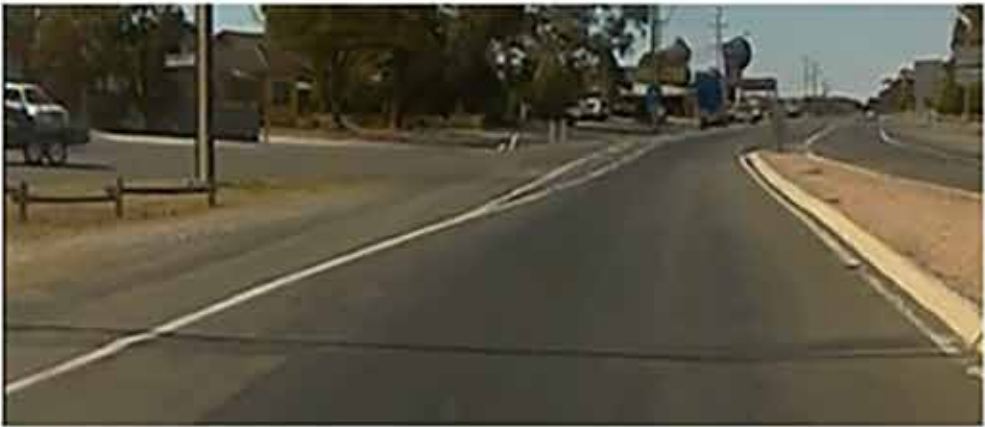
</div> <p data-bbox="501 1352 1228 1382">Figure 4: Current line marking on approach to northern service road</p> <p data-bbox="344 1429 1385 1637">A painted island separates the eastbound lane of Sturt Highway from the service road to access businesses on the north side. This island is continuous with no breaks or formalised entry or exit points. Vehicles are entering and leaving the service road at different locations across the island which is causing confusion and generates many near misses.</p> <p data-bbox="344 1688 1385 1854">It is recommended that entry and exit points to the service road are clearly defined and that a concrete island or other form of physical barrier be installed between Sturt Highway and the service road to prevent uncontrolled movements into and out of the service lane.</p>

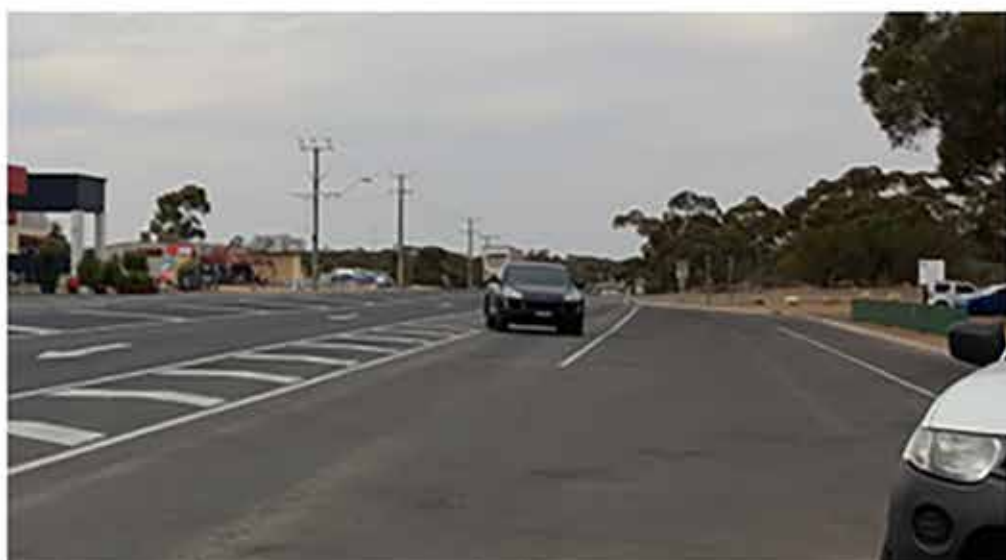
Figure 8: Vehicles regularly enter and exit the highway sporadically over painted islands.

Painted traffic islands and medians on site are functioning poorly. The intention of these devices is generally to direct and restrict traffic however painted traffic islands are regularly being utilised for U-turns, right turns and entering and exiting the highway.

It is recommended that raised concrete islands and medians are utilised as an alternative to painted traffic islands between Ian Oliver Drive and Growers Wine Group. Sections of painted island may still be used on the noses of these island to

<p>accommodate the wider swept paths of caravans and heavy vehicle where required.</p> <p>It is noted that if raised concrete traffic islands are installed that upgrades to street lighting will be required as discussed below in item 11.</p>
9	<p>90 degree parking in front of New Land Bakery</p> <div data-bbox="370 613 1362 1167">

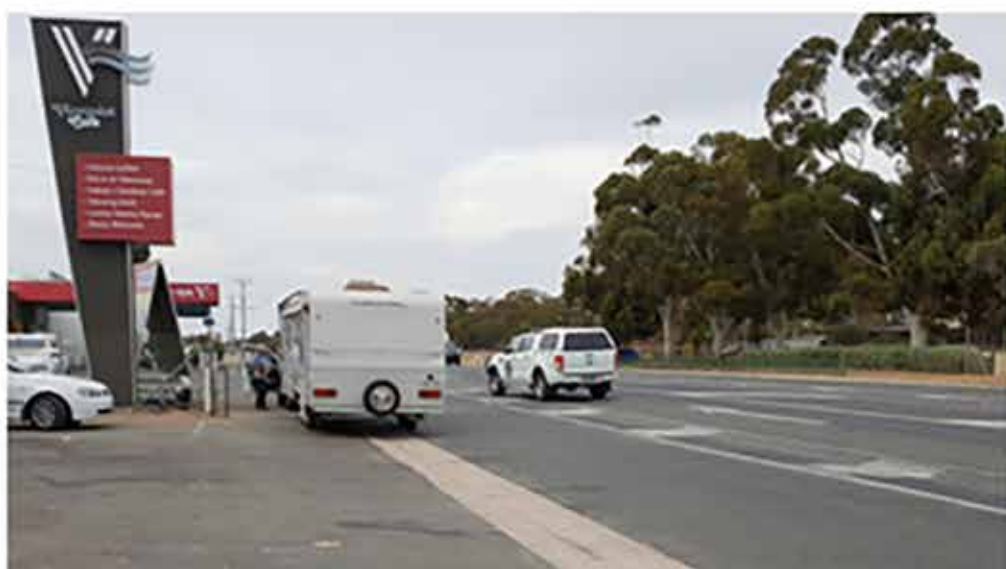
Figure 9: Vehicles regularly enter and exit the highway sporadically over painted islands.

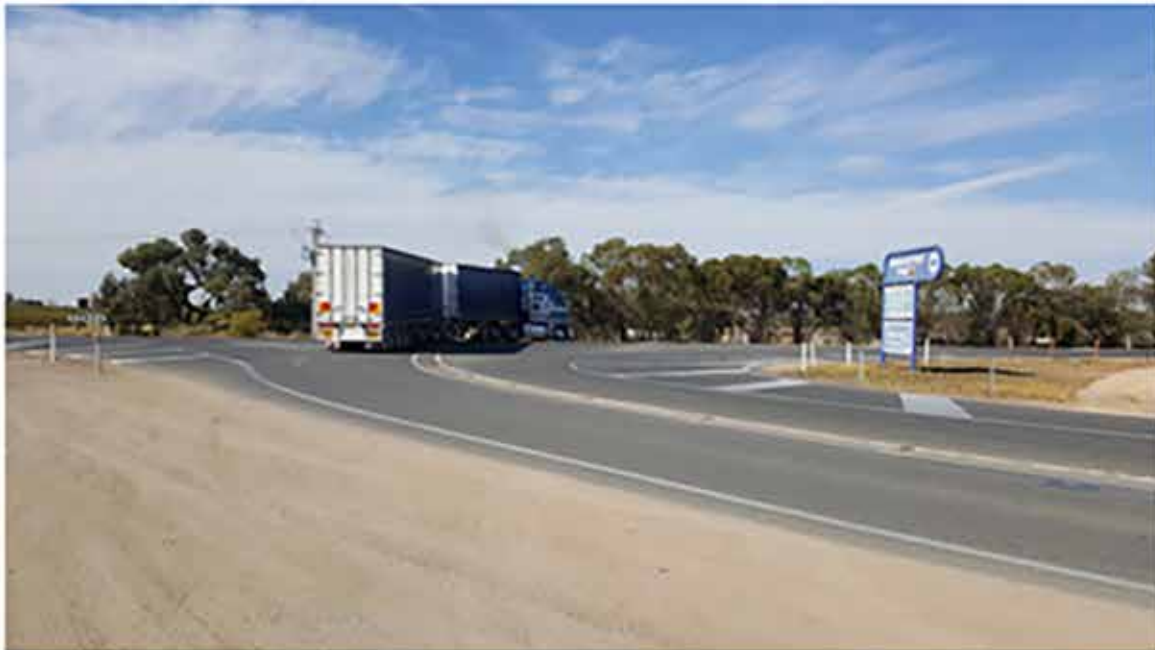
Heavy freight including B-Doubles regularly use this intersection to access the Renmark industrial precinct. All turn movements are supported by the current layout and regularly used however right turn movements are of particular concern due to the time it takes for a heavy vehicle to complete the turn and fully clear the carriageway.

Figure 3: B Doubles regularly turn right from Airport Road

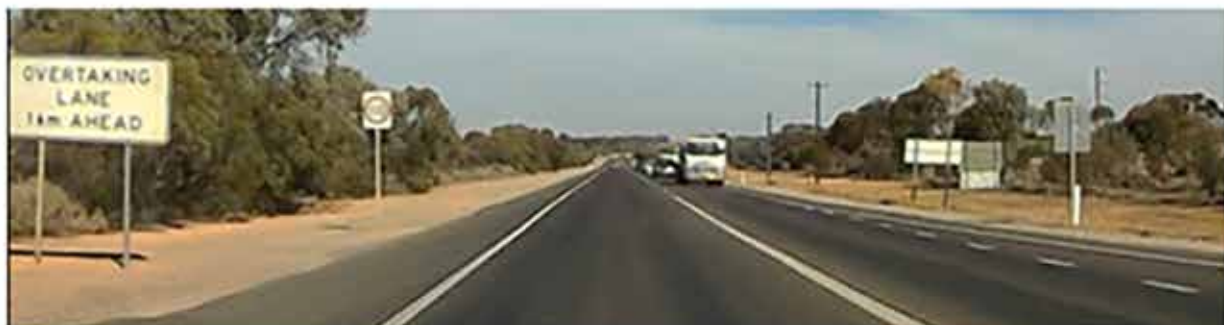
Figure 4: (Looking west) the speed limit changes from 90km/h to 110km/h just beyond the intersection

At the time of our visit, although speeds were not formally recorded, there appeared to be a lack of compliance with this speed zone. Westbound vehicles were noted to be accelerating to the 110km/h speed limit at the intersection, before the 110km/h signage, however, signage was visible from the intersection. Similarly, westbound vehicles were slow to reduce speed from 110km/h to 90km/h and were noted to 'coast' to the lower speed limit after passing the 90km/h signage, which is fairly common practice.

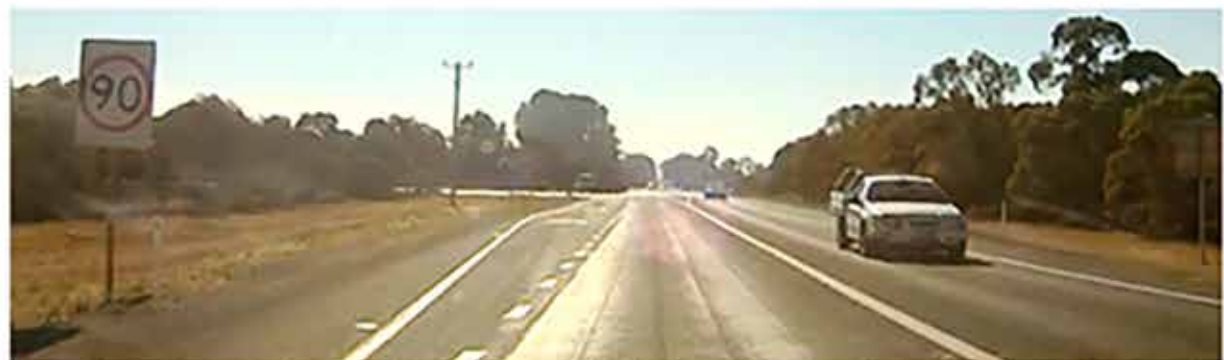
Figure 5: (Looking east) the speed limit changes to 90km/h from 110km/h whilst approaching the intersection
