Limestone Coast

Regional Road Assessment September 2019

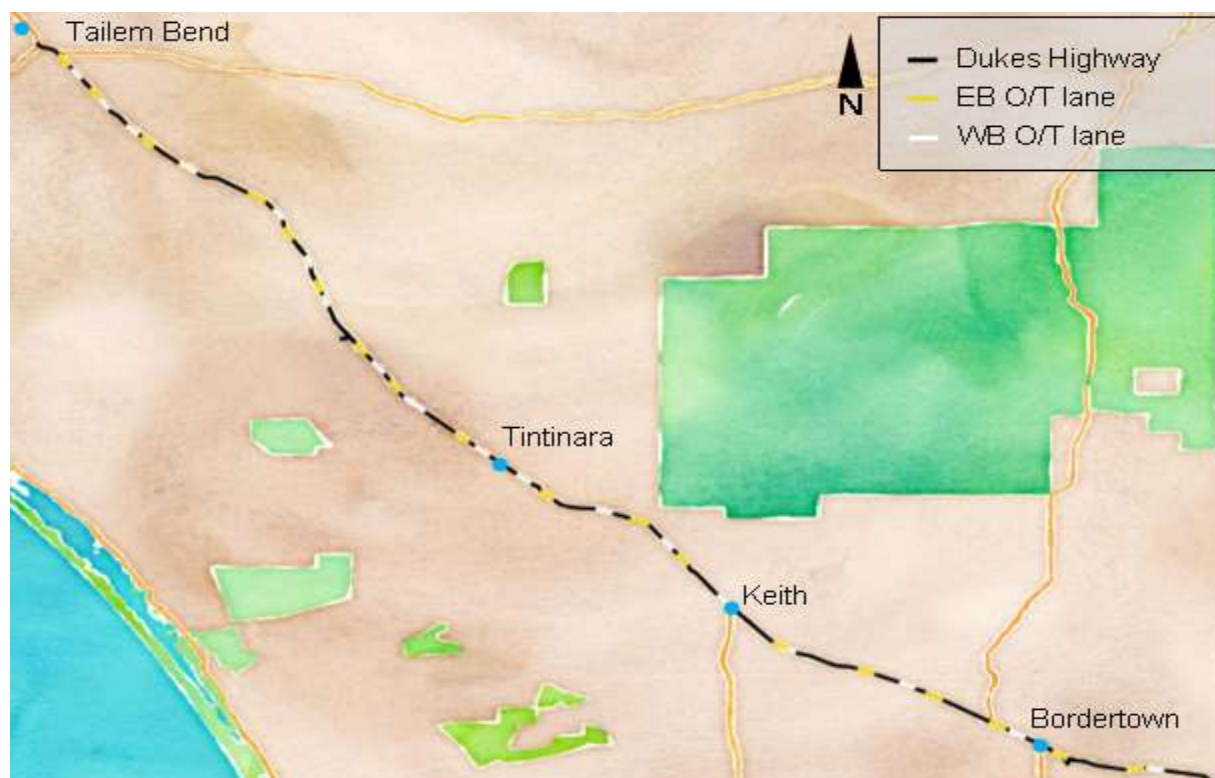
Location of overtaking lanes on Dukes Highway

In general, the surface condition of Dukes Highway is quite good. The clear zone is well established, and barrier protection is regularly provided to protect against fixed roadside hazards. There are 36 overtaking lanes between Tailem Bend and the Victorian border which provide regular opportunities for overtaking.

Traffic volumes are high with a mix of traffic including b-triples and double road trains, tourists towing caravans, and regular commuters. The larger and slower vehicles present challenges for overtaking with almost two kilometres of clear road required to overtake a b-double travelling at 100 km/h without exceeding the posted 110 km/h speed limit.

In the shorter term, RAA recommends that wire rope barrier be installed to separate opposing traffic flows and further address the ongoing issue of catastrophic head on crashes occurring on Dukes Highway.

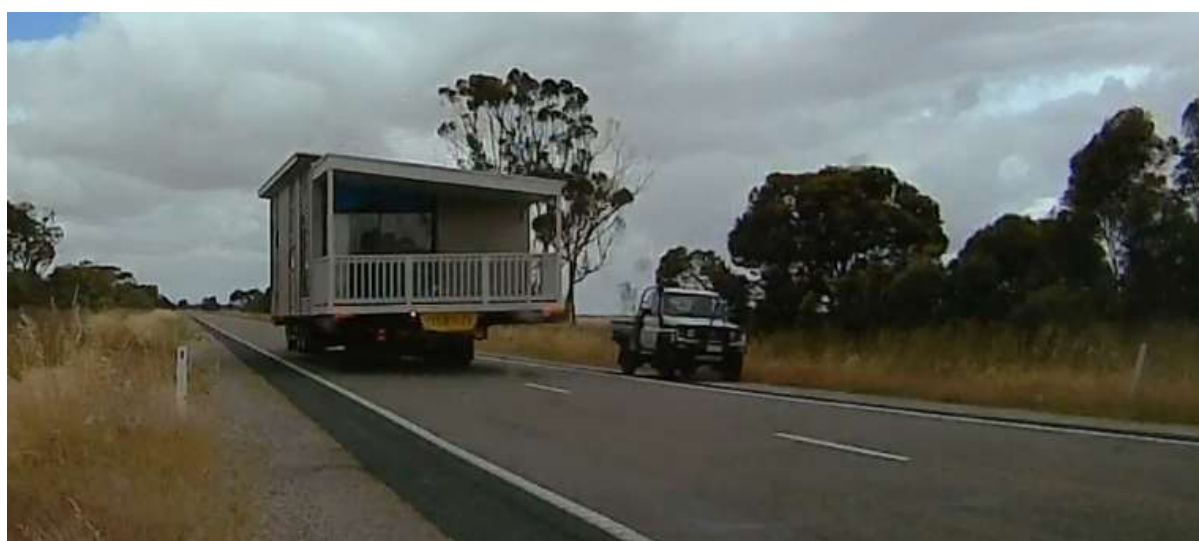
Austrroads Guide to Road Design⁶ specifies that 3.5m lanes and 1.0m sealed shoulders should be the minimum dimensions for a single carriageway rural road carrying between 1,000 and 3,000 vehicles per day. Riddoch Highway falls just short of these dimensions, and RAA recommends road widening to meet these minimum dimensions over time, however, as a lower priority than other required upgrades on Riddoch Highway.

Safety would be improved with wider lanes and shoulders

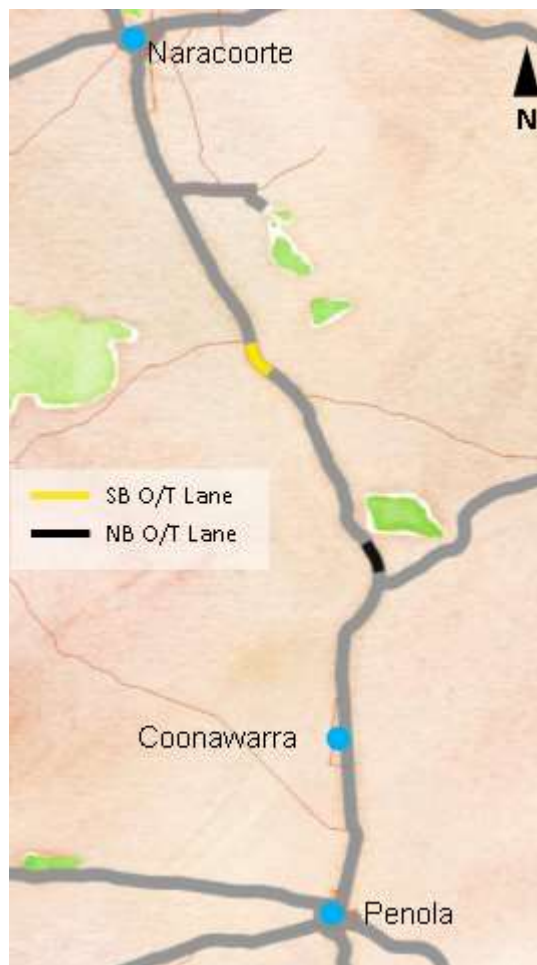
Current overtaking lane locations between Naracoorte and Penola

These overtaking lanes are only 1.1 kilometres long, which is far below the minimum desired length of 1.6 kilometres on a road train route. RAA recommends that these two overtaking

lanes be extended to at least 1.6 kilometres long. RAA also recommends that an additional overtaking lane be installed in each direction to increase the number of safe overtaking opportunities between Naracoorte and Penola.

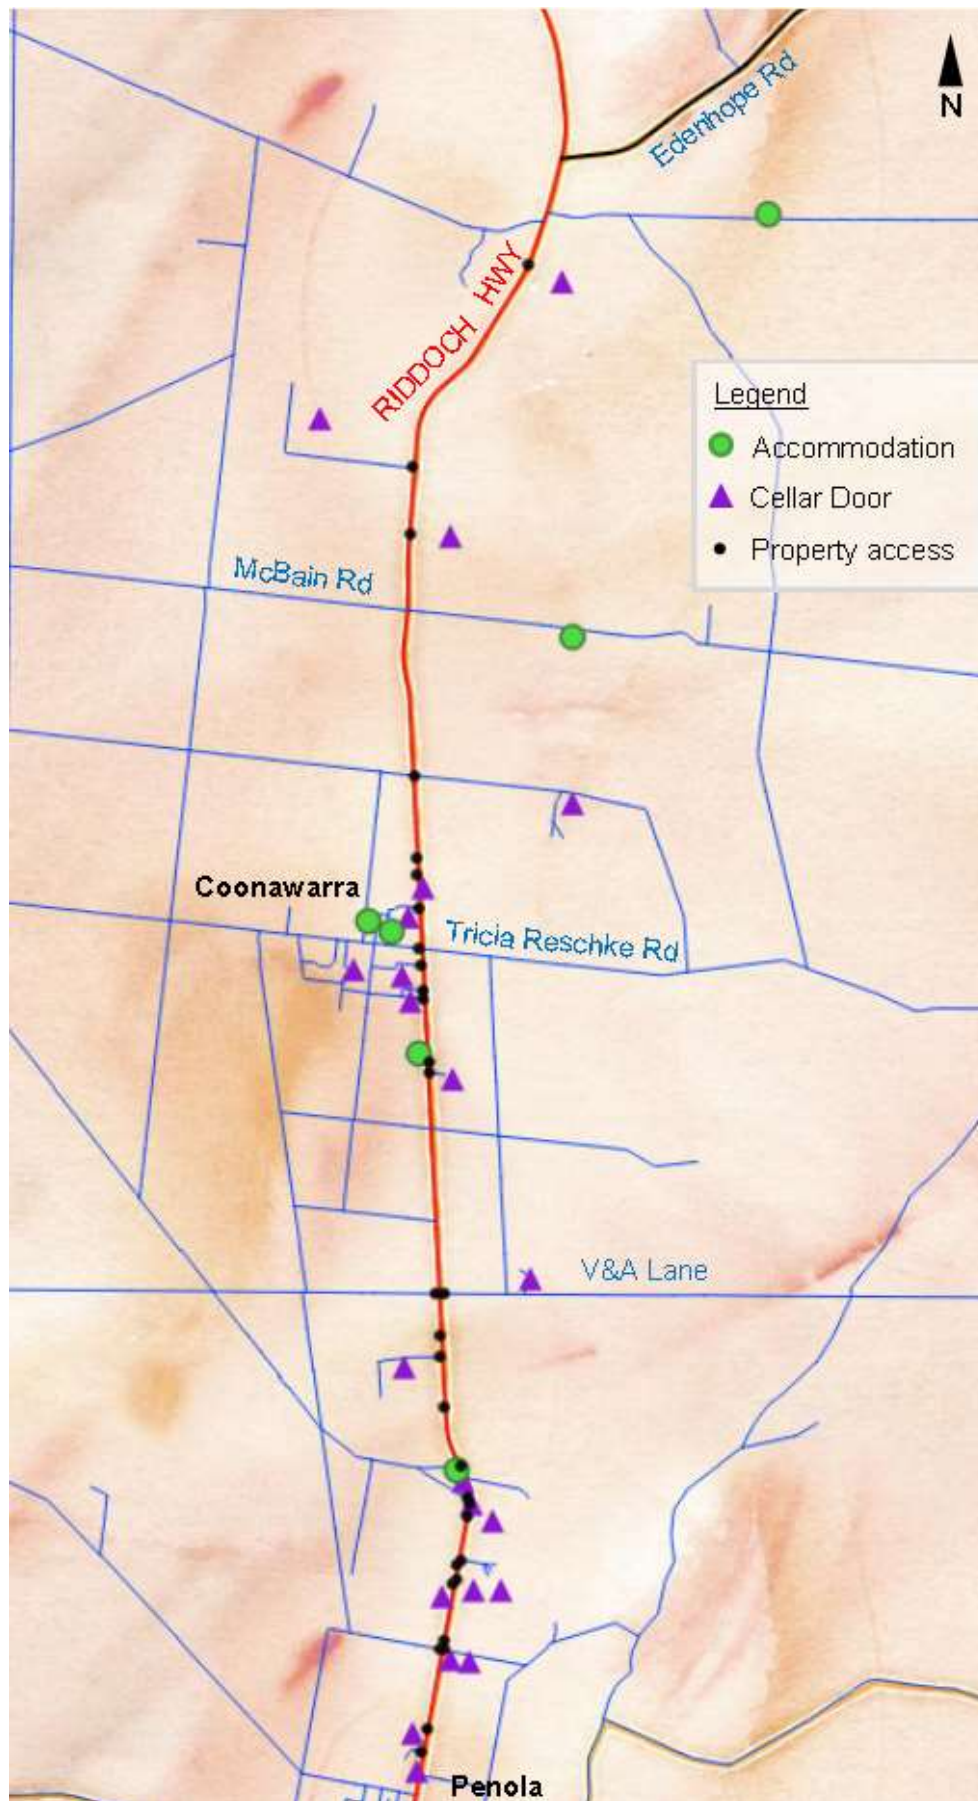
Locations of accommodation and cellar doors in the Coonawarra wine region

Between 2013 and 2017 there were six casualty crashes on the Riddoch Highway in the Coonawarra wine region. Five of these resulted in minor injuries, and one tragically resulted in a fatality. A further 17 crashes occurred that resulted in a vehicle being towed away, or in property damage greater than \$5,000.

RAA recommends that speed limits be reviewed for the 17 kilometres of Riddoch Highway between Penola and Edenhope Road. RAA also recommends that left and right turn lanes be provided from the highway to key cellar door access points and at side road intersections in this region.

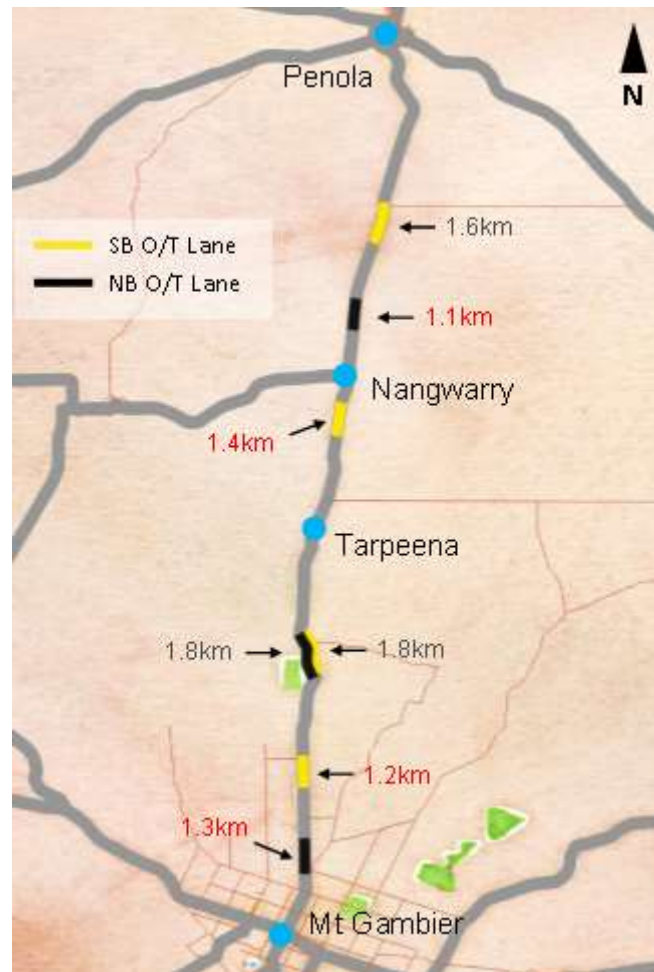
Current overtaking lane locations between Penola and Mount Gambier

The 47 kilometre section of Riddoch Highway between Penola and Mount Gambier is the busiest with AADT between 3,000 to 5,000 vehicles every day. Overtaking lanes are more frequent with four for southbound traffic and additional three for northbound traffic. Four of these overtaking lanes fell below the desirable 1.6 kilometre length and RAA recommends that these four overtaking lanes be extended.

The surface of the road is markedly worse between Penola and Mount Gambier, likely correlating with the high volumes of freight. Ruts were evident along most sections of the road, causing water to pond on the road surface in the wheel paths.

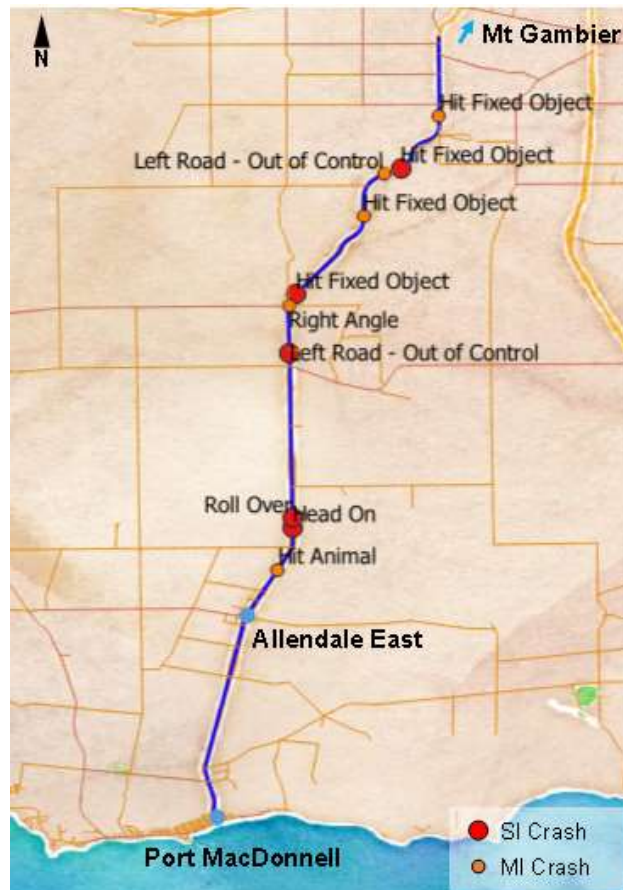
The crash history is poor with 10 casualty crashes occurring in the previous 110 km/h zone between 2013 and 2017 with five of these resulting in serious injuries. Eight of the crashes were single vehicle crashes, primarily due to inattention, and these crash types involved vehicles hitting fixed objects (4), leaving the road out of control (2), rolling over (1) or hitting animals (1).

Locations of 10 casualty crashes between Mt Gambier and Port MacDonnell

RAA recommends the following safety upgrades between Mount Gambier and Port MacDonnell which may facilitate the re-introduction of a 110 km/h speed limit south of Loudon Hill Road.

- Intersection upgrades with all sealed roads to accommodate left and right turning lanes
- 10m apron sealing at all unsealed road intersections
- Ensure consistent 3.5m lane geometry and minimum 1.0m sealed shoulder width
- Minimum 2.0m shoulder seal at property access points
- Remove or protect all hazards within at least 5m of the highway
- Install two overtaking lanes (one in each direction) between Mount Gambier and Allendale East

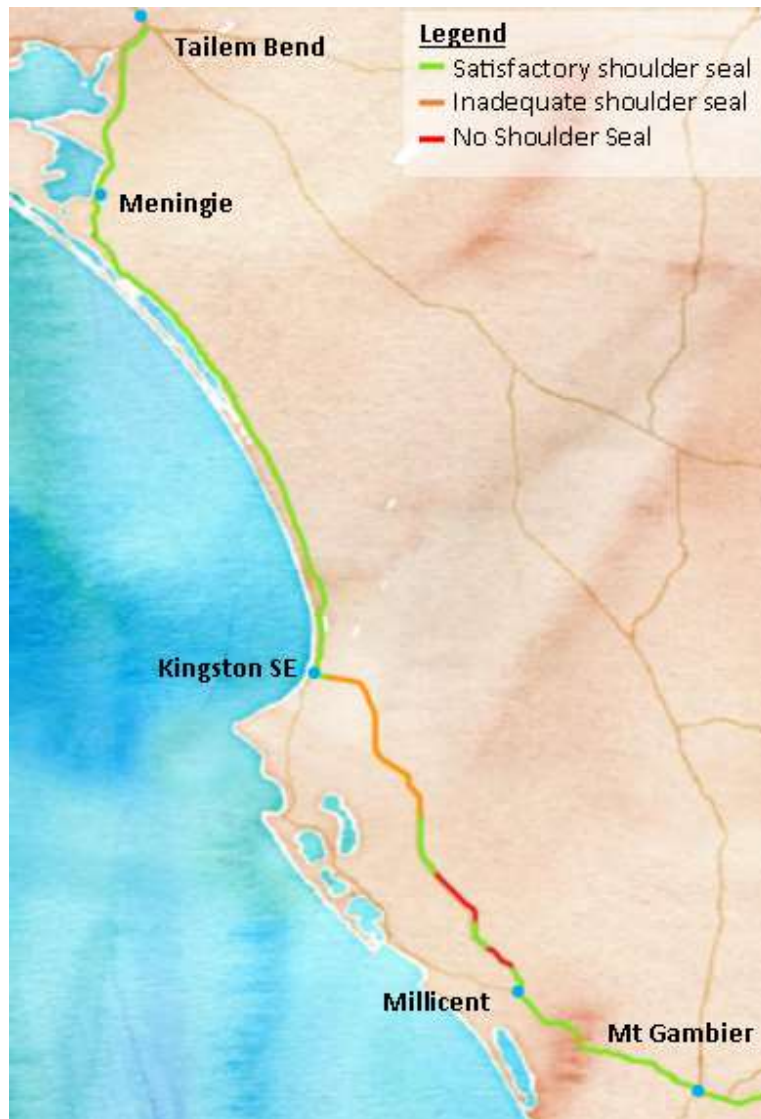
Road widths north of Kingston and south of Millicent are largely adequate for the function of the road; however, for the 105 kilometres between Kingston and Millicent, the road geometry varies widely. Lane widths are generally less than 3.2 metres, and sealed shoulders are mostly very narrow or non-existent. The map below highlights sections of the corridor with inadequate, or no shoulder sealing and edge lines.

Princes Highway shoulder seal map

RAA recommends that shoulders be sealed to a minimum of 1.0m for the entire corridor, with the section between Clay Wells and Millicent highlighted in the above map prioritised. RAA also recommends that lane widths be widened to 3.5m between Clay Wells and Millicent, and a minimum of 3.3m between Kingston and Clay Wells, based on the higher volumes of logging freight between Clay Wells and Millicent.

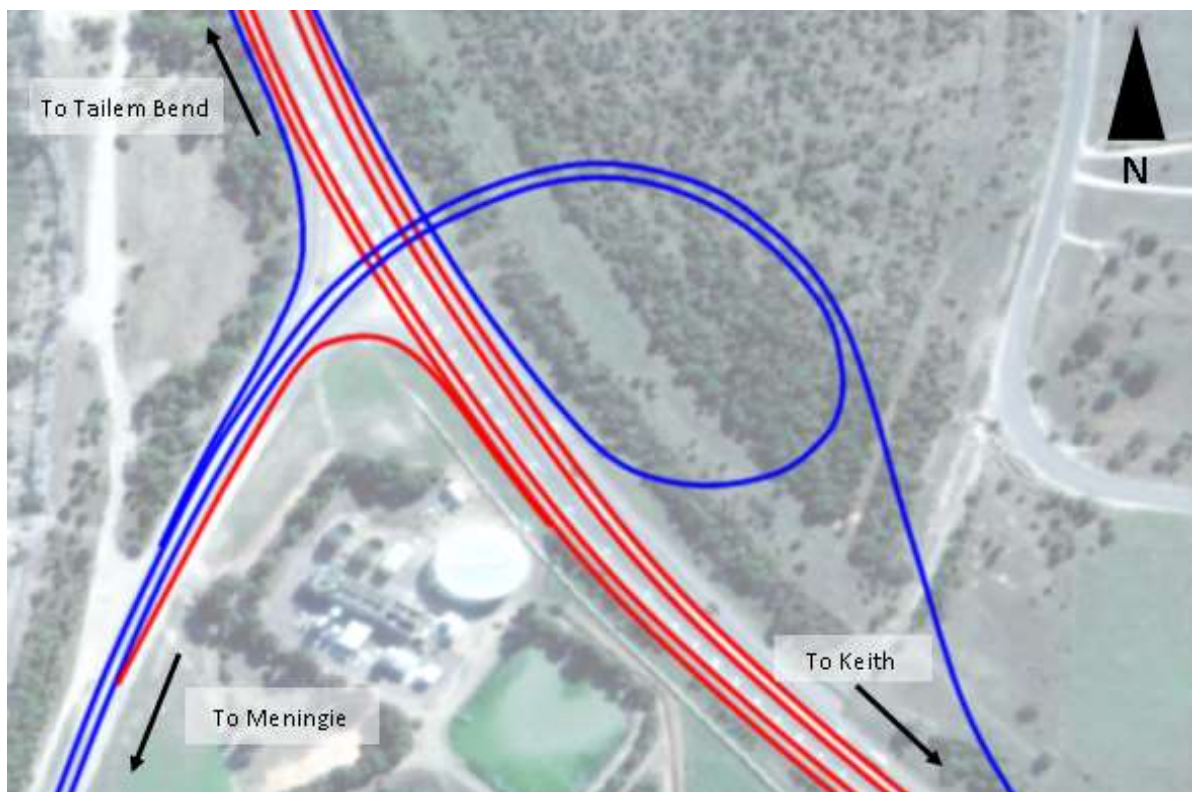
Between 2013 and 2017, there were four casualty crashes at the intersection with Princes and Dukes Highway. Three of these involved southeast bound vehicles turning right onto Princes Highway towards Meningie failing to give way to a northwest bound vehicle continuing along Dukes Highway towards Taillem Bend. Our observations on site indicated that sight distance to the southeast when turning right onto Princes Highway is good but the curvature of Dukes Highway may cause drivers to look in the wrong location for approaching traffic.

Concept sketch of a Princes Highway overpass and duplicated Dukes Highway in Taillem Bend

The intersection layout is good for a low traffic rural T-junction with long, separated turning lanes, a divided median, clear delineation and signage and ample street lighting. RAA are calling for duplication of Dukes Highway, which will result in a significant change at this intersection and a number of treatments such as a full interchange should be considered as there is sufficient adjacent land to remove dangerous at-grade right turns. The sketch below depicts a Princes Highway overpass of a four lane Dukes Highway, which would be a vastly safer treatment at this intersection when Dukes Highway duplication eventuates.

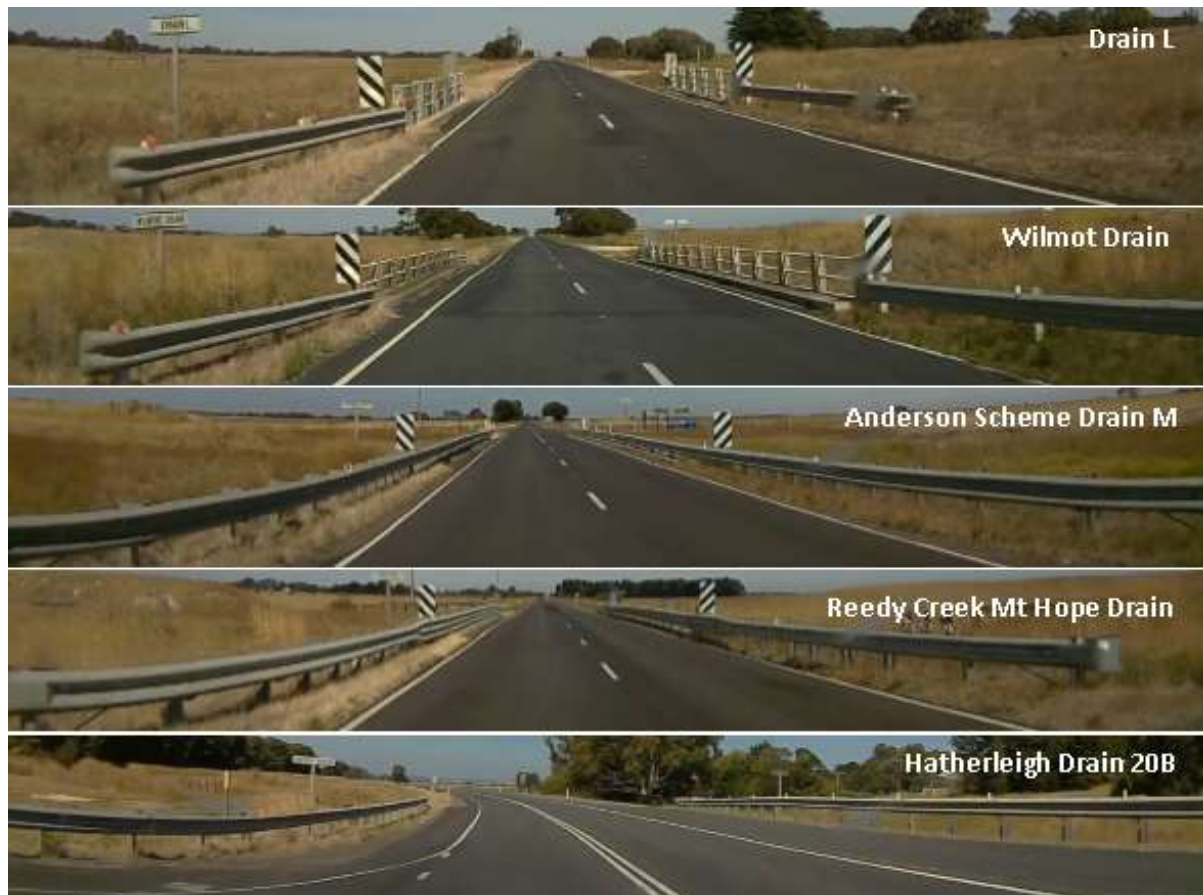
Five major drain bridges exist between Kingston and Millicent, with only one of these (Hatherleigh Drain 20B) sufficiently wide. RAA recommends widening of the four other bridges, namely:

- Drain L bridge (Drain K)
- Wilmot Drain bridge (Reedy Creek Wilmot Drain)
- Anderson Scheme Drain M bridge (Drain M)
- Reedy Creek Mount Hope Drain bridge

Narrow Bridges on Princes Highway

By removing these narrow choke points, both safety and productivity will be improved for all road users.

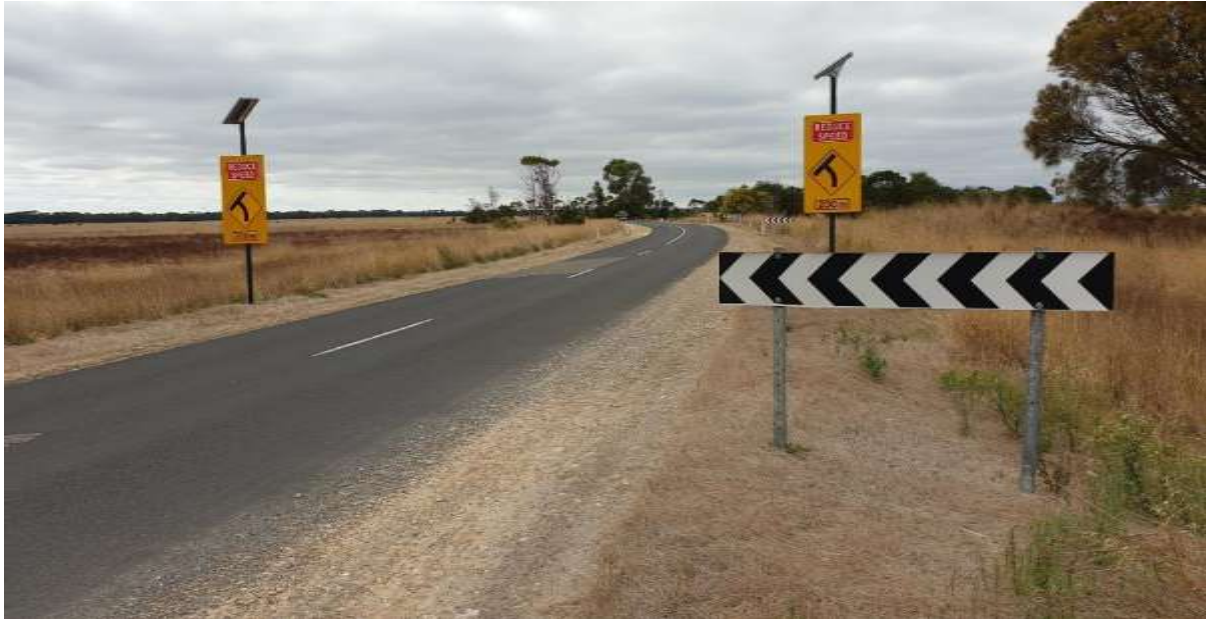
Particularly when approaching from the east, the curvilinear alignment of Clay Wells Road is consistently straight, and the intersection is located some distance from Penola, which increases the likelihood of inattention related crashes. The eastern and western approaches to the intersection have had a high number of passive safety treatments installed, including:

- Duplicated reduce speed warning signs with flashing LEDs
- Duplicated W2-14 't-intersection beyond curve' signs with 400m and 200m plates
- Rumble strips
- Hazard boards
- Shoulder widening and edge line marking at intersection

Multiple warning signs currently indicate the approaching intersection

RAA recommends the following treatments be considered to improve safety and further delineate the intersection in the shorter term:

- Shoulder sealing and widening on Clay Wells Road
- Edge continuity line along Princes Highway through the intersections
- Installation of RRPMS
- Installation of turning lanes
- Installation of street lighting
- Increase size and install additional hazard markers opposite the terminating legs (Clay Wells Road) of the intersection
- Installation of R1-2 'give way' signs and associated holding lines

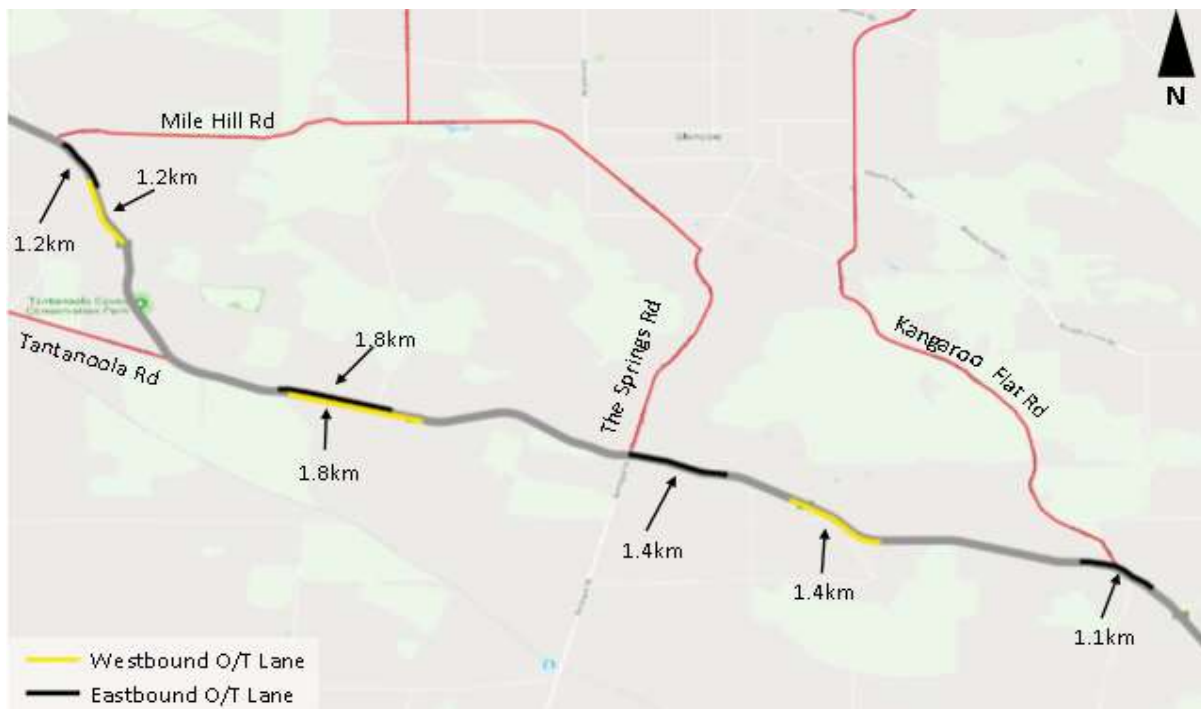
There are seven overtaking lanes (three westbound, four eastbound) between Millicent and Mount Gambier, which provide numerous opportunities to overtake on this busy section with vertical and horizontal alignment also restricting opportunities to overtake. Only two of these overtaking lanes meet the minimum requirement of 1600 metres⁹ in length for a road train route, and RAA recommends that five of these overtaking lanes be extended to allow additional safe overtaking opportunities.

Locations and lengths of overtaking lanes between Millicent and Mt Gambier

In the longer term, increasing traffic volumes between Millicent and Mount Gambier may warrant duplication of this section of Princes Highway.

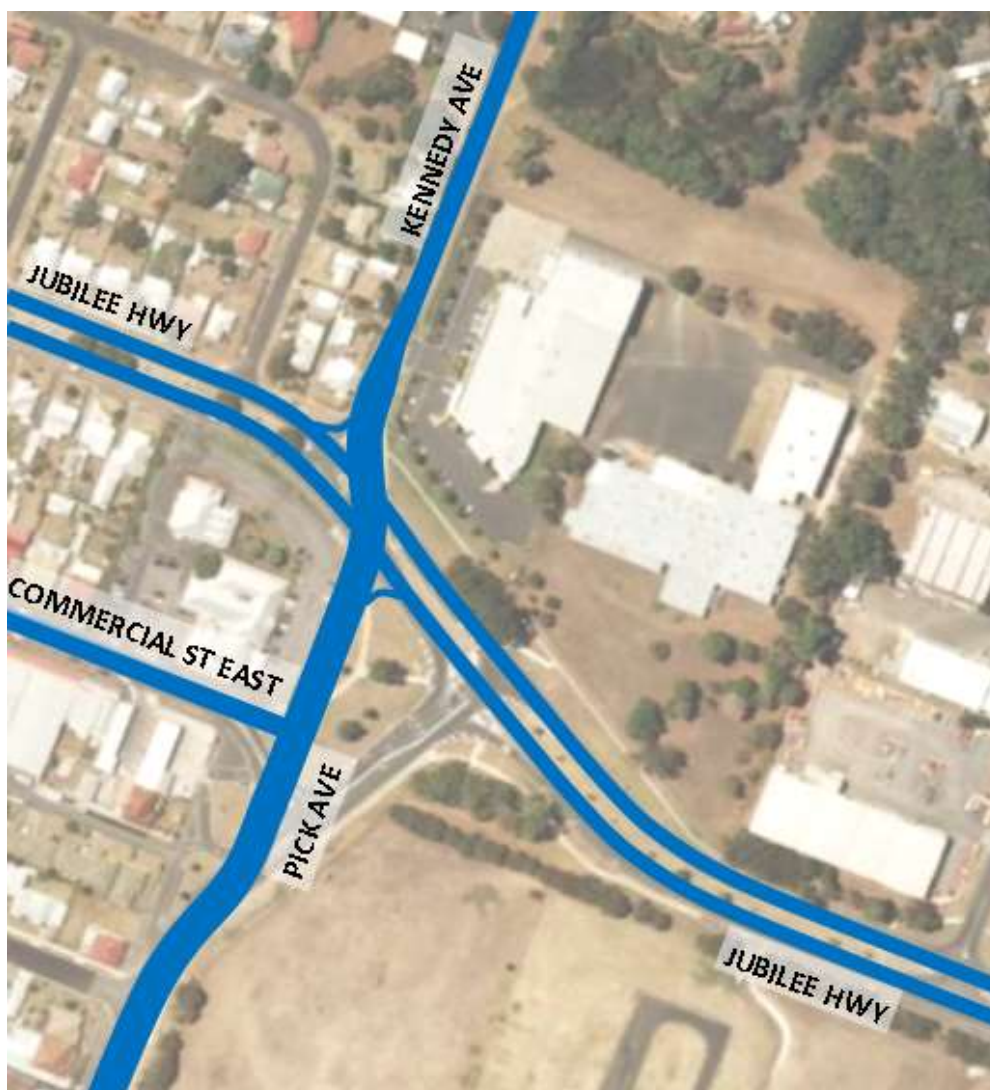
A far more costly option that would retain all turn movements would be to realign Pick Avenue and Kennedy Avenue to form a single signalised intersection, as pictured below. This would help reduce congestion and improve safety whilst also providing an opportunity for safety improvements at the Pick Avenue/Commercial Street East intersection.

Realignment of Pick Avenue and Kennedy Avenue at the intersection with Jubilee Highway

RAA recommends that the right turn lane from Jubilee Highway onto Pick Avenue be extended. Alternative options such as realignment of Pick Avenue and Kennedy Avenue should be considered, however, may not be economically feasible.

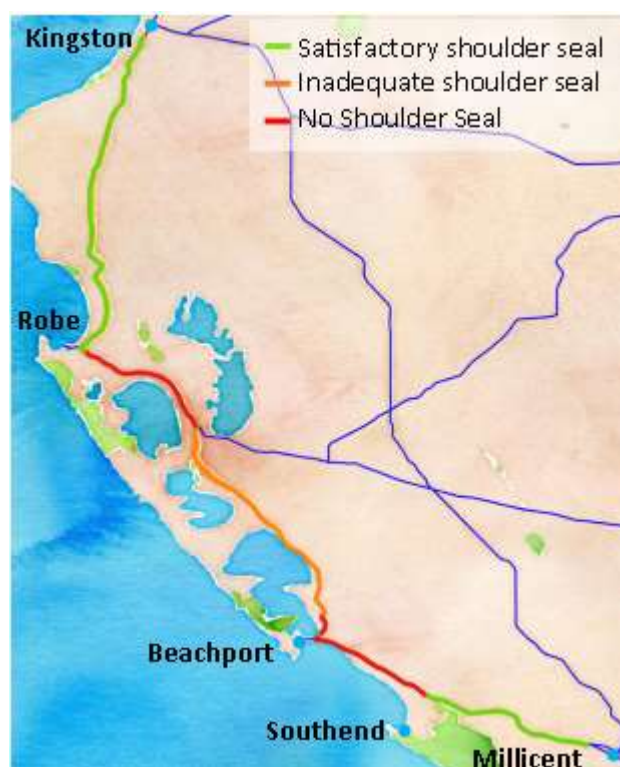
Segment	Lane Width	Sealed Shoulder Width	Total Seal Width
S of Saltwell Road (Cape Jaffa)	3.3m	1.0m	8.6m
W of Sandy Lane (Robe)	2.9-3.1m	N/A	6.0m
N of Beachport – Penola Road (Bray)	3.0-3.1m	0.4m	6.9m
N of Southend	3.1m	N/A	6.2m
S of Southend	3.1m	0.8m	7.8m

Southern Ports Highway shoulder seal map

RAA recommends that sections with no shoulder seal be prioritised along the corridor for 1.0m shoulder sealing, with other sections of narrow shoulder seal to be widened further.

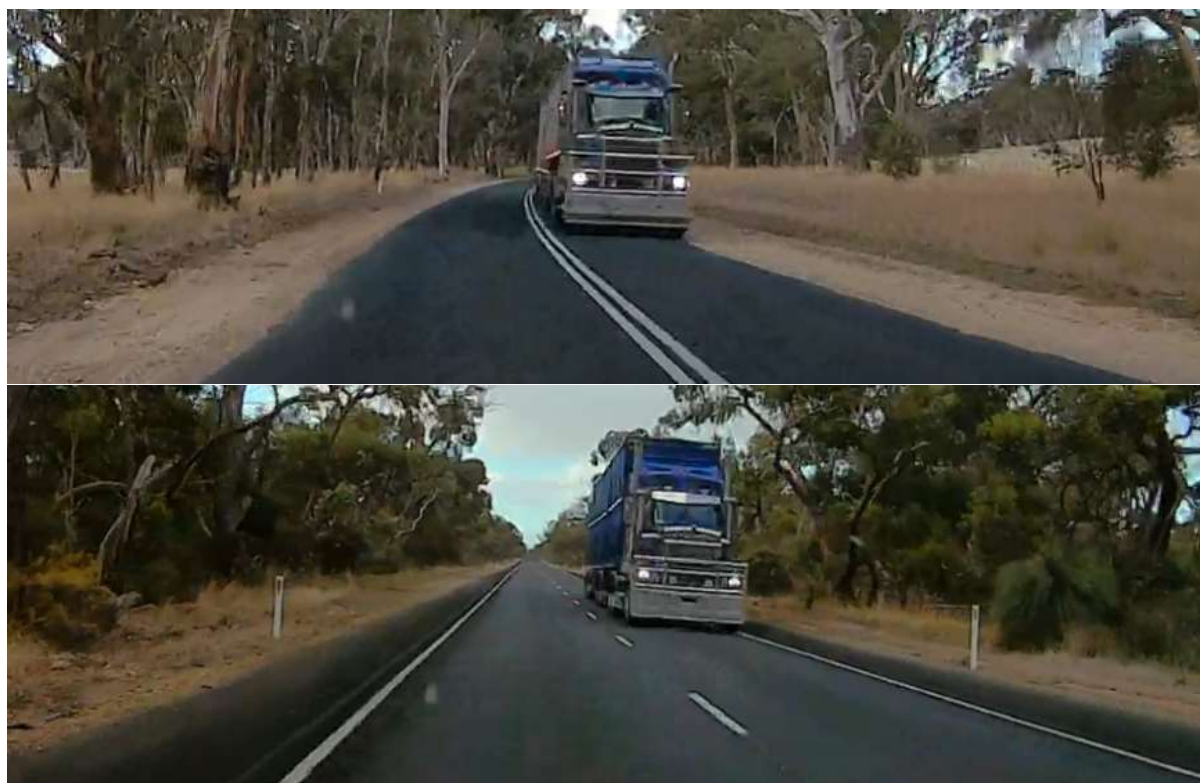
When travelling north on Naracoorte Road, the four kilometres immediately north of Riddoch Highway has good lane and shoulder geometry, with road widening works on this section of the road appearing to be relatively recent. The lanes and shoulders then narrow for the next 3.5 kilometres before another four-kilometre section with wide lanes and shoulder seal begins just south of The Gap Road. The 38 kilometres through to the intersection with Rowney Road has no shoulder seal, with edge lines provided along the 3.5 kilometres between Rowney Road and Bordertown providing no additional seal width. In total, less than 15% of Naracoorte Road has a suitable geometry for its current PBS Level 2A (b-double) classification. As such, RAA recommends that shoulders on the remaining sections of Naracoorte Road be sealed to provide minimum 3.3m lanes and 1.0m sealed shoulders.

The sections of Naracoorte Road with wider lanes and sealed shoulders are significantly safer

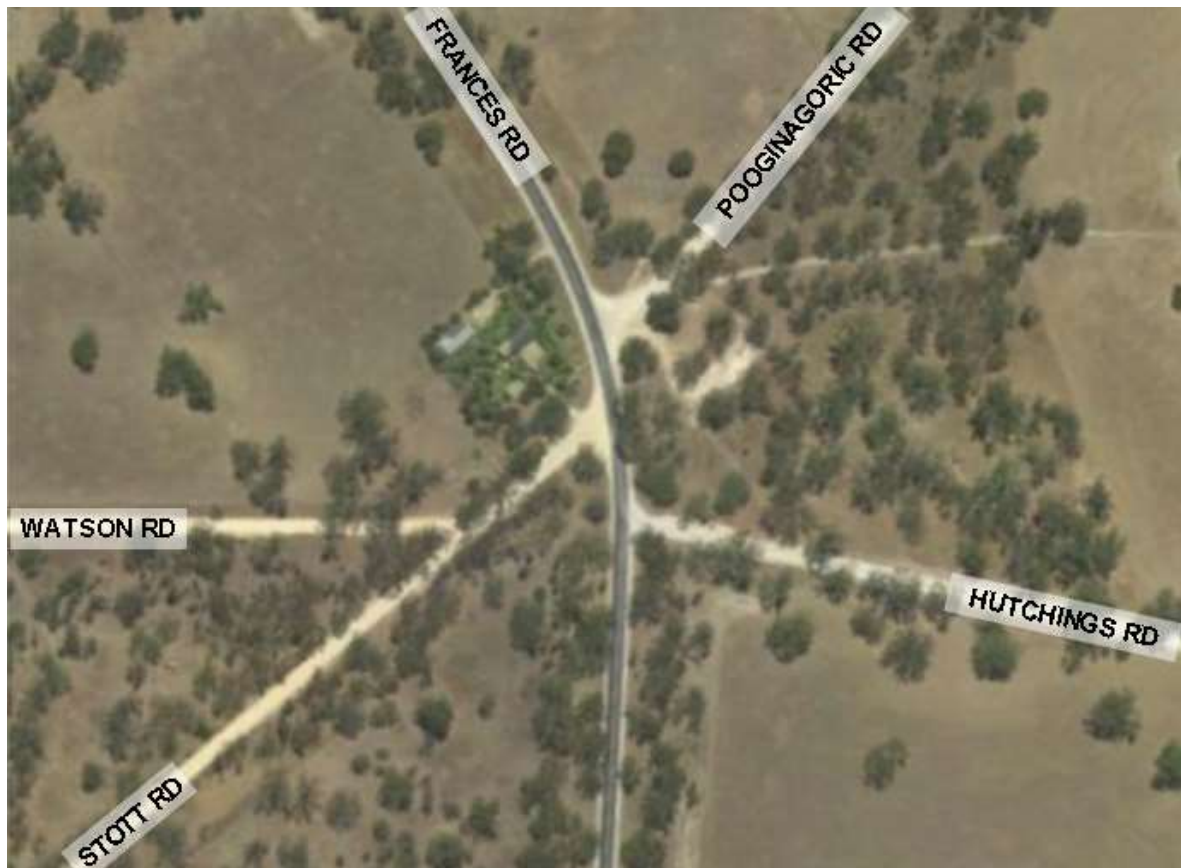
A number of survey respondents raised the section of Frances Road between Pooginagoric Road and Hutchings Road as an issue. There are three T-intersections on a gradual curve of this 100 metre section of Frances Road in Pooginagoric as pictured below.

Survey respondents raised Frances Road between Pooginagoric Road and Hutchings Road

Farm machinery and heavy vehicles frequently drive across Frances Road from Stott Road to Hutchings Road and vice versa. These vehicles turning right from Stott Road travel very slowly due to their size and handling characteristics before making a left turn onto Hutchings Road. Sight distance of southbound vehicles is compromised by the road geometry

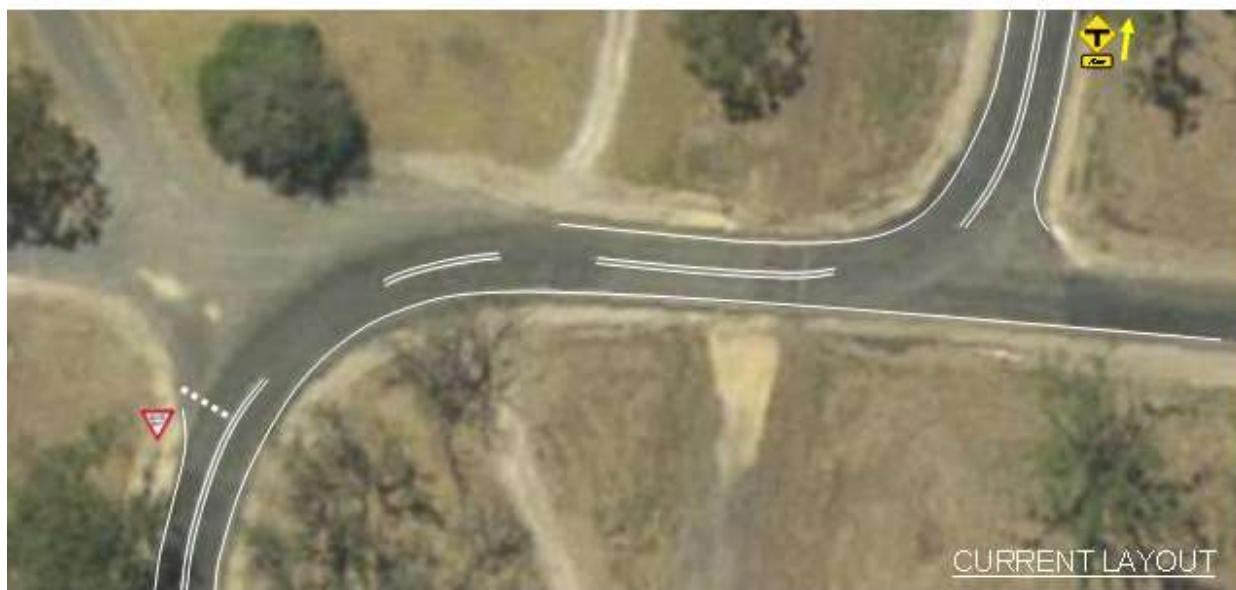
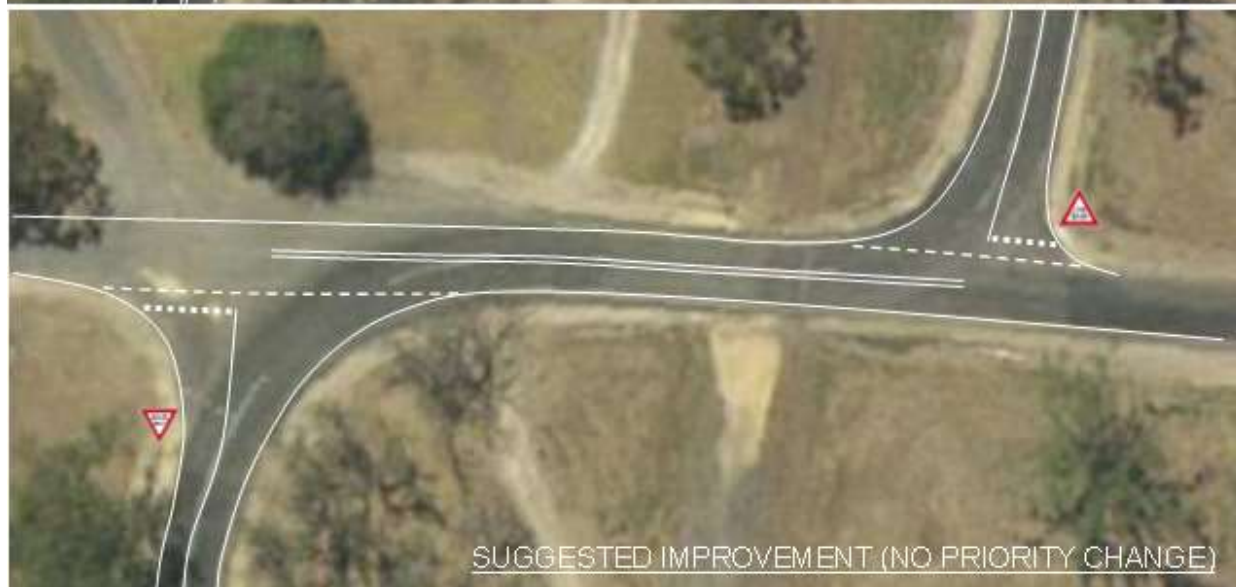
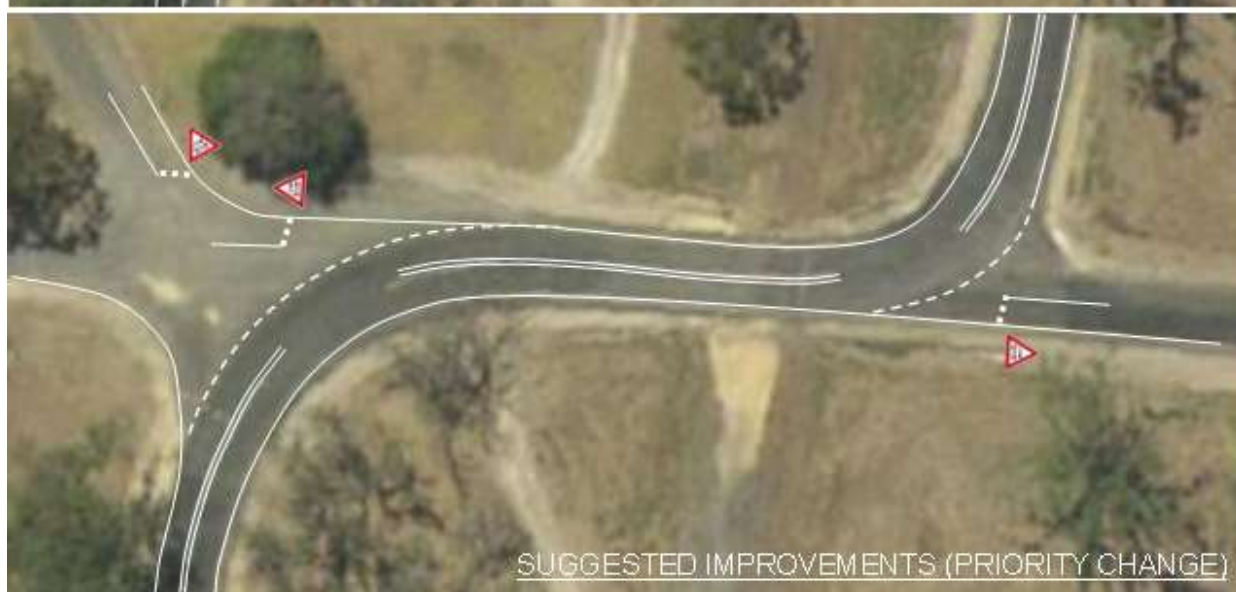
The diagrams over the page highlight the current lack of delineation at the intersection, and show the changes suggested by RAA.

If the current give way conditions are to remain unchanged, RAA recommends that line marking and signage be reviewed and updated to delineate the priorities through the intersection.

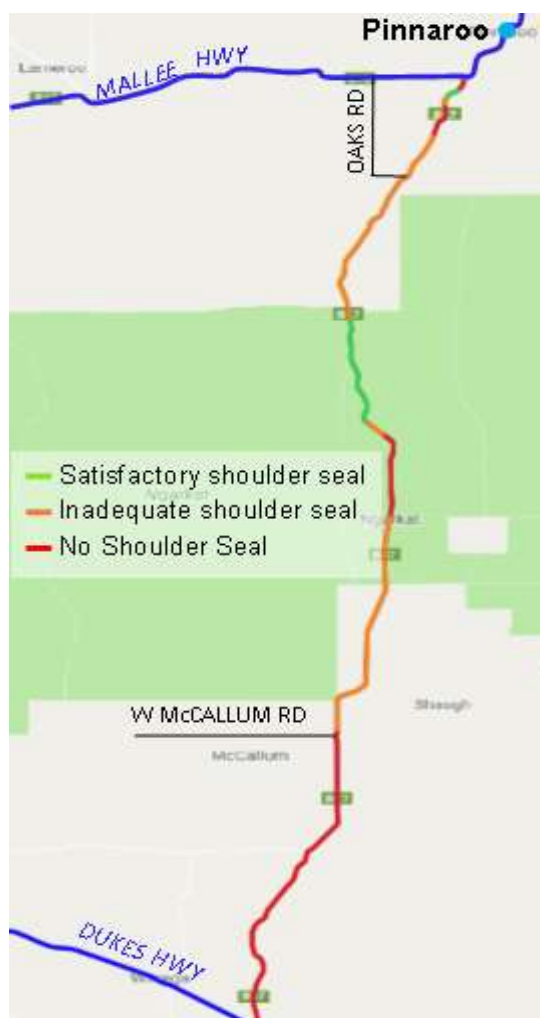
Ngarkat Highway is generally narrow with inconsistent geometry along the length of the highway. The northern section has some level of shoulder seal, however, this is often crumbling, in poor condition and of a narrow width that offers little safety benefit. The 33 kilometre section between Dukes Highway and West McCallum Road has no shoulder seal, and RAA recommends this section should be prioritised for 1.0 metre shoulder sealing along the route. Only 12 of the remaining 82 kilometres of Ngarkat Highway is considered by RAA to be acceptable geometrically for the current function as an inter-regional b-triple route. RAA recommends that widening of the existing narrow shoulder seal to 1.0m be undertaken on the remaining sections of Ngarkat Highway.

Ngarkat Highway shoulder seal map

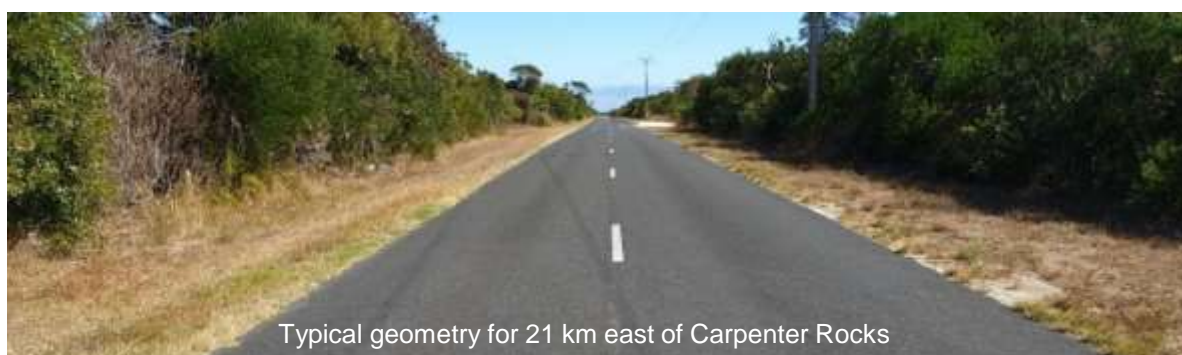
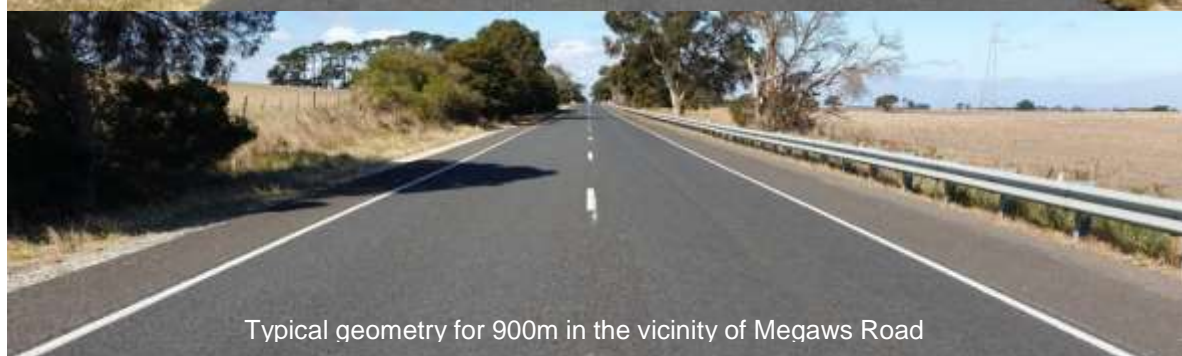
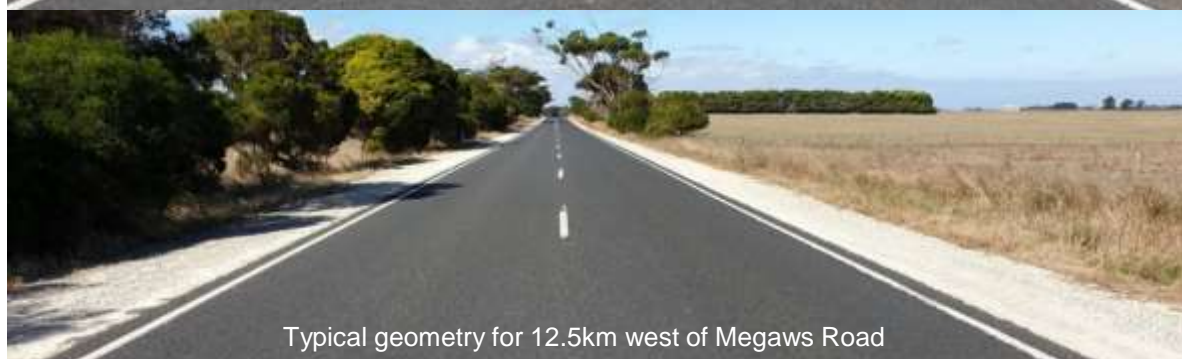
The geometry of Carpenter Rocks Road is not consistent along the length of the road. The section under council control has 3.0 metre wide lanes and no sealed shoulder for the entire 18 kilometre length. The section under DPTI control has lane widths varying between 3.0 and 3.3 metres with varying levels of sealed shoulder widths. A 900 metre section east of Megaws Road is well constructed with wide shoulders and barrier protection.

Varying geometry of Carpenter Rocks Road

RAA recommends that shoulders be sealed to minimum 1.0 metre for the length of Carpenter Rocks Road, with consideration given to a 1.5 metre shoulder seal between Burrungule Road and Mount Gambier due to the high traffic volumes and number of property access points.

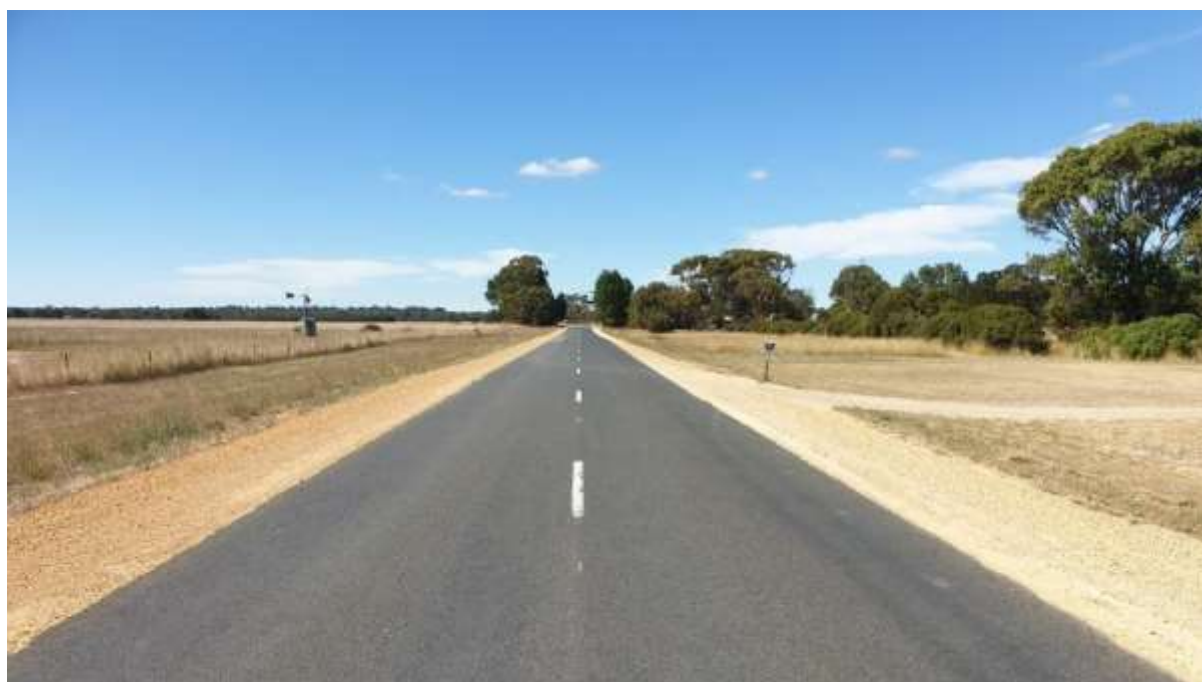
Numerous survey respondents mentioned undulations on Lucindale Road as a major transport issue that needed to be addressed in the region.

“Lucindale to Naracoorte Road – surface and road edges need repair or total overhaul.”

Typical Lucindale Road geometry

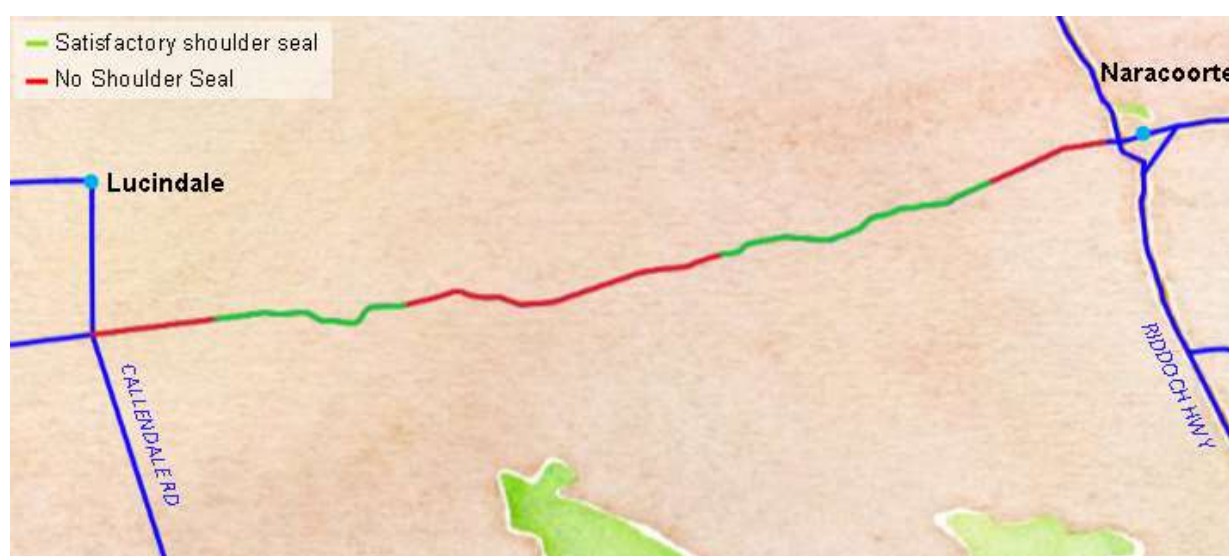
Lucindale Road is generally quite narrow with more than 50% of the road lacking sealed shoulders. There are currently two sections along the road with 1.0 metre shoulder sealing, as highlighted in the map below. The geometry of this road is not suitable for a route carrying this volume of traffic, and RAA strongly recommends that 1.0 metre wide shoulder sealing be undertaken for the remaining 19 kilometres without shoulder sealing and lanes be widened to 3.3 metres.

Map of current shoulder sealing along Lucindale Road
