Limestone Coast

Regional Road Assessment September 2019

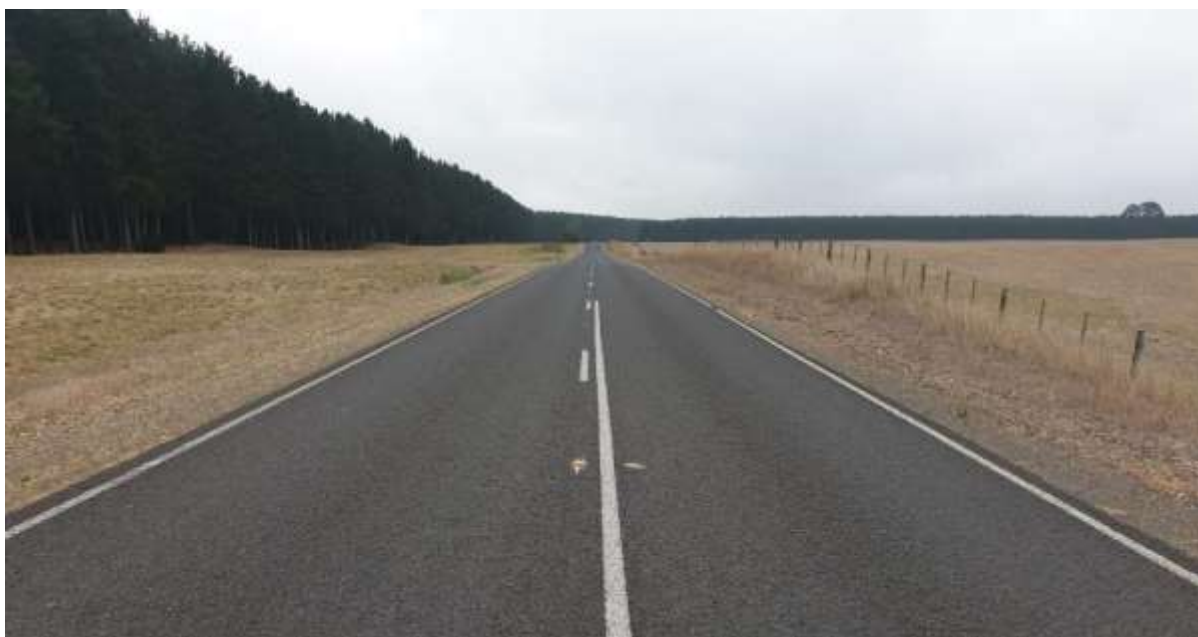
Glenelg Highway has adequate lane width with narrow sealed shoulders, and this geometry is consistent along the length of the South Australian government maintained section of road. Shortly after crossing the Victorian border, lane widths become quite narrow, however, a narrow sealed shoulder is maintained which provides a seal width of just over 6.1 metres. This treatment is not common in South Australian roads this narrow, and generally roads with a seal width around 6 metres do not have any edge lines, allowing vehicles to utilise the full width of their lane at the expense of improved delineation.

Typical geometry on the South Australian section of Glenelg Highway

RAA recommends that shoulders be widened to 1.0m due to the high significance of this corridor; however, this should occur as a lower priority to other roads in the region without any level of shoulder seal.

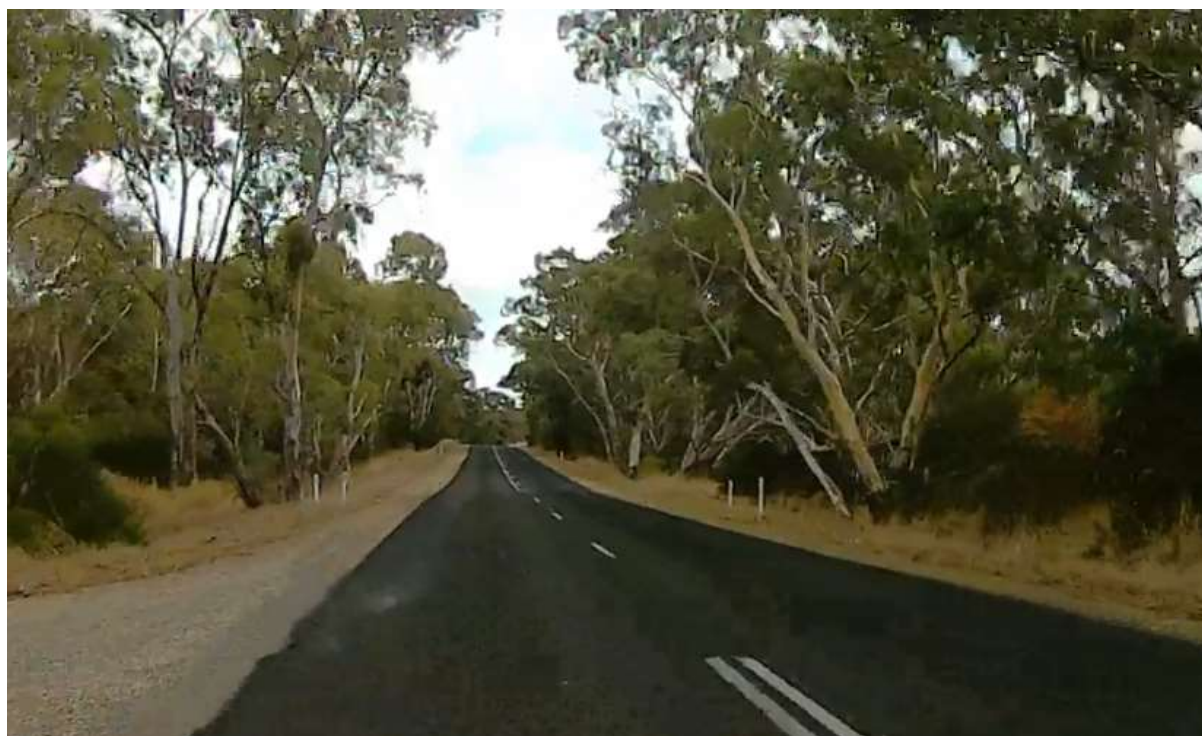
Typical cross section of Avenue Range Road

The clear zone is generally maintained to approximately three metres, however, moderately dense and hazardous vegetation exists outside of this width for many parts of the corridor. RAA recommends that additional barrier protection be installed to provide further protection, particularly around curves. Removal of trees within three metres of the carriageway should also be considered.

Avenue Range Road – Key Recommendations		Authority
■	Minimum 0.5 metre shoulder seal.	DPTI
■	Widen narrow bridges.	DPTI
■	Additional barrier protection, particularly around curves.	DPTI
■	Remove trees within three metres of the carriageway.	DPTI/NLC/ KDC

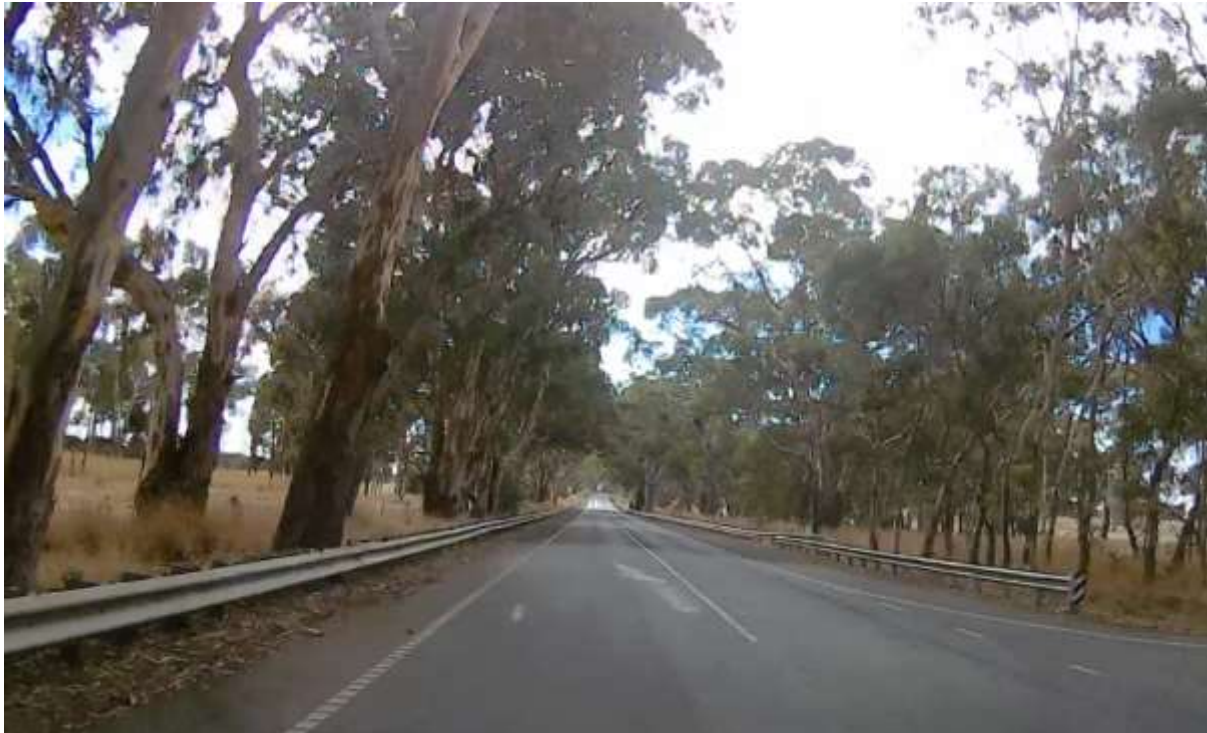
Barrier protection to combat crashes into trees along Wimmera Highway

ATLM is installed along the edge lines between Naracoorte and Hynam, however this is not continued through to the Victorian border. The risk of serious crashes involving trees east of Hynam is high due to the frequency of roadside vegetation, and RAA recommends that ATLM edge lines be extended through to the border as a minimum. Vegetation removal or additional barrier protection should also be considered between Hynam and the border.

Wimmera Highway – Key Recommendations		Authority
<ul style="list-style-type: none"> ▪ Install ATLM between Hynam and the Victorian border. ▪ Consider vegetation removal or additional barrier protection between Hynam and the Victorian border. 		DPTI
		DPTI/NLC

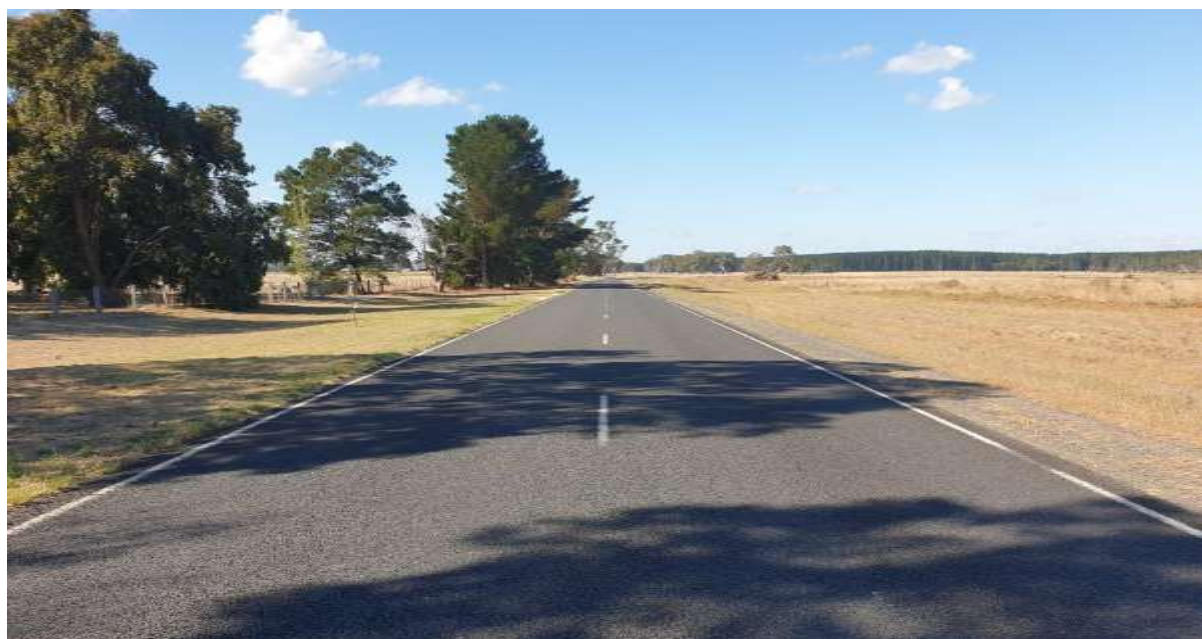
Nangwarry Road has good geometry for its current function

There is a gradual curve before the intersection with Riddoch Highway, and RAA recommends that intersection warning signage be installed prior to this intersection. Large, duplicated 60 km/h signs have been installed 50 metres before the intersection, which is unusual, but does not create confusion. Their presence may serve to clarify the 60 km/h speed limit after turning onto Riddoch Highway – even though these signs do not apply to Riddoch Highway.

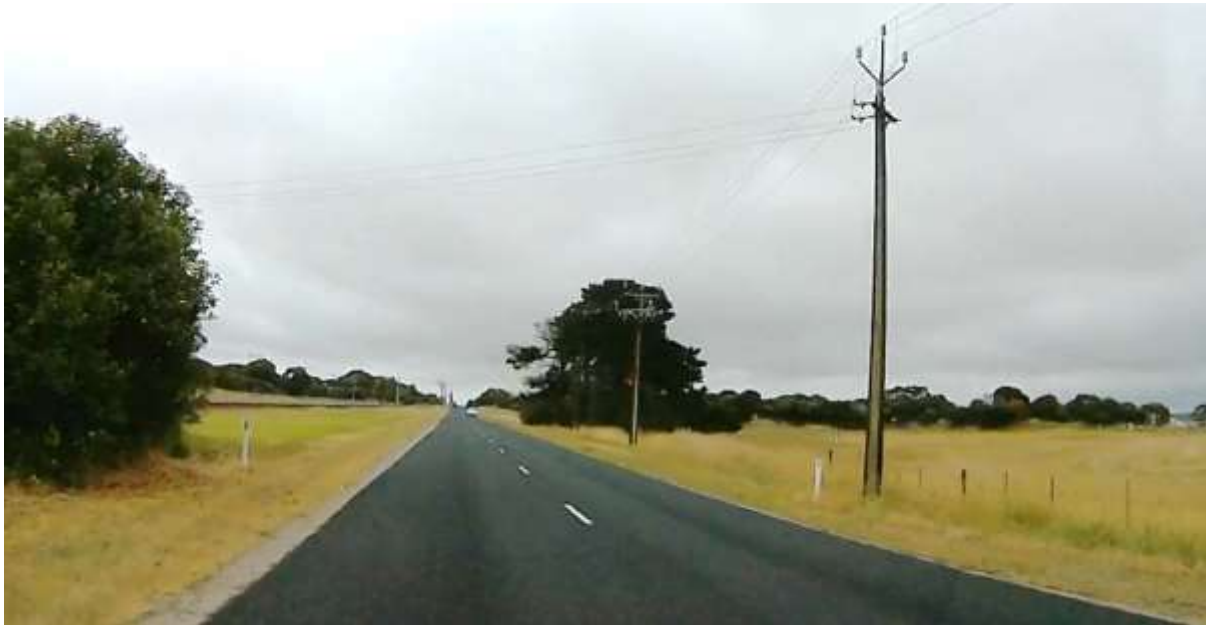
Tantanoola Road is generally in good condition with 3.2 metre lane widths and a wide clear zone. Some localised hazard removal or protection is required with trees and stobie poles present in close proximity to the road. In the longer term, RAA recommends that shoulders be sealed to a minimum width of 0.5 metres to further improve safety.

Typical Tantanoola Road geometry

Tantanoola Road – Key Recommendations		Authority
▪ Removal or protection of roadside hazards		DPTI/DCG
▪ Seal shoulders to minimum 0.5 metres		DPTI

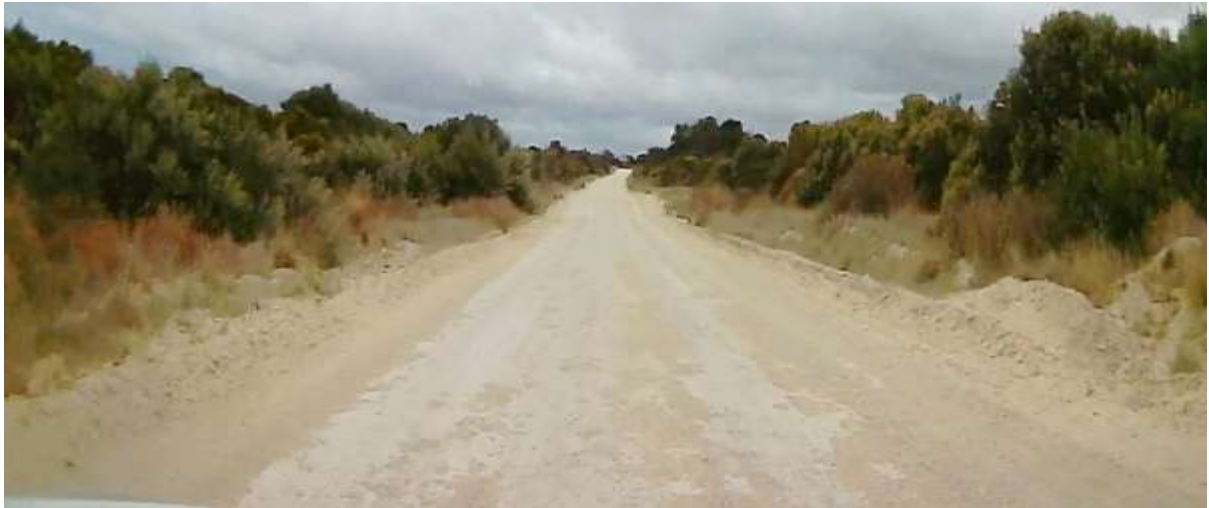
In general, the road condition of Sandy Lane is adequate. Some sections of the road are slightly corrugated, and the presence of vegetation along the road may pose some risks. This road may benefit from being included in the long-term road-sealing program.

Typical Sandy Lane geometry
