Yorke Peninsula

Regional Road Assessment
April 2019

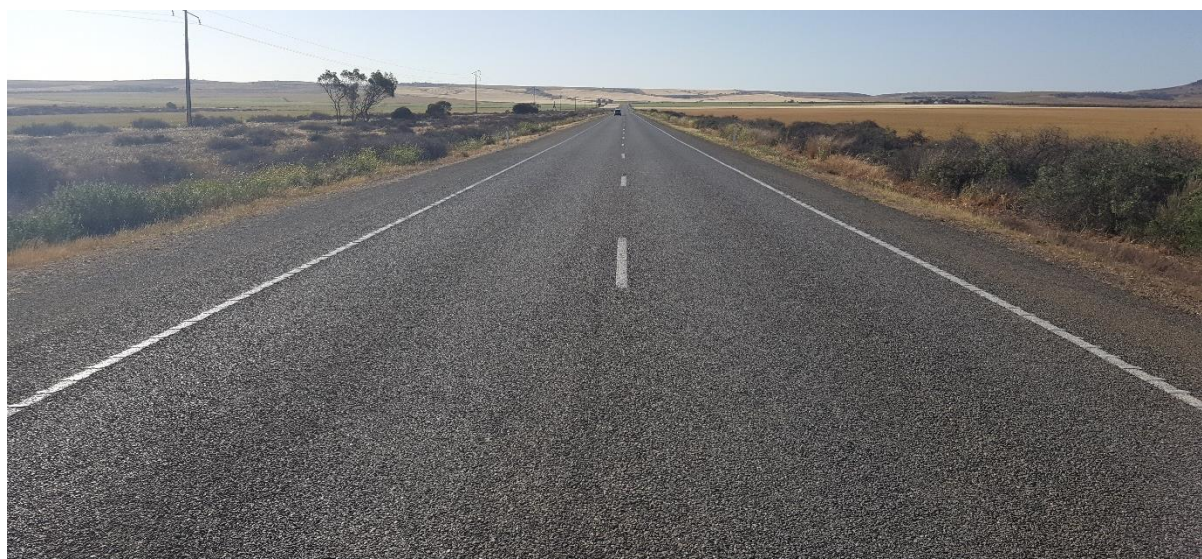
The geometry of Copper Coast Highway has been significantly improved since our 2014 assessment.

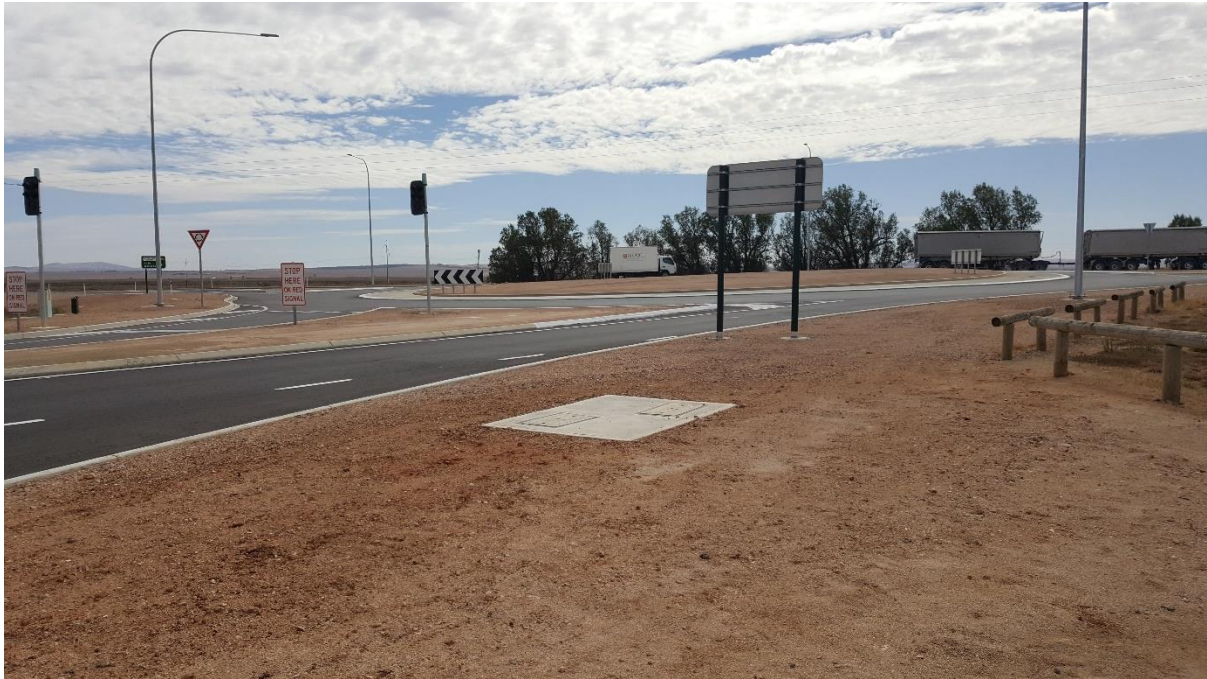
The new Federation Corner roundabout

The new roundabout has significantly improved safety at the intersection by reducing speeds and impact angles in the event of a crash. Signage was clear, and delineation was good during the day. Delineation was also suitable at night with street lighting, RRPMS, guide posts and reflective paint all present. Heavy vehicles were observed making all turning movements without restriction.

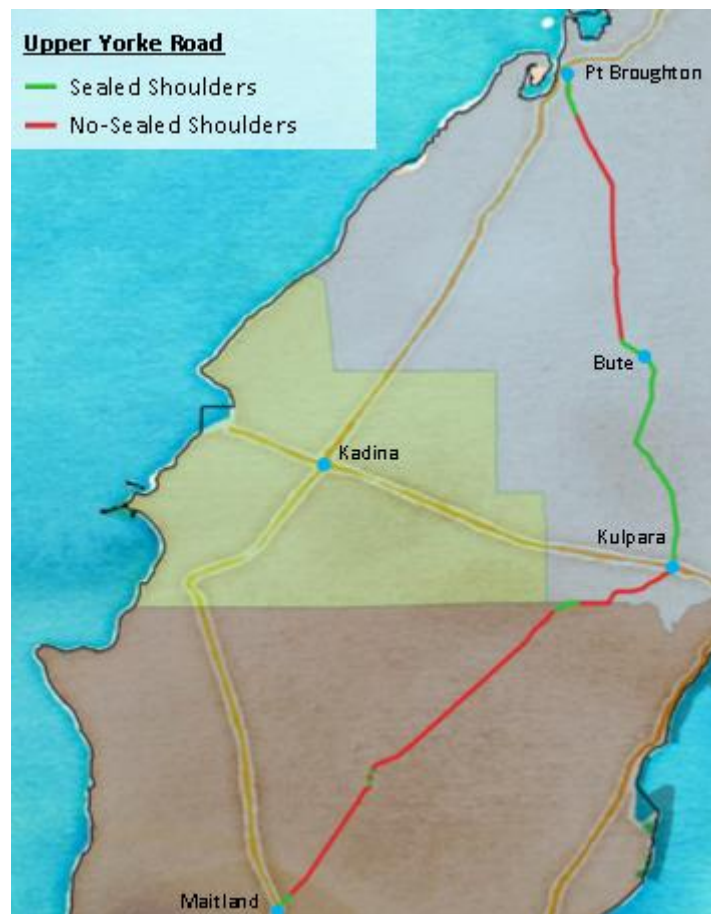
Current sections of shoulder seal on Upper Yorke Road

The map below outlines all sections of Upper Yorke Road with any level of shoulder seal as of October 2018.

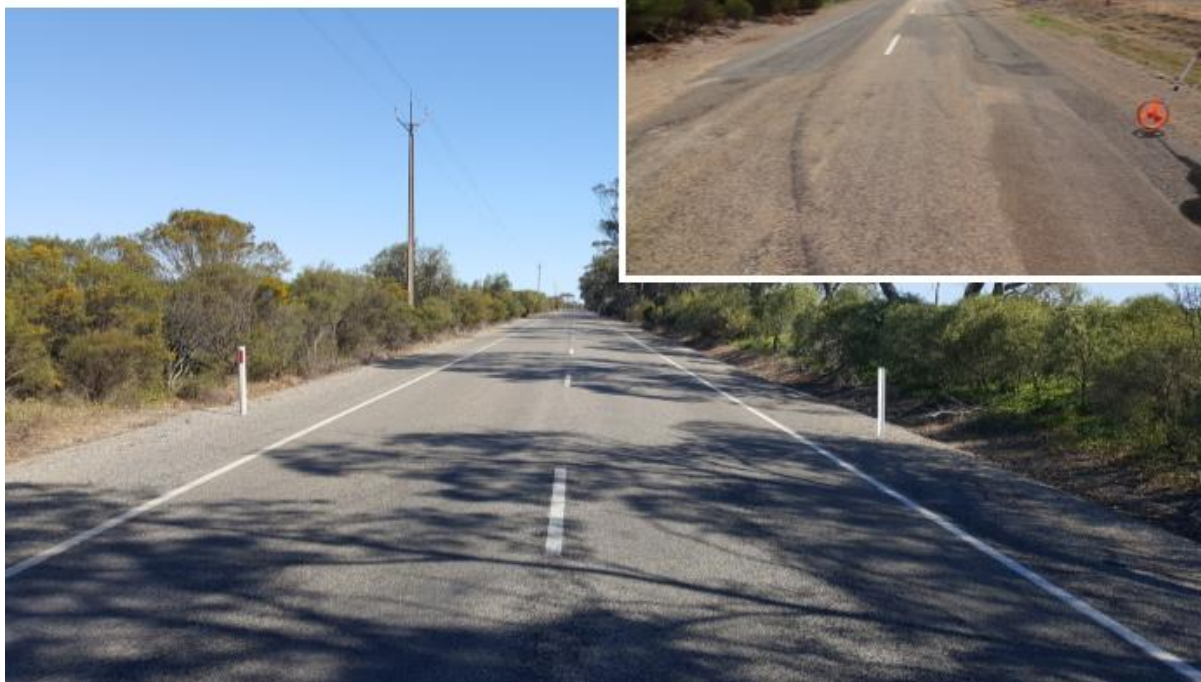
The Bute to Kulpara section of Upper Yorke Road in 2018 compared to 2013 (inset)

It was noted that D4-1-1 'unidirectional hazard markers' are being used to incorrectly delineate curves on this and other sections of Upper Yorke Road. RAA recommends that these be replaced with D4-6 'chevron alignment markers' as specified in AS1742.2 (2009)¹⁰ and discussed earlier in this report.

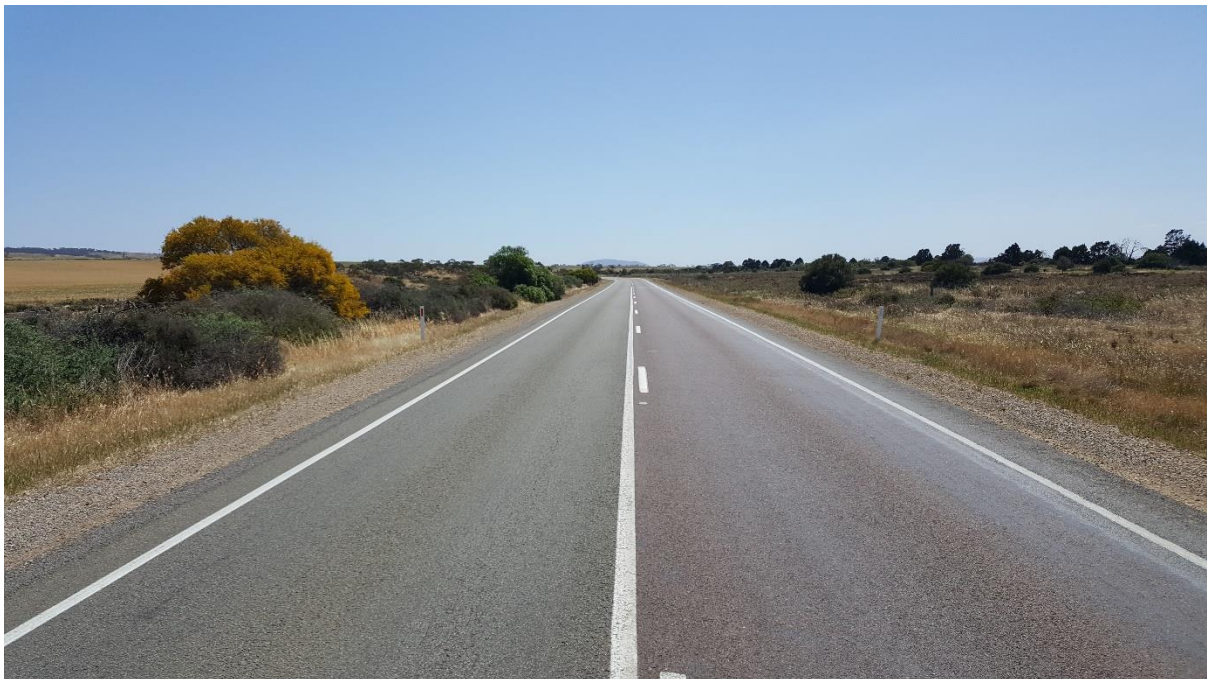
Geometry north of Ardrossan is good.

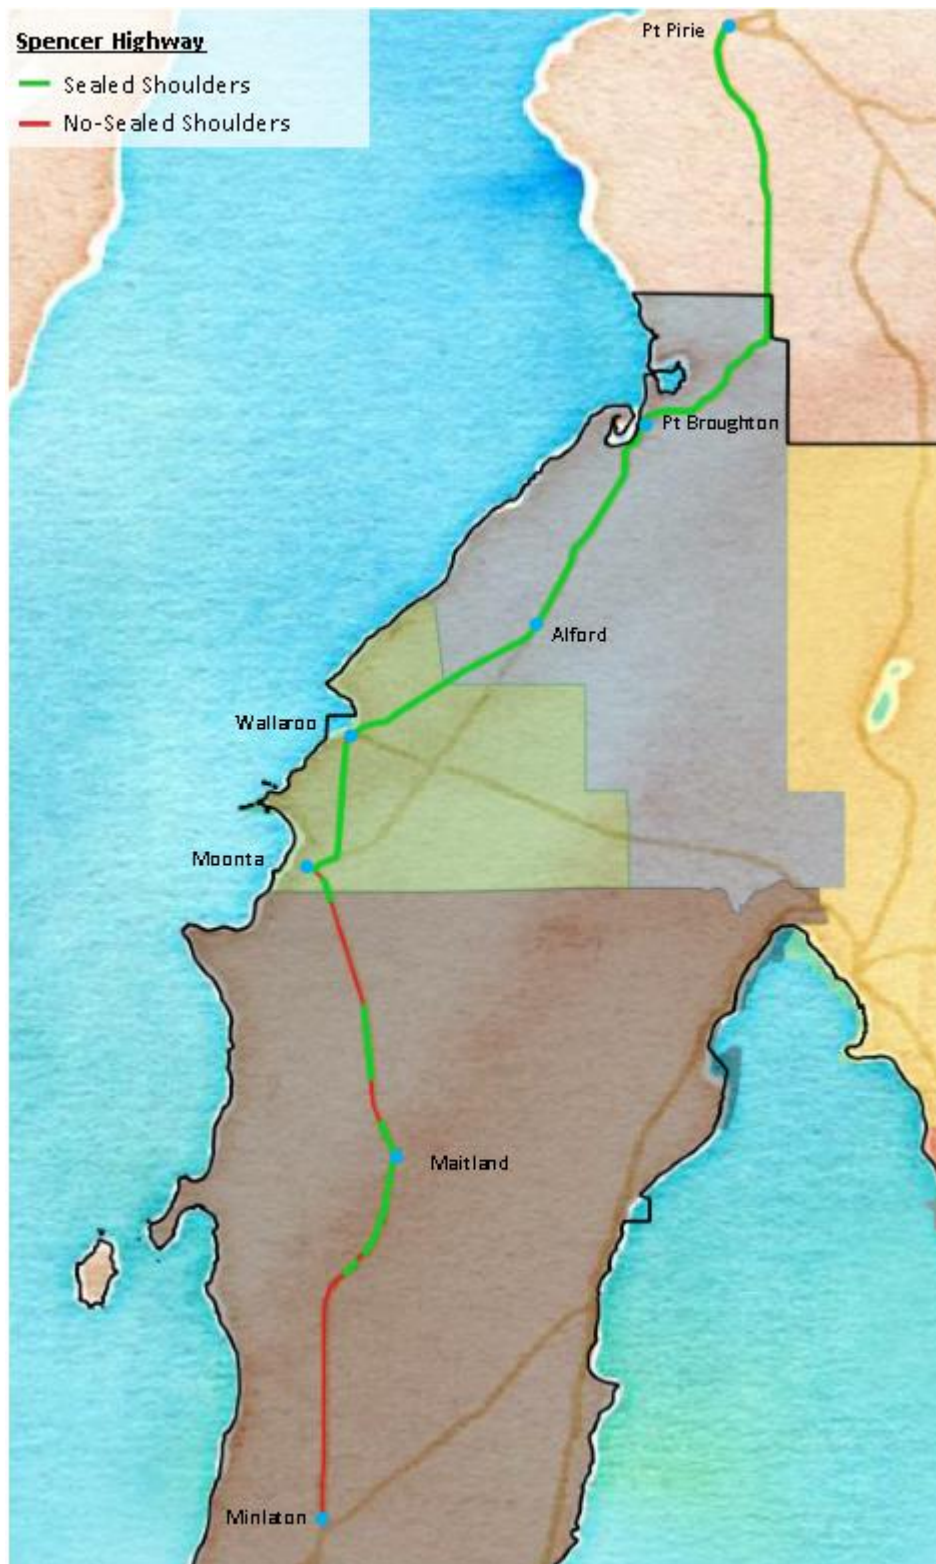
Current sections of shoulder seal on Spencer Highway

The map below outlines all sections of Spencer Highway with any level of shoulder seal as of October 2018, noting that shoulder seal is lacking for most of the highway between Moonta and Minlaton, and that the section between Wallaroo and Moonta only has a very narrow shoulder seal. RAA recommends that all remaining sections of Spencer Highway have shoulders sealed to one metre, and lanes widened to a minimum of 3.3 metres between Moonta and Minlaton. In addition, RAA recommends widening of the shoulder seal between Wallaroo and Moonta, however, as a lower priority than sealing of shoulders in other sections.

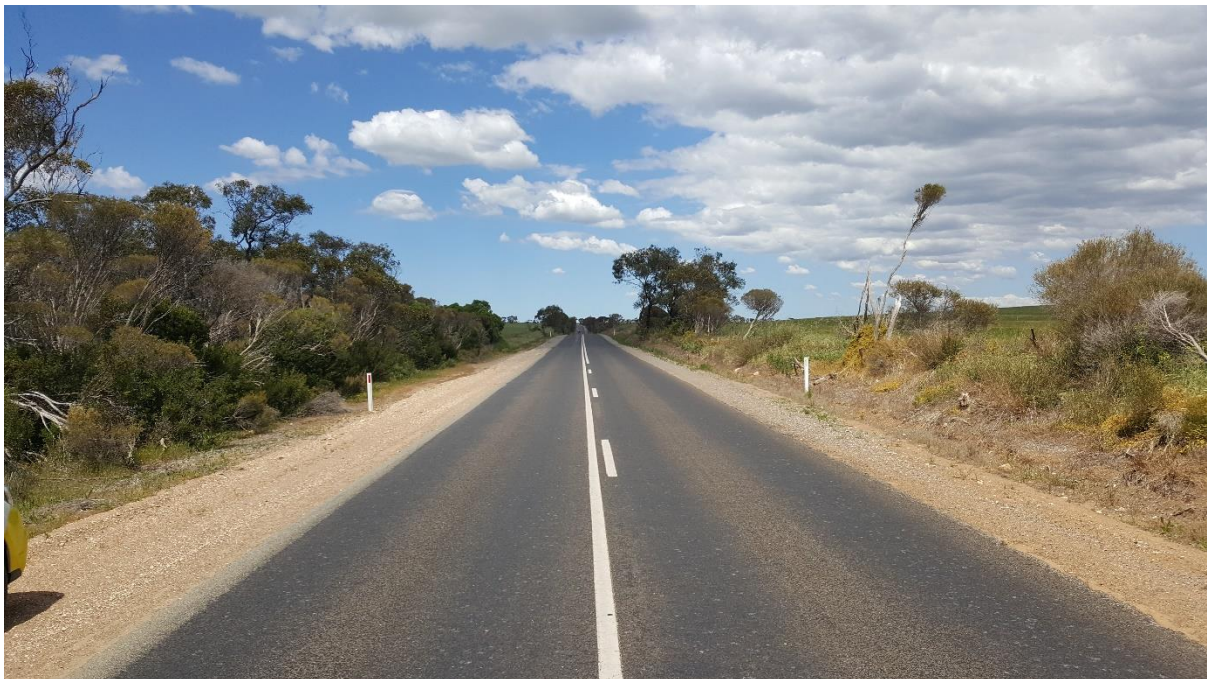
Spencer Highway between Moonta and Maitland has significantly varying geometry and conditions. Some sections are quite good, and it was evident that recent work had been undertaken to improve safety, but other sections are in much poorer condition with narrow geometry. Delineation was generally good, with signs, guide posts and line marking all in use and in good condition. For most of the road, the surface is in serviceable condition, however, minor corrugated sections were noted as well as local sections of edge breakup which would be repaired if shoulders were sealed. For the 10 kilometres north of Maitland, the surface is uneven and undulating, and edge break up is more prominent. This should be the first section targeted for improvement between Moonta and Maitland, with consideration to reseal this 10 kilometre stretch of highway.

More than 50% of this section has no shoulder seal at all, with other sections having varying levels of shoulder seal, generally between 200mm and 500mm wide. RAA recommends that shoulders are sealed to one metre on the remaining 20 kilometres (approx.) of this section without any form of shoulder seal, and consideration should be given to widening existing shoulder seal. Increasing the lane width to 3.3 metres as a part of this work should also be considered.

Typical geometry between Moonta and Maitland

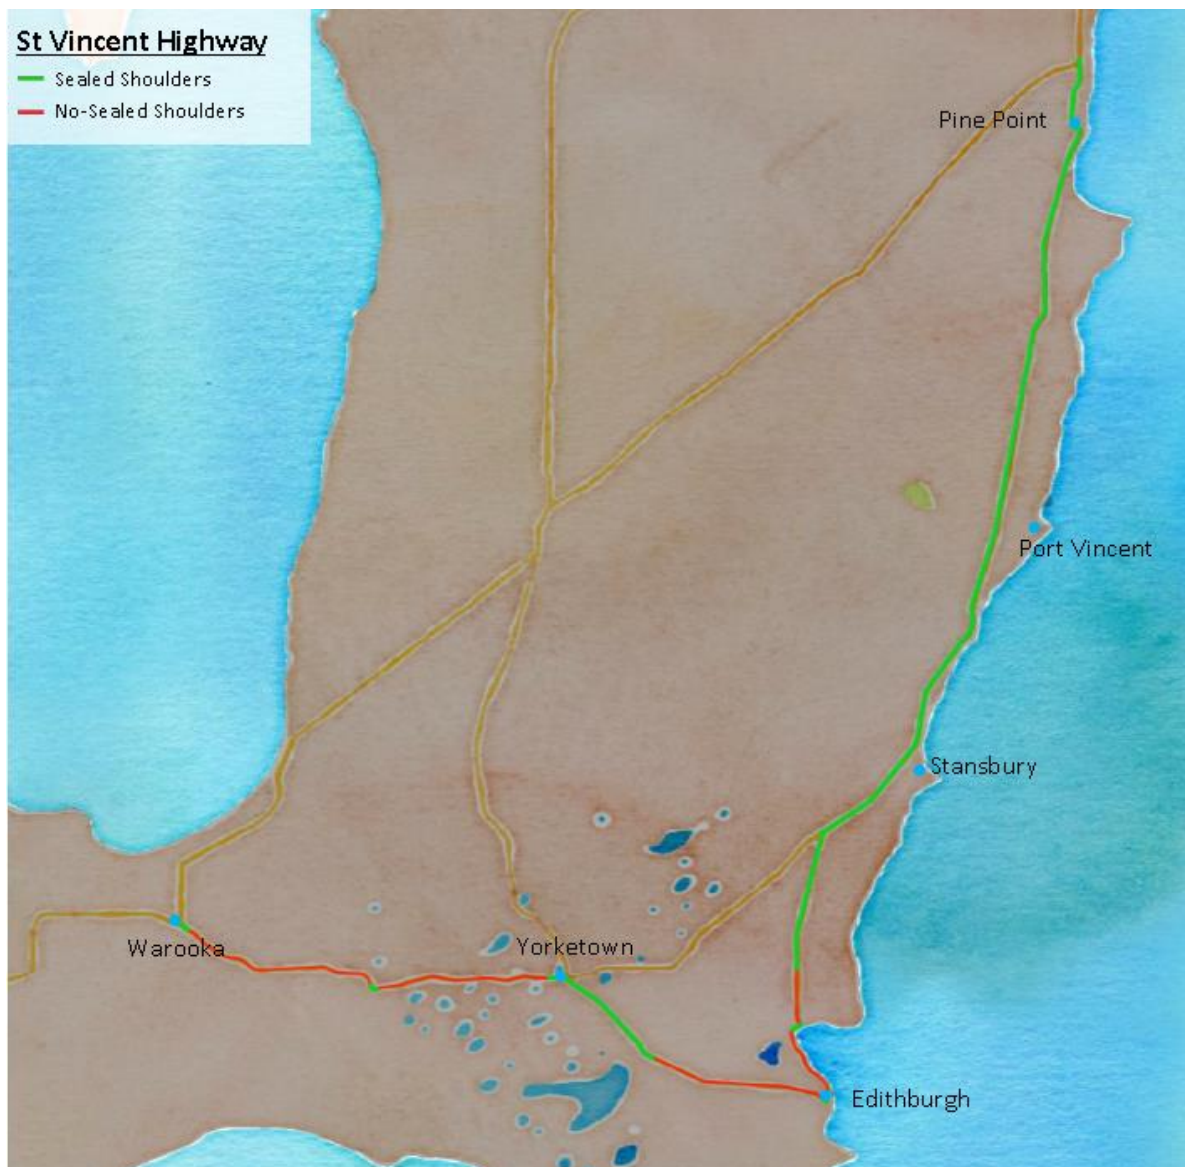
The map below outlines all sections of St Vincent Highway with any level of shoulder seal as of October 2018, noting that shoulder seal is lacking for most of the highway between Port Giles and Warooka. As a priority, RAA recommends that St Vincent Highway has shoulders sealed to one metre where they are not currently sealed, followed by widening of the existing shoulder on the road train route between Yorke Highway and Port Giles Road to one metre.

Map showing sections of shoulder seal on St Vincent Highway

RAA also recommends lane widening be undertaken between Port Giles and Warooka to provide 3.3m lanes in each direction.

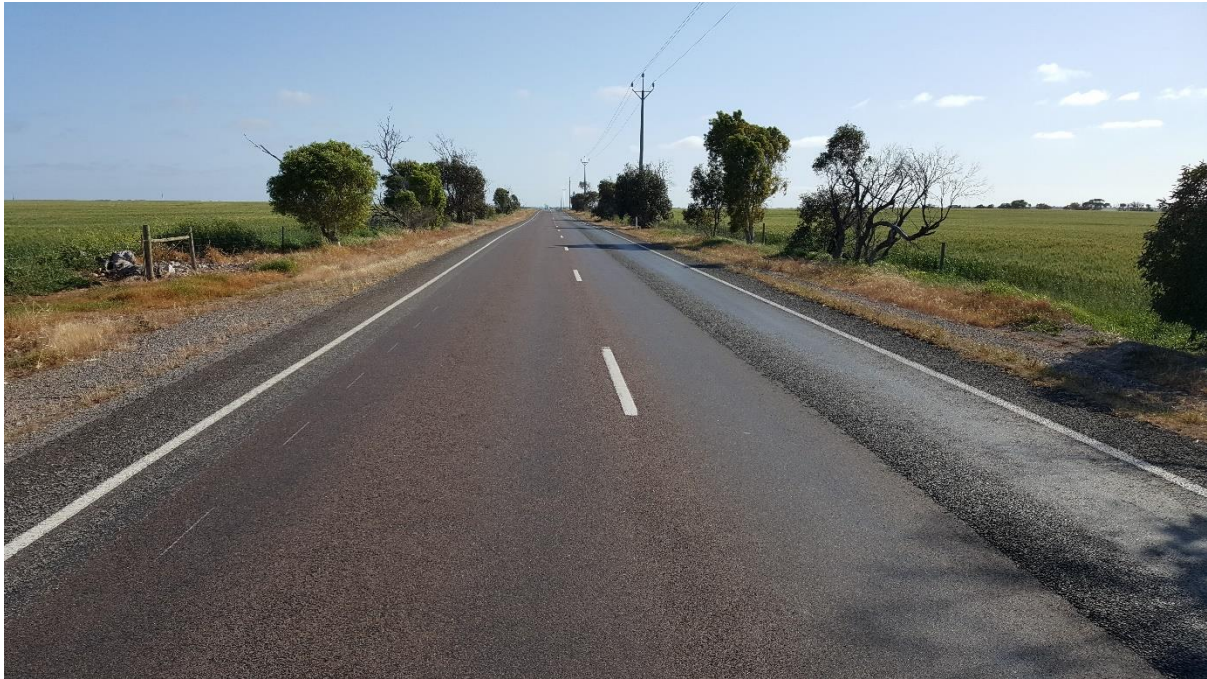
Some minor undulations were noted between Pine Point and Port Giles, however, these did not present any major hazards at the time of assessment. Between Stansbury and Port Giles, the surface is showing early signs of failure with cracks and ruts forming, which should be monitored with surface rehabilitation works undertaken where necessary.

Highway geometry is reasonable between Pine Point and Port Giles

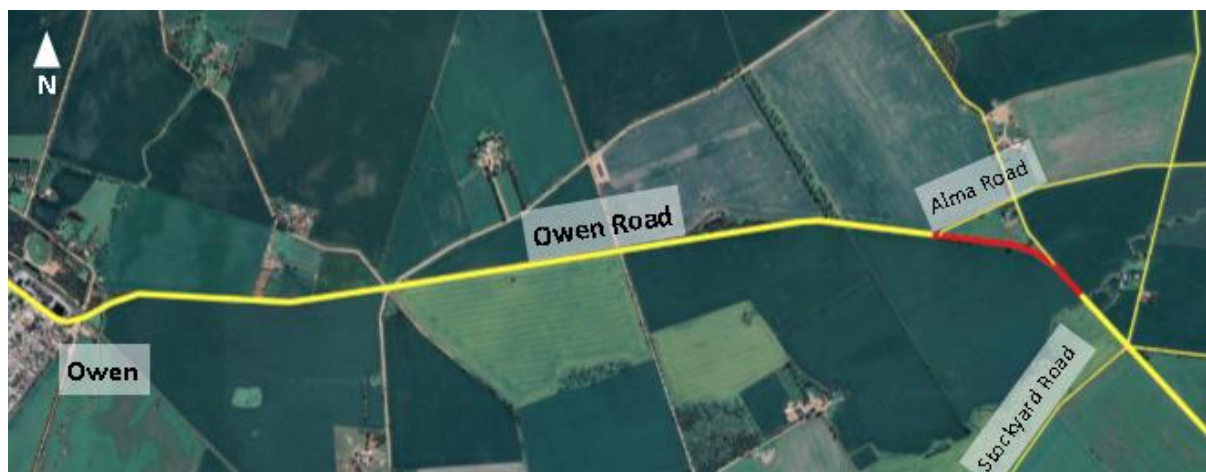
A particularly poor section is located just east of Owen and approximately 800 metres in length, between the intersections with Stockyard Road and Alma Road. This section was around a sweeping curve and had significant undulations that, when combined with the sweeping curve create a high crash or rollover risk, especially for heavy vehicles or vehicles towing a trailer or caravan. RAA recommends that this section of road be prioritised for reconstruction.

Map specifying the location of the dangerous curve between Stockyard Road and Alma Road

Owen Road – Key Recommendations	Authority
<ul style="list-style-type: none"> As a priority, repair the failed 800 metre section between Stockyard Road and Alma Road. 	DPTI
<ul style="list-style-type: none"> For the 20 kilometres between McKenzie Road and Traeger Road, seal shoulders to one metre and widen lanes to 3.3 metres. 	DPTI

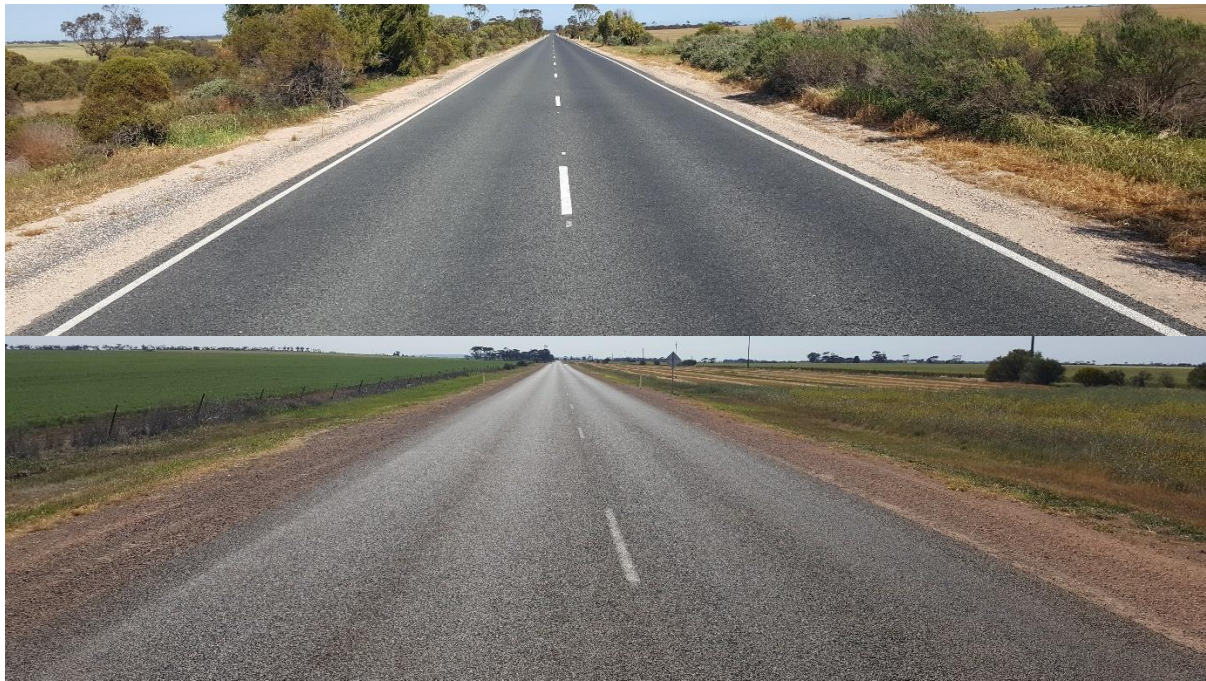
There were multiple mentions of Thrington Road in the member survey. RAA's assessment indicated that the road was in good condition and it was apparent that work had been undertaken recently to improve this road. Between Moonta and Kadina – Cunliffe Road, lanes were 3.4 metres wide, with 300 millimetre wide sealed shoulders, and east of Kadina – Cunliffe Road, lanes were 3.7 metres wide with no edge line marking. RAA recommends marking edge lines east of Kadina – Cunliffe Road to further delineate the edges. This should coincide with refreshing of the centre line marking, as this was beginning to fade.

Thrington Road west (top image) compared to east (bottom image) of Kadina – Cunliffe Rd

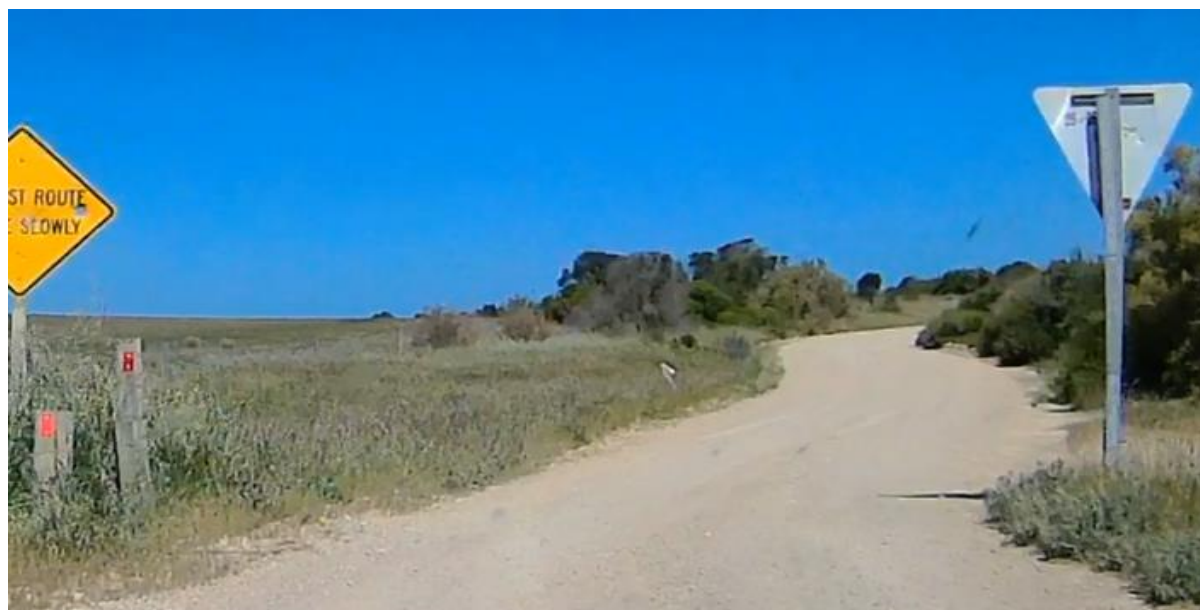
Tourist route signage is placed at the start of the route on Clan Ranald Road, however, was not seen replicated at various intervals. RAA suggests that similar reminder signs could be placed along the route to assist wayfinding, acknowledging that placing a significant number

Tourist route signs on Clan Ranald Road

of signs along the route will detract from the natural beauty that makes this region so popular amongst tourists.
