Regional Road Assessment: Fleurieu Peninsula and McLaren Vale

Report: August 2021

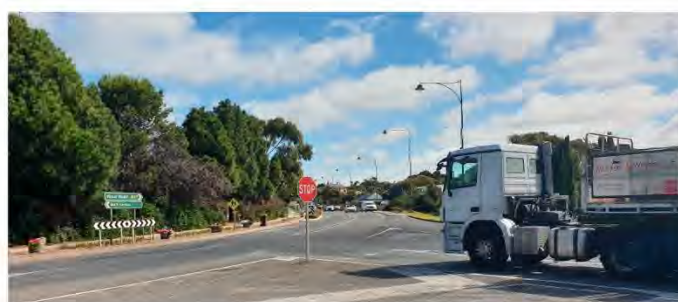
Intersection of Port Elliot Rd/Flagstaff Hill Rd, Middleton

Upgrade intersections in the region to improve safety and efficiency. Example intersections include Victor Harbor Road/Goolwa Road (Mt Compass), Main South Road/Sellicks Beach Road (Sellicks Beach), Port Elliot Road/Flagstaff Hill Road (Middleton), Armstrong Road/Greenhills Road (Victor Harbor) and Main Road/Malpas Road (McLaren Vale).

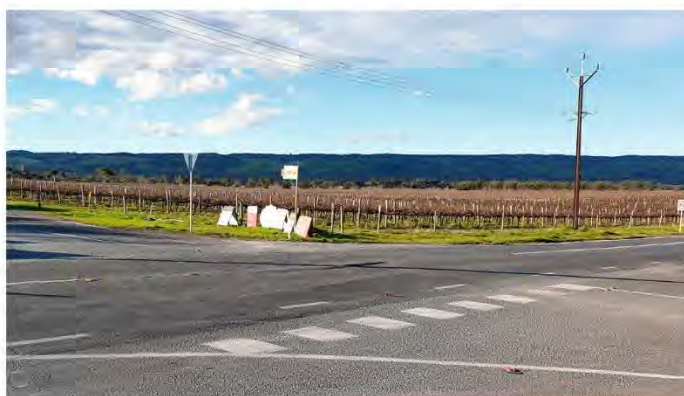
Intersection of Main Rd/Johnston Rd/McMurtrie Rd, McLaren Vale

Improve safety at four-way crossroad intersections in the McLaren Vale region by enhancing signage, delineation and providing horizontal deflection to reduce right angle crashes.

This should include a holistic review of the local road network to identify opportunities for partial or full road closures and right turn bans at appropriate intersections.

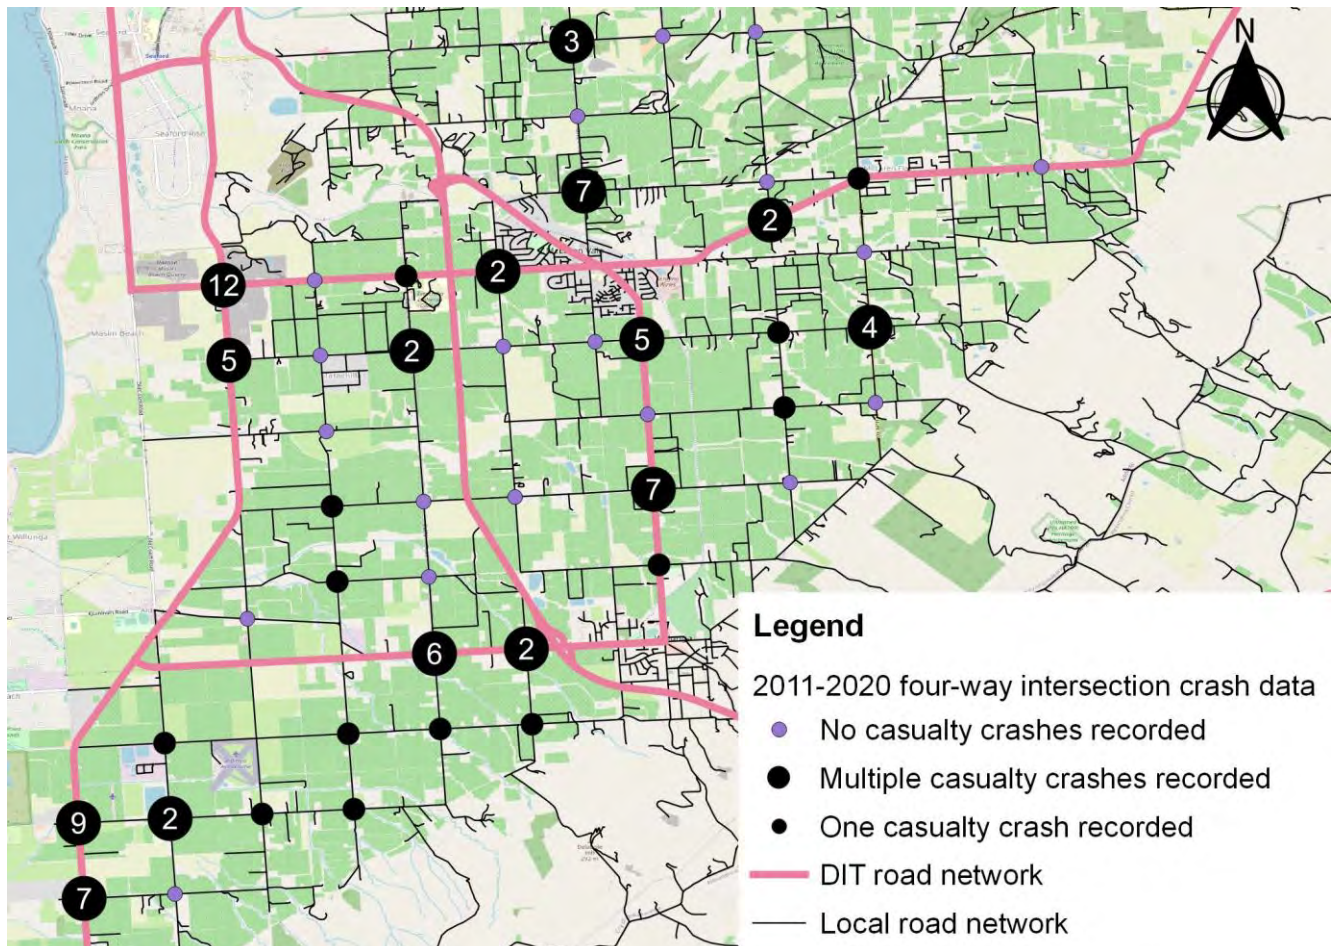
As with many agricultural areas in South Australia, the McLaren Vale region is divided into a grid by a network of intersecting north-south and east-west roads. This is particularly evident when looking at a map of the region, such as the map in Figure 29 which highlights the locations of almost 50 four-way intersections in the region and the associated crash data for the 10 years between 2011 and 2020.

Figure 29: Map of four-way crossroad intersections in the McLaren Vale region

Whilst several of these higher profile intersections are discussed throughout this report, it is evident that both the City of Onkaparinga Council and the Department for Infrastructure and Transport need to establish a program of intersection improvements to improve safety at four-way crossroad intersections in the McLaren Vale region. Intersection upgrades should include as a minimum, upgraded delineation and larger warning signs through to the introduction of horizontal deflection by installing staggered teardrop intersections and where appropriate, roundabouts.

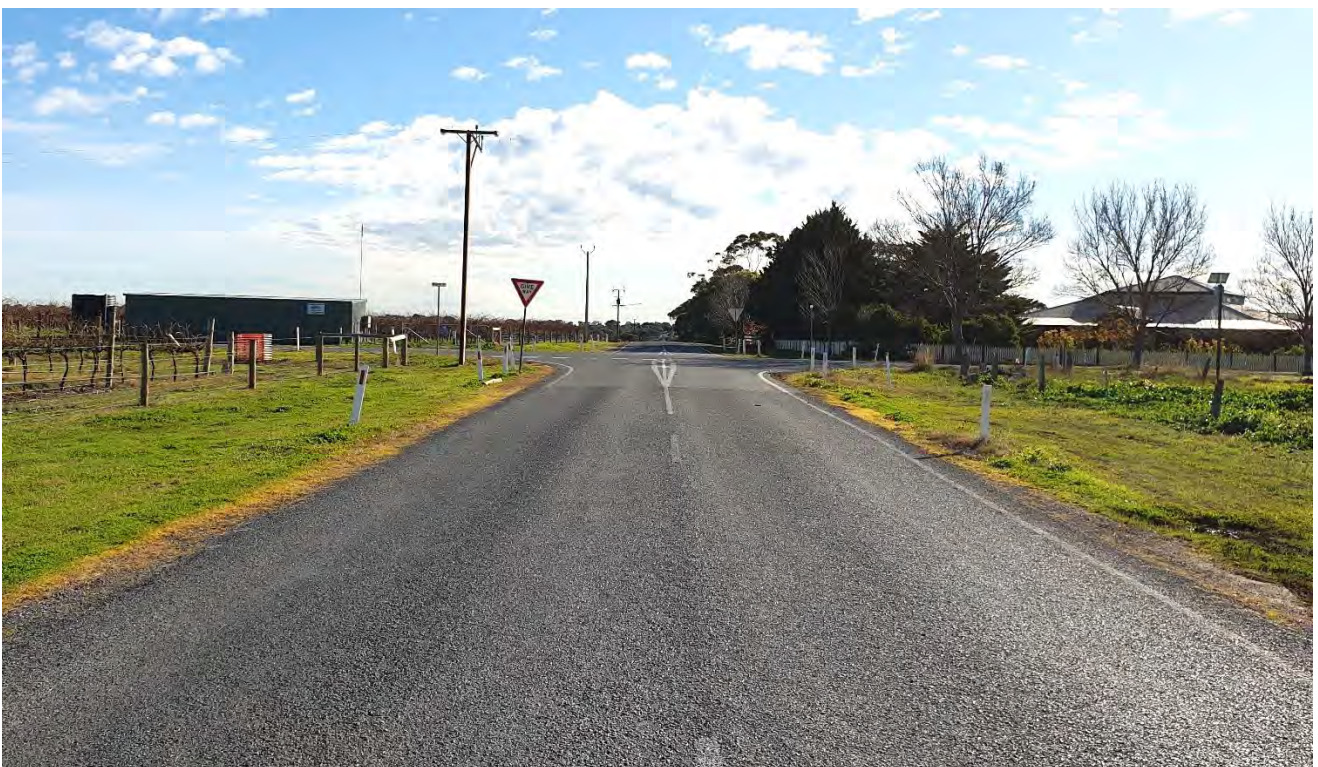
- The 'see-through effect' is prominent at many crossroad intersections in the region. This is where a driver on the minor approach has poor visibility of the presence of an intersection ahead, and the road they are travelling on can appear to be a continuing road. Often this effect is exacerbated by a continuing row of trees, stobie poles, grape vines or even delineator guideposts. An example of this is shown in Figure 30 at the intersection with California Road and Malpas Road.

Figure 30: Although approaching a give way sign, there are few visual cues of the upcoming intersection other than signage (Intersection shown: California Road/Malpas Road, looking north on California Road)

Lower cost treatments to reduce crash severity or likelihood can include partial or full road closures, right turn restrictions or bans (e.g., left in/left out), staggered teardrop intersection treatments, rumble strips on minor road approaches, improved intersection delineation, rural junction active warning systems (RJAWS), permanent speed limit reductions, increased and enhanced signage.

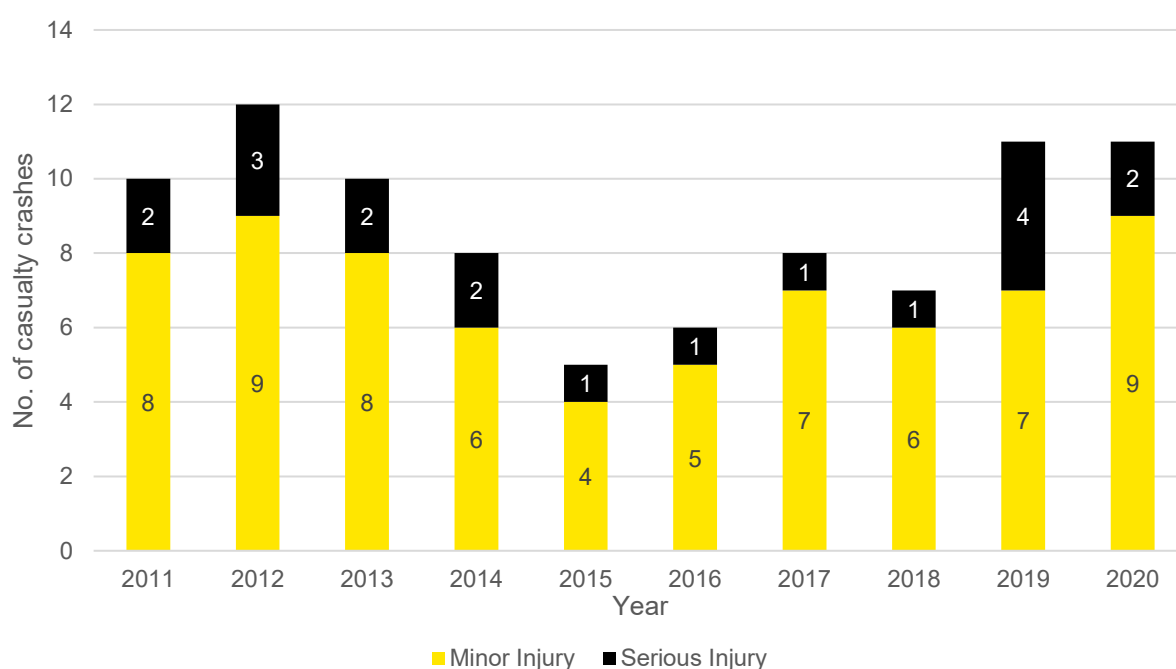
RAA has reviewed the number of casualty crashes occurring at the four-way crossroad intersections highlighted in Figure 29 over the 10 years since 2011. Since 2015, there has been an increasing number of crashes at four-way intersections, which may be attributable to the growing popularity of McLaren Vale as a tourist destination and increasing traffic volumes on the road network.

Figure 31: Casualty crashes at four-way intersections in the McLaren Vale region (2011-2020)

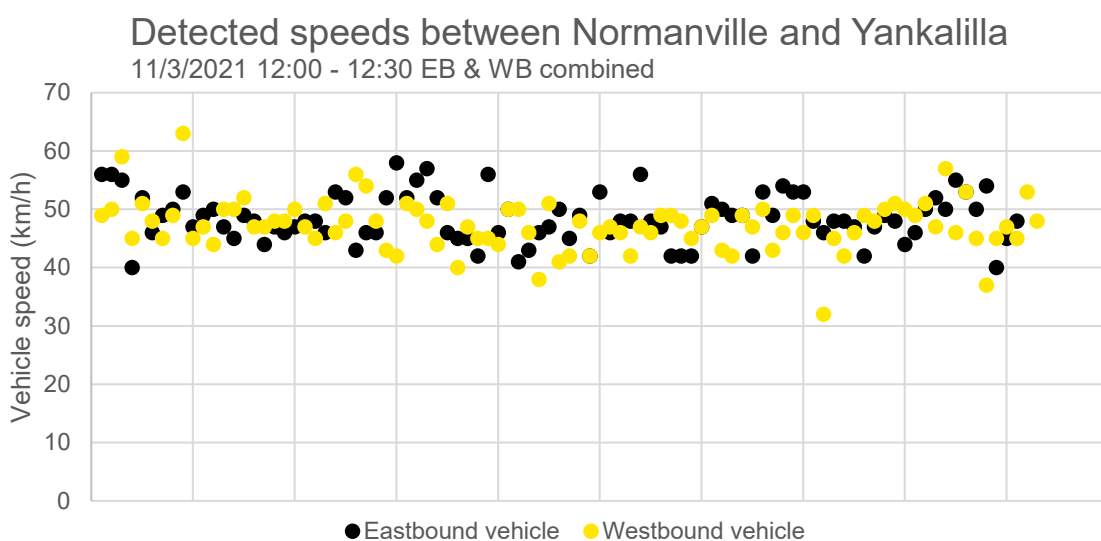
Between 12:00 and 12:30 on 11 March 2021, RAA conducted a short speed survey of vehicles between Yankalilla and Normanville. This highlighted good compliance with the 50km/h speed limit, with an average free flow speed of 47.9km/h measured over 184 speed readings in both directions. Vehicles travelling in a stream of traffic were excluded from this analysis to ensure free flow speed was measured.

Figure 33: Results of short speed survey between Yankalilla and Normanville

RAA supports the application of the 50km/h limit and notes that overall compliance is good. To further reinforce the limit, RAA recommends that streetscape improvements be undertaken to create a visibly lower speed limit environment. This may include construction of kerb and gutter, marking of formal cycle lanes and parallel parking bays, construction of footpaths, and planting of street trees.

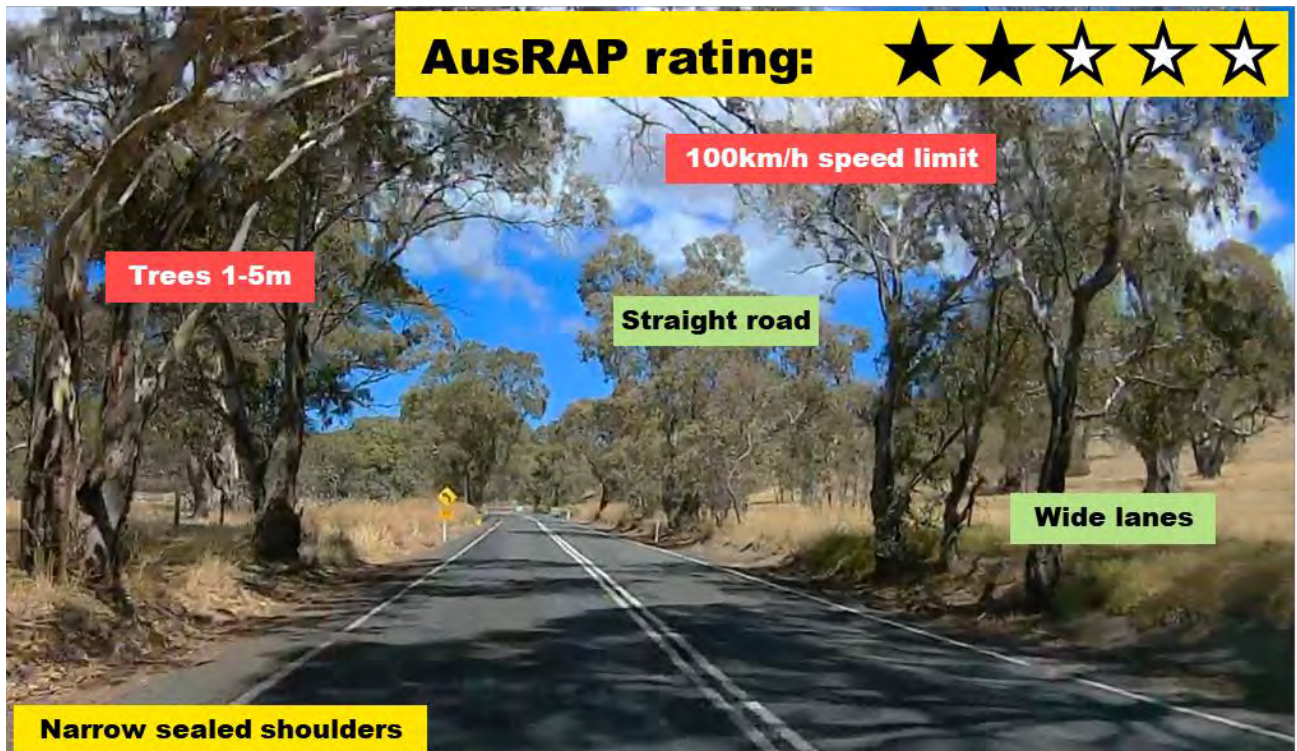
The AusRAP star rating of Main South Road typically varies between one and two stars, with some three-star sections present along the corridor. For a section to be rated three stars, it typically must be free of fixed hazards other than safety barriers, and on a moderately curving, or straight road section.

Figure 35: Example of a two-star AusRAP star rated section on Main South Road

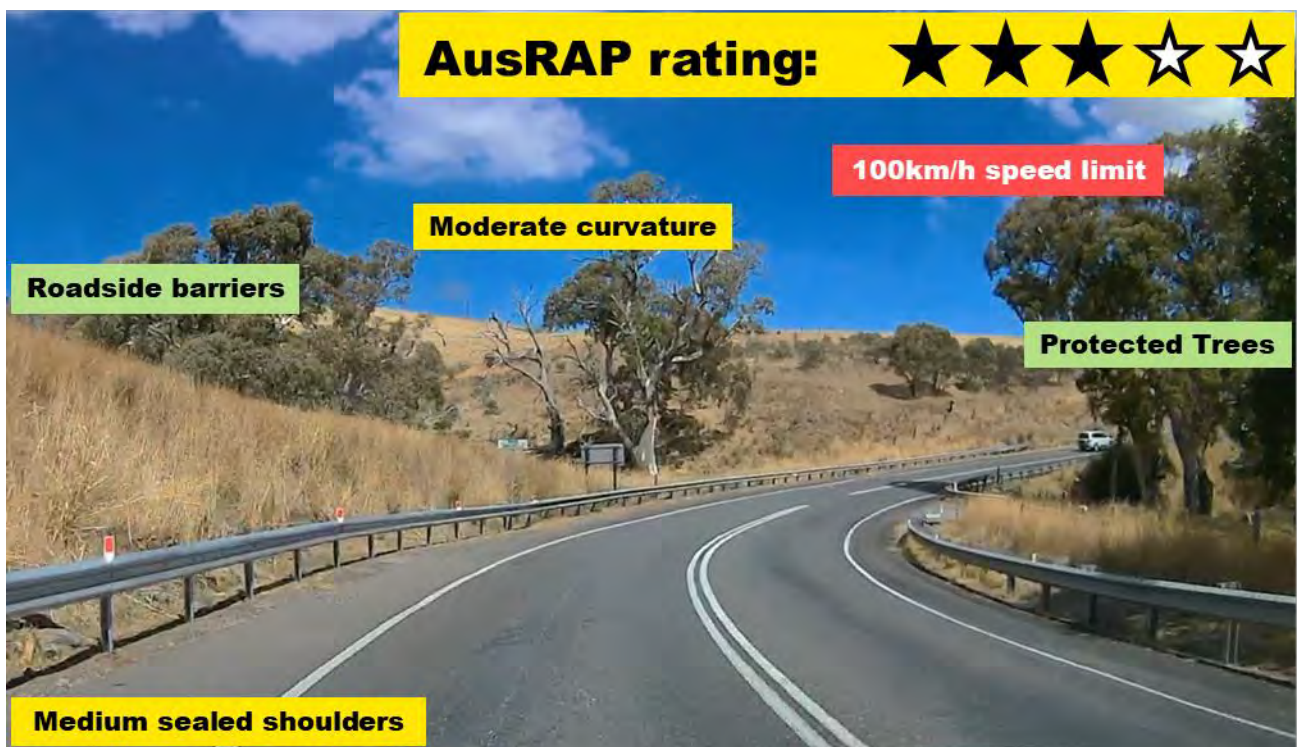
Figure 36: Example of a three-star AusRAP star rated section on Main South Road

Comparing Figure 34 and Figure 36, which are both similar cross-sections, highlight the important difference that safer roadsides have on road star rating.

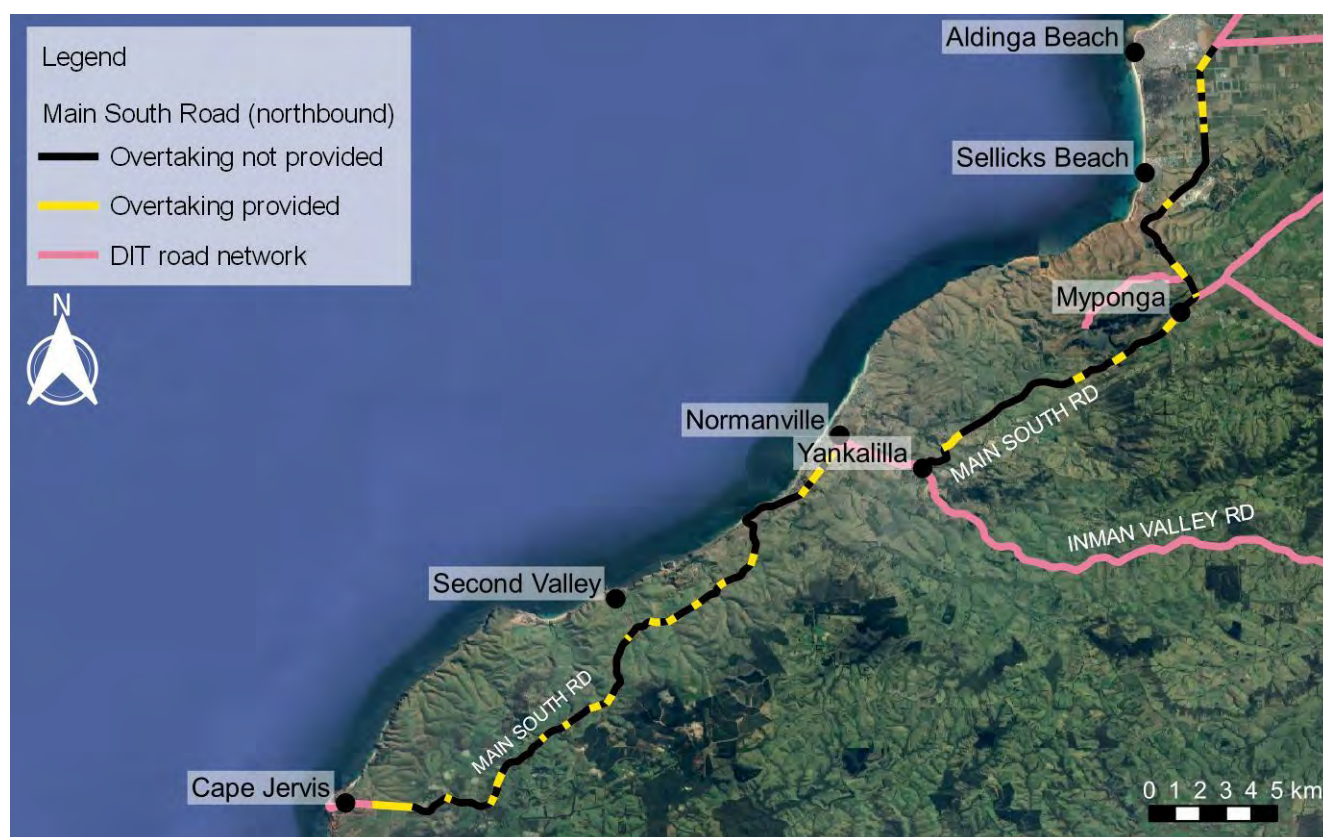
RAA has reviewed Main South Road and mapped out the sections of the road where overtaking is permitted in each direction. This involved a review of footage taken whilst driving the corridor and available satellite imagery. This analysis only considered sections with a speed limit of 80km/h or higher, with sections within townships excluded. On average for the corridor, only 29% of the length in the southbound direction and 25% of the length in the northbound direction is available for legal overtaking. These sections are often less than 500m long, meaning that legal overtaking is often unrealistic. When only considering sections greater than 500m in length, overtaking is considered possible 15% of the time in the northbound direction, and 19% of the time in the southbound direction, with existing overtaking lanes making up many of these opportunities.

Figure 38: Locations where overtaking is provided on Main South Road (heading north)

Given these results, RAA recommends that an additional northbound overtaking lane is provided between Myponga and Sellicks Beach, given that there is presently only one in this direction, overtaking is scarcely provided otherwise, and traffic volumes are high (5,600 vehicles per day). RAA

also recommends that a northbound overtaking lane be constructed between Wirrina Cove and Normanville.

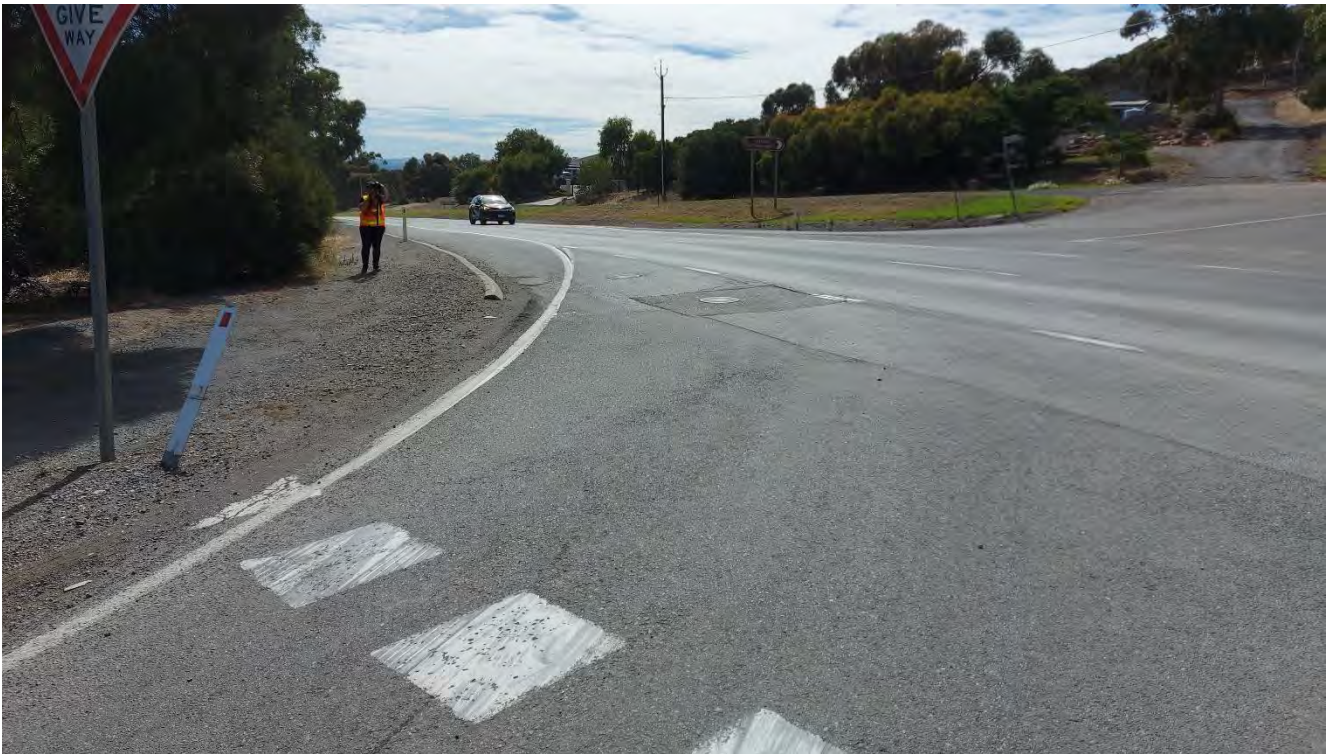
Figure 40: Poor sight distance from Sellicks Beach Road to the northeast

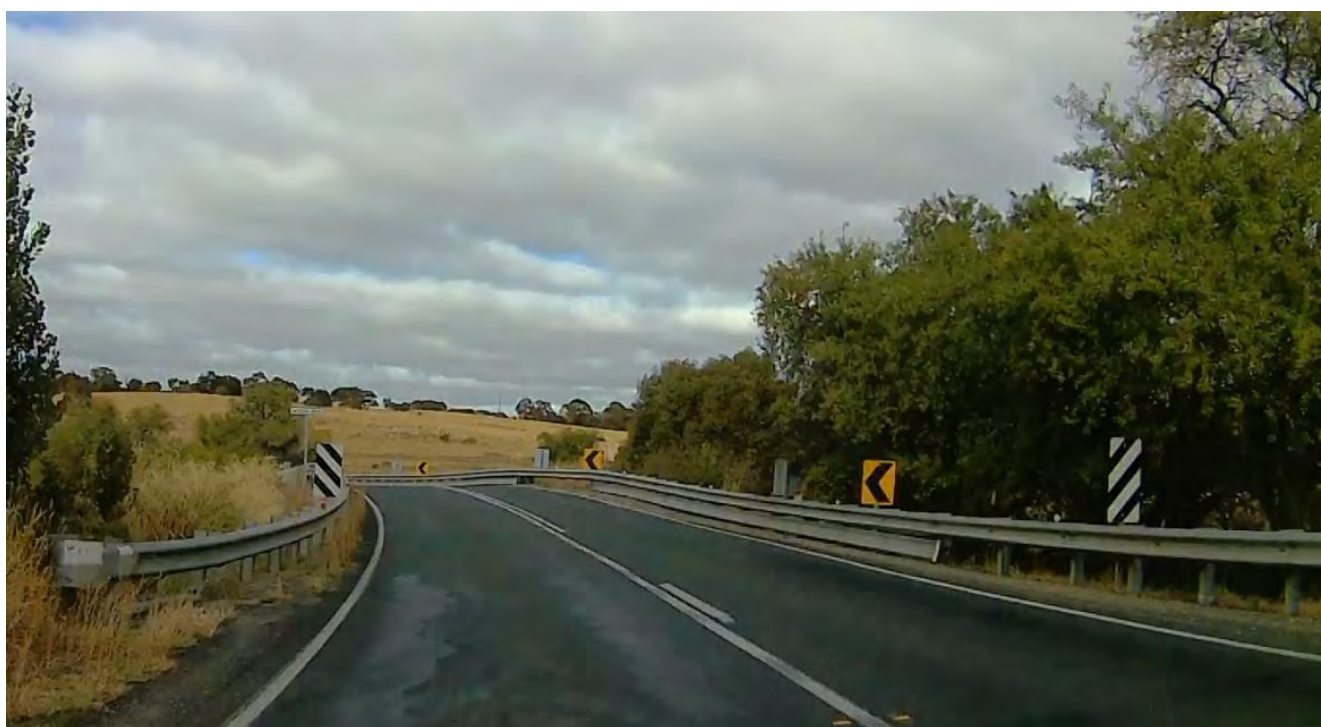
Narrow bridges were also raised highly by survey respondents, with several narrow bridge and culvert structures present along the corridor. The most concerning of these is the Jackson Creek Bridge, located about 3.5km south of Strathalbyn. This bridge creates a blind crest in the road, is narrow and located on a substandard, blind curve with radius of approximately 180m.

Figure 47: Jackson Creek Bridge, 3.5km south of Strathalbyn

The advisory speed over the Jackson Creek Bridge is currently 65km/h, which feels fast through the curve given the poor horizontal and vertical alignment. The best improvement at this location would be to reconstruct the curve to a radius of at least 400m, which would facilitate safer travel at higher speed and allow a new section of road and culvert to be constructed mostly offline, and to modern standards. This would require some land acquisition on the inside of the curve.

Realign Alexandrina Road over Jackson Creek, 3.5km south of Strathalbyn, which will require construction of new culverts and allow a curve with better horizontal and vertical geometry to be constructed.

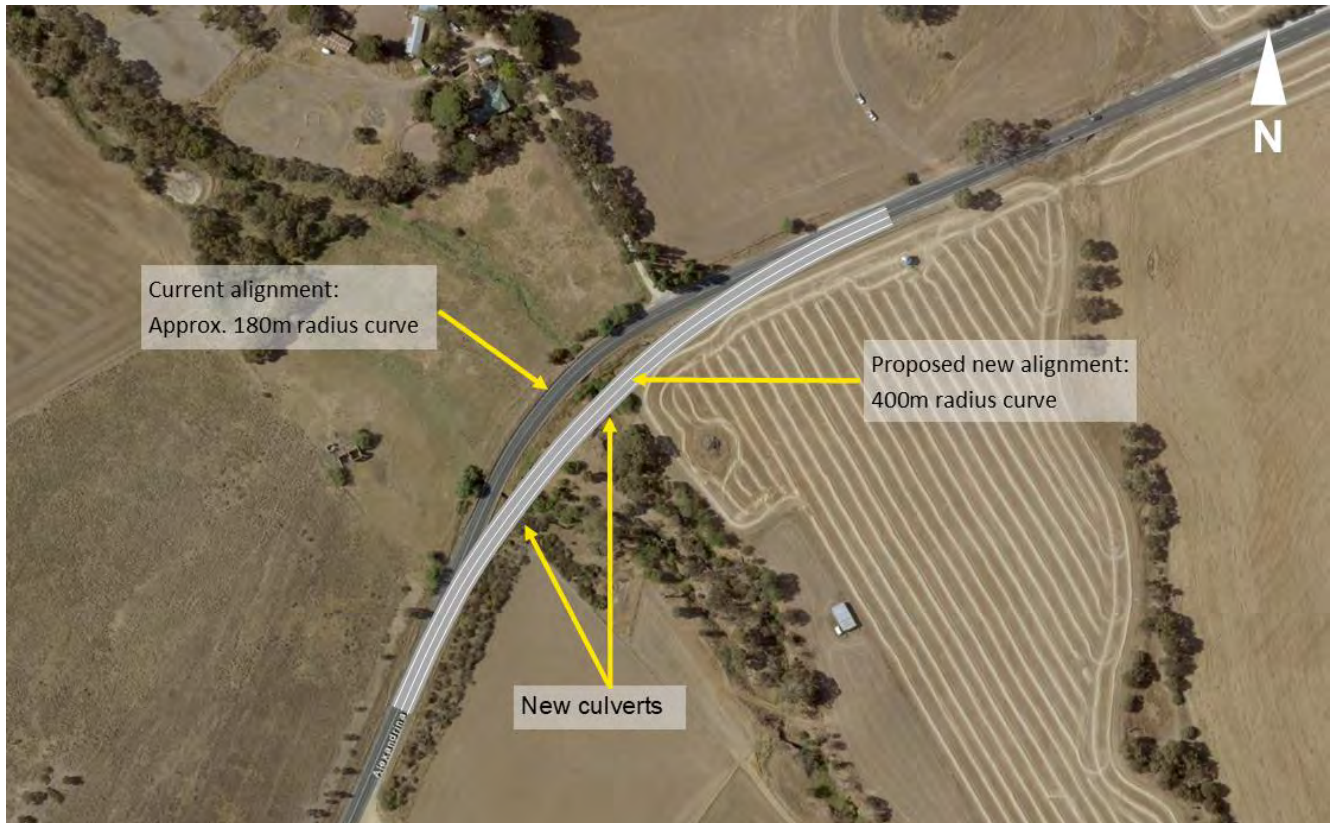
Figure 48: RAA proposed curve realignment to improve safety at the Jackson Creek Bridge

A sketch of this proposal is included in Figure 48 below.

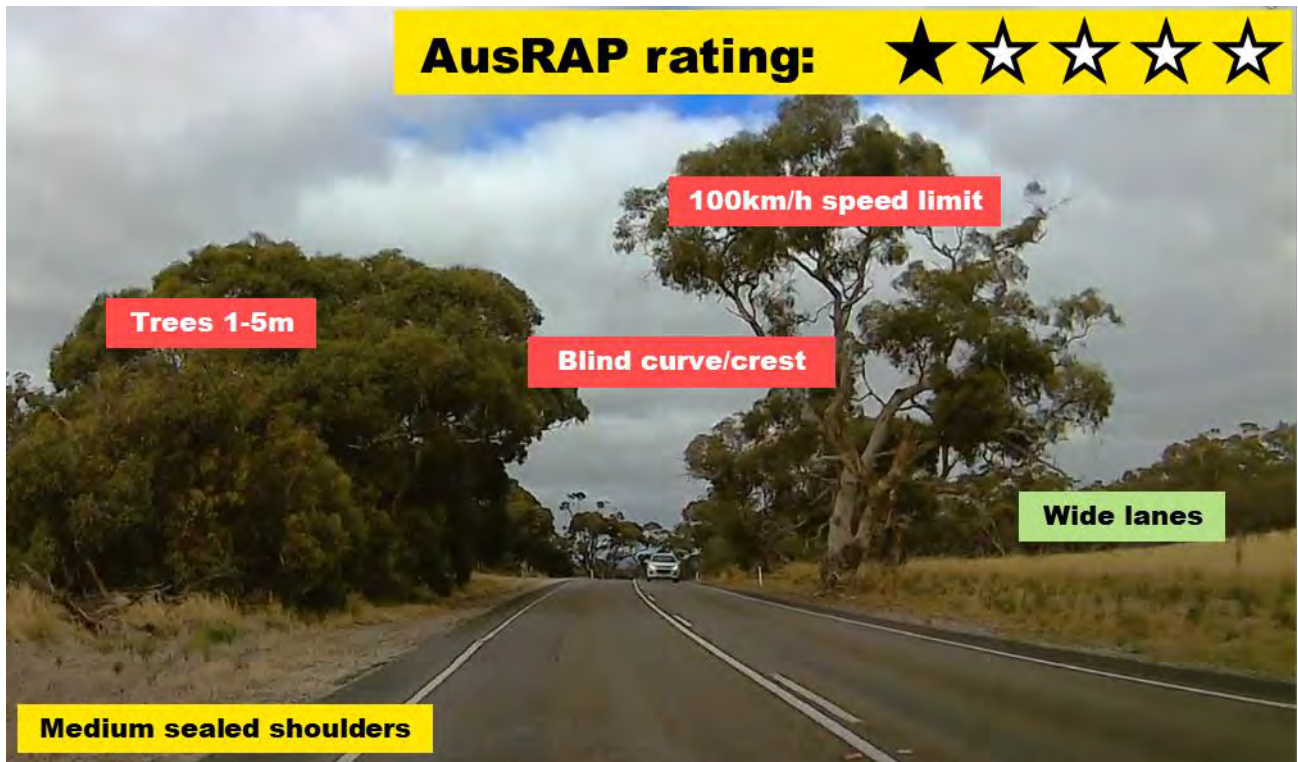
Figure 49: Section of one star rating on Alexandrina Road

To create a consistent three star rated corridor, all roadside hazards should be removed or be behind barriers, and several curves should be realigned. A central dividing barrier would take this to four stars.

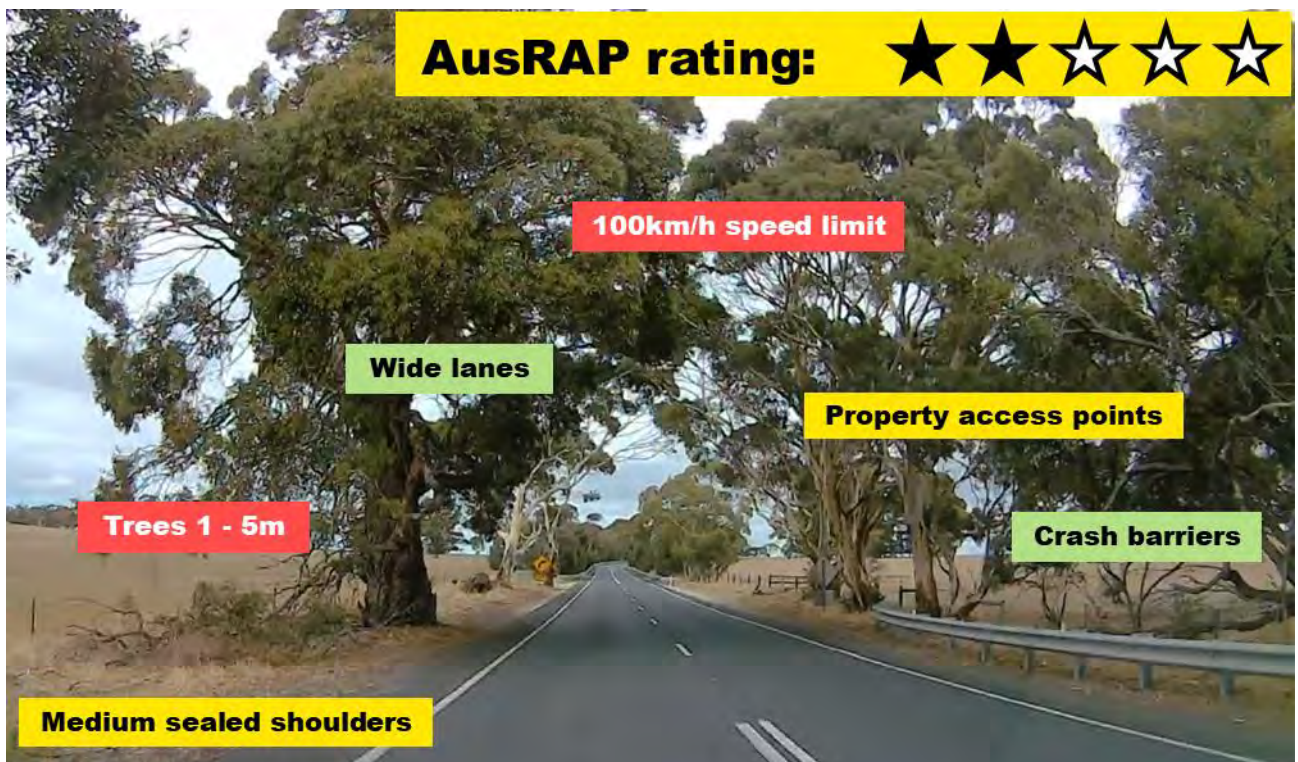
Figure 50: Section of two-star rating on Alexandrina Road

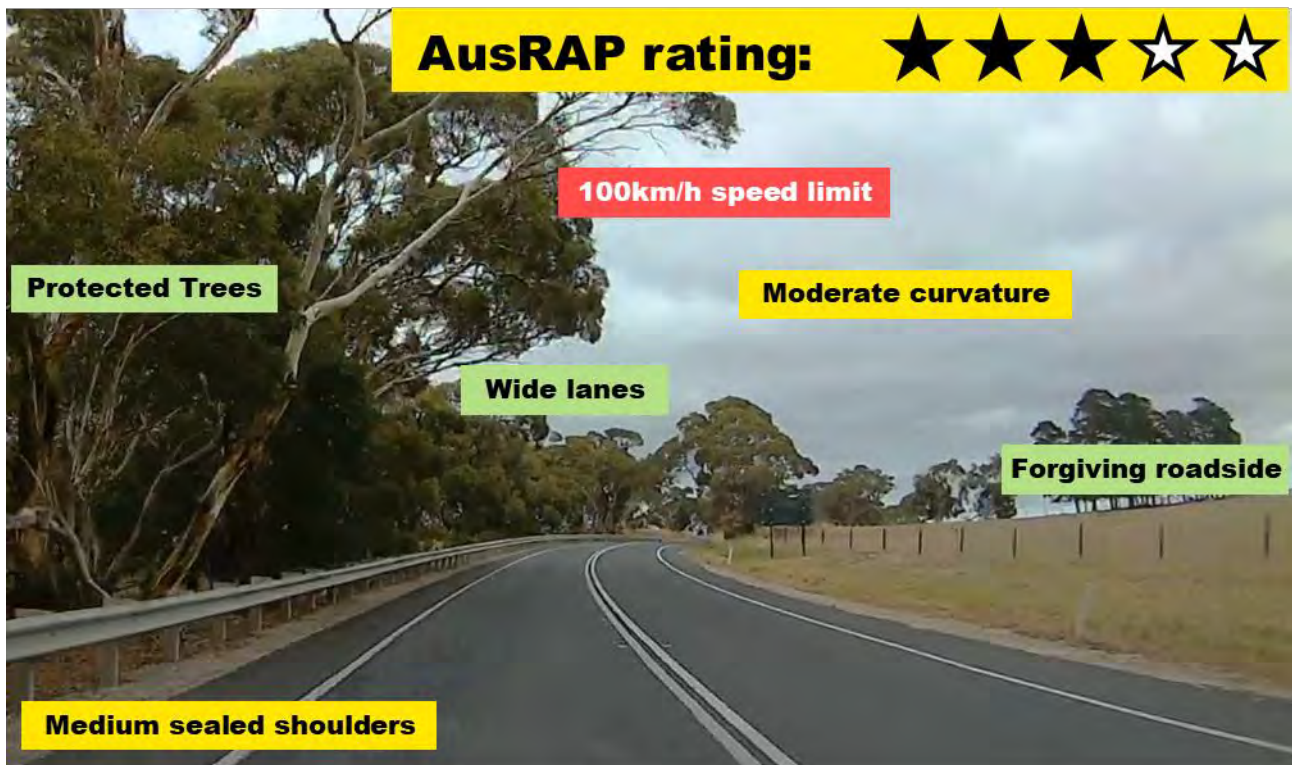
Figure 51: Section of three-star rating on Alexandrina Road

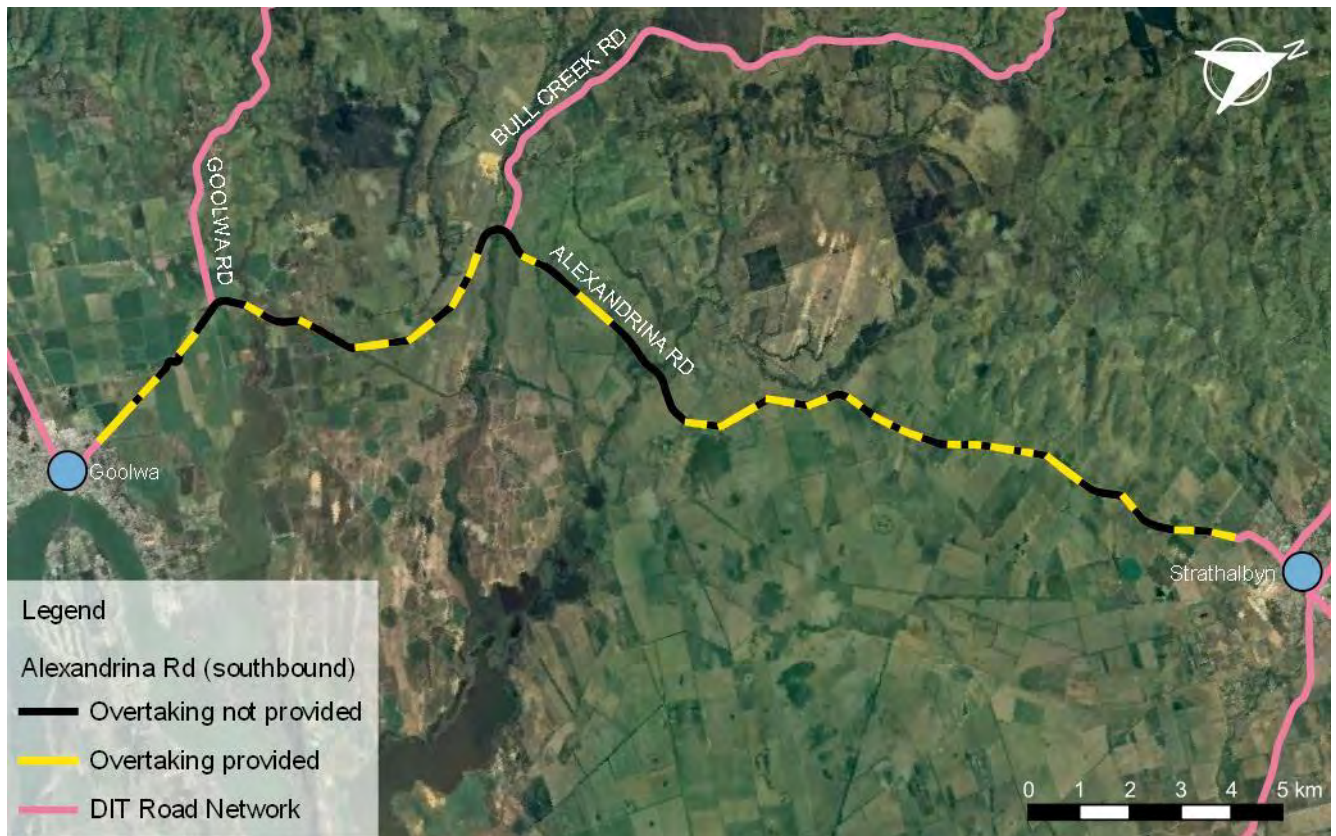
This review indicates that the percentage of road providing overtaking is 47% in the northbound direction, and 49% the southbound direction. In reality, the percentage of time where overtaking is viable is much lower given that many of these overtaking opportunities are less than 500m in total length. RAA considers 500m to be the minimum distance for legal overtaking to occur, in the case where a vehicle travelling at 100km/h overtakes another vehicle travelling at 80km/h.

Figure 54: Locations where overtaking opportunities are provided along Alexandrina Road (heading south)

If considering sections less than 500m long to be unsuitable for the majority of legal overtaking manoeuvres, overtaking opportunities are only present 10% of the time in the northbound direction and 11% of the time in the southbound direction. In other words, RAA considers most overtaking opportunities along Goolwa Road to be highly dangerous, given the typical very short length of these opportunities.

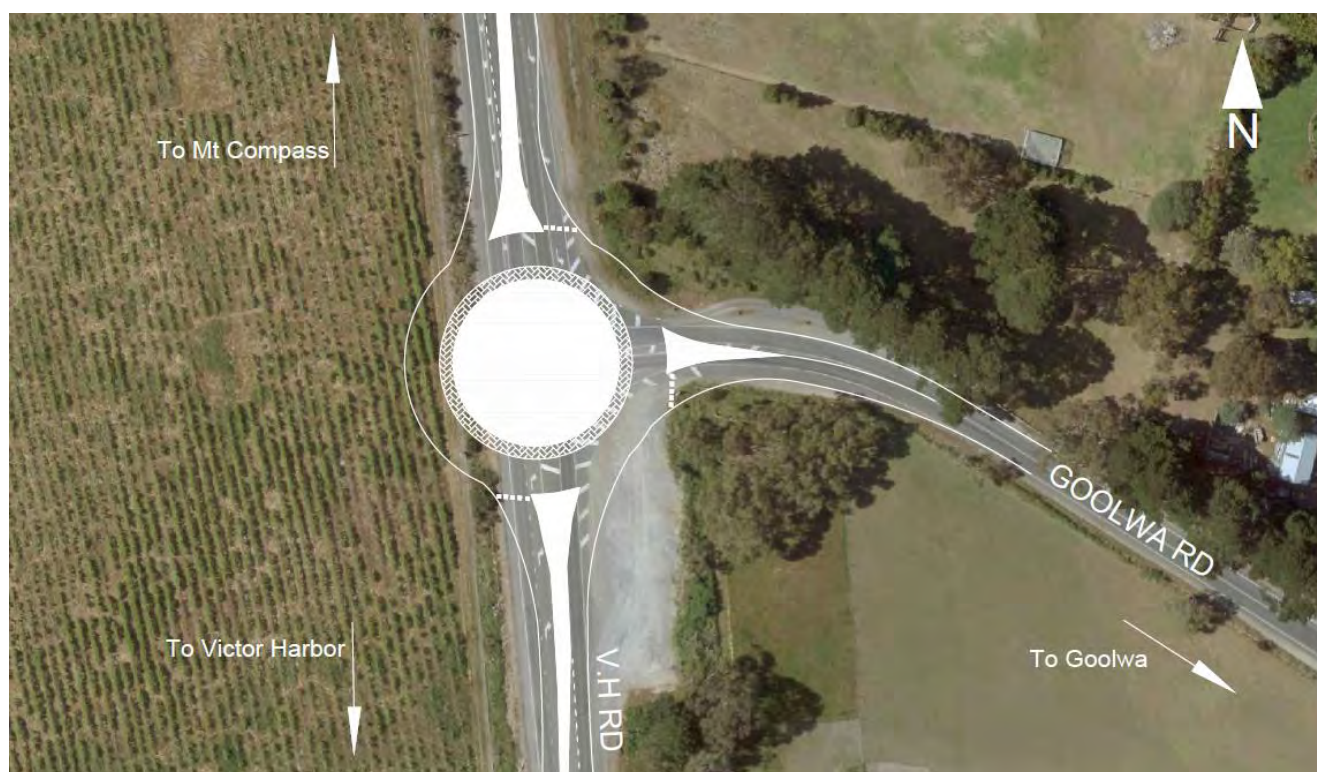
Figure 58: RAA concept sketch of a roundabout at the Victor Harbor Road/Goolwa Road intersection (22m central island radius used)

Install a roundabout at the intersection with Goolwa Road and Victor Harbor Road, as raised in RAA's *2021 Highway Assessment: Victor Harbor Road*.

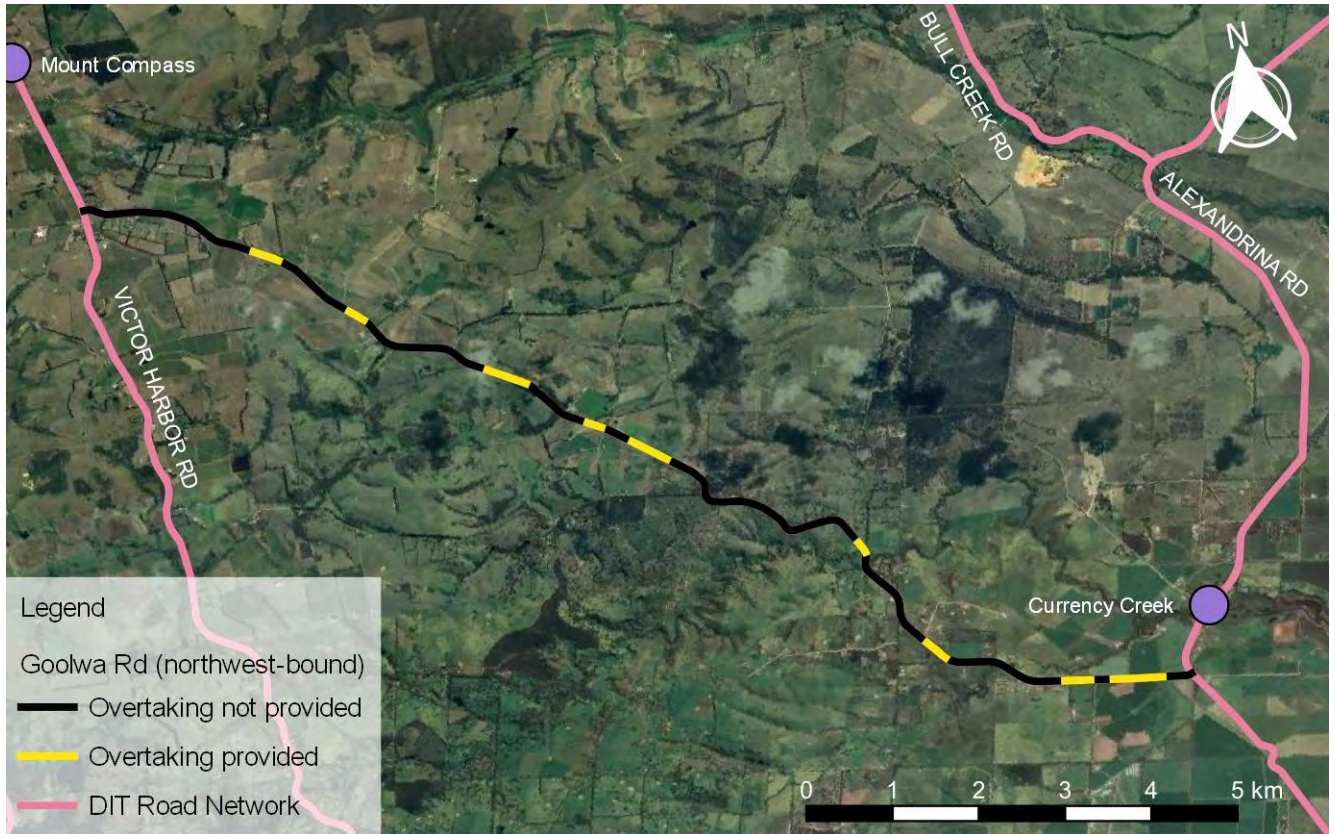
Overtaking opportunities are scarce, with overtaking provided for 24% of the corridor length in each direction after reviewing the percentage of broken dividing line. However, most of these overtaking opportunities are very short. If considering that the minimum length of broken dividing line to safely

overtake another vehicle is 500m, overtaking is realistically available for 8% of Goolwa Road in the southeast direction, and 12% in the northwest direction. There are only two lengths of road providing overtaking that are greater than 500m long in the southeast direction of travel, each measuring approximately 580m and 720m. There are three lengths of road providing overtaking greater than 500m long in the northwest direction of travel, each measuring approximately 585m, 600m and 665m.

Figure 60: Locations where overtaking opportunities are provided along Goolwa Road (heading northwest)

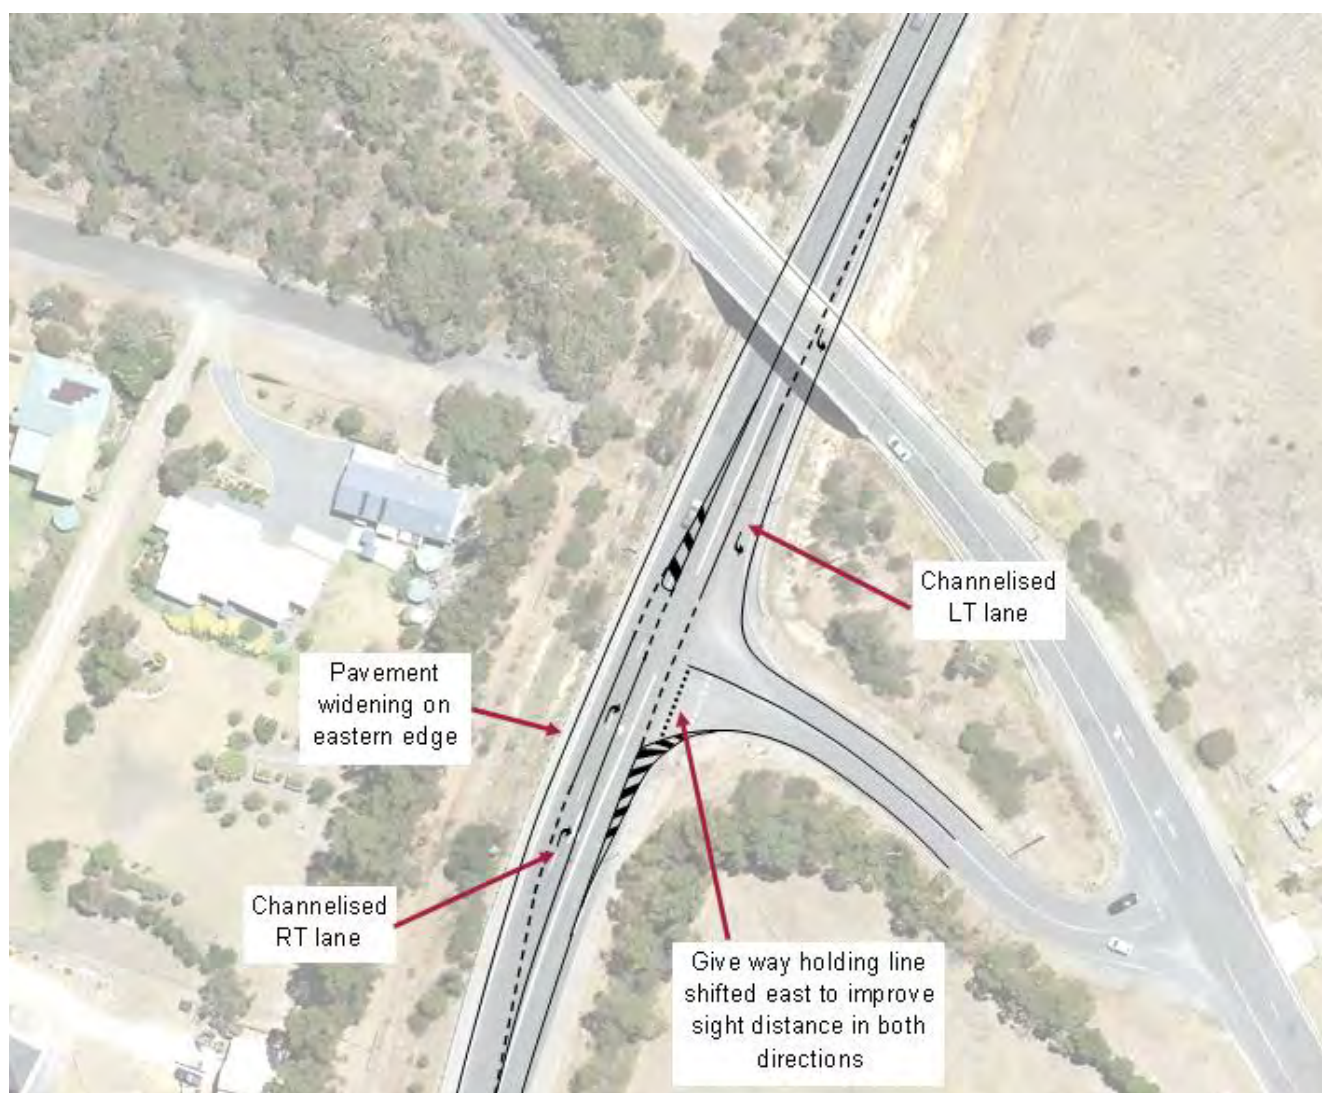
RAA recommends that the intersection be upgraded to provide improved sight distance and introduce channelised turn lanes onto Greenhills Road as shown in the concept sketch in Figure 66 . This treatment may require some pavement widening on the north-western side of Armstrong Road, however detailed surveys and measurements will be required to determine the full extent of the required widening and whether it is achievable without having to modify the existing embankment.

Figure 66: RAA concept sketch of an upgraded Armstrong Road/Greenhills Road intersection

Upgrade the intersection with Armstrong Road and Greenhills Road to provide improved sight distance and channelised turn lanes into Greenhills Road.

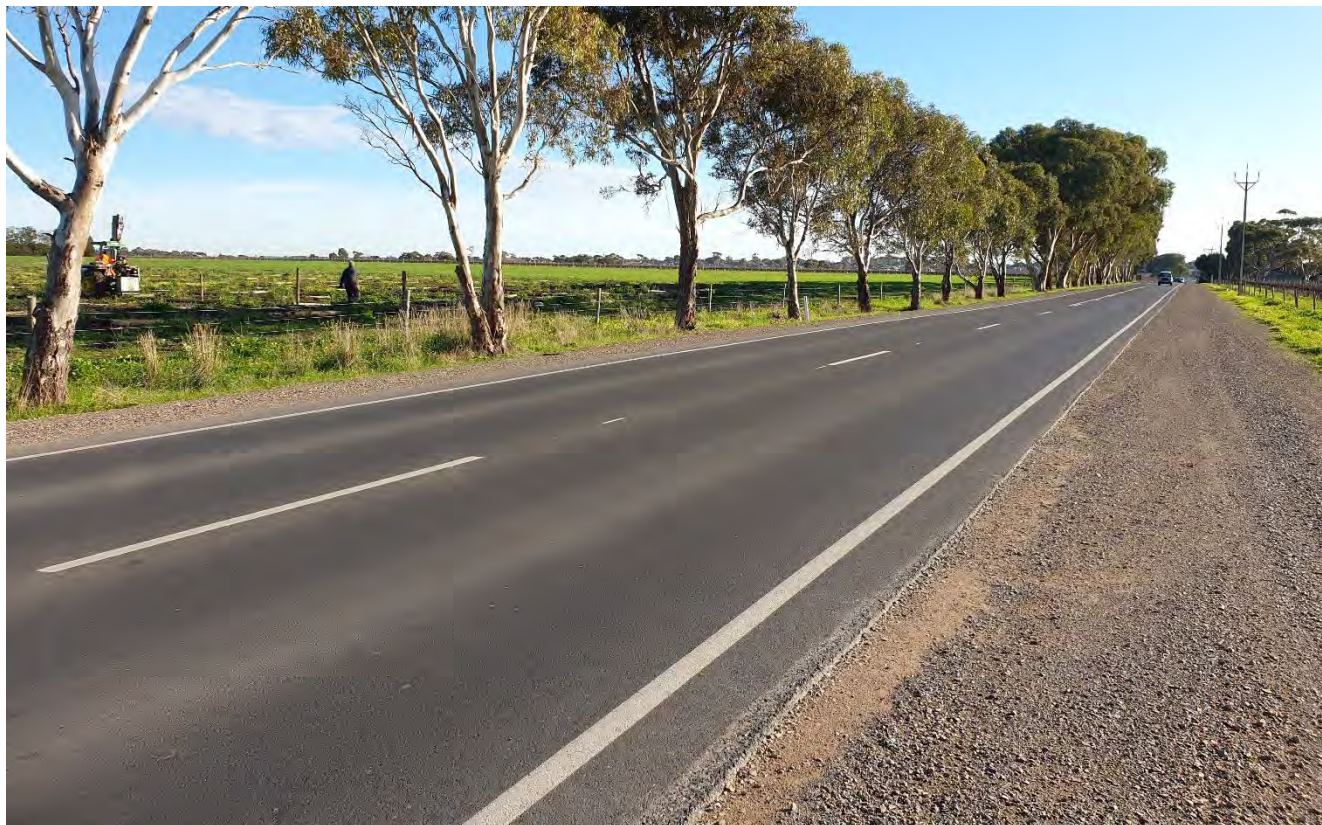
At the time of our assessment, a 500m section of Main Road, north of Branson Road was being resealed. A follow-up review of the surface condition revealed that this had removed most of the undulations in the surface; however, reactive soils and high groundwater use in the vicinity can often lead to undulations to returning shortly after. Full road reconstruction between McLaren Vale and Willunga may be required to address the recurring issue.

Figure 67: 500m of resealing north of Branson Road has significantly improved comfort between McLaren Vale and Willunga
