Regional Road Assessment: Fleurieu Peninsula and McLaren Vale

Report: August 2021

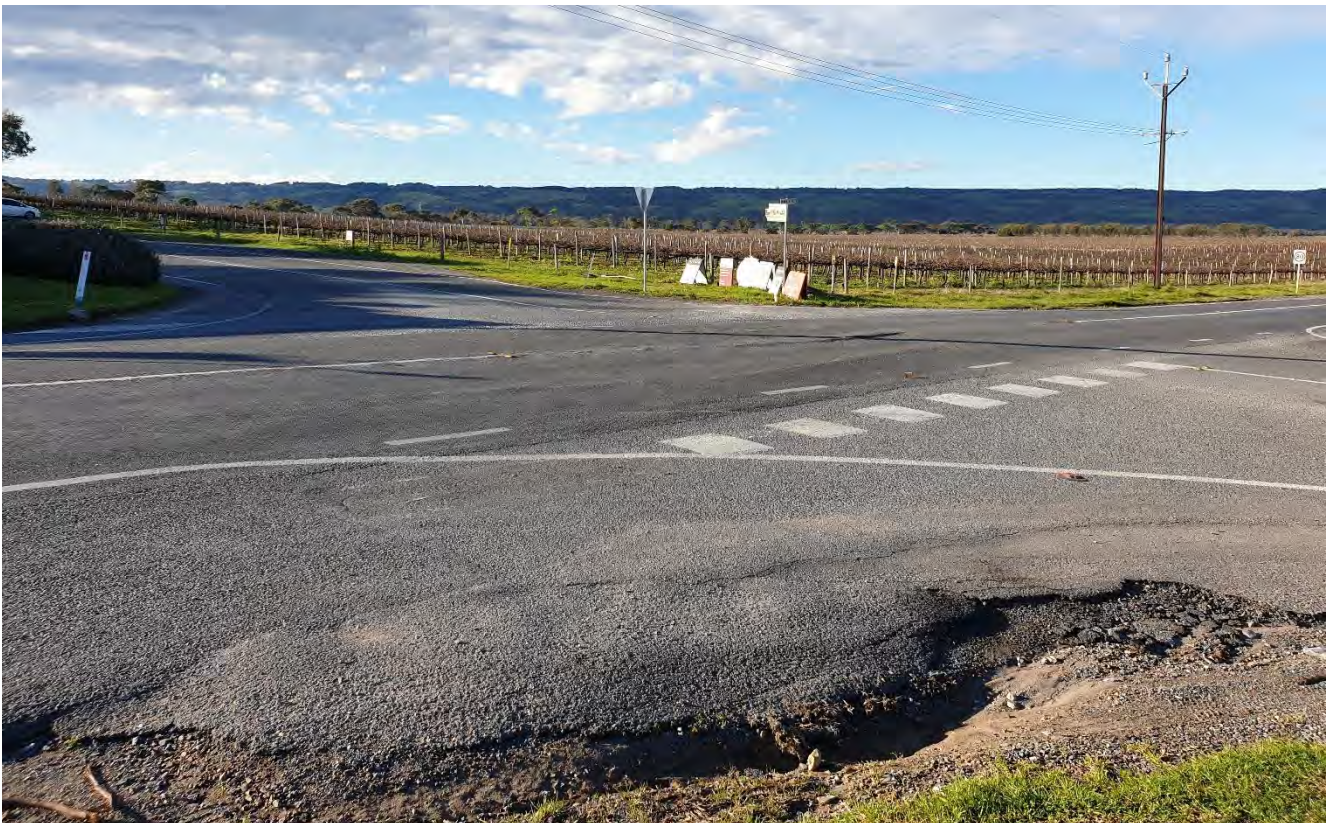
RAA's primary safety concern for Main Road is the design of intersections between McLaren Vale and Willunga, with the current four-way crossroad design not fit for the current purpose and function of the road. There are four crossroad intersections along the corridor which should all be prioritised for upgrade, with the highest priority for the intersection with Malpas Road and Binney Road due to the higher traffic volumes on Malpas Road compared to other side road approaches and the 80km/h speed limit.

Figure 69: A roundabout will improve safety at the intersection with Main Road, Johnston Road and McMurtrie Road

Upgrades at Binney Road/Malpas Road and McMurtrie Road/Johnston Road must strongly consider roundabouts given the collector and sub-arterial function of the intersecting roads. They provide an important east-west link across the region and carry high volumes of tourist traffic with several highly popular destinations along each road.

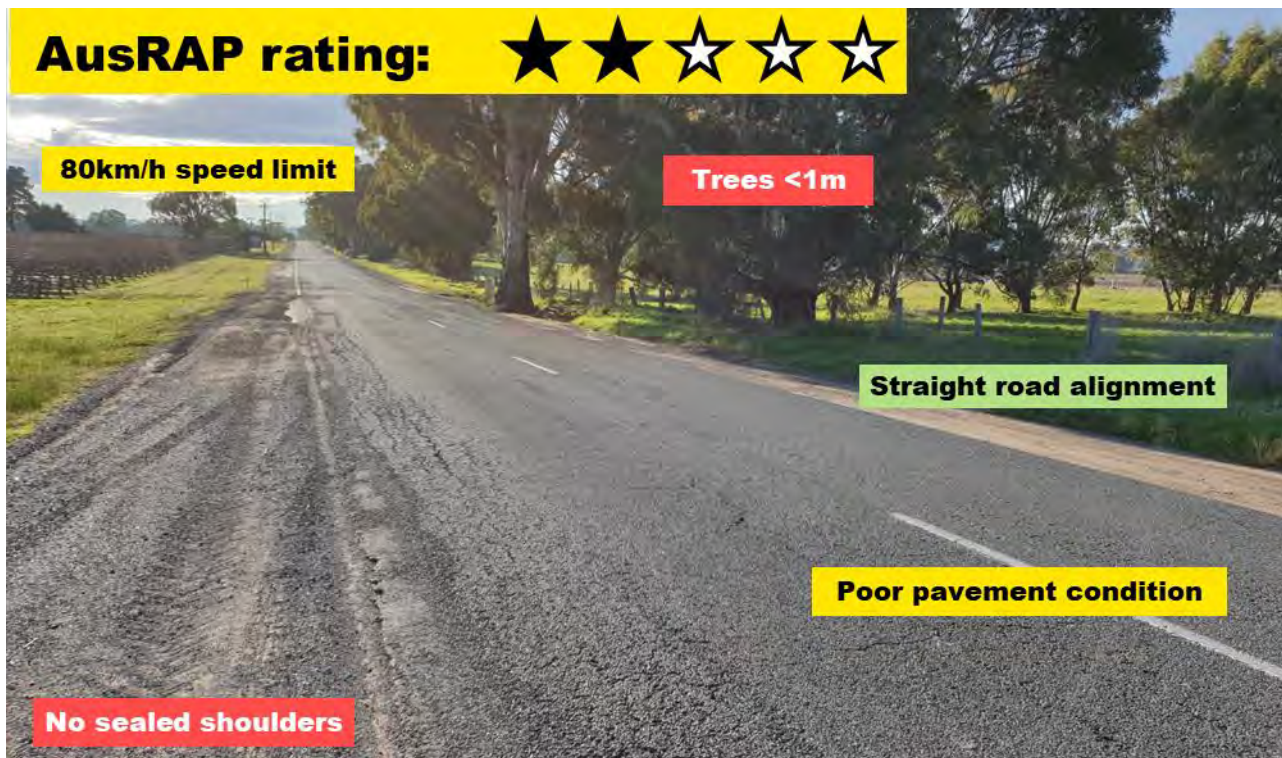
Kangarilla Road is typically rated between 1 and 2 stars, with the presence of roadside hazards one of the key contributing factors to this rating. Sections with trees and stobie poles on both sides of the carriageway are rated one star, whereas sections with hazards on only one side of the carriageway are more likely to be rated as two stars.

Figure 71: Typical AusRAP star rating on Kangarilla Road

Installing sealed shoulders and resealing the road will bring Kangarilla Road to a two-three star standard and protecting roadside hazards in conjunction with this will see the road receive a four star rating due to its straight and flat alignment.

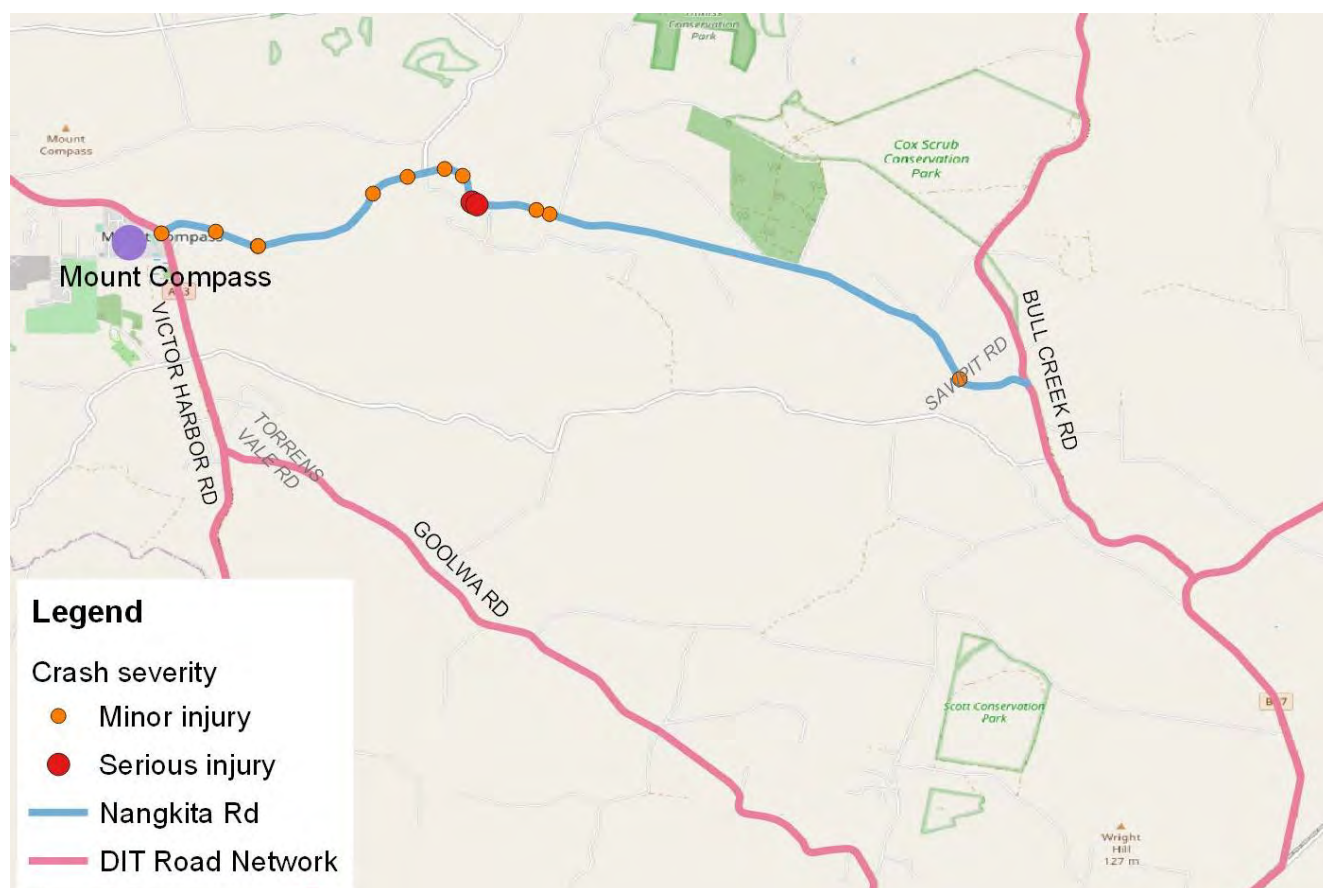
Of all crashes, 13 out of 14 occurred on the 6km section between Victor Harbor Road and Stones Ford Road, as highlighted in Figure 73. Whilst traffic volume data is not publicly available for council roads, using an assumption of 1,000 vehicles per day gives this 6km section a very poor casualty crash rate of 119 casualty crashes per 100 million vehicle kilometres travelled.

Figure 73: Locations of casualty crashes occurring on Nangkita Road between 2016 and 2020

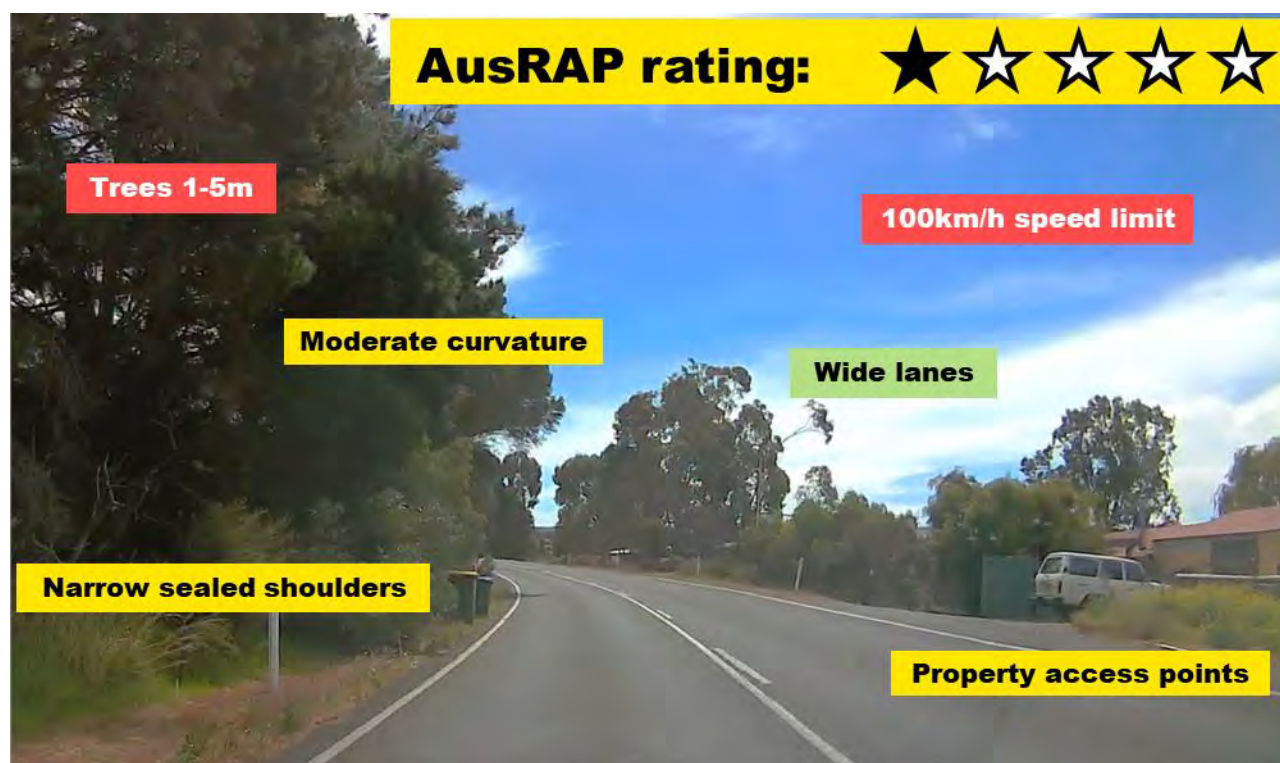
Nangkita Road is typically rated between one and two stars under AusRAP star rating protocols. The section pictured in Figure 74 is an example of a high one star rated section of Nangkita Road near Bull Creek Road.

Figure 74: Typical AusRAP star rating on Nangkita Road

The star rating of this section would increase from one to two stars if the sight distance around the curve was improved, or the speed limit was reduced to 80km/h. If trees were located behind a crash barrier, this section would be rated three stars.

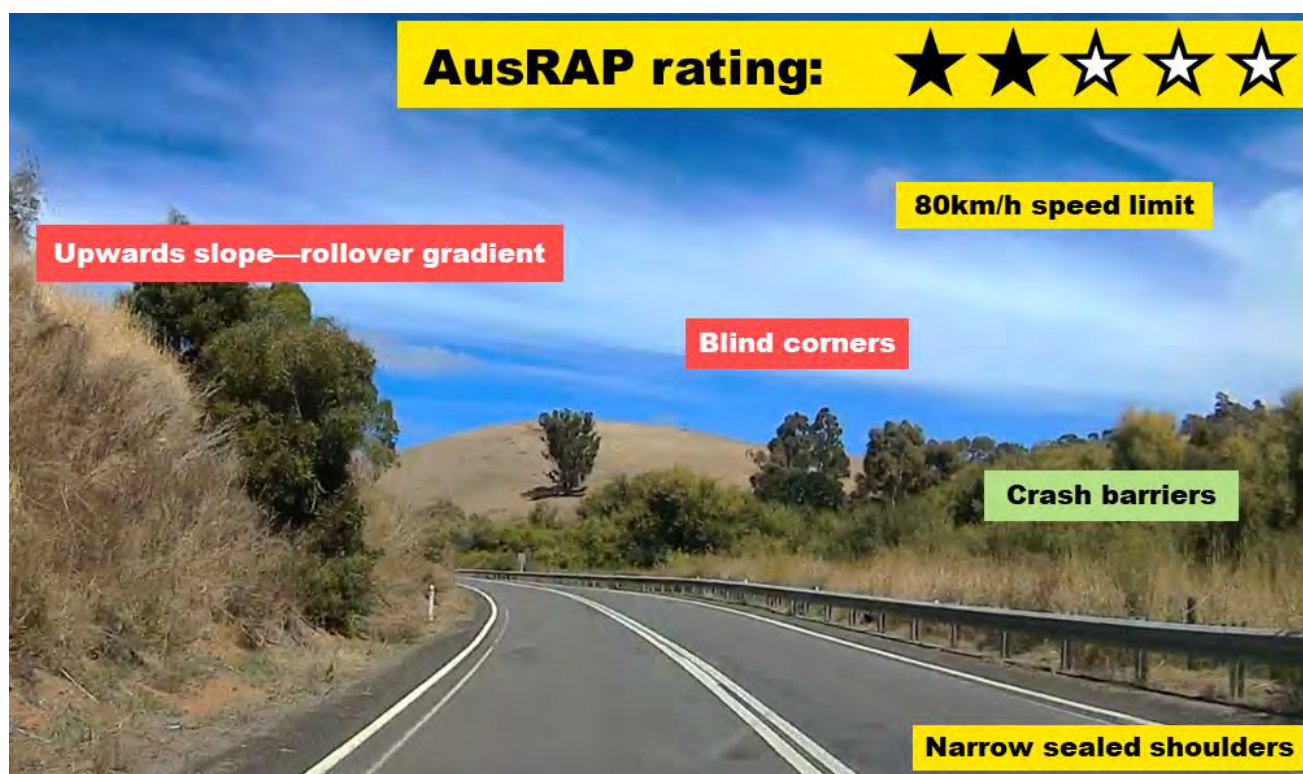
Bull Creek Road is typically rated one or two stars, with some short three-star sections. The section pictured in Figure 80 below is an example of a high two star rated section north of Ashbourne in the 80km/h zone, which could be improved to three stars by widening the lanes and shoulder or introducing additional barrier protection on the passenger side of the road. These treatments would be costly due to the need to excavate the embankment to widen the road or provide enough clearance behind the barrier for horizontal deflection. For comparison to the section south of Ashbourne, this section would be rated one star if it were in the 100km/h zone.

Figure 80: Typical AusRAP star rating on Bull Creek Road

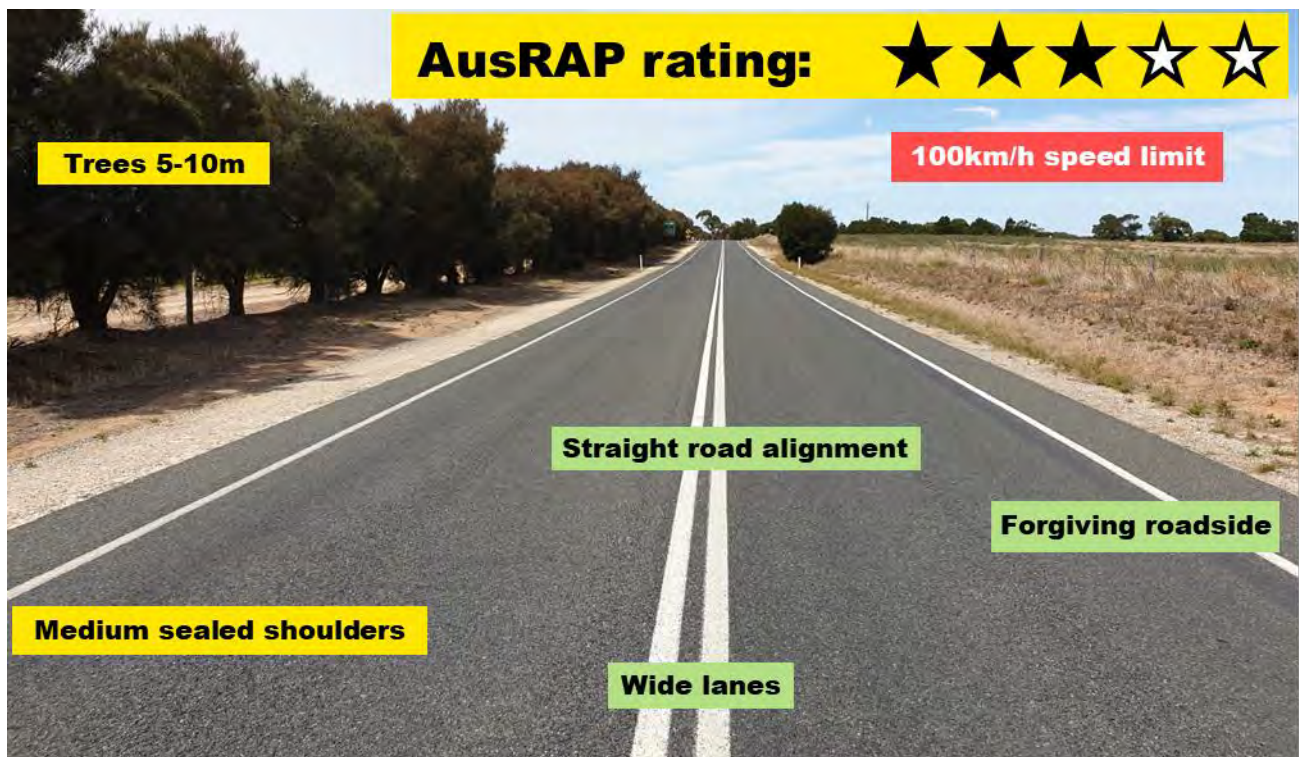
Langhorne Creek Road is typically rated three stars under AusRAP star rating protocols, largely due to its good geometry and relatively well maintained 5m clear zone. Curves, intersections, and areas where hazards are within 5m of the road are more likely to be rated two stars.

Figure 83: Typical AusRAP star rating on Langhorne Creek Road

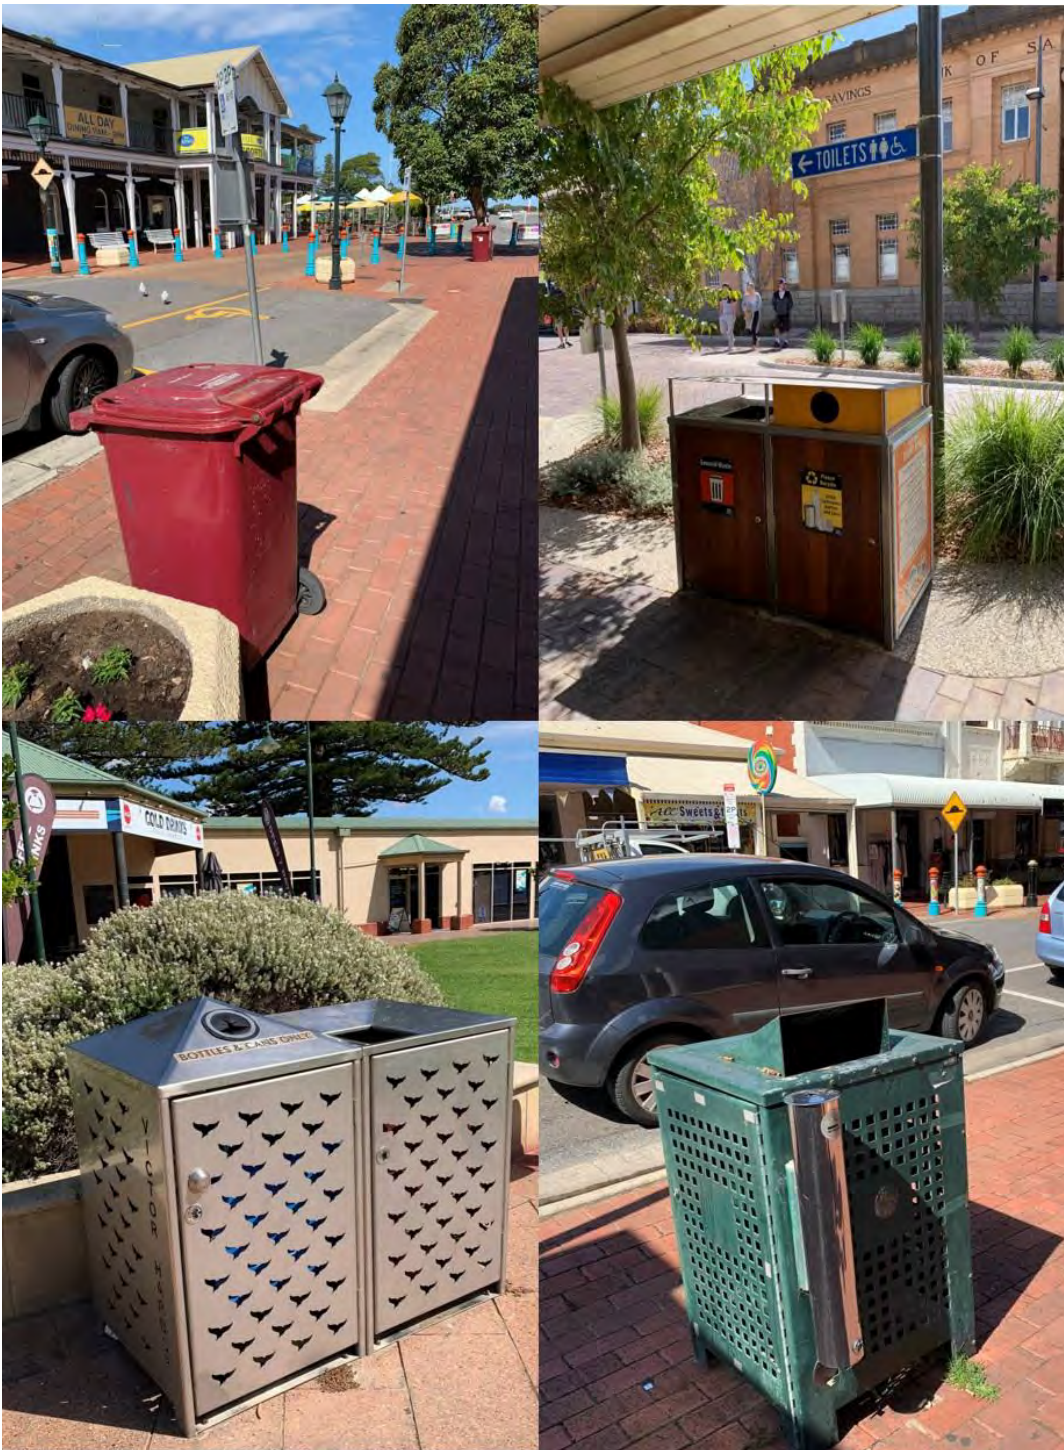
Figure 89: Street bins in the centre of Victor Harbor vary widely in type and quality

- Installing road signage to assist visitors in locating electric vehicle charging points on Stuart Street and large vehicle parking bays on the Esplanade
- Establishing additional large vehicle parking bays
- Rolling out street bins with separate waste and recycling compartments seen on Ocean Street uniformly across the central area – currently there is inconsistency in the type and quality of bin provided
- Pedestrian wayfinding could be installed to guide visitors to nearby attractions such as Granite Island, the attractions around Warland Reserve and Victor Central Shopping Centre

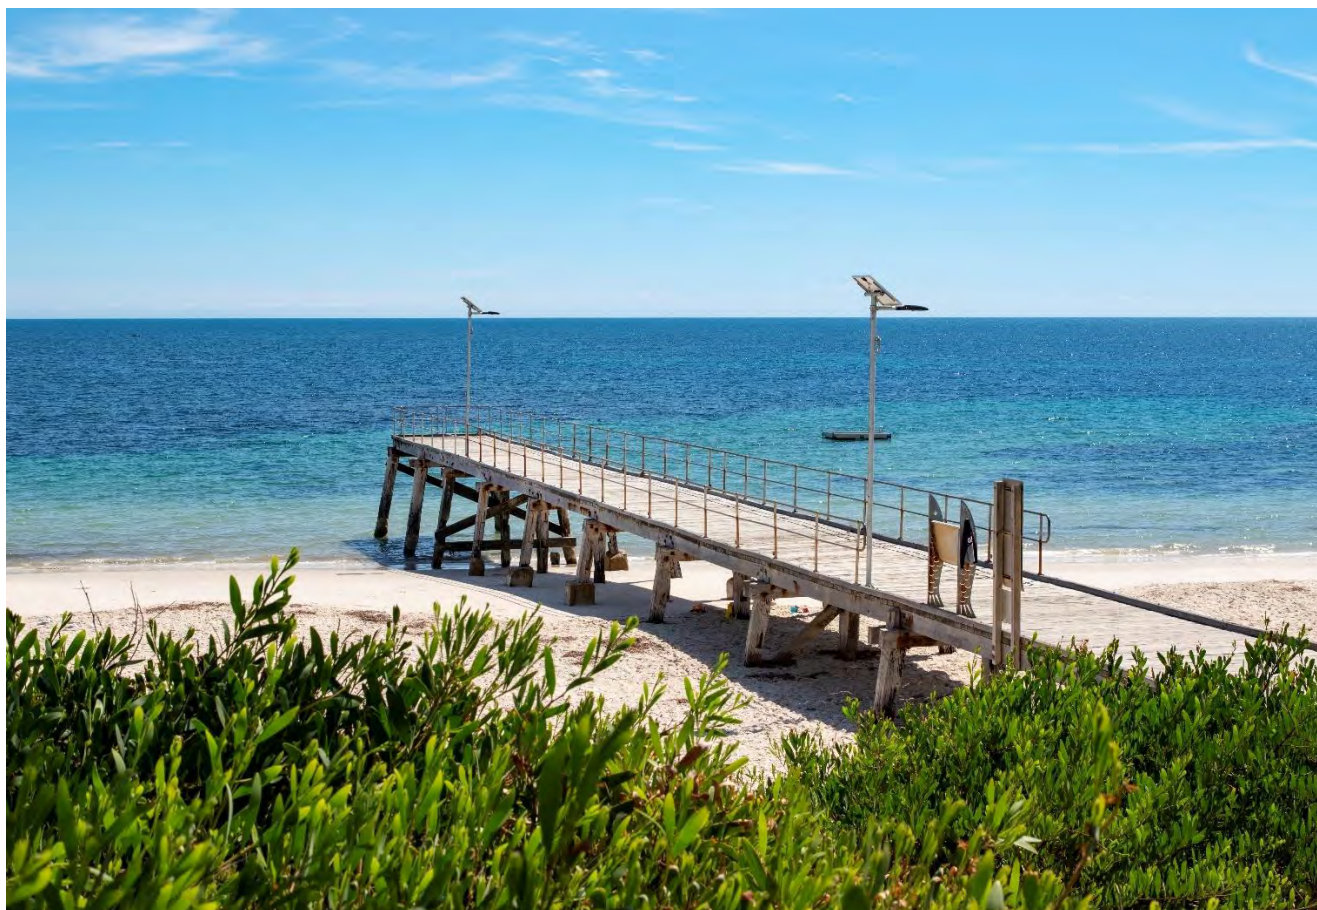
Figure 91: An improvement to the Normanville's jetty infrastructure is highly sought after by locals and would attract visitors

- Considering a complete redevelopment and extension of the existing Normanville jetty infrastructure to further enhance the proposed upgrades to the Normanville Foreshore Masterplan and assist in attracting visitation. RAA recognises the council's role as an advocate of the State Government owned jetty and is open to collaborating on the issue
- Unlike other towns in the region, no signs were seen advertising free public Wi-Fi
- Providing more time restricted parking bays during daytime hours could help to provide visitors with better access to shops and services
- Establishing additional large vehicle parking bays
- Improving road signage and wayfinding to assist visitors in locating public services and facilities such as the electric vehicle charging station on Edwards Avenue
