Little Sahara Dunes Complex Access

Road Safety Audit

March 2017

RAA

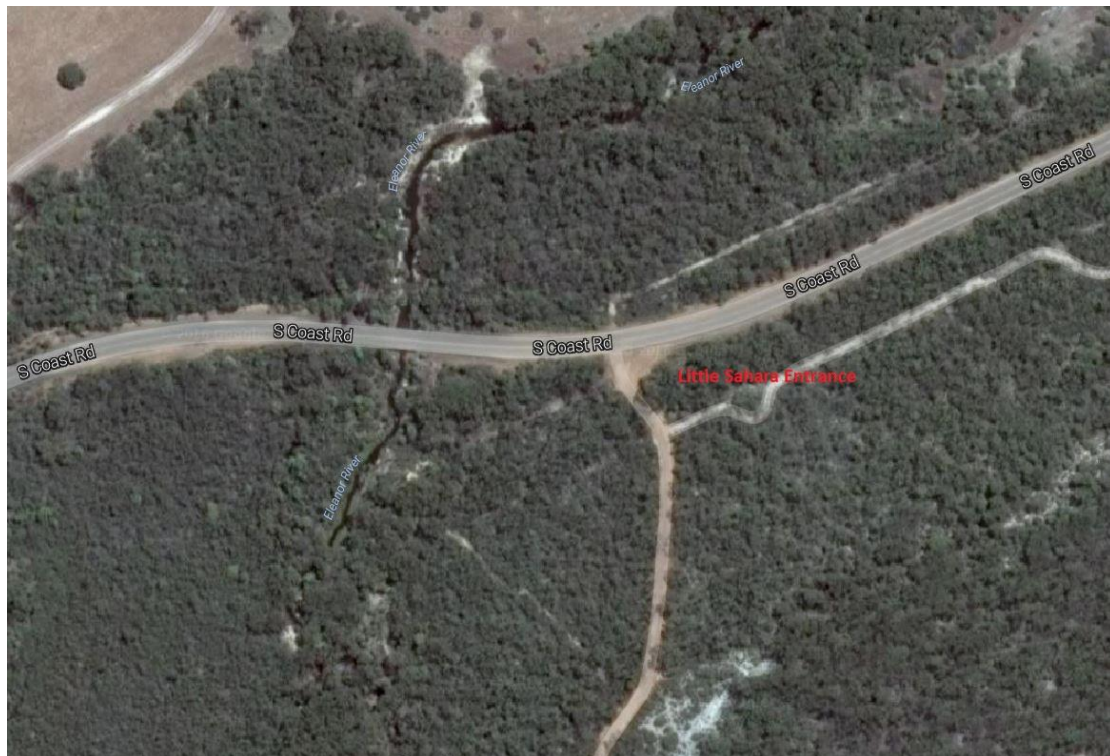
Figure 1 – Site

Since 2010 there have been seven (7) reported crashes at this location, all attributed to driver inattention. All crashes incurred property damage to both the vehicles involved and the guardrail. In one instance, the crash was so severe, the vehicle hit the guardrail twice. There were a total of 7 crashes at the site, 4 of which were serious injury crashes.

There is a speed advisory sign of 85km/hr on approach to the curve and temporary 'Reduce Speed' signs have also been installed by Council since August 2015. The lane widths are narrow, ranging from 2.9m at the last chevron alignment marker (CAM) before the bridge to 3.4m at the first CAM before the turn off into Little Sahara. Edge breaks are apparent against the unsealed shoulder and two Raised Reflective Pavement Markers (RRPMs) have been damaged and are no longer effective.
