# Tinsmith Corner

Road Safety Audit

March 2017

# Tinsmith Corner Road Safety Audit

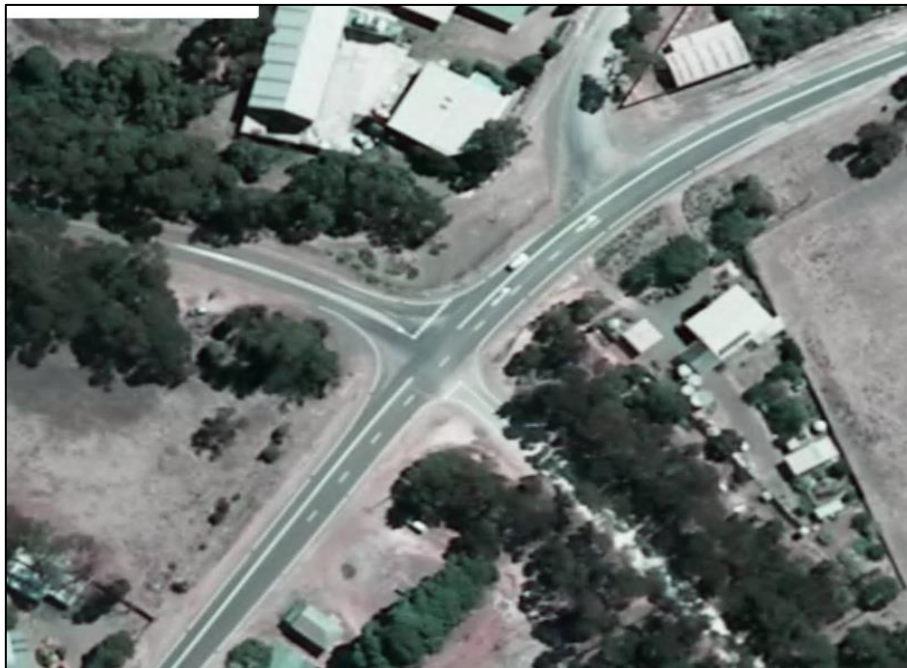
Figure 1 - Site

Tinsmith Corner is located three kilometres from Kingscote, connecting North Coast Road and Tinsmith Road to the Playford Highway. There are some standing geometric characteristics that present at this site, including:

- A 280 metre long broken back curve;
- Sight distance is limited to 150 metres within a 100 km/h zone;
- An additional intersection (Bullock Track) less than 40 metres from the intersection of Tinsmith Road and Playford Highway; and
- Presence of trees that restrict sight distance on the curve.

Prior to 2003, when an additional by-pass lane was added, there were regular occurrences of accidents or near miss incidents. The by-pass lane shown, while correcting the propensity for driver error, introduced some added issues:
