Heatherbank Terrace, Stonyfell

Road Safety Audit

May 2017

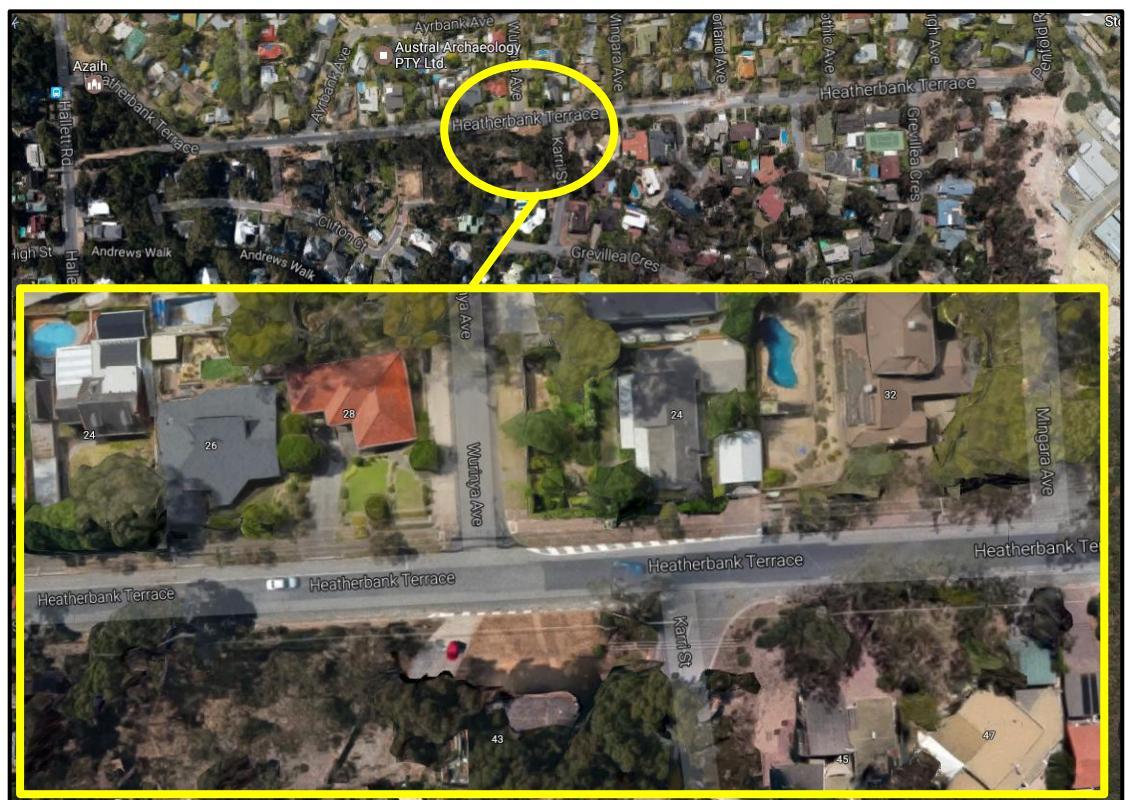
Figure 1 – Location of driveway link on Heatherbank Terrace

Heatherbank Terrace is a residential street in Stonyfell running in an east-west direction, connecting Hallet Road to Penfold Road. The street is characterised by a steep grade, which peaks at 16%, running downhill in the westbound direction.

Between 2006 and 2015, there were 7 crashes reported on Heatherbank Terrace involving property damage to vehicles. The only crash that occurred within the vicinity of the driveway link was a "hit parked vehicle" crash in 2011. Since the driveway link was installed in 2016, RAA is not aware of any crashes having occurred on Heatherbank Terrace.
