Risky Roads

Survey Results 2017

June 2017

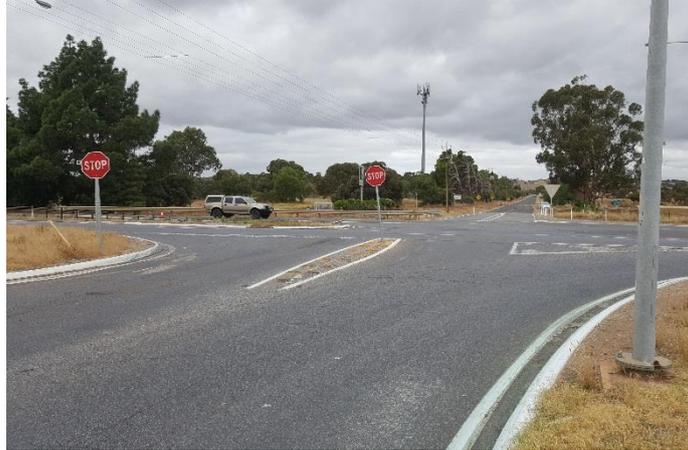
The intersection of Dalkeith Road and Main North Road is a new entry onto the top 10 list, despite having been a concern for some time. It received a handful of nominations in the 2013 Risky Roads survey, but didn't garner enough votes to make the top 10 list. It is a four-way unsignalised intersection in Kudla, on the outskirts of Gawler. Main North Road, which passes through the intersection, is a dual carriageway which has a speed limit of 90km/h and accommodates an average of 34,800 vehicles per day. This traffic volume is an increase of 10% when compared with five years ago. The exit from Dalkeith Road is controlled by a stop sign, whilst the exit from the opposite Smith Road is controlled by a give way sign. The intersection is maintained by the State Government.

A scroll through the archives from The Bunyip brings up many articles regarding resident frustration regarding this intersection and how there have been several unsuccessful attempts to secure Black Spot funding to make it safer. The majority of crashes that occur at this intersection are right angle crashes, most often as a result of vehicles on Dalkeith Road disobeying the stop sign, by virtue of either not bringing their vehicle to a complete halt or by not giving way to vehicles on Main North Road.
